**REPORT  
ON  
GEOTECHNICAL ASSESSMENT**

**PROPOSED RESIDENTIAL SUBDIVISION  
TALBINGO VILLAGE  
TALBINGO**

*Prepared for:*  
**SITE PLUS PTY LTD**

**APRIL 2006  
PROJECT 40569**

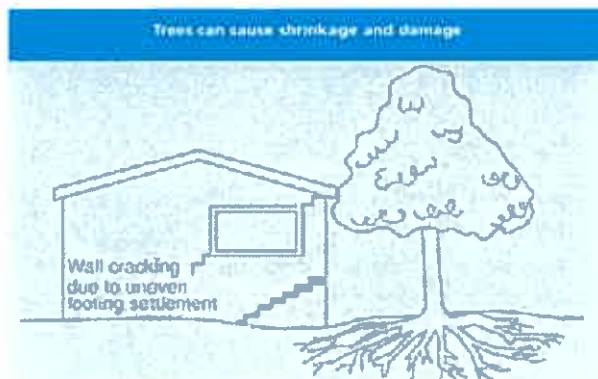
As the moisture absorption process completes its journey to the innermost areas of the building, the internal footings will rise. If the spread of moisture is roughly even, it may be that the symptoms will temporarily disappear, but it is more likely that swelling will be uneven, creating a difference rather than a disappearance in symptoms. In buildings with timber flooring supported by bearers and joists, the isolated piers will rise more easily than the strip footings or piers under walls, creating noticeable doming of flooring.

As the weather pattern changes and the soil begins to dry out, the external footings will be first affected, beginning with the locations where the sun's effect is strongest. This has the effect of lowering the external footings. The doming is accentuated and cracking reduces or disappears where it occurred because of dishing, but other cracks open up. The roof lines may become convex.
