GEOTECHNICAL INVESTIGATION REPORT

Project Title – 20 Heradale Pde, Batemans Bay

Project Type – Proposed Residential Development

Project No. – GR23206 Rev 01

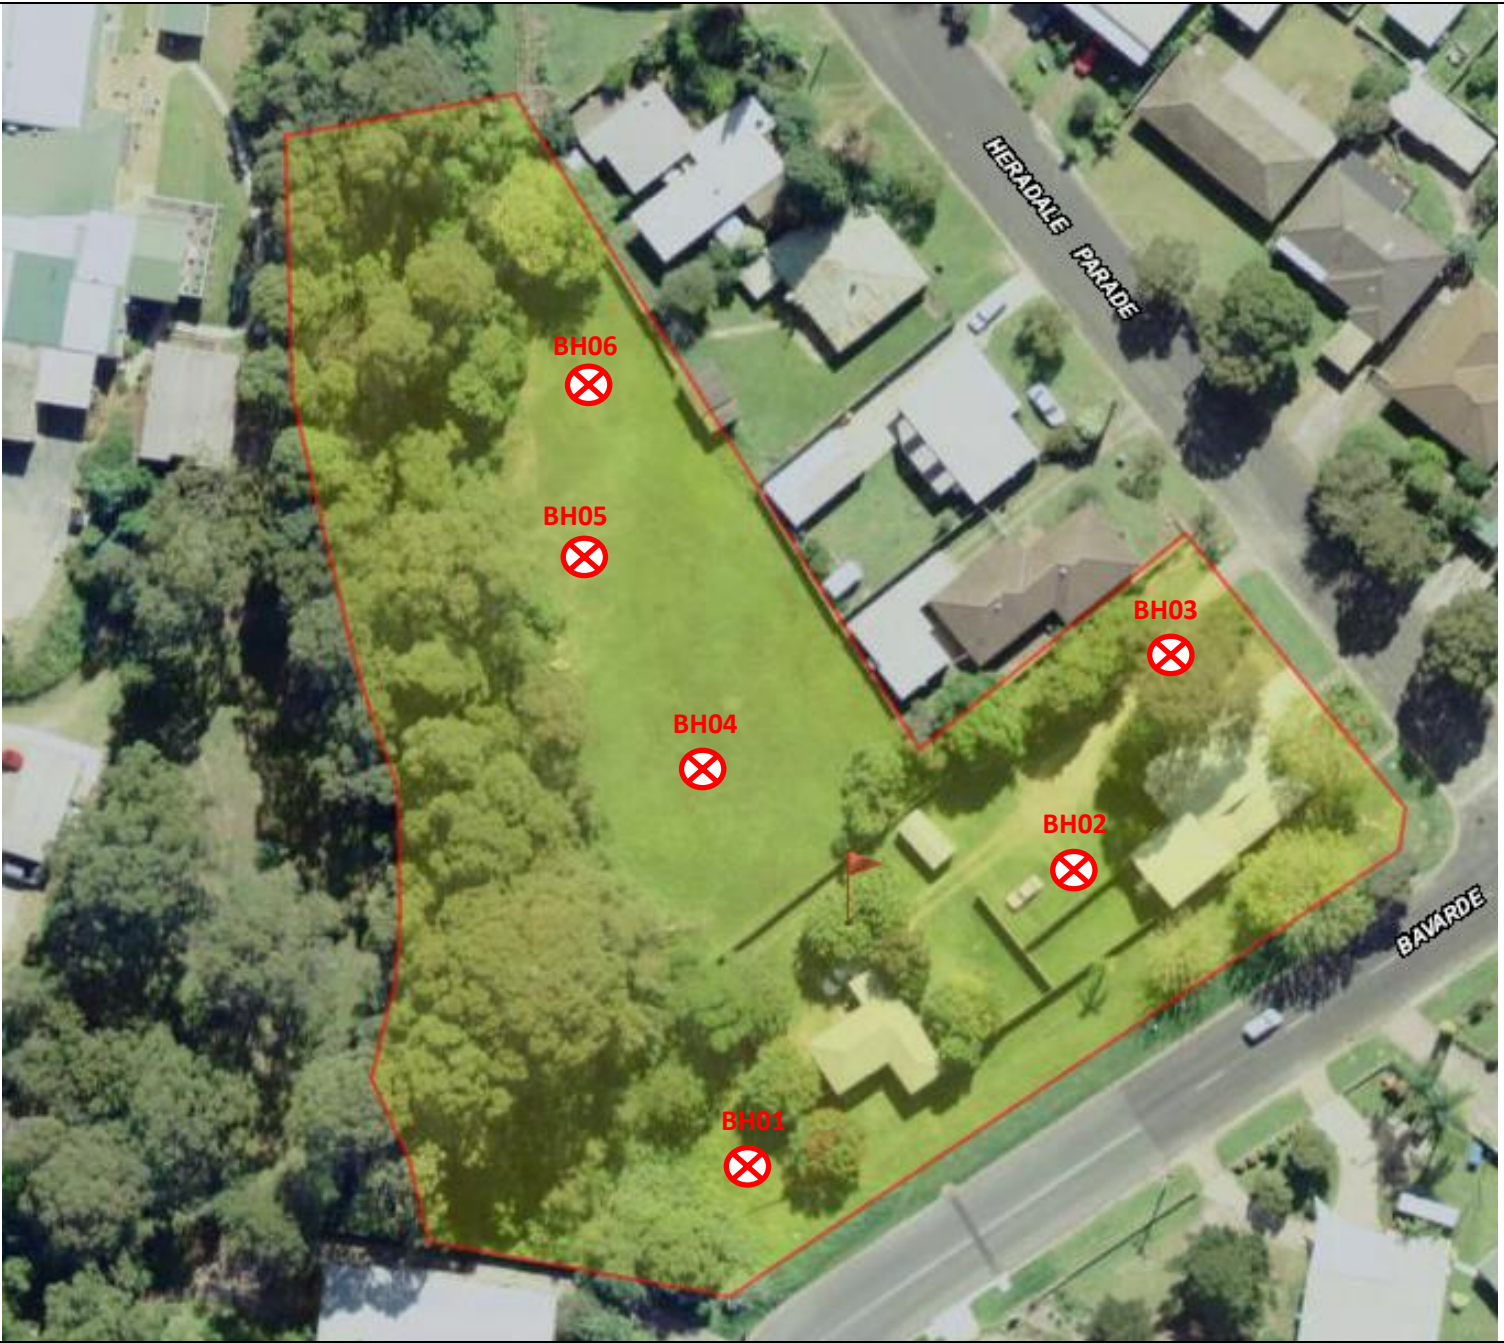
Appendix A:
Site Plan with Borehole Locations

Drawn	KT	CLIENT: PLACE STUDIO AU PTY LTD SITE ADDRESS: 20 Heradale Pde, Batemans Bay	Figure	1
Checked	SG		Title	Site Plan
Date	12/10/2023		Job No	GR23206
Scale @ A3	NTS

The results of the investigation indicate that the subsurface profile comprises poorly graded sand underlain by siltstone bedrock. Based on the borehole information, a summary of subsurface conditions is presented below. The location of each borehole can be found in Appendix A and more detailed logs can be found in Appendix B
