Place Studio AU Pty Ltd

**Project:** Proposed Residential Development  
**Site Location:** 20 Heradale Pde, Batemans Bay NSW  
**Reference:** GR23206-A Rev 01  
**Report Date:** 03/09/2024

## **RE: Groundwater Assessment**

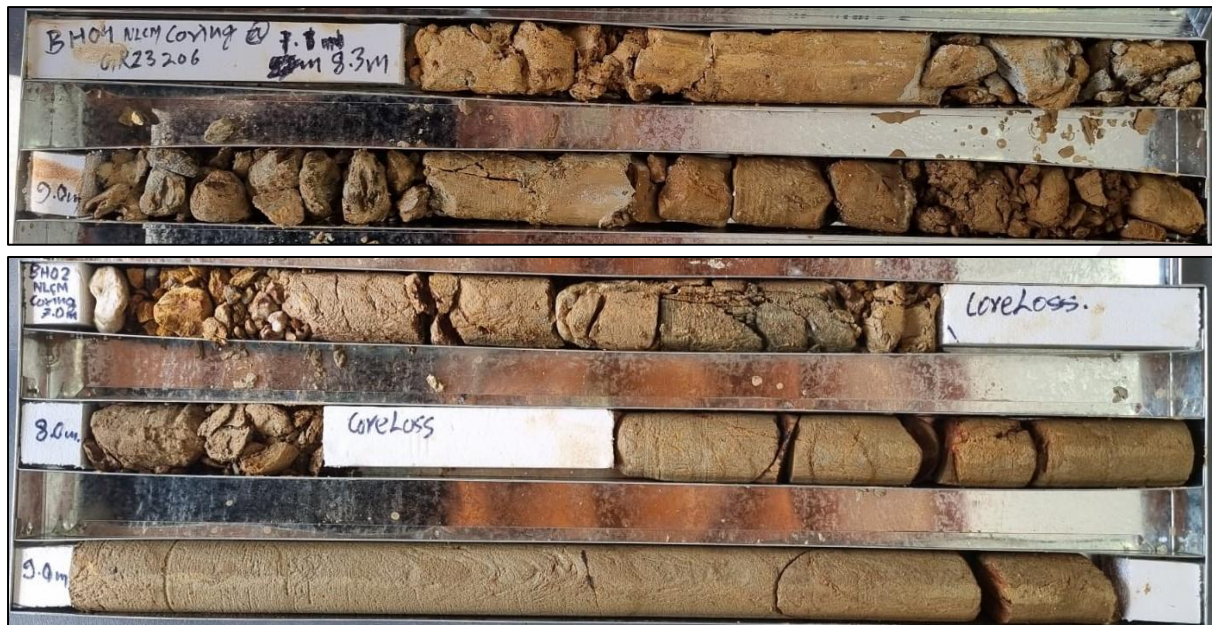
**Figure 2:** Coring Photos – Borehole BH01 (Top) and BH02 (Bottom)

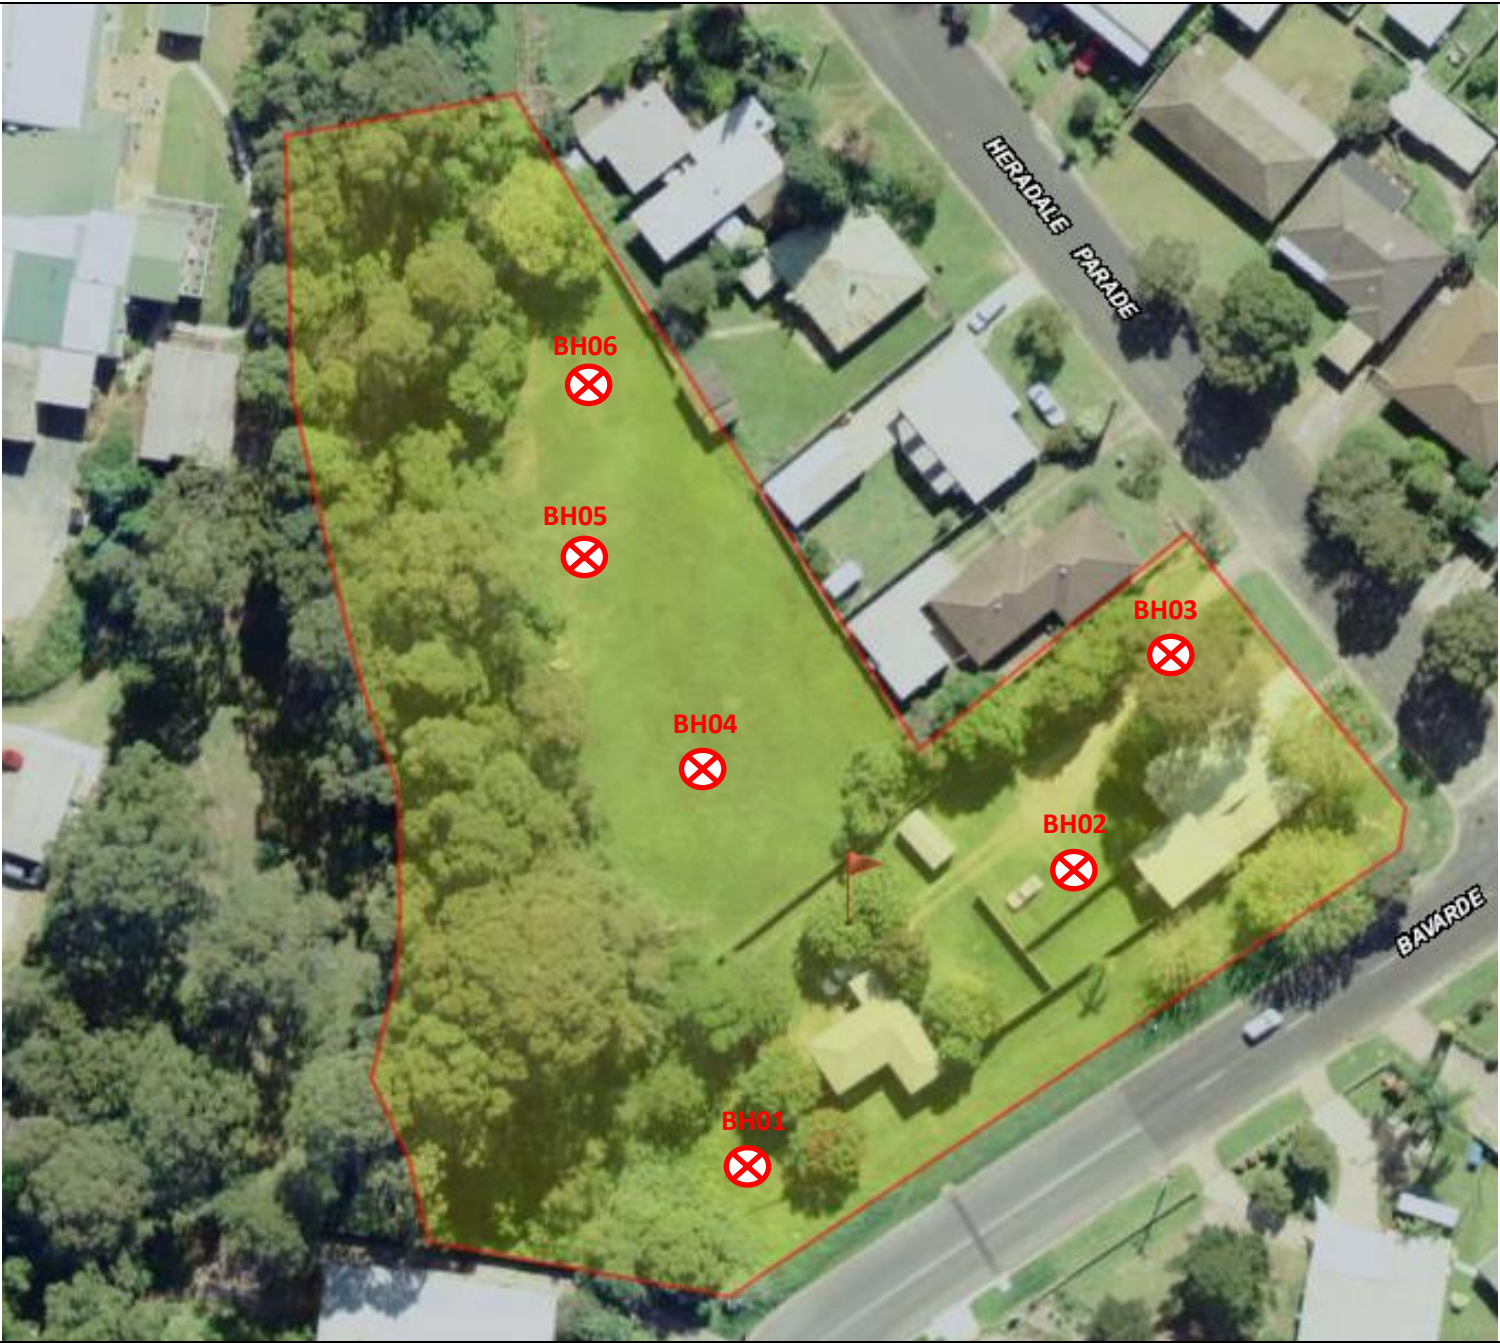
**Appendix A:**  
**Site Plan with Borehole Locations**

The results of the investigation indicate that the subsurface profile comprises poorly graded sand underlain by siltstone bedrock. Based on the borehole information, a summary of subsurface conditions is presented below. The location of each borehole can be found in Appendix A and more detailed logs can be found in Appendix B
