### Re: Chelsea Gardens Estate

SEEC have been invited by Aoyuan International (our client) to respond to peer reviewed comment on SEEC report 2000035-LC by 03/05/2022 to align with a scheduled meeting between the client and Wingecarribee Shire Council. The report in question has multiple revisions it is assumed the comments made relate to the latest revision 20000305-LC-03 dated 6/11/2020. Comments made by the peer reviewer and SEECs response are presented below:

### Comments by Terry Hams, Beveridge Williams, 2022

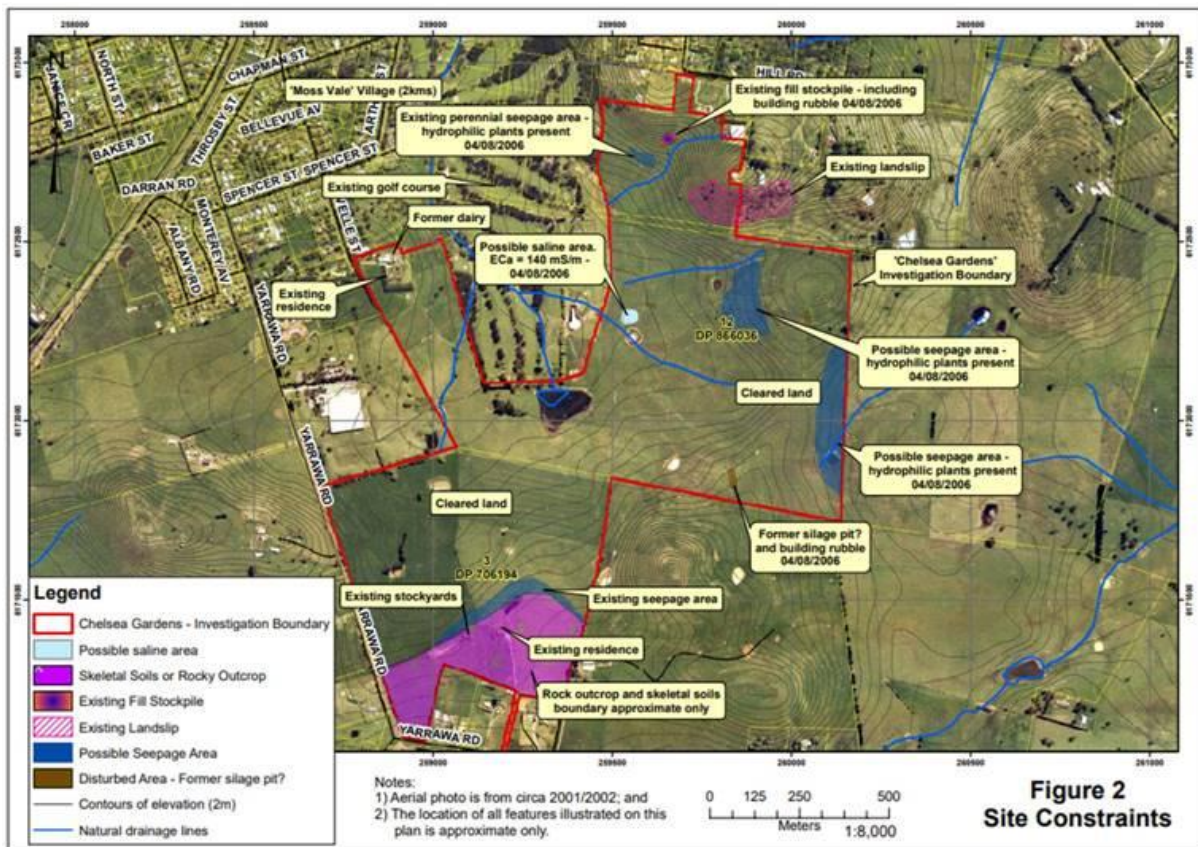
*“I have obtained a copy of the 2006 Harvest report from Council’s DA Tracker site. This report refers to possible groundwater/salinity issues at page 7 and considers the issue of groundwater from pages 16 to 19 with the general findings depicted in Figure 2 which has been copied below.*

Copy of Figure 2 from Harvest Report 2006.

At Page 7, an area of seepage is reported as having been observed around the rock outcrop on the south-east portion of the site (currently planned for Stage 2). This area is identified in Figure 2 as being around the perimeter of the purple-coloured rock area and is distant from the proposed irrigation area in the east of the site.

Further, an existing perennial seepage area is noted as having been observed in the northern portion of the site. This area is located to the north of Shelly Road in Figure 2 and again distant from the proposed irrigation area.

At page 7, of the Harvest Report there is a comment that “rush plant species (*Juncus* sp) were observed sporadically over the major part of this site. This plant species indicates that the site is probably poorly drained (in places) and possibly intermittently saturates.” There are two areas in Figure 2 which are adjacent to the proposed irrigation area where these plants were observed. It is noted that these areas are not identified as seepage areas, just areas with rush plants.

At page 20, the Harvest Report confirms that “During field investigations on the 4th of August, 2006, two main areas of seepage were observed on this property (Figure 2). The first

of these was located in the northern portion of the CGDS in the steep area near hill road and the second occurs in the southern portion of this CGDS at the base of the syenite/microsyenite plateau." Both of these areas are identified in Figure 2 and are both distant from the proposed irrigation zone.

It is noted that SEEC Test pits 2 and 5 are located in the eastern blue area marked in the Harvest Figure 2 as a "possible seepage area" and that SEEC Test pits 4 and 7 are in the

*other blue area marked in the Harvest Figure 2 as "possible seepage area" located to the immediate west of the proposed irrigation area.*

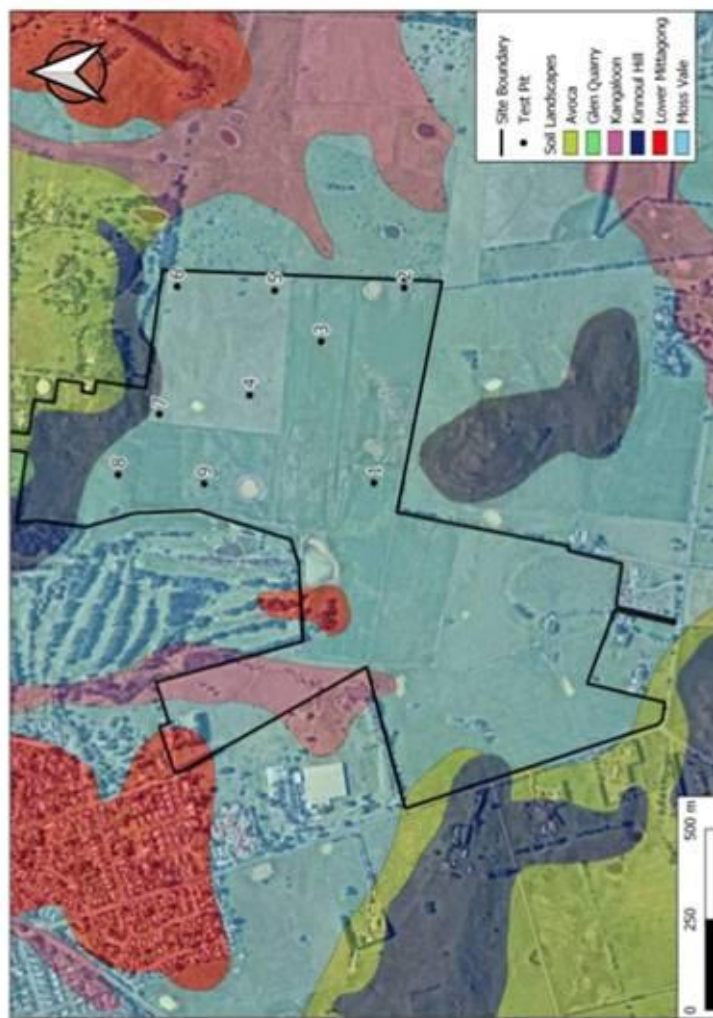
The Land Capability Assessment (LCA) completed by SEEC in October 2020 was based on 9 test pits with the test pits being spread across the proposed irrigation site as indicated in Figure 4 of the LCA (copied below).

Figure 4. Soil Landscapes and Location of Test Pits.

Copy of Figure 4 from SEEC LCA.

*These SEEC test pits were excavated to a depth of at least 1m and no sign of saturation or seepage was noted. The soils were generally classified as being "moderately well drained".*
