# Security and CPTED Report

Project Reference: 896 Woodville Road, Villawood

Project Address: 896 Woodville Rd, Villawood, NSW 2163

Report Ref: 390910-896-Woodville-Rd-CPTED-Report-

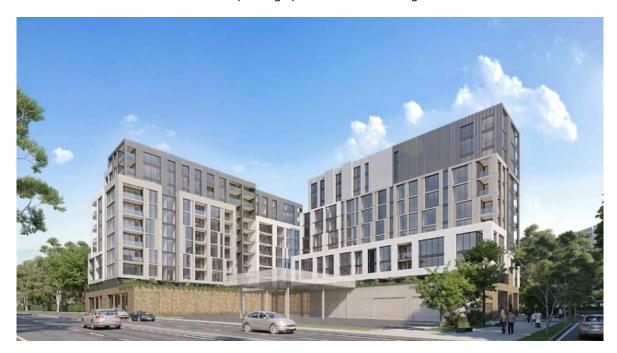
Figure 5-1 – Proposed development.

We understand the project involves the development of 896 Woodville Road Villawood, for ABA Pty Ltd. The proposal includes a Mixed-Use Building with 148 units along with ground floor retail spaces as well as residential and commercial parking spaces as shown in Figure 5-1.

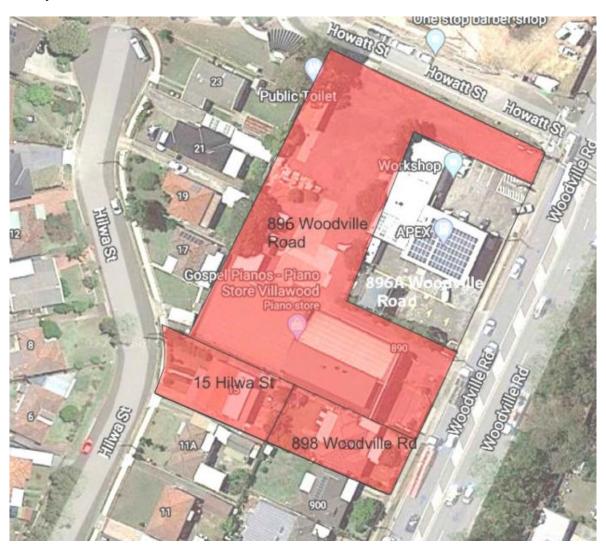
Figure 5-2 – Aerial view of Proposed Development (Courtesy of Six Maps)

The site is shown by the aerial view in Figure 5-2. The development is a C shaped building with its south-east side having the longest frontage facing Woodville Road sharing common boundaries with the adjacent fuel station.

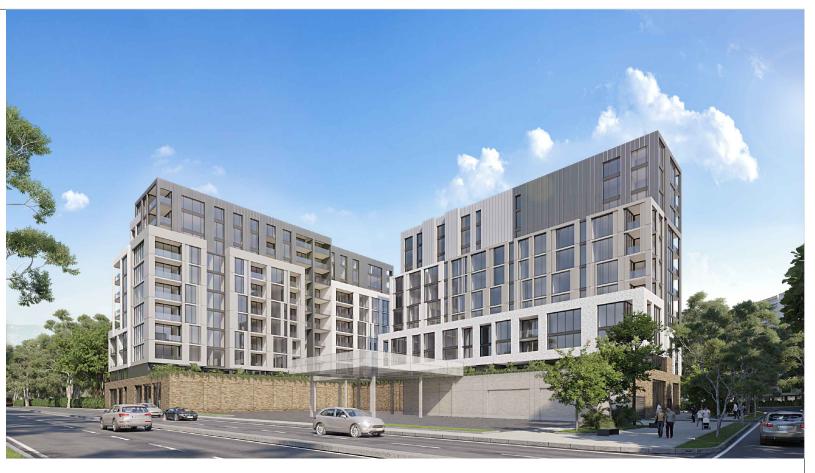
890 WOODVILLE ROAD, VILLAWOOD, NSW 2163 ZONING: B2 – LOCAL CENTER-SHOP TOP HOUSING

SITE AREA	4135.1 m <sup>2</sup>
HEIGHT (PERMISSIBLE) (AFFORABLE HOUSING SCHEME)	35.1 m(27.0m LEPX130%)
HEIGHT (PROPOSED)	35.1 m
FSA (PERMISSIBLE)	N/A
FSA (PROPOSED)	5.1:1
LAND USE	B2- LOCAL CENTER
TOTAL CAR SPACES REQUIRED	259
TOTAL CAR SPACES PROVIDED	246
RESIDENTIAL PARKING	
COMMERCIAL PARKING
