# Review of Environmental Factors –Glen Innes Hospital Upgrade (Demolition)

Prepared by GeoLINK

This Review of Environmental Factors (REF) has been prepared for NSW Health Infrastructure (HI) and assesses the potential environmental impacts which could arise from demolition of the Old Nurses Quarters at Glen Innes Hospital located at 85 Taylor Street, Glen Innes.

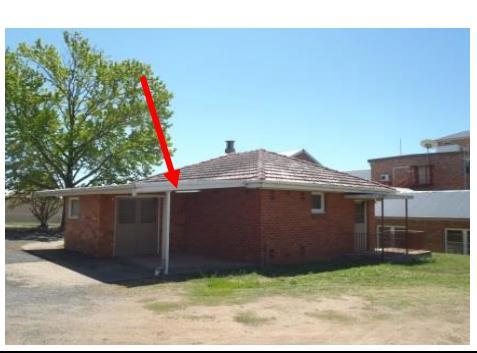
Mortuary (GI03): Photo No. 042: Eave

The Flat Fibre Cement Sheet soffit lining to the eave was presumed to contain asbestos and **as such SHALL** be considered an asbestos-containing material until or unless it is proven otherwise. Damaged sheets were replaced in 2012.

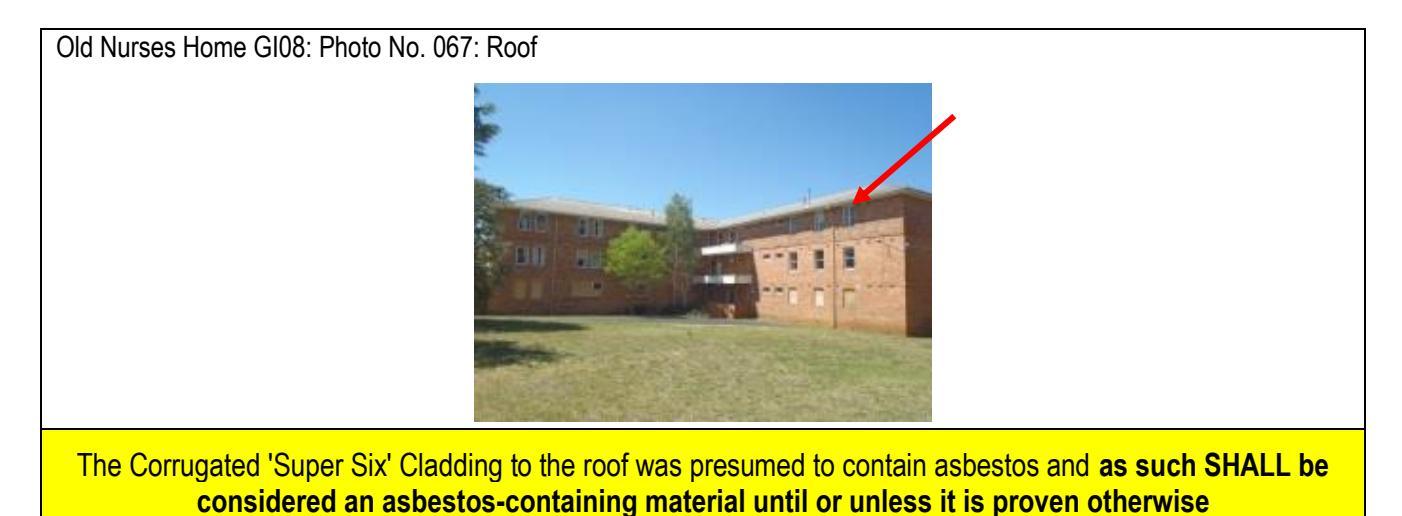
### **Old Nurses Home**

Built in the early 1950s, a three-storey construction built of solid brickwork and concrete floors, timber framed roof with asbestos corrugated roof sheeting. There is friable asbestos debris throughout the subfloor and ceiling of this building. Do not enter unless under controlled conditions.

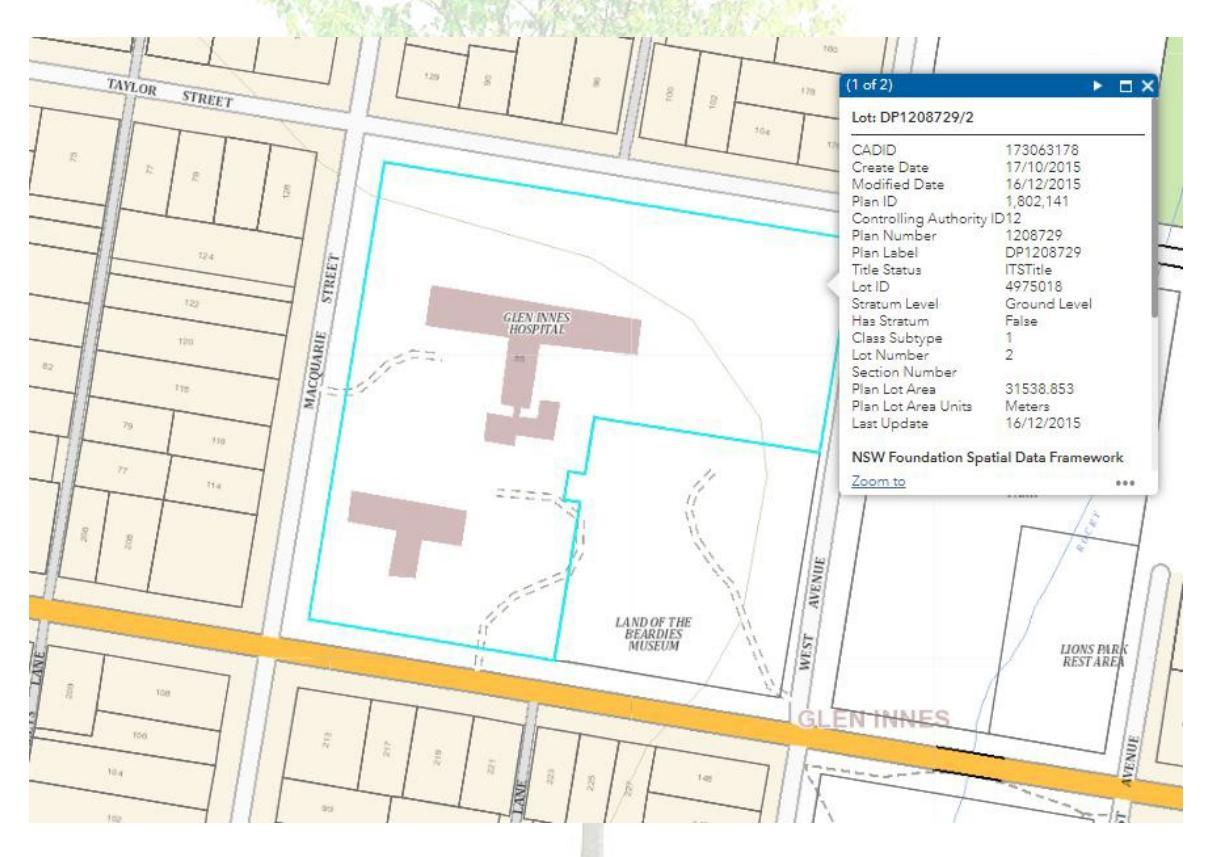
**Diagram 1 - Site Location and lot boundary**. Source – Adapted from supplied plans.

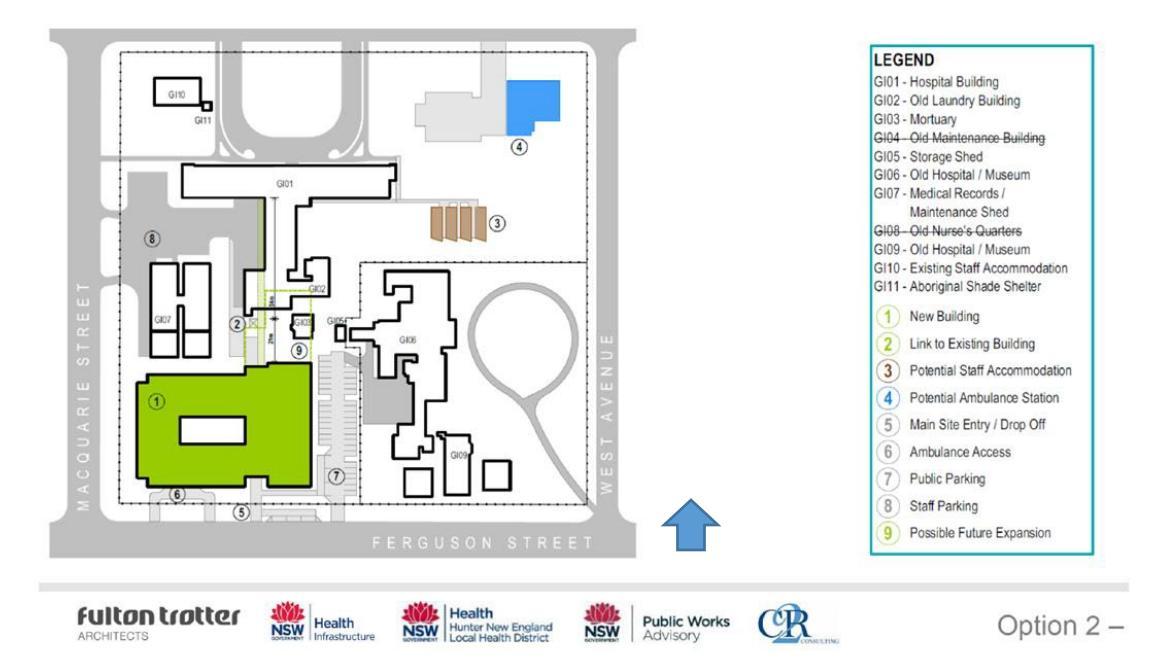
Diagram 2 – Primary development are in green – demolition of existing building and construction of new. Source – Adapted from Master Plan supplied.

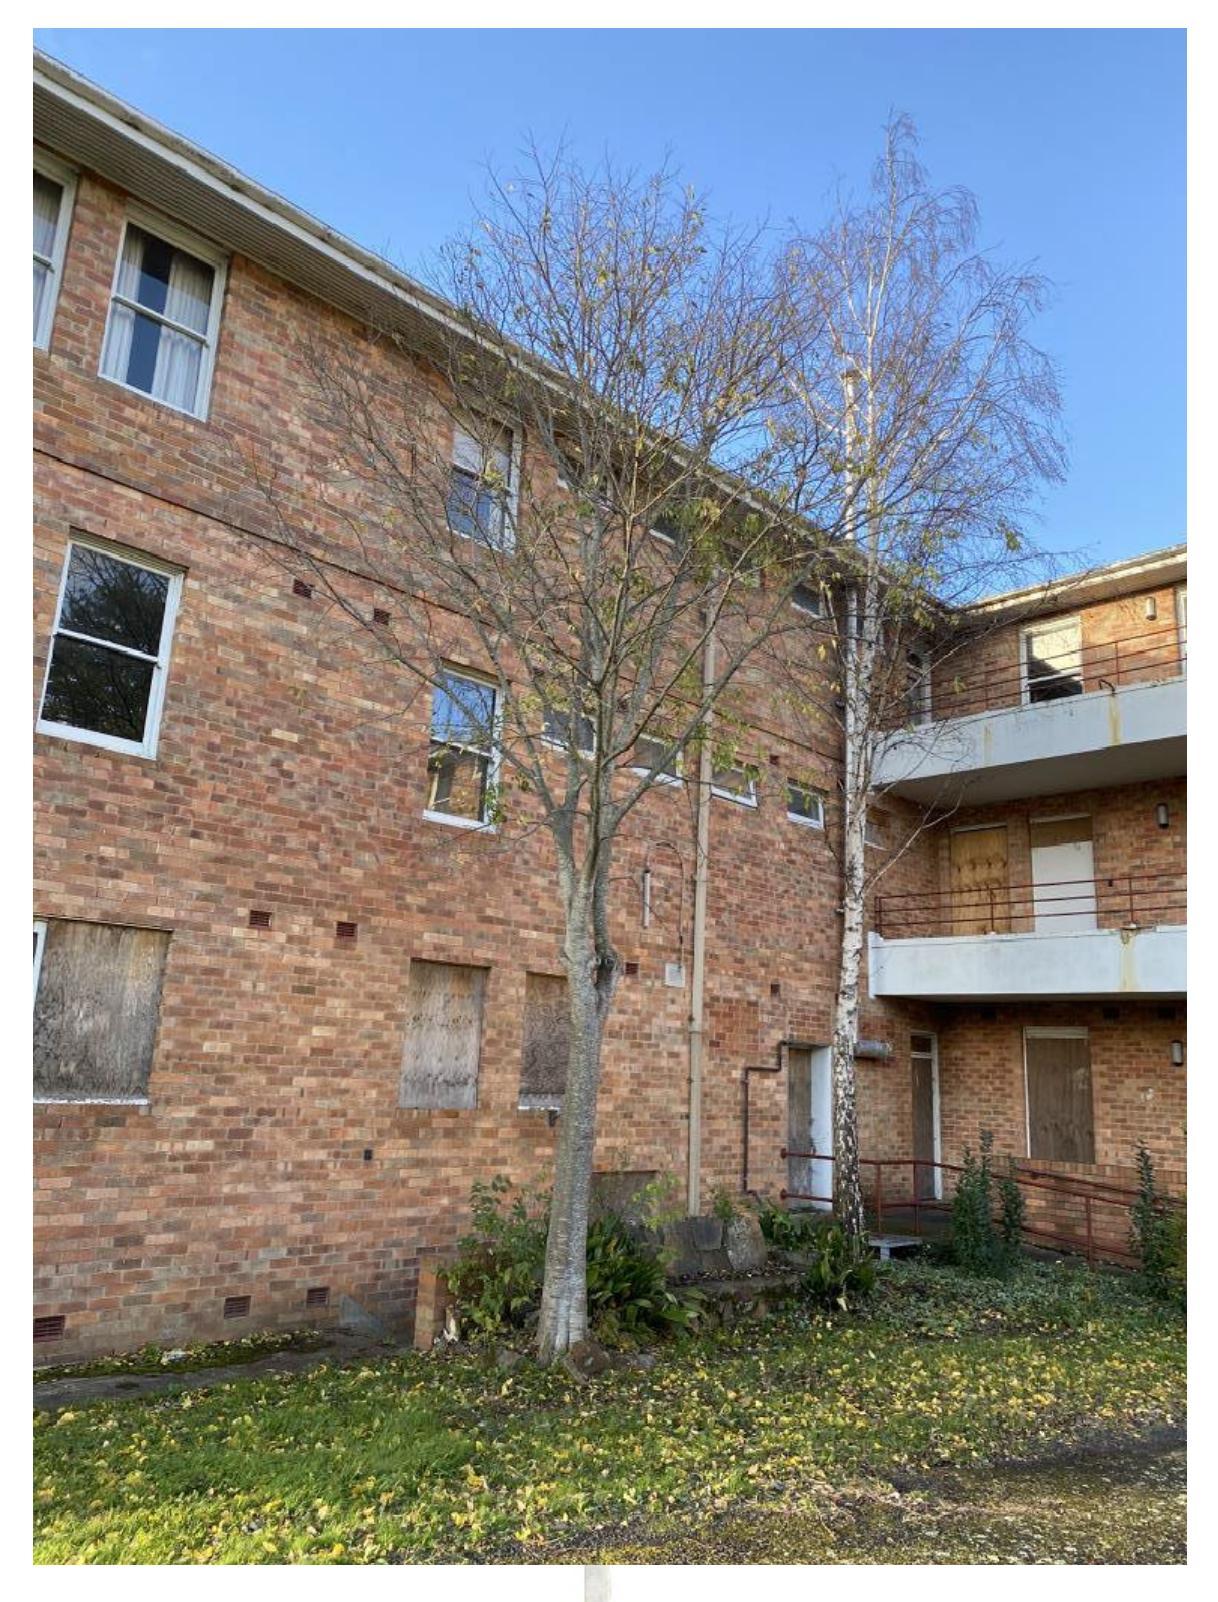
**Photo 5. Tree numbers 46 and 47** – examples of trees that are graded with low significance and will have to be removed to allow demolition as the stems are at the edge of the existing building footing. The trees are also in direct conflict with the proposed new building.

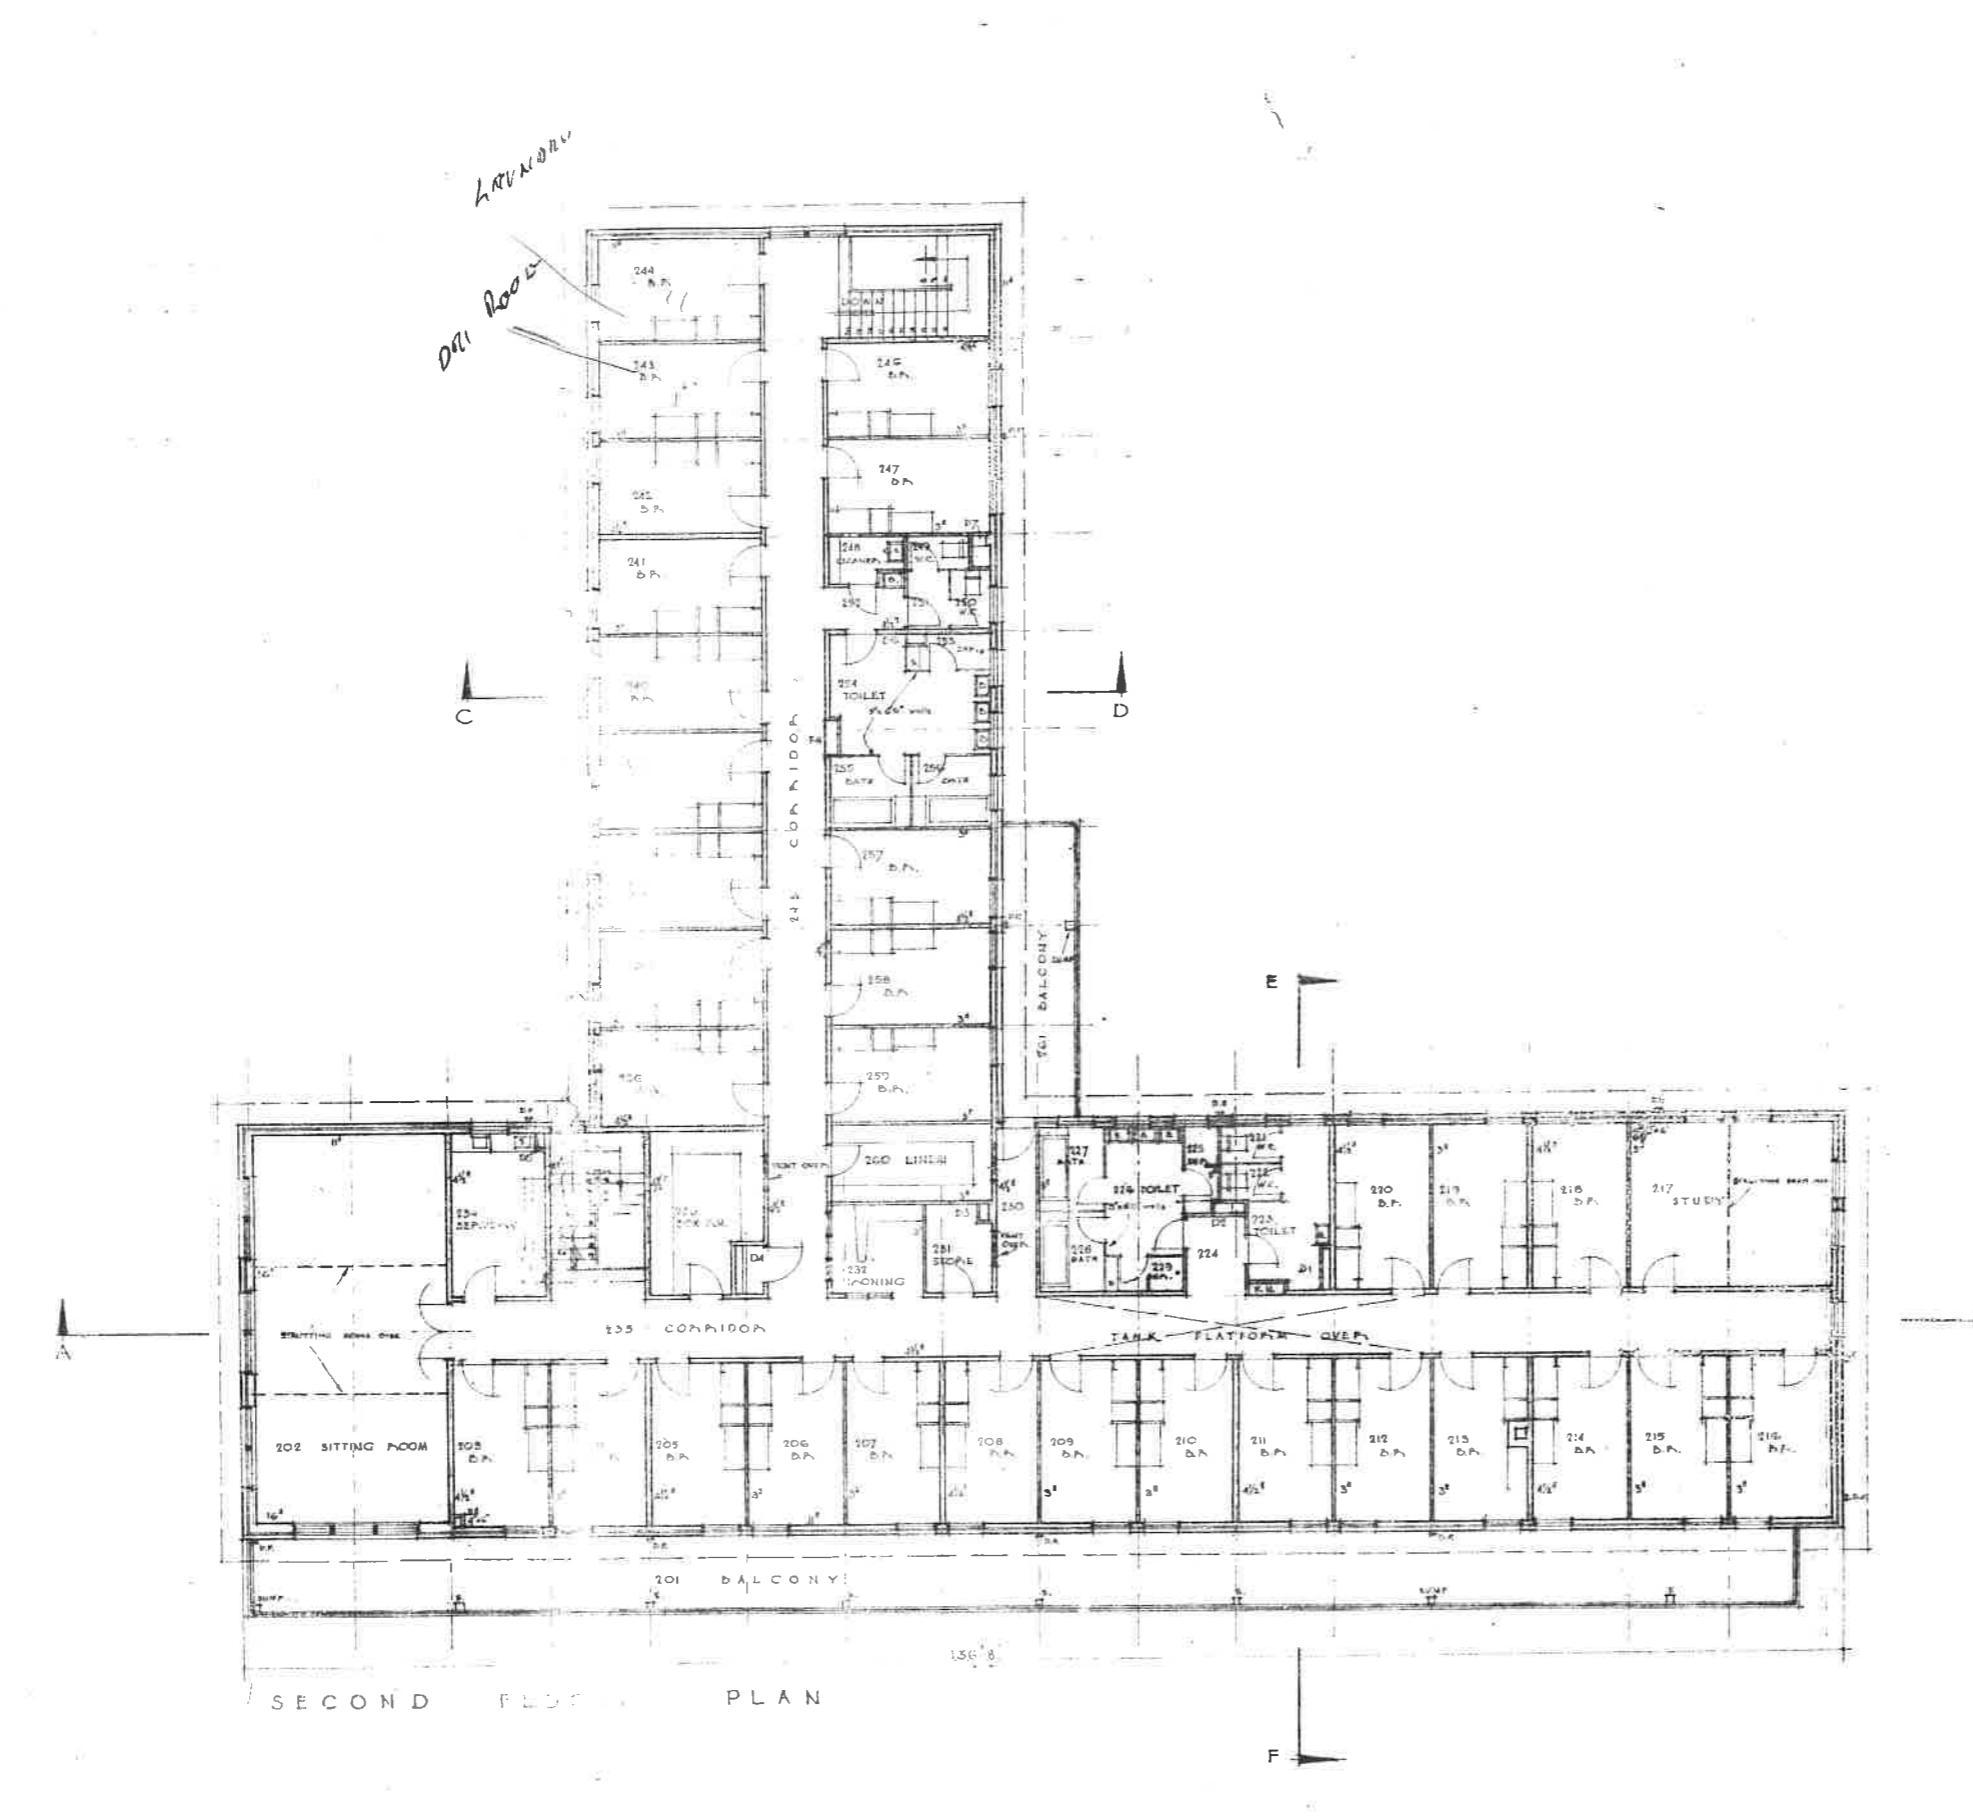
В GLEN INNES DISTRICT HOSPITAL NEW NURSES' HOME SECOND FLOOR PLAN

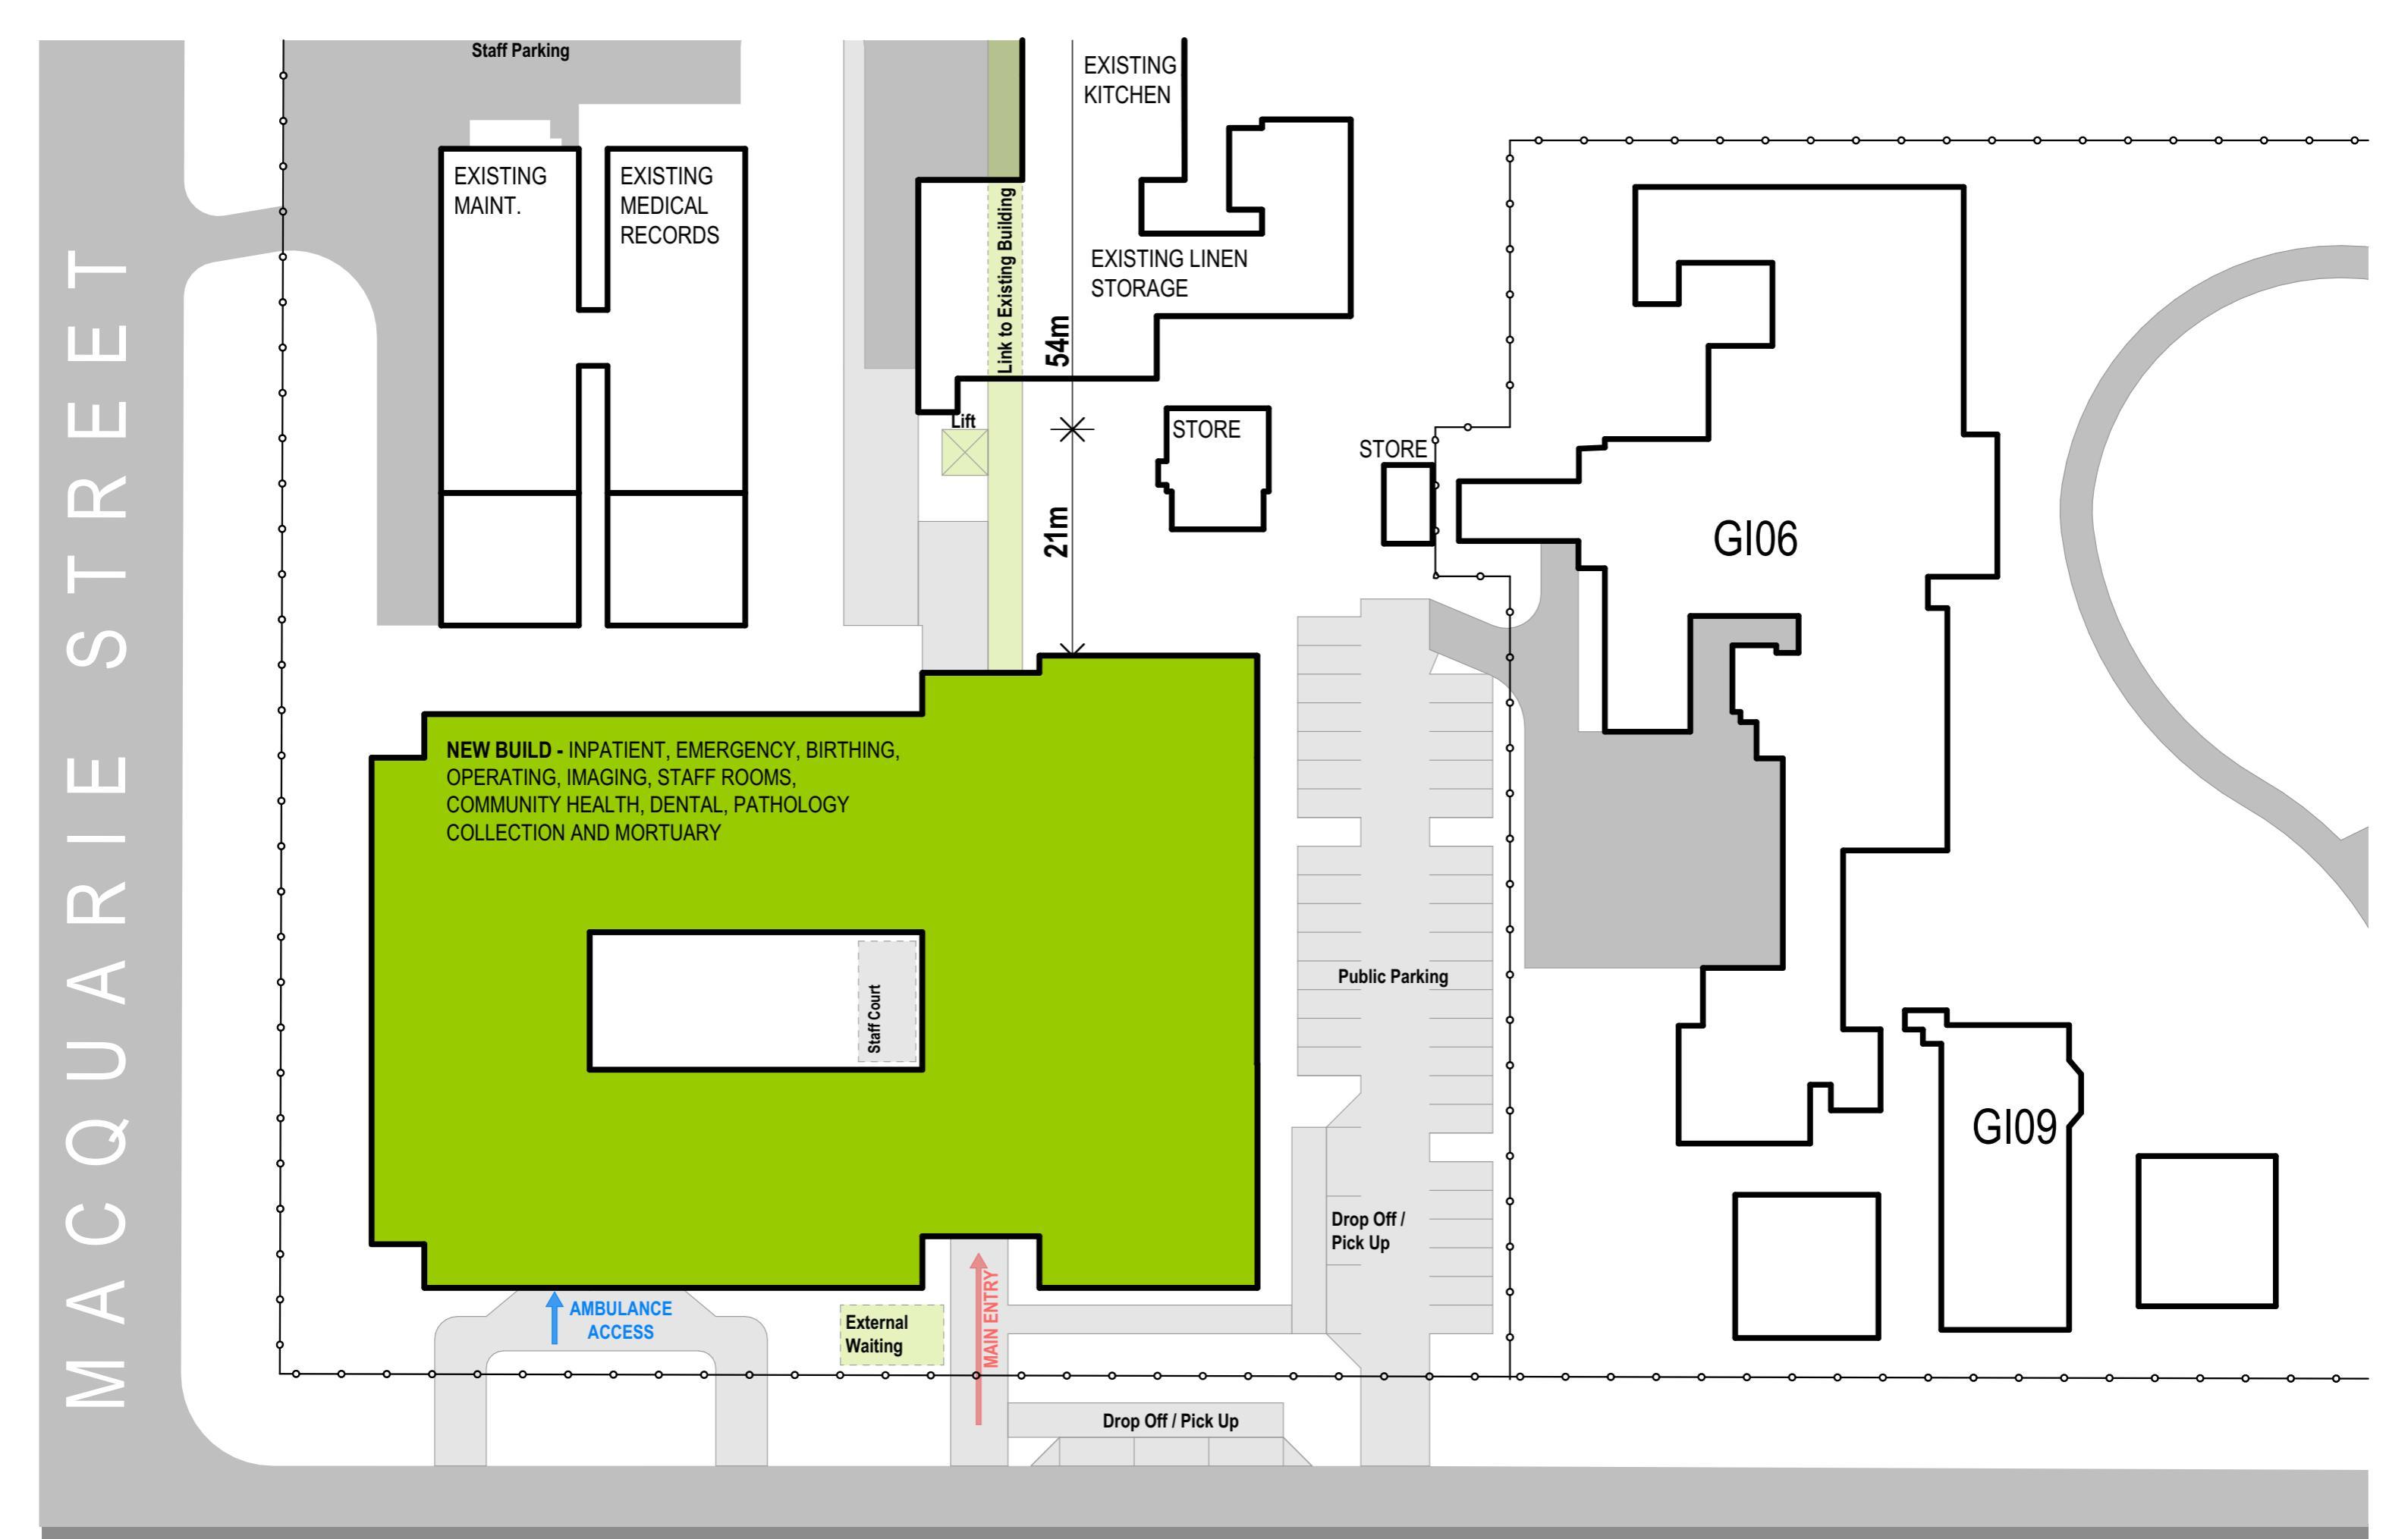
MASTERPLAN OPTION 5 - ZONAL PLAN - GROU

# JAL PLAN – GROUND FLOOR GLEN INNES DISTRICT HOSPITAL UPGRADE FOR HEALTH INFRASTRUCTURE NSW
