Arborist Impact Assessment

1 Winbourne Street & 6 Mulgoa Way Mudgee NSW 2850

17th of November 2022

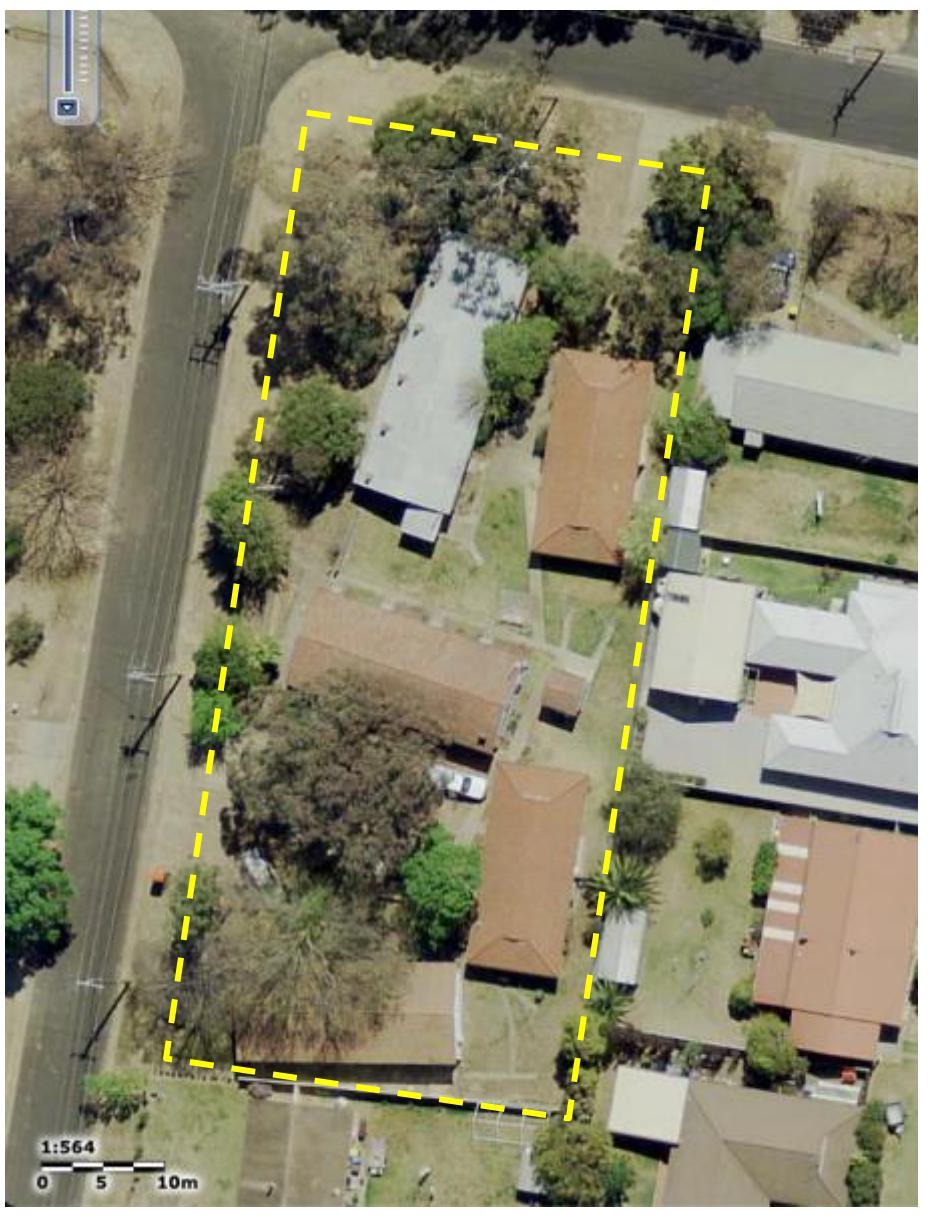
Figure 1: Aerial map of 1 Winbourne Street and 6 Mulgoa Way Mudgee NSW 2850. Yellow line indicates site.

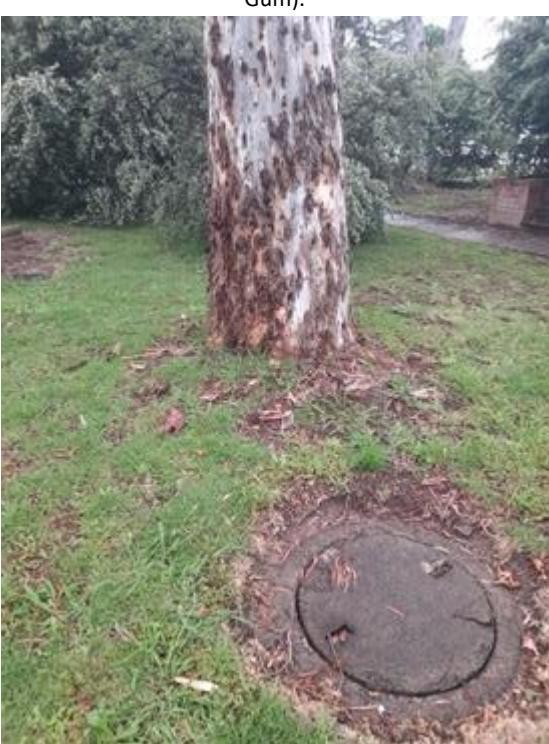
Plate 3: Tree 2, <u>Eucalyptus mannifera</u> (Red Spotted Gum), near services.

4.2.6 Tree 1&2 is a *Eucalyptus mannifera* (Red Spotted Gum) and has an issue with its proximity to sewerage services as observed in Plate 3. This is a major constraint for the development.

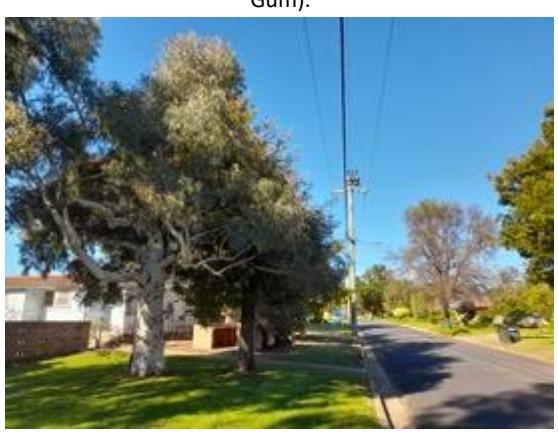
Plate 4: Tree 4, *Eucalyptus mannifera* (Red Spotted Gum).

4.2.7 Tree 4 is a *Eucalyptus mannifera* (Red Spotted Gum), and is over-pruned with heavy lopping as observed in Plate 5 rendering the tree anaesthetic from a landscape perspective and shortening its life span.

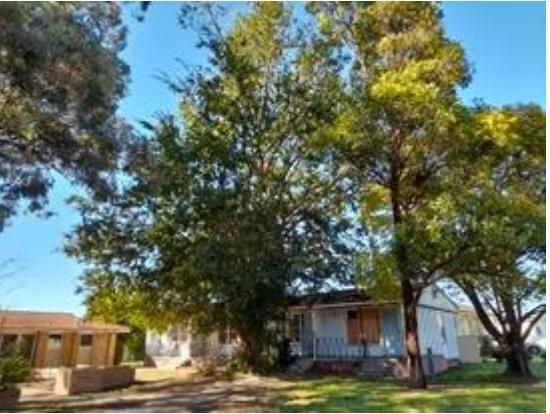
Plate 8: Tree 13, Ulmus parvifolia (Chinese Elm).

13	<u>Ulmus parvifolia</u> Chinese Elm	100% Major (greater than 10%).	Moderate	Impacts: Major impacts from the proposed dwelling (within footprint). Recommendation: Remove and replenish.	
14	<u>Eucalyptus robusta</u> Swamp Mahogany	40.1% Major (greater than 10%).	Moderate	Impacts: Major impacts from the proposed dwelling and paving. Recommendation: Retain and protect tree with a low impact driveway. Sensitive construction measures, utilizing pier and beam footings and AQF level 5 supervision to preserve structural roots.	R (Kamior: 40.1%, 25.3 m ²)
15	<u>Ulmus glabra</u> Golden elm	36.1% Major (greater than 10%).	Moderate	Impacts: Major impacts from the proposed dwelling and paving. Recommendation: Remove and replenish.	
16	<u>Ulmus parvifolia</u> Chinese Elm	Major (in SRZ)	Very Low	Impacts: Major impacts from the trenching required for the proposed services. Recommendation: Remove and replenish.

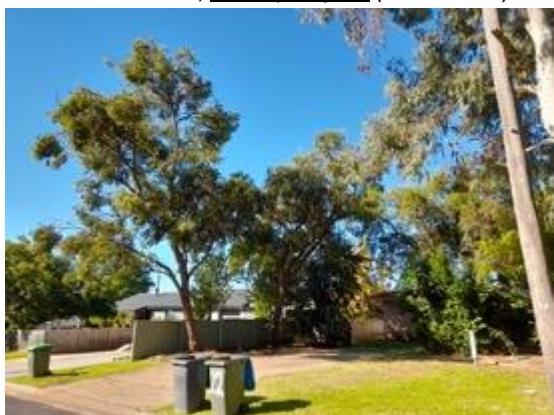
Plate 2: Tree 17 and 18, Eucalyptus robusta (Swamp Mahogany).

17	<u>Eucalyptus robusta</u> Swamp Mahogany	Major (in SRZ)	Moderate	Impacts: Major impacts from the trenching required for the proposed services. Recommendation: Remove and replenish.	116
18	<u>Eucalyptus robusta</u> Swamp Mahogany	Major (in SRZ)	Moderate	Impacts: Major impacts from the trenching required for the proposed services. Recommendation: Remove and replenish.

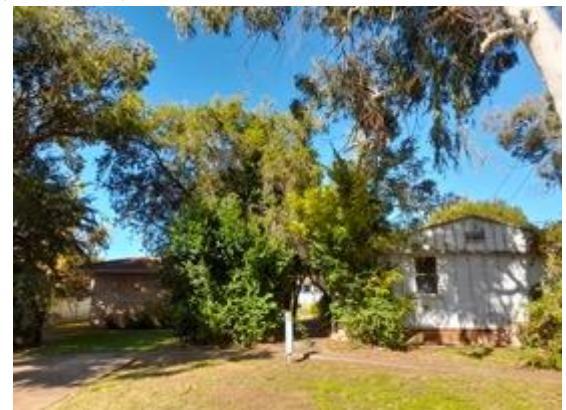
Plate 3: Tree 19 *Grevillea robusta* (Silky Oak), and tree 20 *Callistemon viminalis* (Bottlebrush).

19	<u>Grevillea robusta</u> Silky Oak	100% Major (greater than 10%).	Very Low	Impacts: Major impacts from the proposed driveway (within footprint). Recommendation: Remove and replenish.	19
20	<u>Callistemon viminalis</u> Bottlebrush	100% Major (greater than 10%).	Moderate	Impacts: Major impacts from the proposed dwelling (within footprint). Recommendation: Remove and replenish.	20 19
21	<u>Ligustrum lucidium</u> Privet	100% Major (greater than 10%).	Very low	Impacts: Major impacts from the proposed dwelling (within footprint). Recommendation: Remove (exempt from replenishment).	
22	<u>Acer negundo</u> Box Elder	100% Major (greater than 10%).	Very Low	Impacts: Major impacts from the proposed dwelling (within footprint). Recommendation: Remove and replenish.

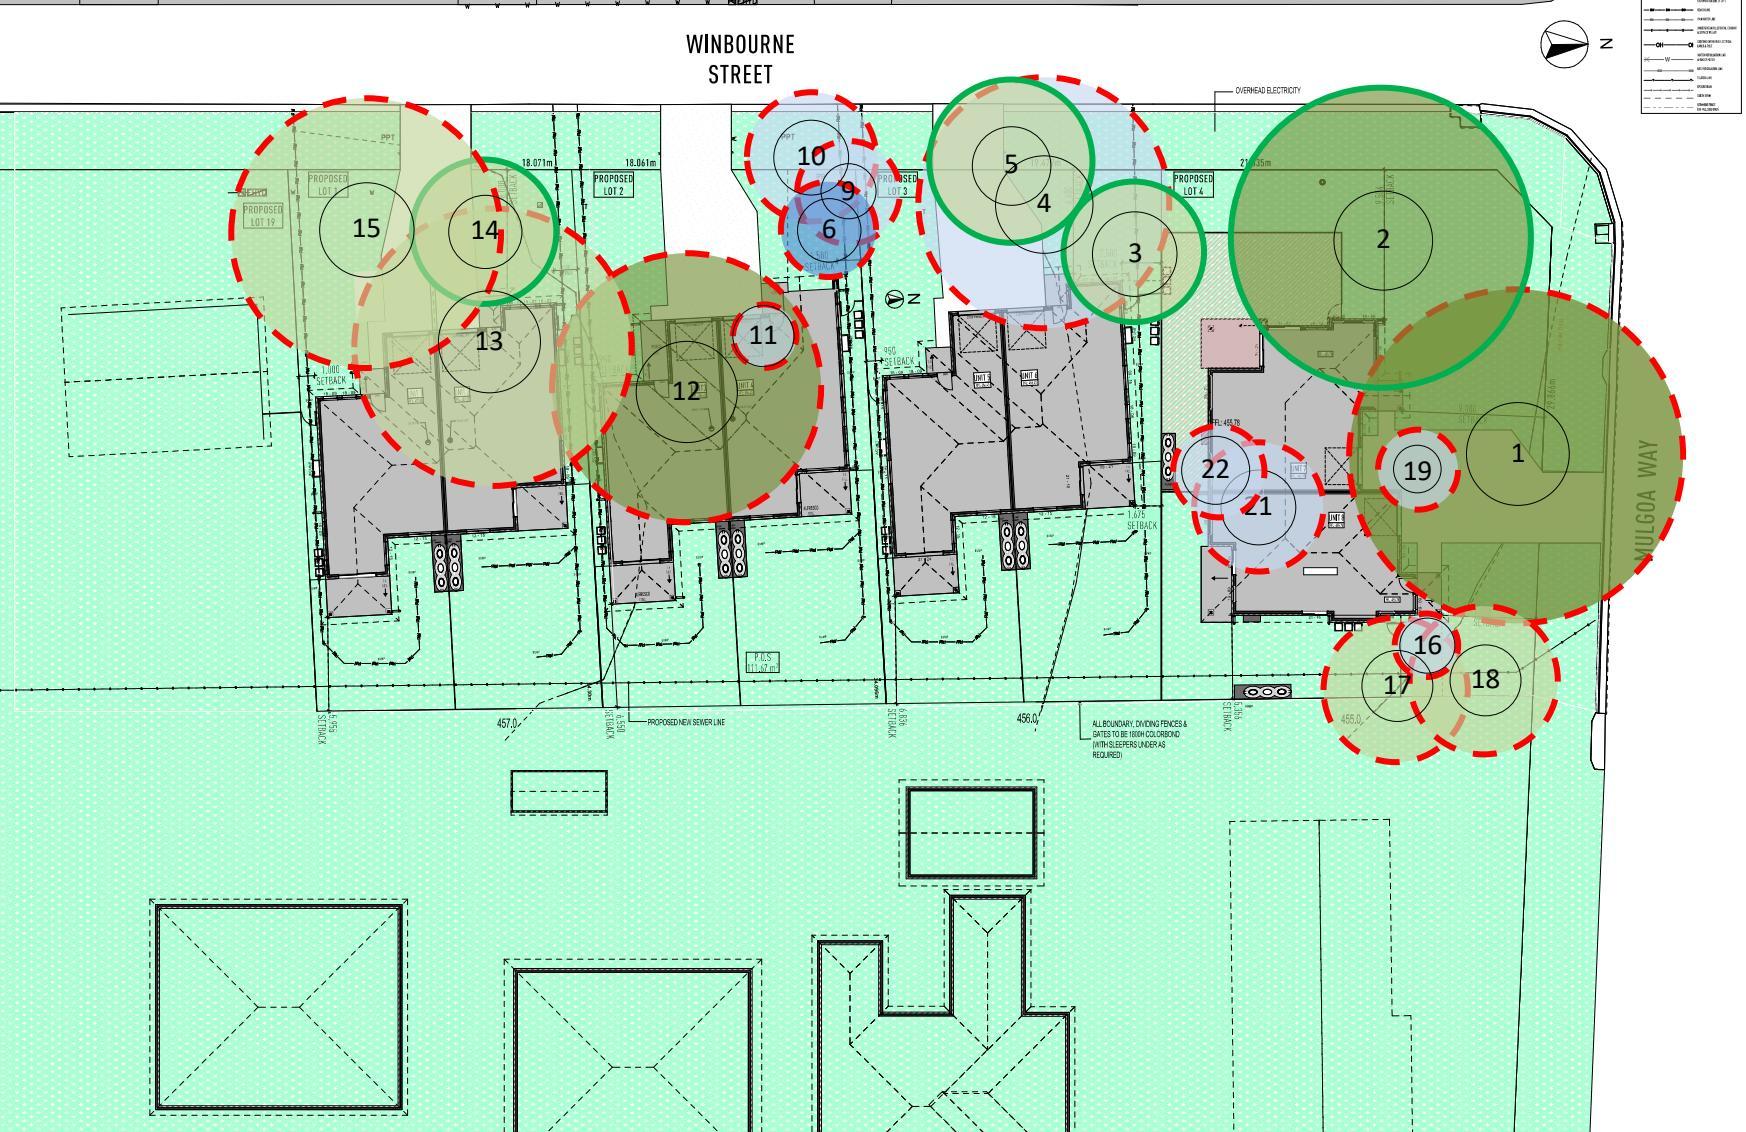
5.5 Map B Tree Management Plan-Current Proposal

Tre	e number	Count	Tree Works
1, 4, 6, 7,	8, 9, 10, 11, 12,		Remove. Seventeen
13, 15, 16	13, 15, 16, 17, 18, 19, 20,		(17) trees to
2:	1 and 22		replenish.
2, 3,	5, and 15.	4	Retain.

5.1.3 Tree works is recommended as follows (See Map B Tree Management Plan);

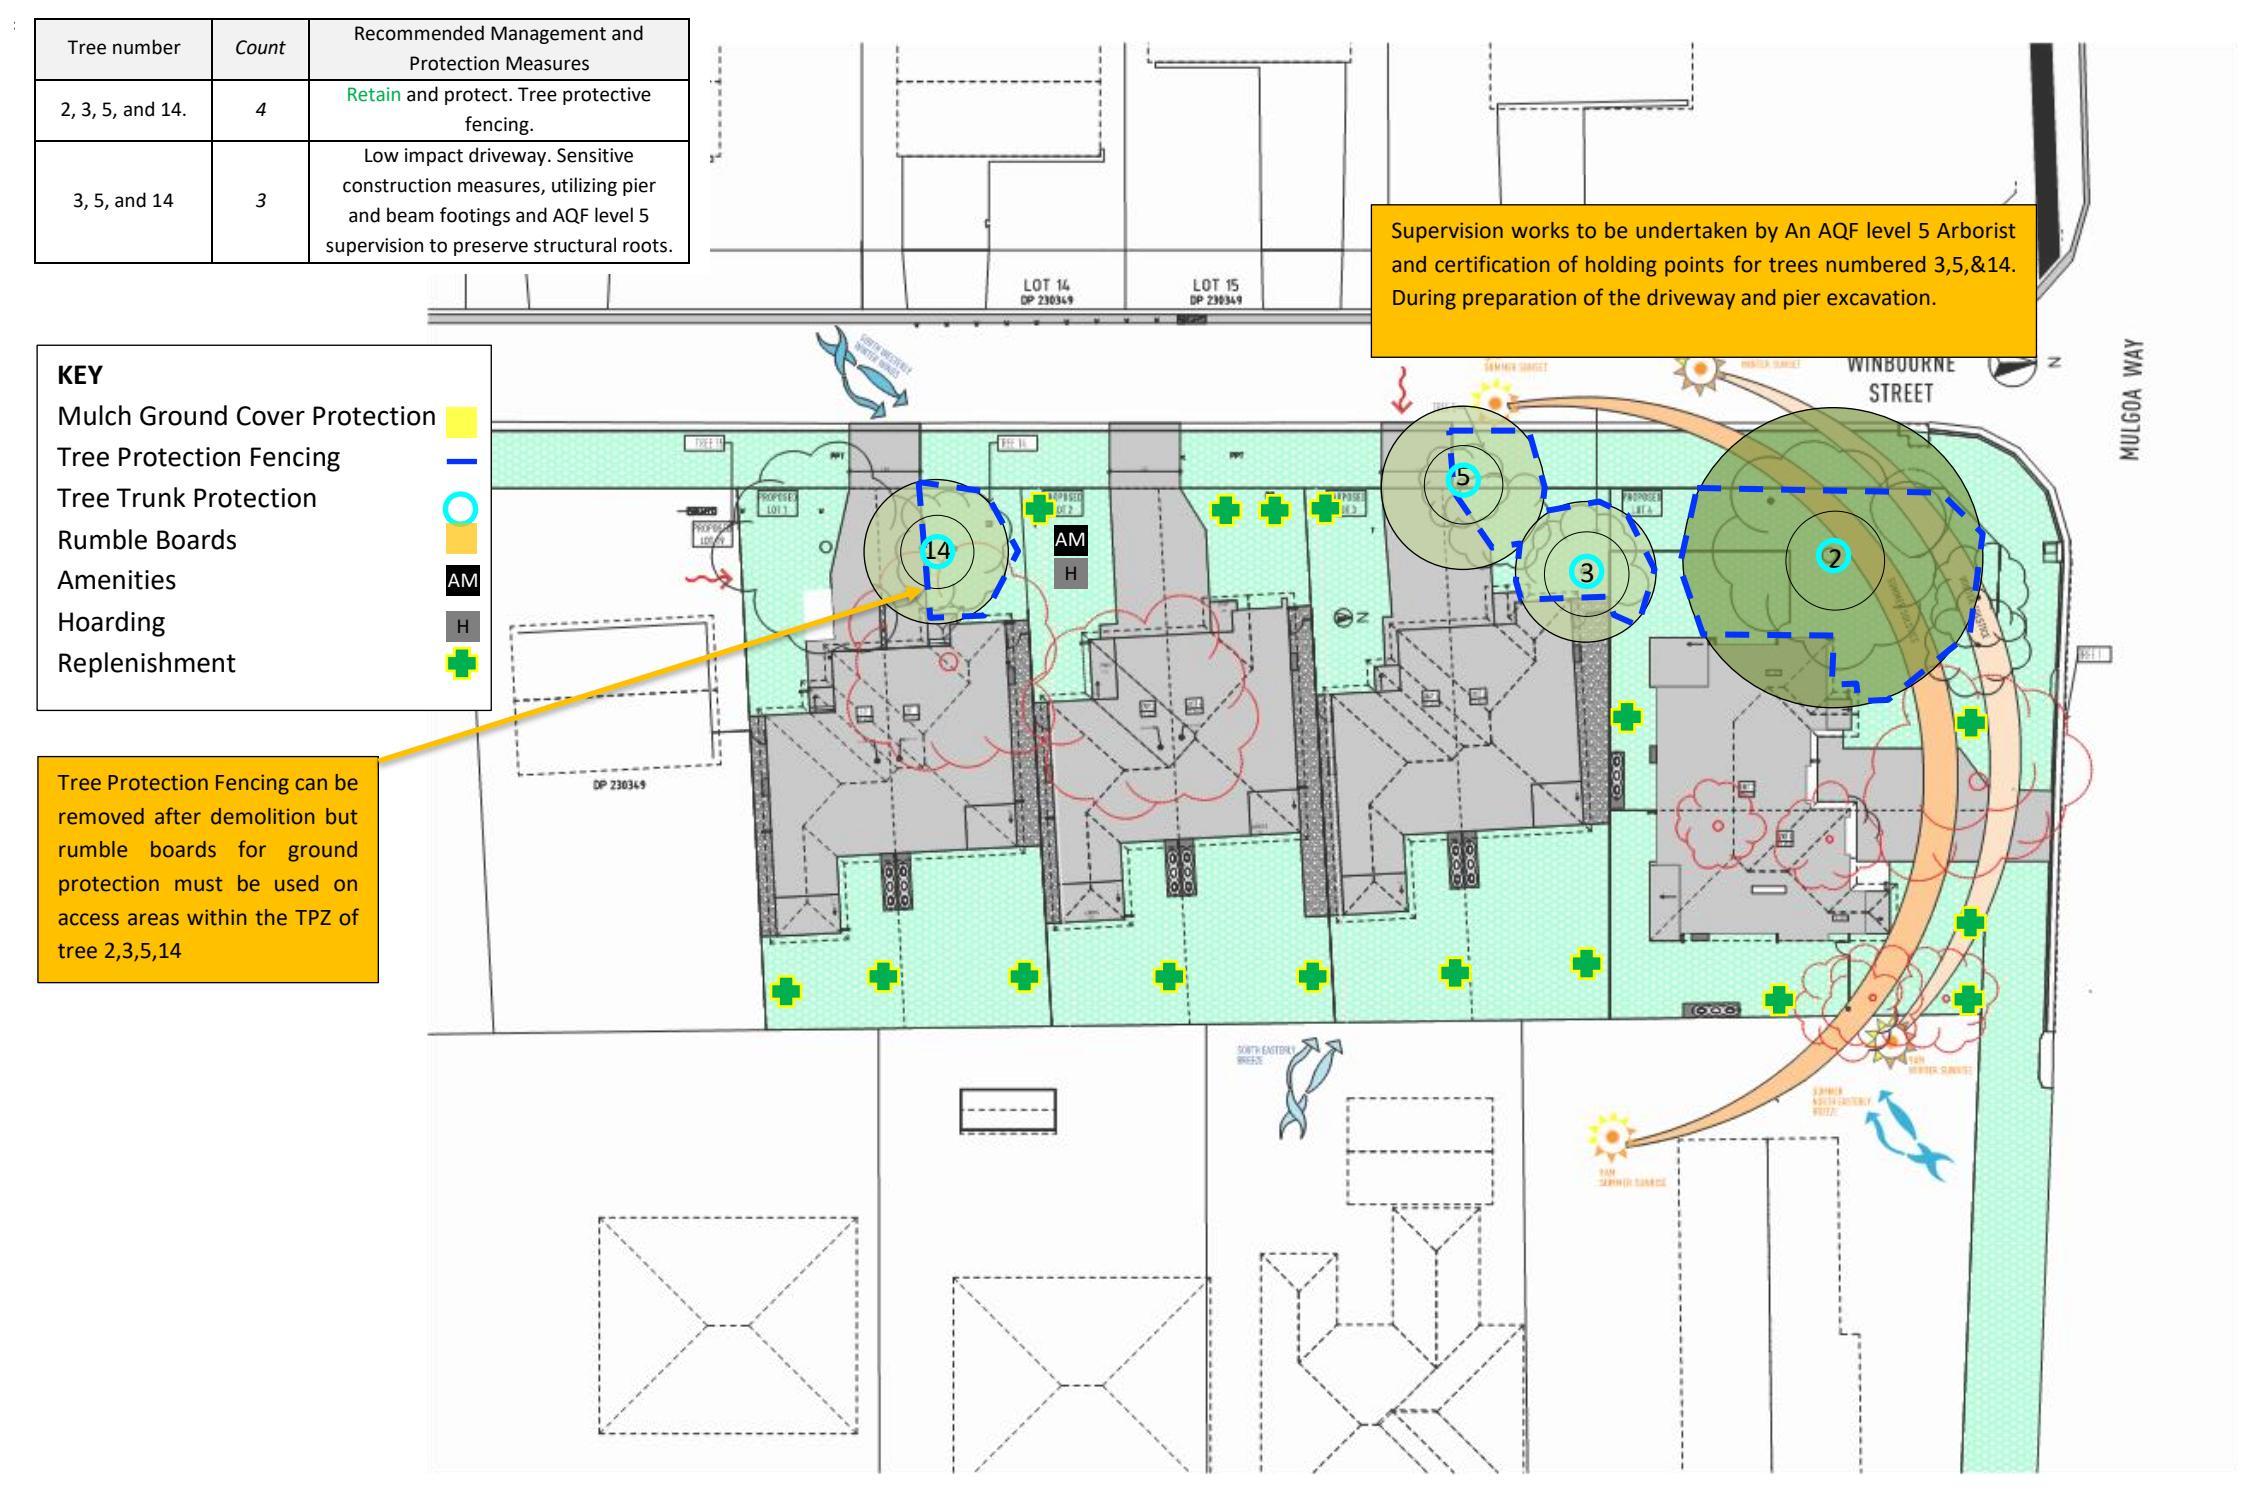
5.6 Map C Tree Protection Plan

Tree Protection Plan	Housing Plus	Original scale 1:200 A3
--	--	----------------------	--------------	-------------------------

5.3.2 All retained trees should be protected by fencing and / or ground protection before any demolition, development, or soil stripping starts. The protected area is an exclusion zone. Fencing and ground protection should not be removed or altered unless agreed by the supervising arborist.

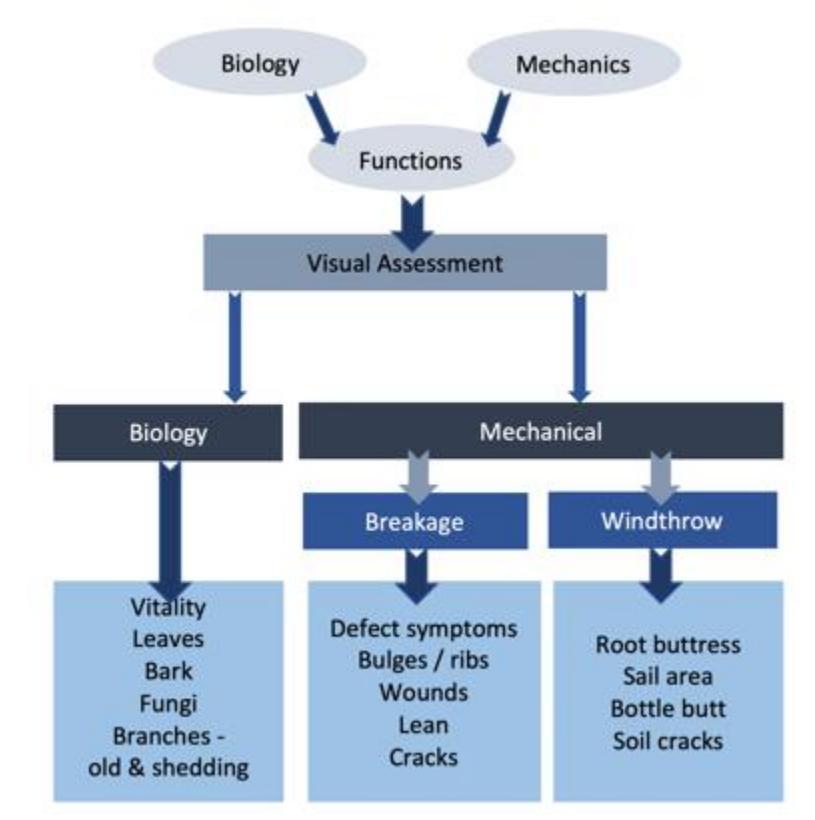
Diagram 1: VTA Chart by Claus Mattheck (1994) The Body Language of Trees adapted

2.3.2 **Visual Tree Assessment (VTA)** (Mattheck and Breloer 1994), a method assessing for biological and lower level mechanical functions and signs of decay, damage or defects (Appendix A).

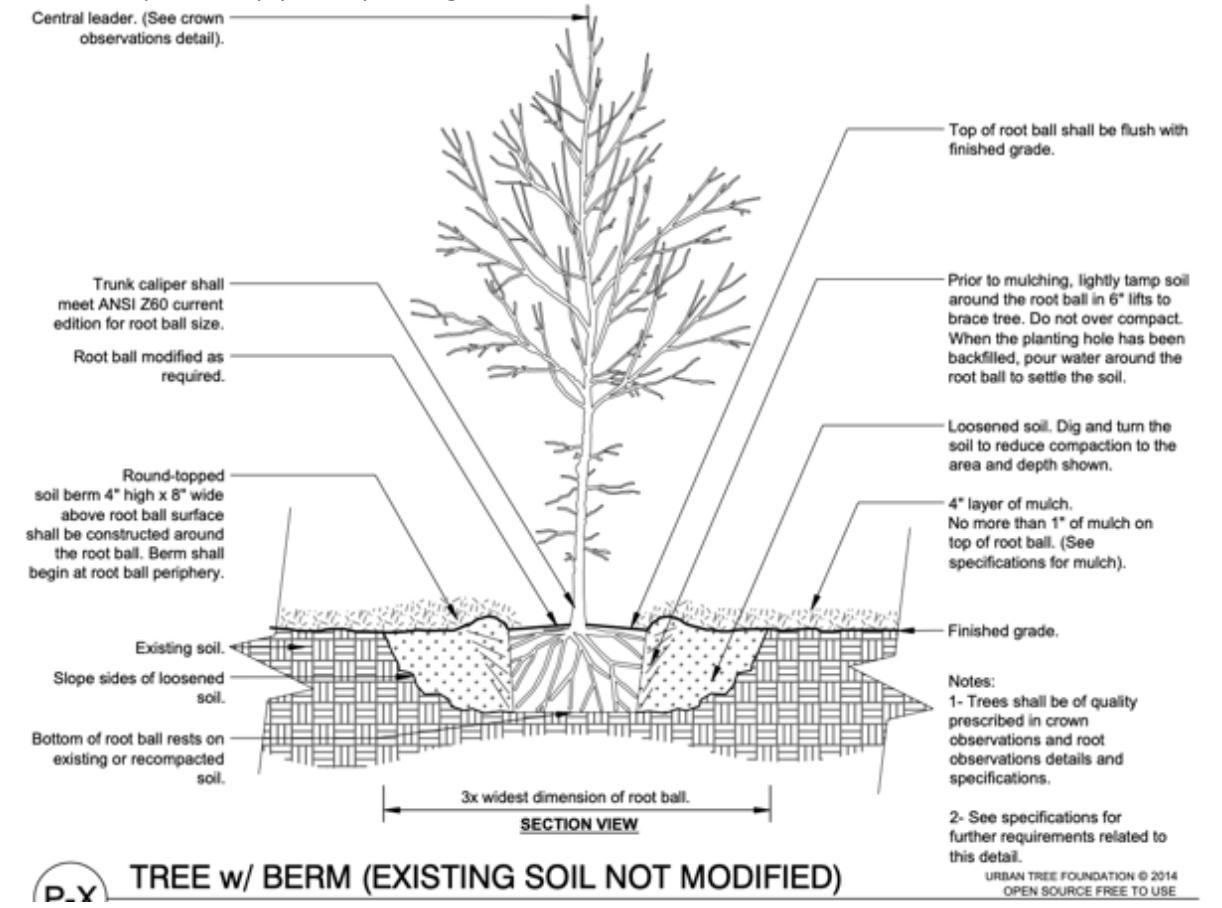
Diagram 2 Urban J (2014) Tree Planting Specification diagram

- 1. Dig the hole at least twice as wide as the pot size.
- 2. Loosen the soil at the sides of the hole. Fill hole with water and allow to drain away.
- 3. Place the loosened root ball in the hole. Fill back soil. The top of the root ball should be level with the surrounding soil.
- 4. Water the plant deeply after planting, once a week for the first two months.
