ARBORIST'S STAGE C REPORT

PROPERTY:	25 – 29 Prospero Street, Maryland NSW
NUMBER OF SUBJECT TREES:	6
NUMBER OF SHRUBS:	11
DATE OF REPORT:	28 October 2020 (updated 13 April 2023)
REQUESTED BY:	NSW Land & Housing Corporation

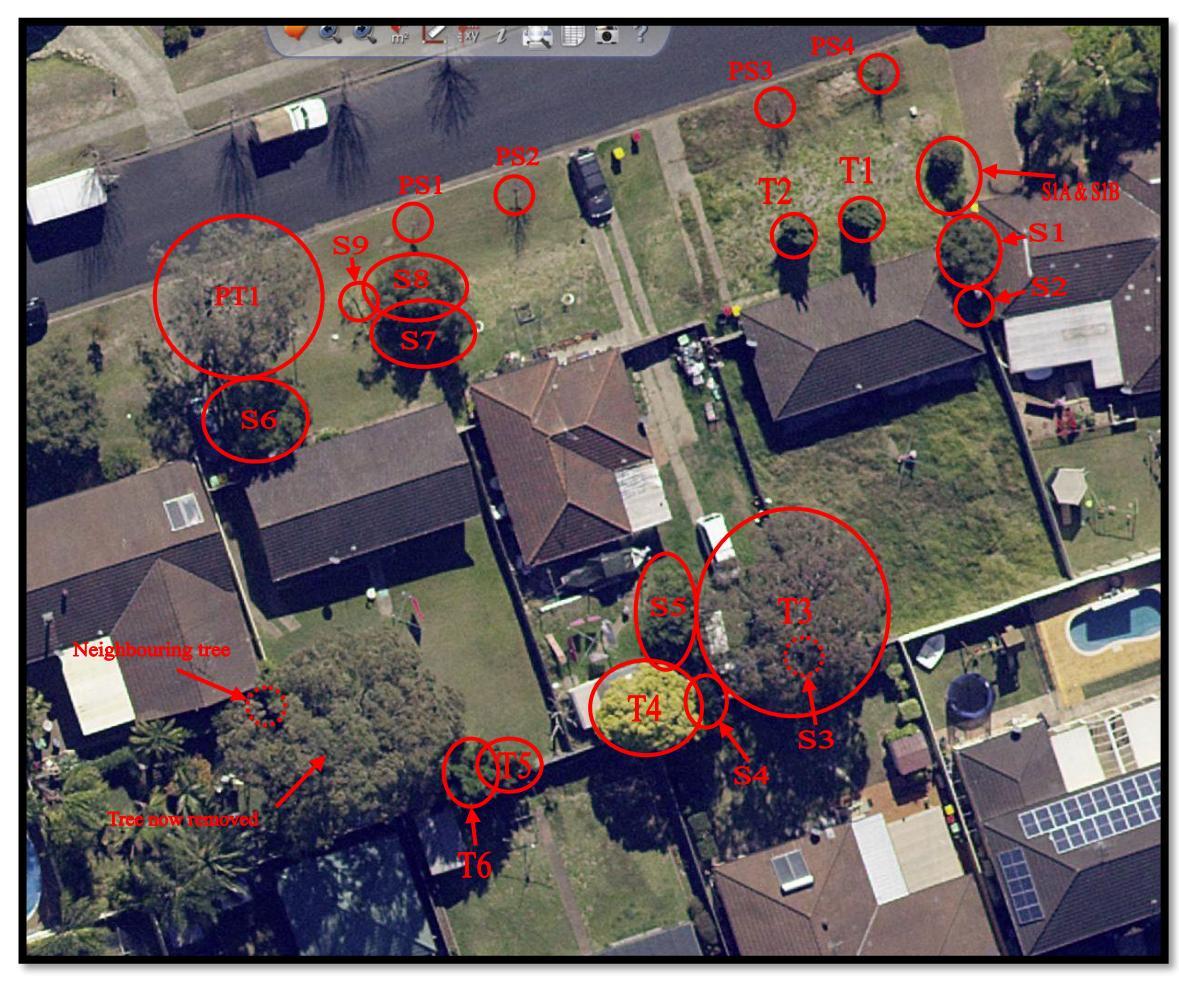
An aerial photograph (Six Maps) used as a site plan showing the positions of the subject trees and shrubs (indicated by the [numbered] red circles, and showing the approximate canopy extents).

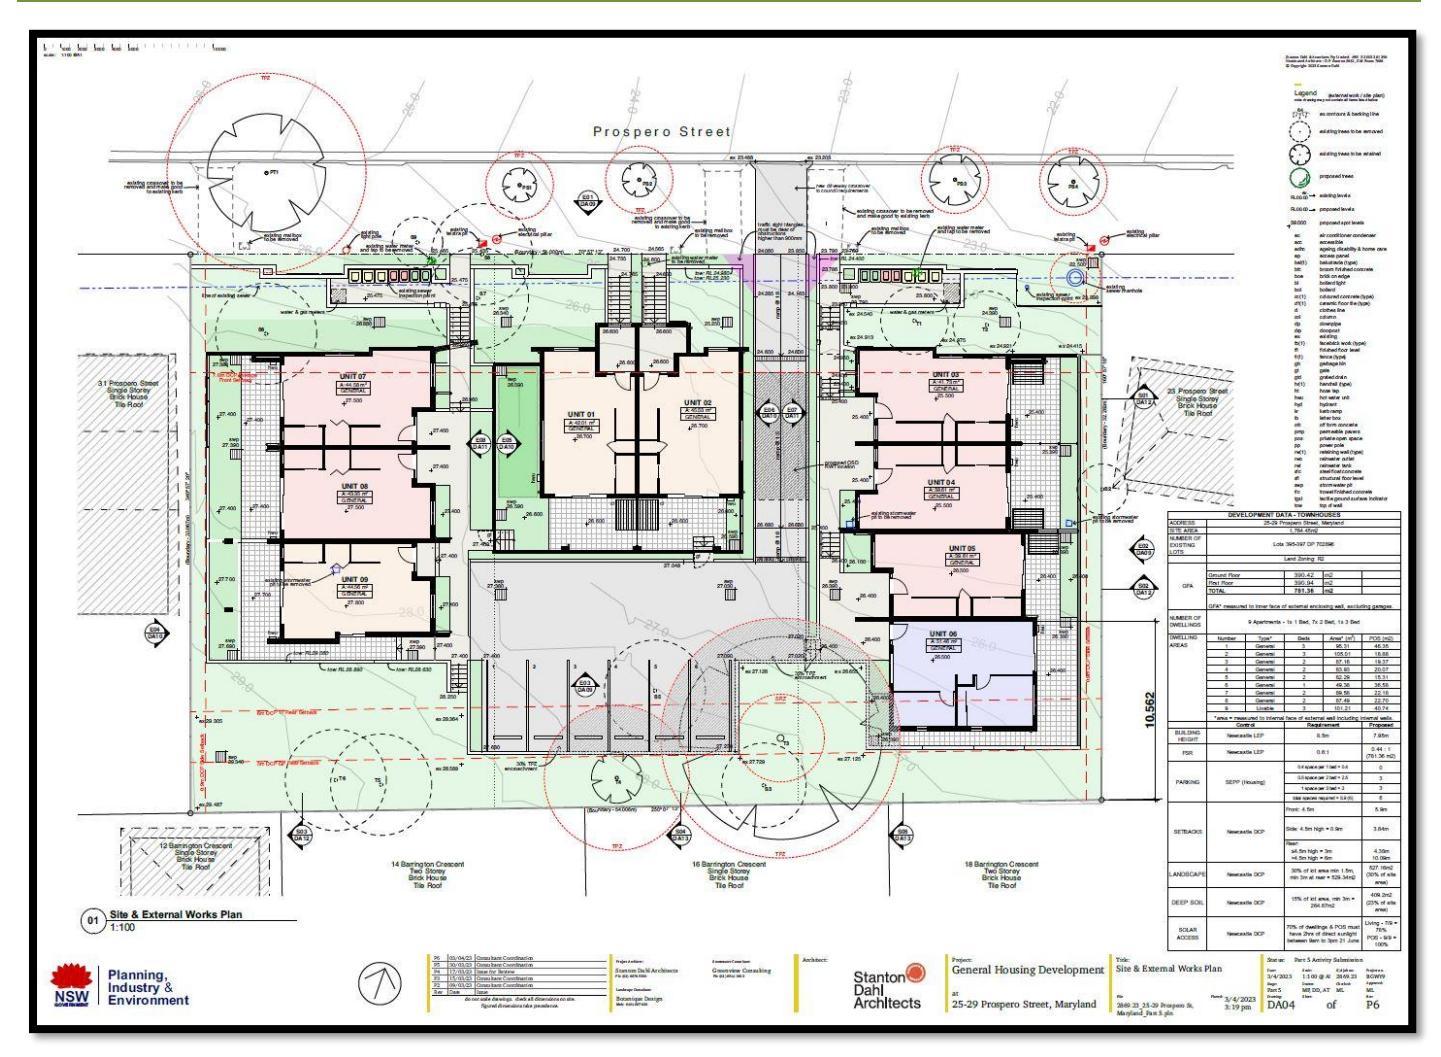
A supplied site plan of the proposed development, showing the positions of the trees and TPZs.

The encroachment required for T3 consists mostly of above ground concrete on a bed of 10 - 15 mm aggregate and some building using screw piles. Additionally, some pruning of the canopy is required for this tree.

The encroachment required for T4 consists of above ground concrete on a bed of 10 - 15 mm aggregate. The proposed development will require the following percentages of encroachment:

Tree	TPZ	Encroachment	SRZ	Encroachment	Tree	TPZ	Encroachment	SRZ	Encroachment
<mark>3/</mark>	7.1	32%	2.6	0%	<mark>4/</mark>	4.3	30%	2.1	13.47%

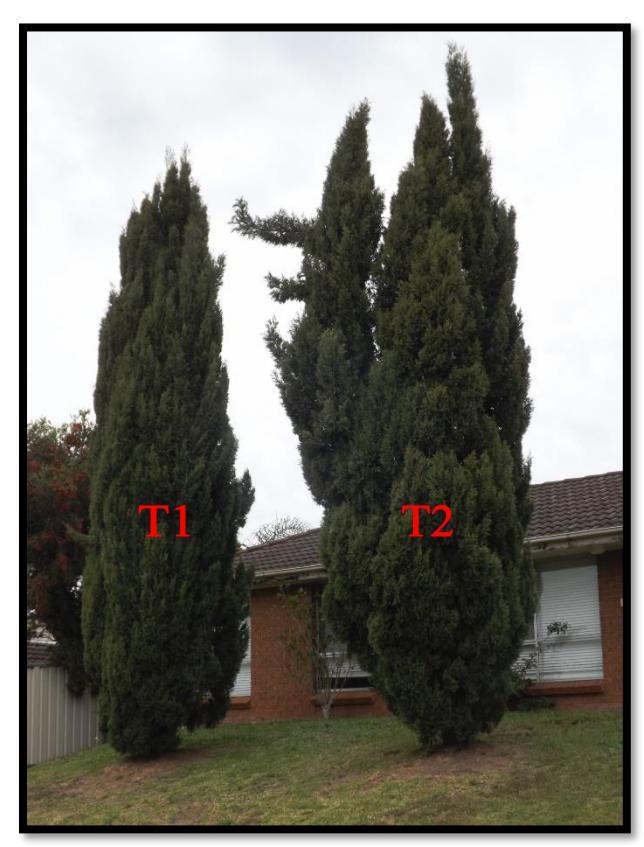
Number of	Tree	Species	Height	Condition	l	DBH	TPZ	ULE	Retention	Comments
Trees	Number		(metres)	Health	Structure	(mm)	(metres)		Value	
2	T1	<i>Cupressus</i> <i>sempervirens</i> (Italian Cypress)	8	Good	Good	N/A	2 (minimum as required by AS 4970)	2B	Low	Suitable to remove.
	T2	Cupressus sempervirens (Italian Cypress)	8	Good	Good	N/A	2 (minimum as required by AS 4970)	2B	Low	Suitable to remove.

Trees 1 and 2 viewed from the NW.

- T1, T2, T5 and T6 be removed
- T3 and T4 be retained and protected as discussed
- S1 S9 be removed if required or retained and protected as discussed
- PT1, PS1 PS4 be retained and protected as discussed

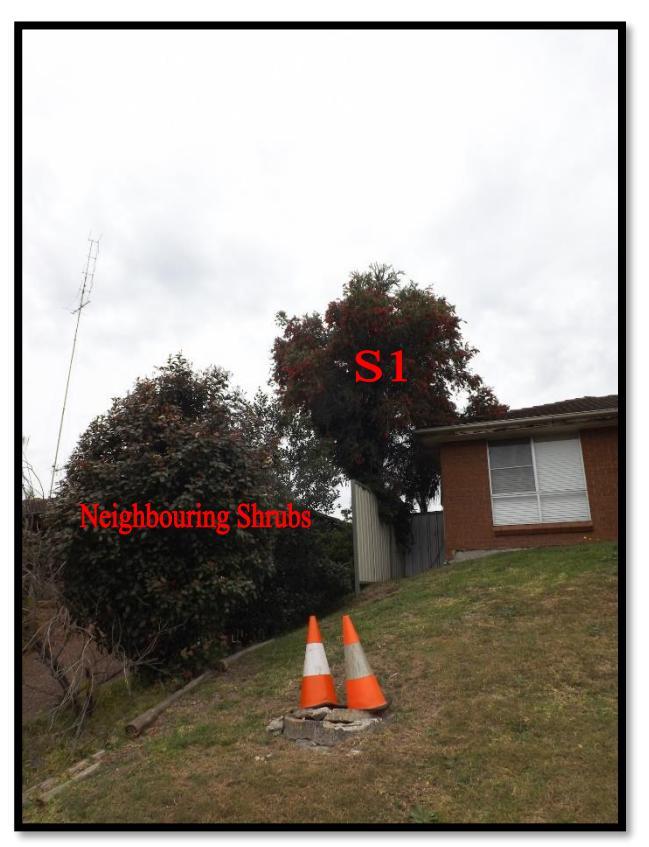
Number of	Shrub	Species	Height	Condition	n	DBH	TPZ	ULE	Retention	Comments
Shrubs	Number		(metres)	Health	Structure	(mm)	(estimated		Value	
							metres)			
2	S1	Callistemon	6	Good	Good	N/A	3	2B	Low	Suitable to
		viminalis				(could				remove
		(Weeping				not				(within 3
		Bottlebrush)				reach				metres of
						trunk)				house)
	S2	Syagrus	3	Good	Good	N/A	2	2B	Low	Suitable to
		romanzoffiana								remove
		(Cocos Palm)								(within 3
										metres of
										house)

Shrub 1 viewed from the NW.

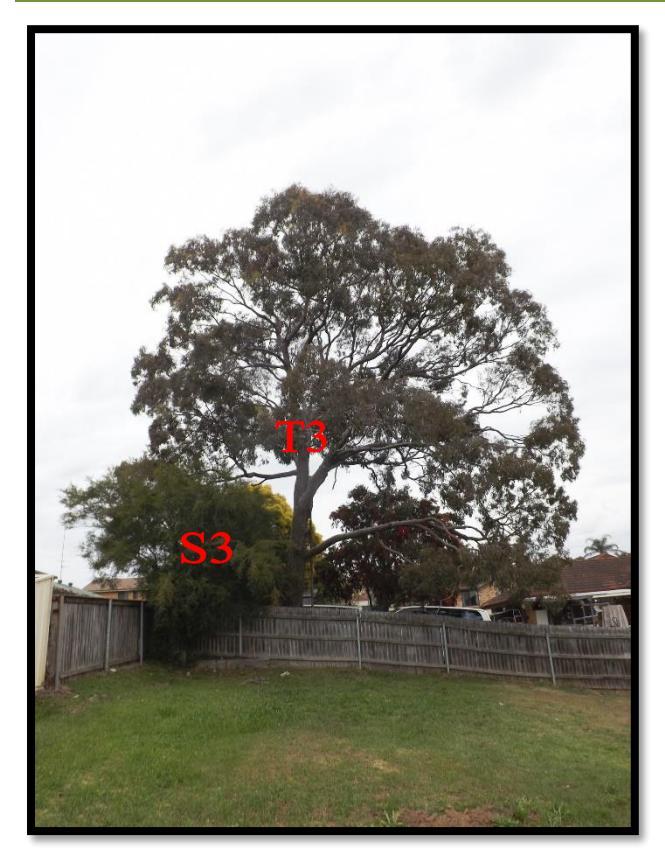
Number	Tree	Species Height		Condition		DBH (mm)	TPZ	ULE	Retention	Comments
of Trees	Number		(metres)	Health	Structure		(metres)		Value	
2	Τ3	<i>Eucalyptus</i> <i>crebra</i> (Narrow Leaved Ironbark)	16	Good	Good	590	7.1	2B	Moderate	Retain and protect
	T4	<i>Melaleuca</i> <i>bracteata</i> 'Revolution Gold'	10	Good	Good	360	4.3	2B	Moderate	Retain and protect
Shrubs 3	S3	Leptospermum petersonii (Lemon Scented Tea Tree)	6.5	Good	Poor	N/A multi - stemmed	3 (canopy spread)	4C	Very Low	Topped. Suitable to remove.
	S4	Buckinghamia celsissima (Ivory Curl Tree)	8	Good	Fair (form)	180 (combined)	2.2	2B	Low	Co – dominant stems from 500 mm high. Suitable to remove.
	\$5	Callistemon viminalis (Weeping Bottlebrush)	8	Good	Poor	250	3	4C	Very Low	Topped. Suitable to remove.

Tree 3 & Shrub 3 viewed from the NE.

As the type of encroachment for T3 & T4 is *AS* 4970 acceptable (above ground concrete on a bed of aggregate), the impact will be reduced to slight.

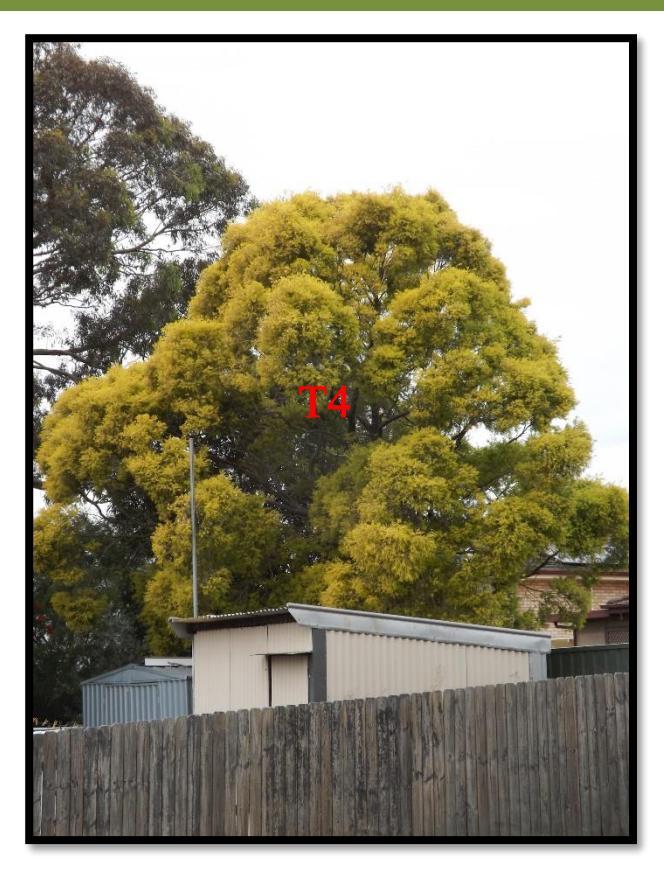
Tree 4 viewed from the NW.

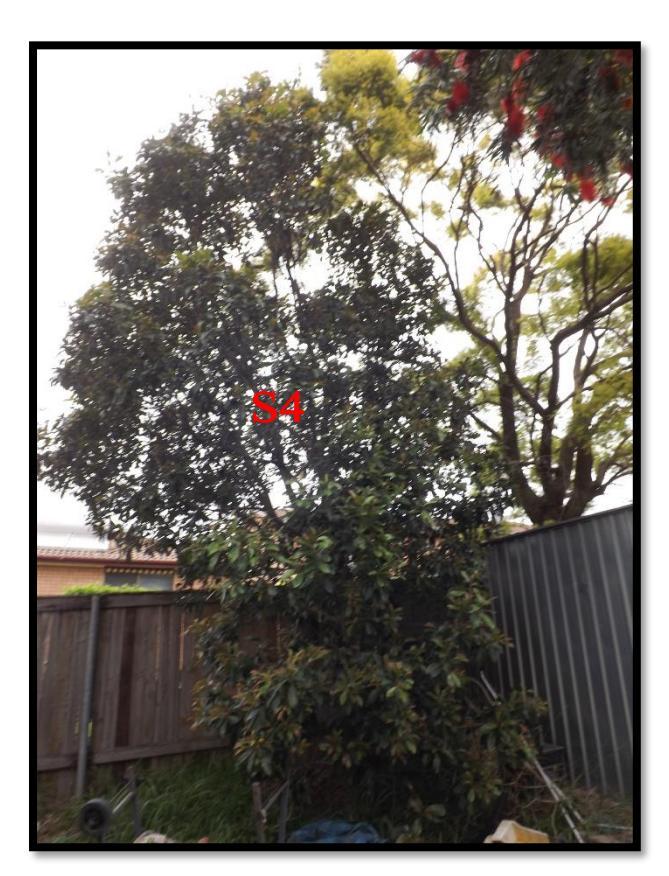
Shrub 4 viewed from the north.

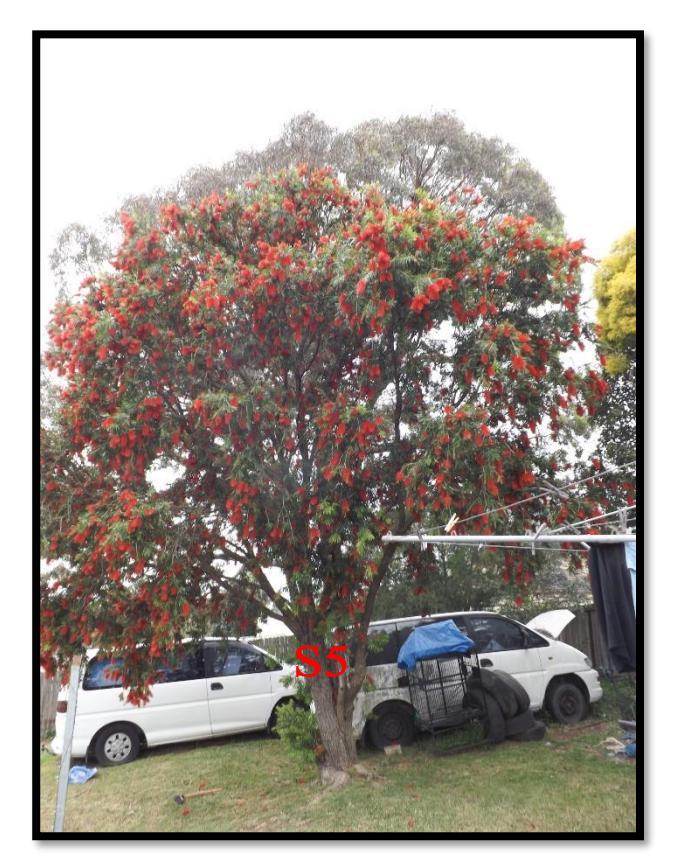
Shrub 5 viewed from the south.

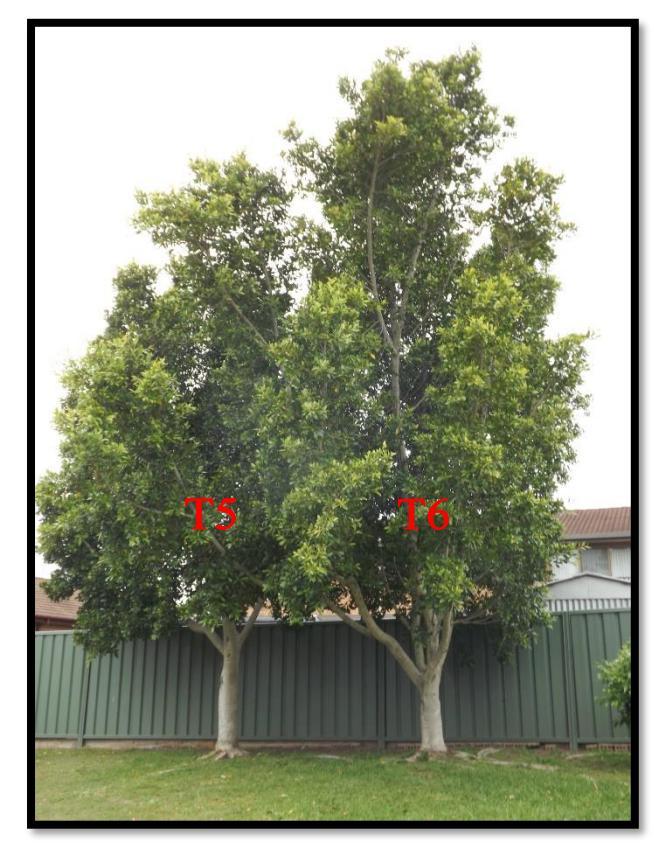
Number	Tree	Species	Height	Condition	1	DBH	TPZ	UL	Retention	Comments
of Trees	Number		(metres)	Health	Structure	(mm)	(metres)	Е	Value	
2	T5	Ficus	9	Good	Fair	220	2.6	2B	Low	A young tree
		<i>microcarpa</i> var			(form)					with a large
		hillii								growth and
		(Hill's Fig)								infrastructure
										damage
										potential.
										Suitable to
										remove.
	T6	Ficus	10	Good	Fair	230	2.8	2B	Low	A young tree
		<i>microcarpa</i> var			(form)					with a large
		hillii								growth and
		(Hill's Fig)								infrastructure
										damage
										potential.
										Suitable to
										remove.
Shrubs 4	S6	Callistemon	6.5	Good	Fair	250	3	2B	Low	Suitable to
		viminalis			(form)	(combined)				remove (3 metres
		(Weeping								to existing
		Bottlebrush)								house).
	S7	Callistemon	6.5	Good	Fair	250	3	2B	Low	Three dominant
		viminalis			(form)	(combined)				stems from 300
		(Weeping								mm high.

Trees 5 & 6 viewed from the north.

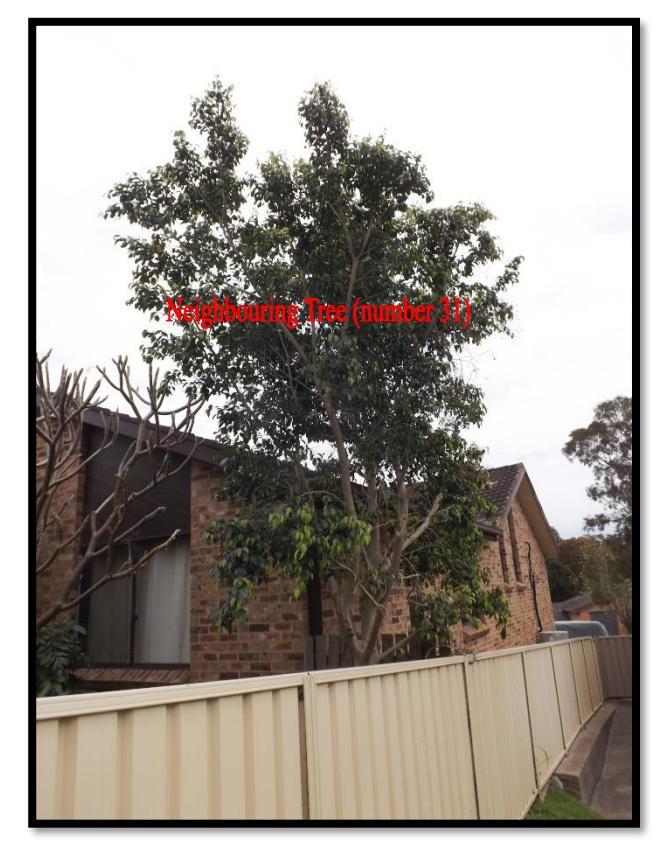
The small tree in number 31 (500 mm from the fence) requires the minimum 2 metres TPZ (1.5 metres into number 29). This tree is an immature specimen of *Ficus benjamina* (Weeping Fig). Some encroachment is required into its TPZ to install a blockwork retaining wall and prepare soil for turf.

As the encroachment is 8% of the TPZ and very minor, the impact on the tree is likely to be minimal.

Neighbouring tree (west) viewed from the south.

The Arborist confirms the encroachment is consistent with tree retention, and the protection measures recommended are equal to the other retained trees as described in the following section.

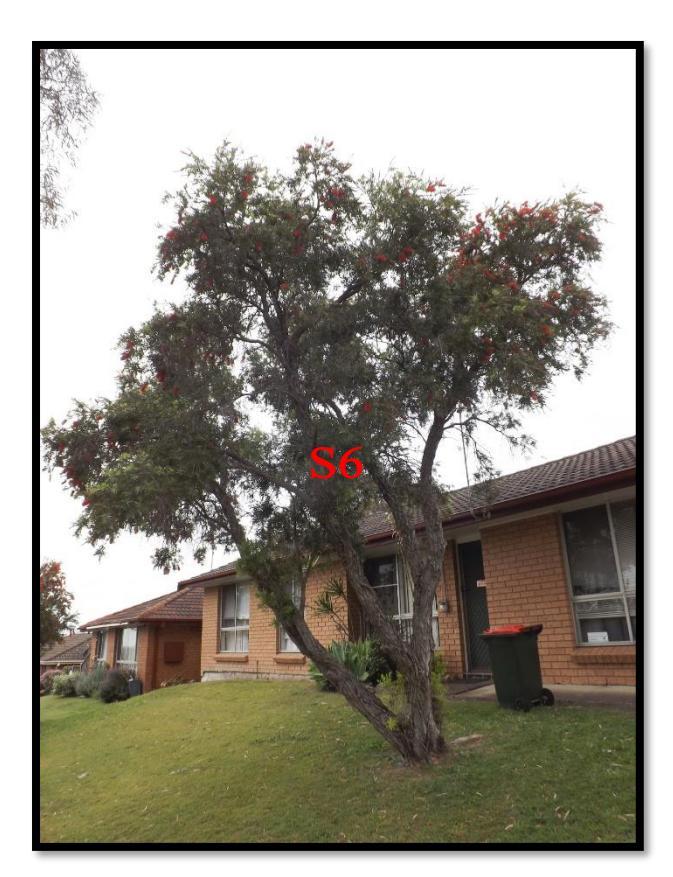
Shrub 6 viewed from the NW.

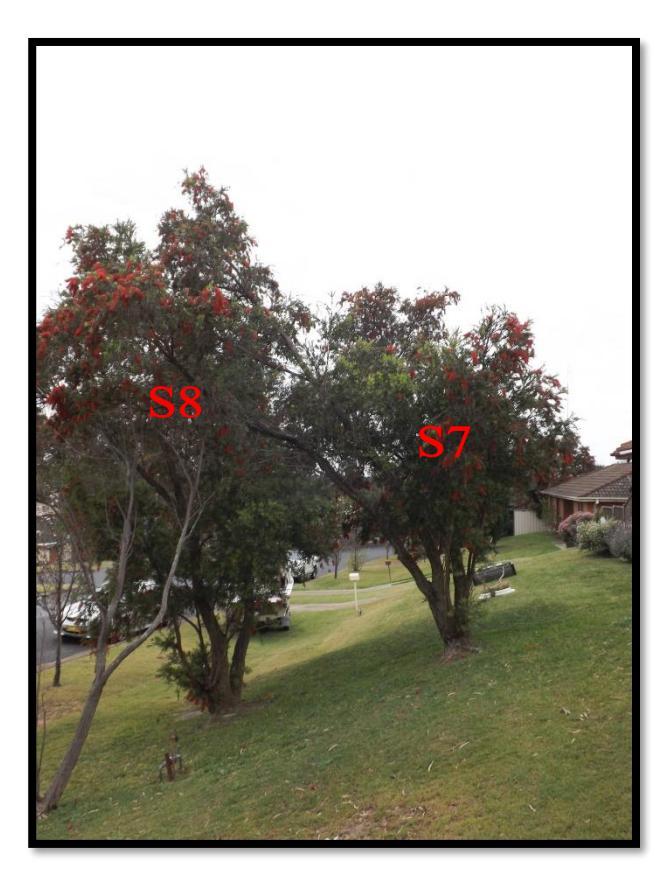
Bottlebrush)								Suitable to
										remove.
	S8	Callistemon	6	Good	Fair	240	2.8	2B	Low	Retain if possible
		viminalis			(form)	(combined)				(close to
		(Weeping								boundary).
		Bottlebrush)								
	S9	Leptospermum	5	Fair	Poor	110	2	3B	Very Low	A poor
		petersonii			(form)	(combined)	(minimum as required			specimen.
		(Lemon					by AS			Suitable to
		Scented Tea					4970)			remove.
		Tree)

Shrubs 7 & 8 viewed from the west.

S8 requires removal due to its proximity to the boundary. Approximately 30% encroachment may be required for the neighbouring shrubs adjacent to number 25. The impact for these could be reduced by the use of *AS* 4970 preferred construction such as permeable paving or raised concrete.

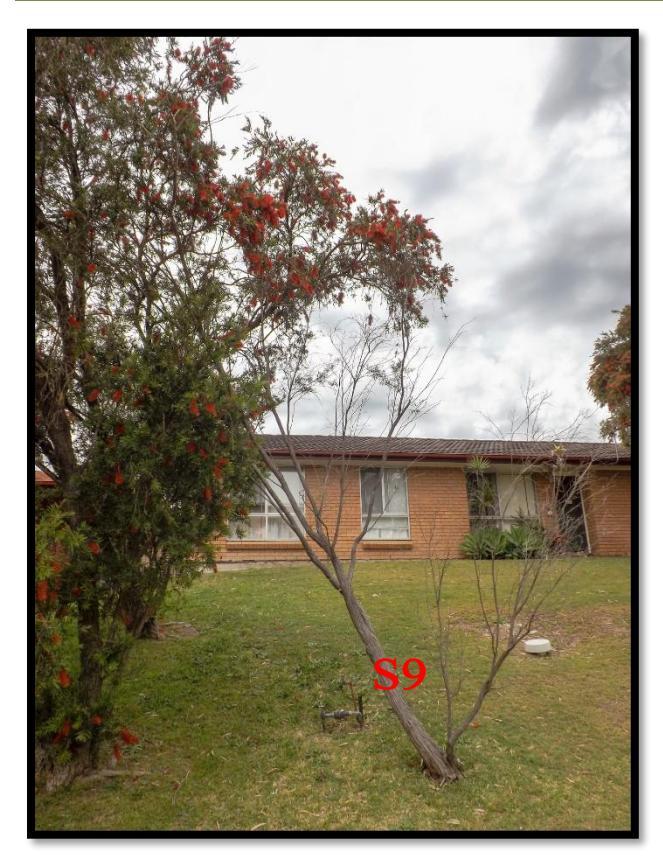
Shrub 9 viewed from the north.

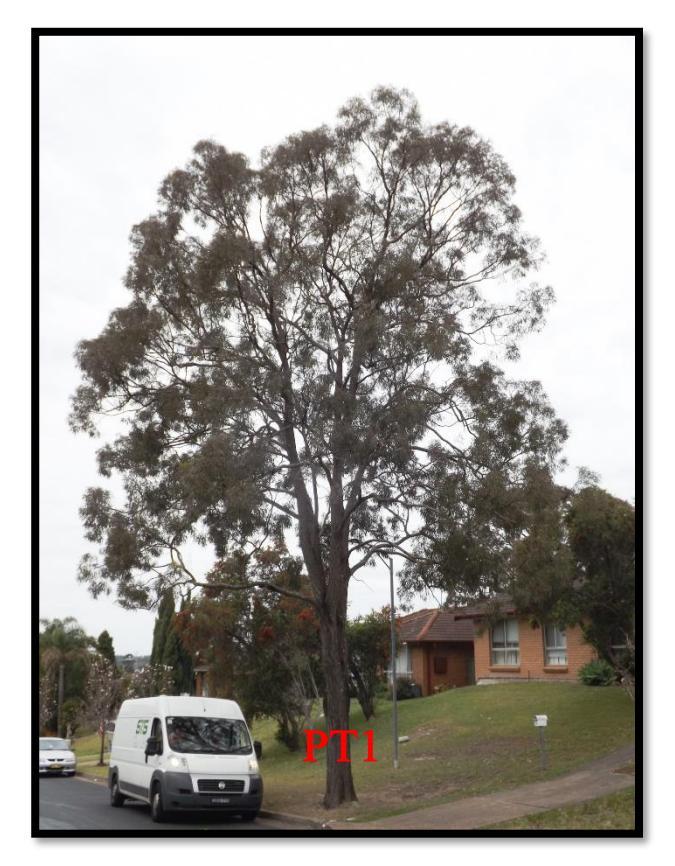
PUBLIC	IREES									
Number	Tree	Species	Height	Condition	1	DBH	TPZ	ULE	Retention	Comments
of Trees	Number		(metres)	Health	Structure	(mm)	(metres)		Value	
1 Shrubs 4	PT1 PS1 – PS4	<i>Eucalyptus</i> <i>crebra</i> . (Narrow Leaved Ironbark). <i>Pyrus</i> cv. (Ornamental Pear)	14 2-3	Good Good	Fair Good	490 N/A	5.9 2 (minimum as required by <i>AS</i>	3B 2B	Moderate	Retain and protect. Co – dominant stems from 2.2 metres high with a developing structural fault. Council should be notified of structural fault. Retain and protect.

Public Tree 1 viewed from the NW.

The public tree/shrubs require retention and protection.

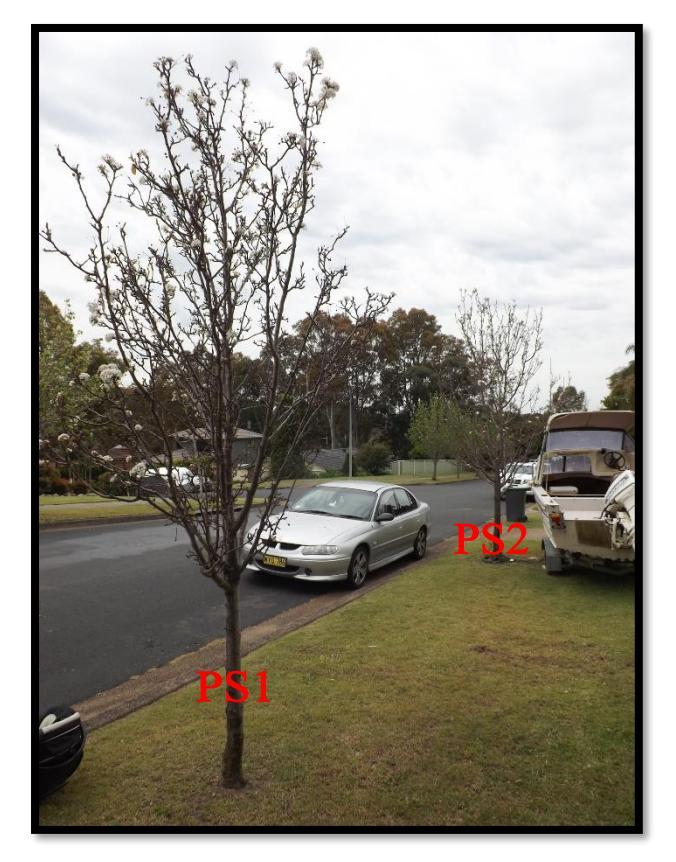
Public Shrubs 1 & 2 viewed from the west.

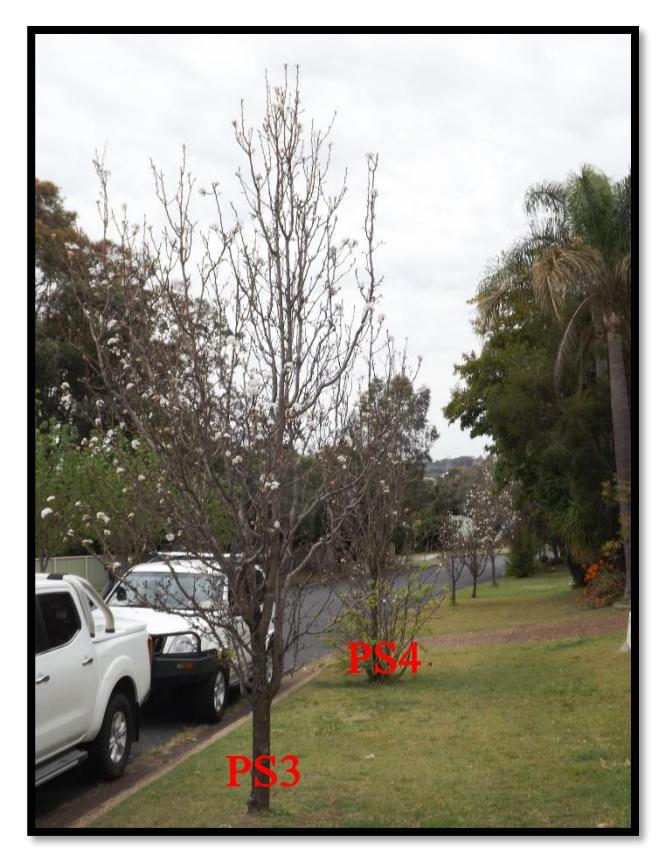
Public Shrubs 3 & 4 viewed from the west.
