### Wyong Hospital Redevelopment

Geotechnical Investigation

15 September 2014

Prepared for Appian Group

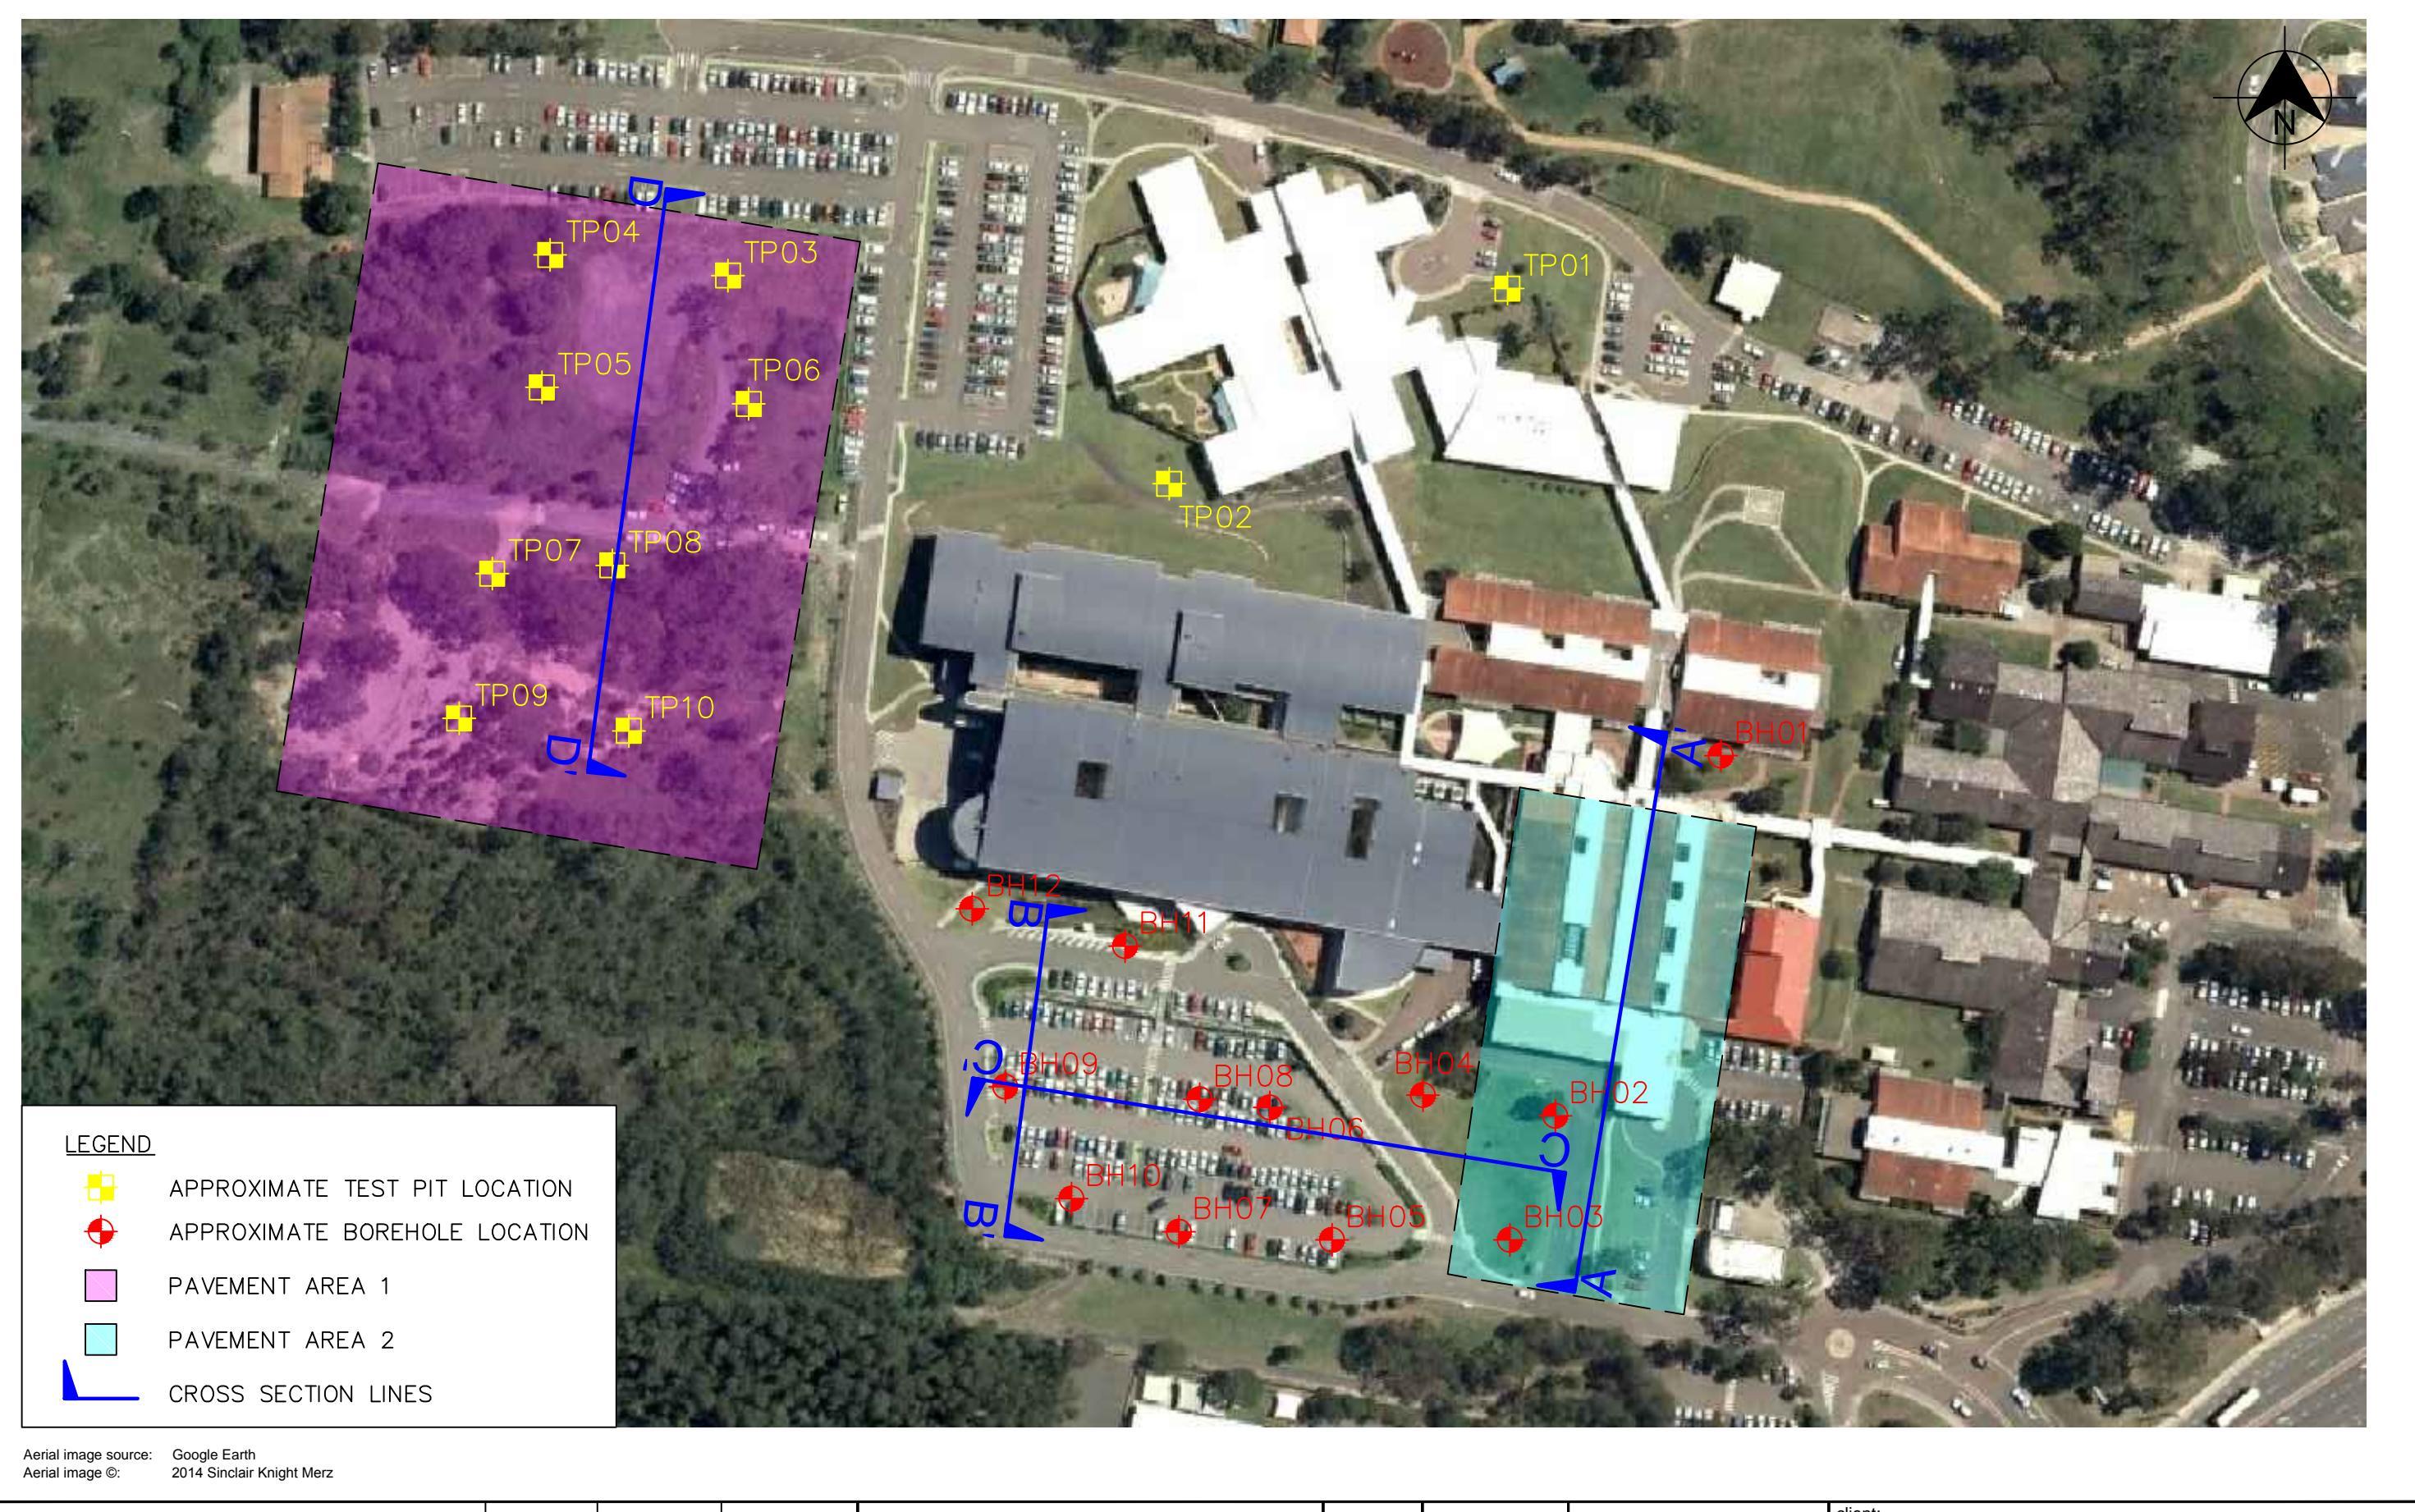
ent:	Appian Group					
oject:	: HI Wyong Hospital Redevelopment Henry Moore Drive, Hamlyn Terrace					
e:	Geotechncial Site Investigation Plan					
o no:	GEOTWARA22354AA	figure no: FIGURE 1

Borehole and test pit locations were marked on the site survey plan supplied by the client and approximate interpreted reduced levels noted on the logs.

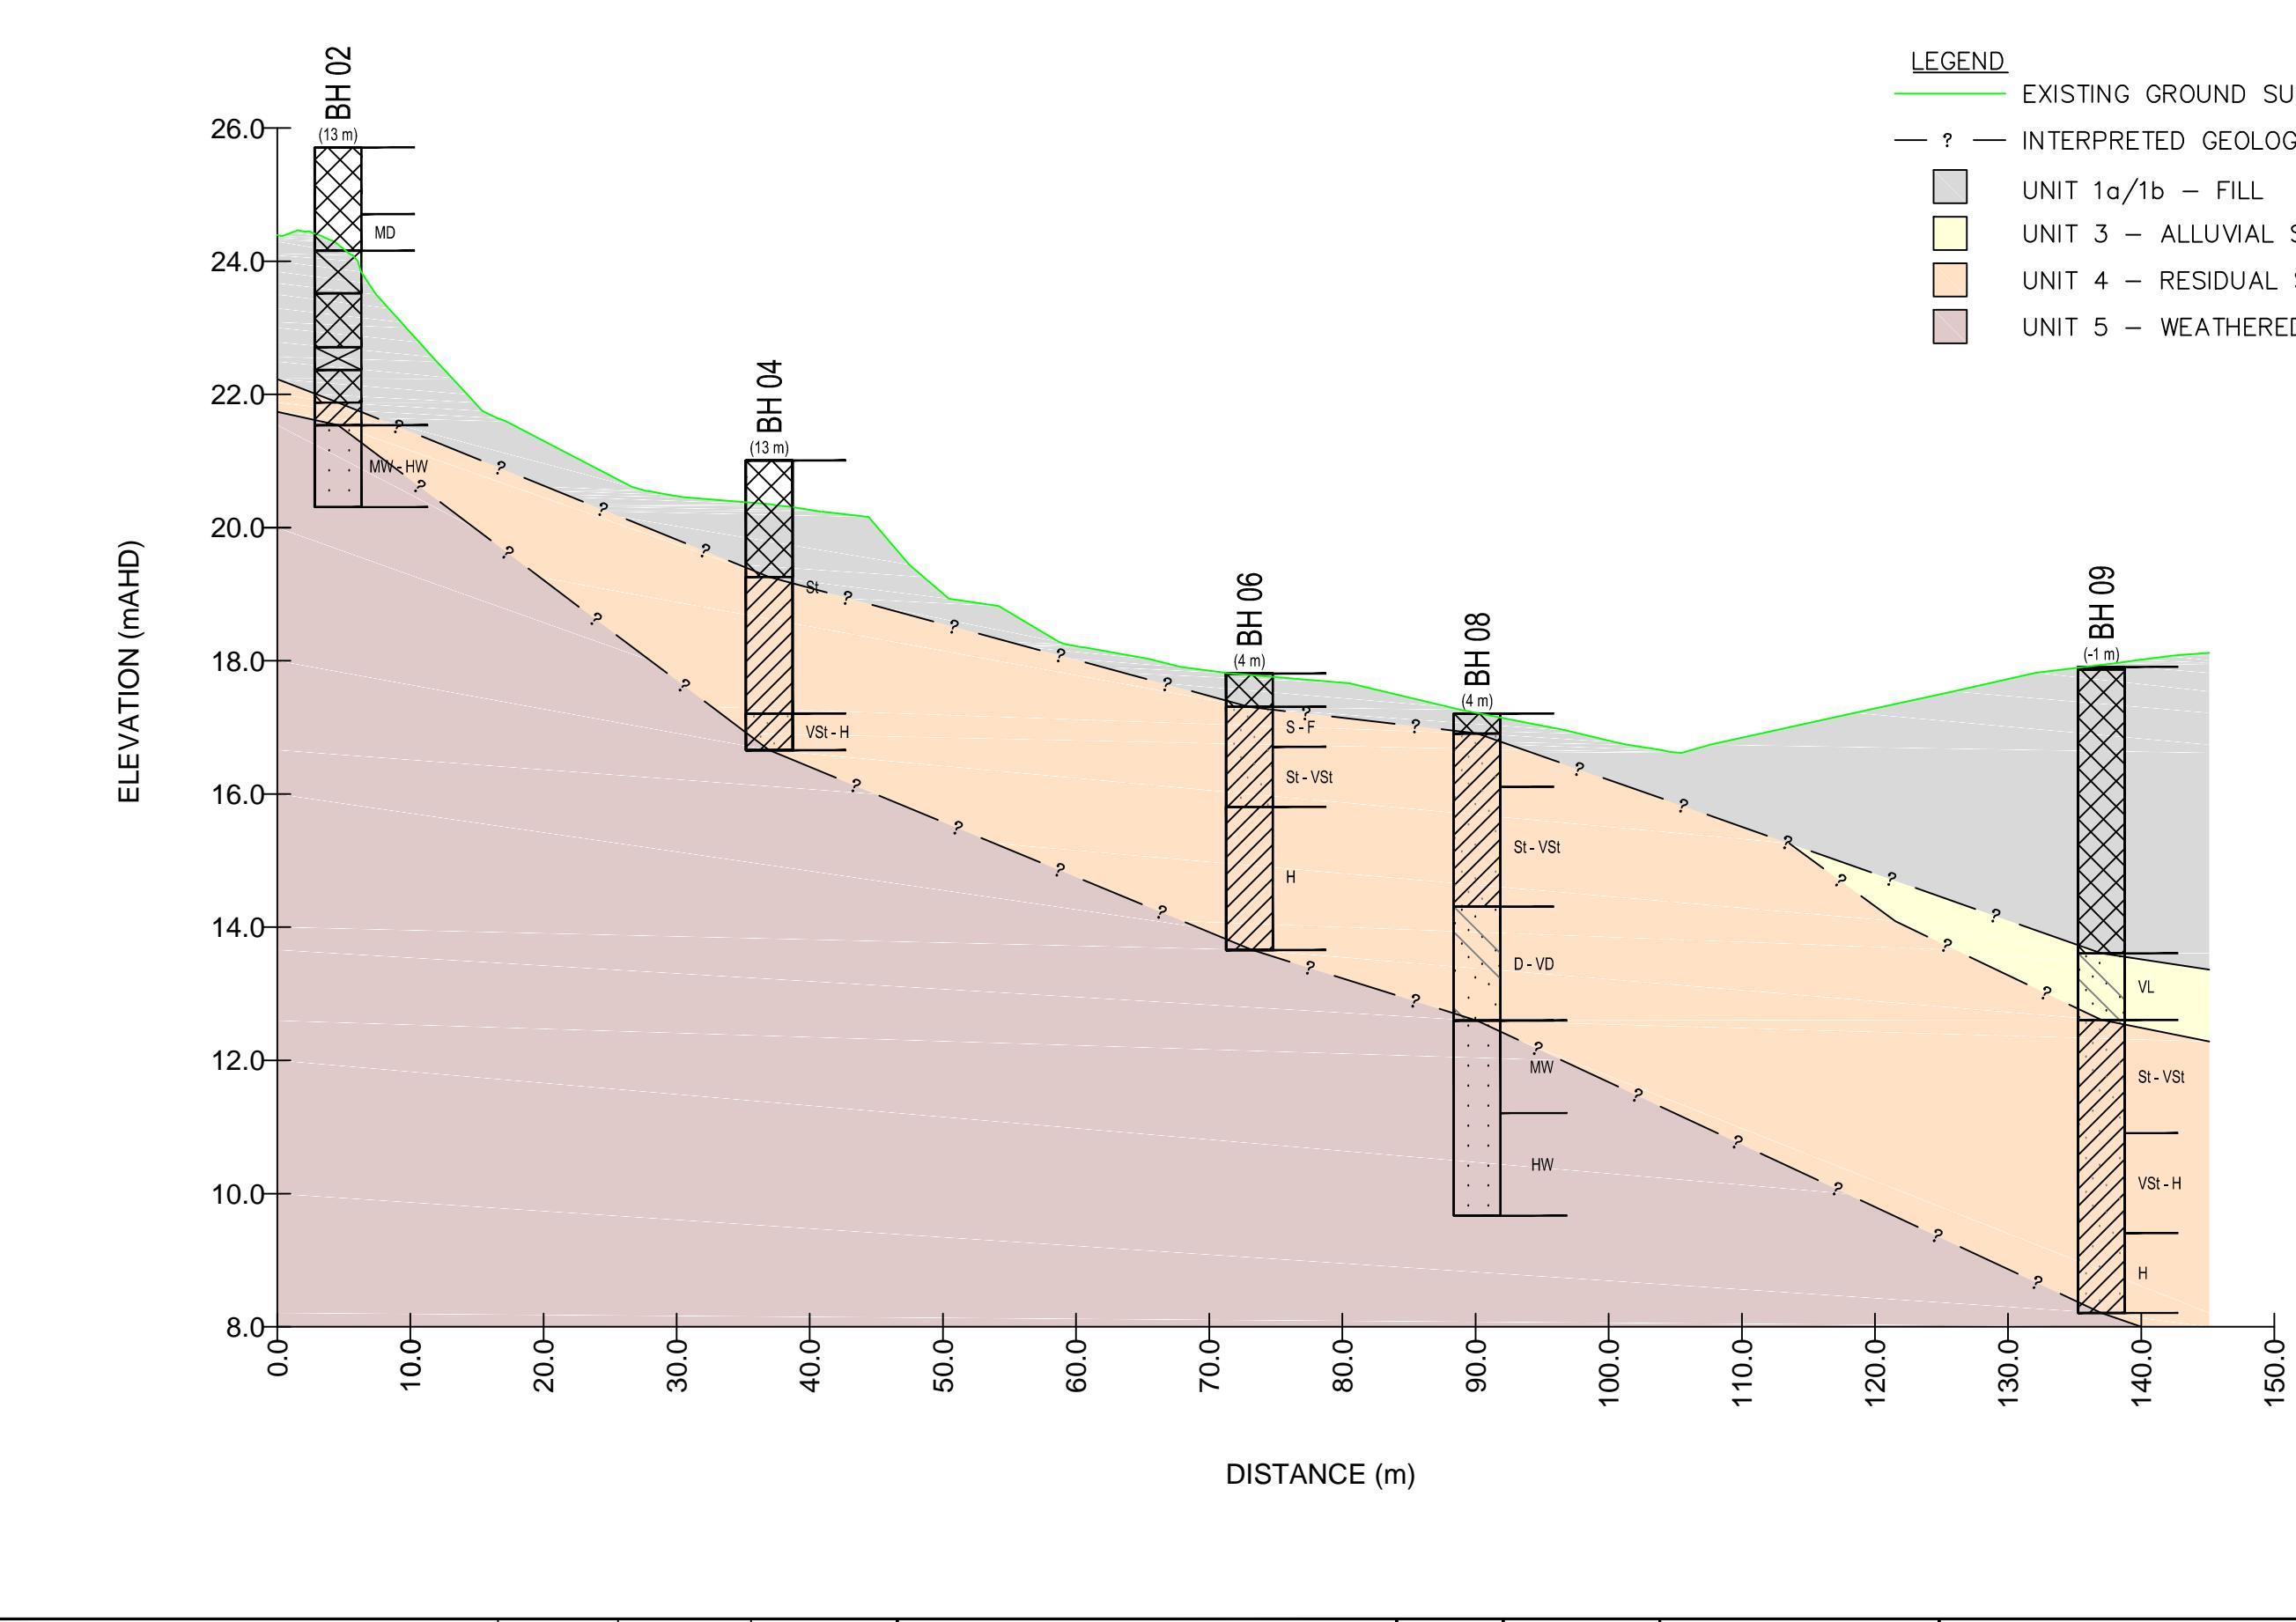
ient:	Appian Group				
oject:	HI Wyong Hospital Redevelopment Henry Moore Drive, Hamlyn Terrace				
le:	Interpreted Geological Cr	oss Section C-C'			
b no:	GEOTWARA22354AA	figure no: FIGURE 4

# - EXISTING GROUND SURFACE - ? - INTERPRETED GEOLOGICAL BOUNDARY UNIT 3 – ALLUVIAL SOIL UNIT 4 – RESIDUAL SOIL UNIT 5 - WEATHERED ROCK

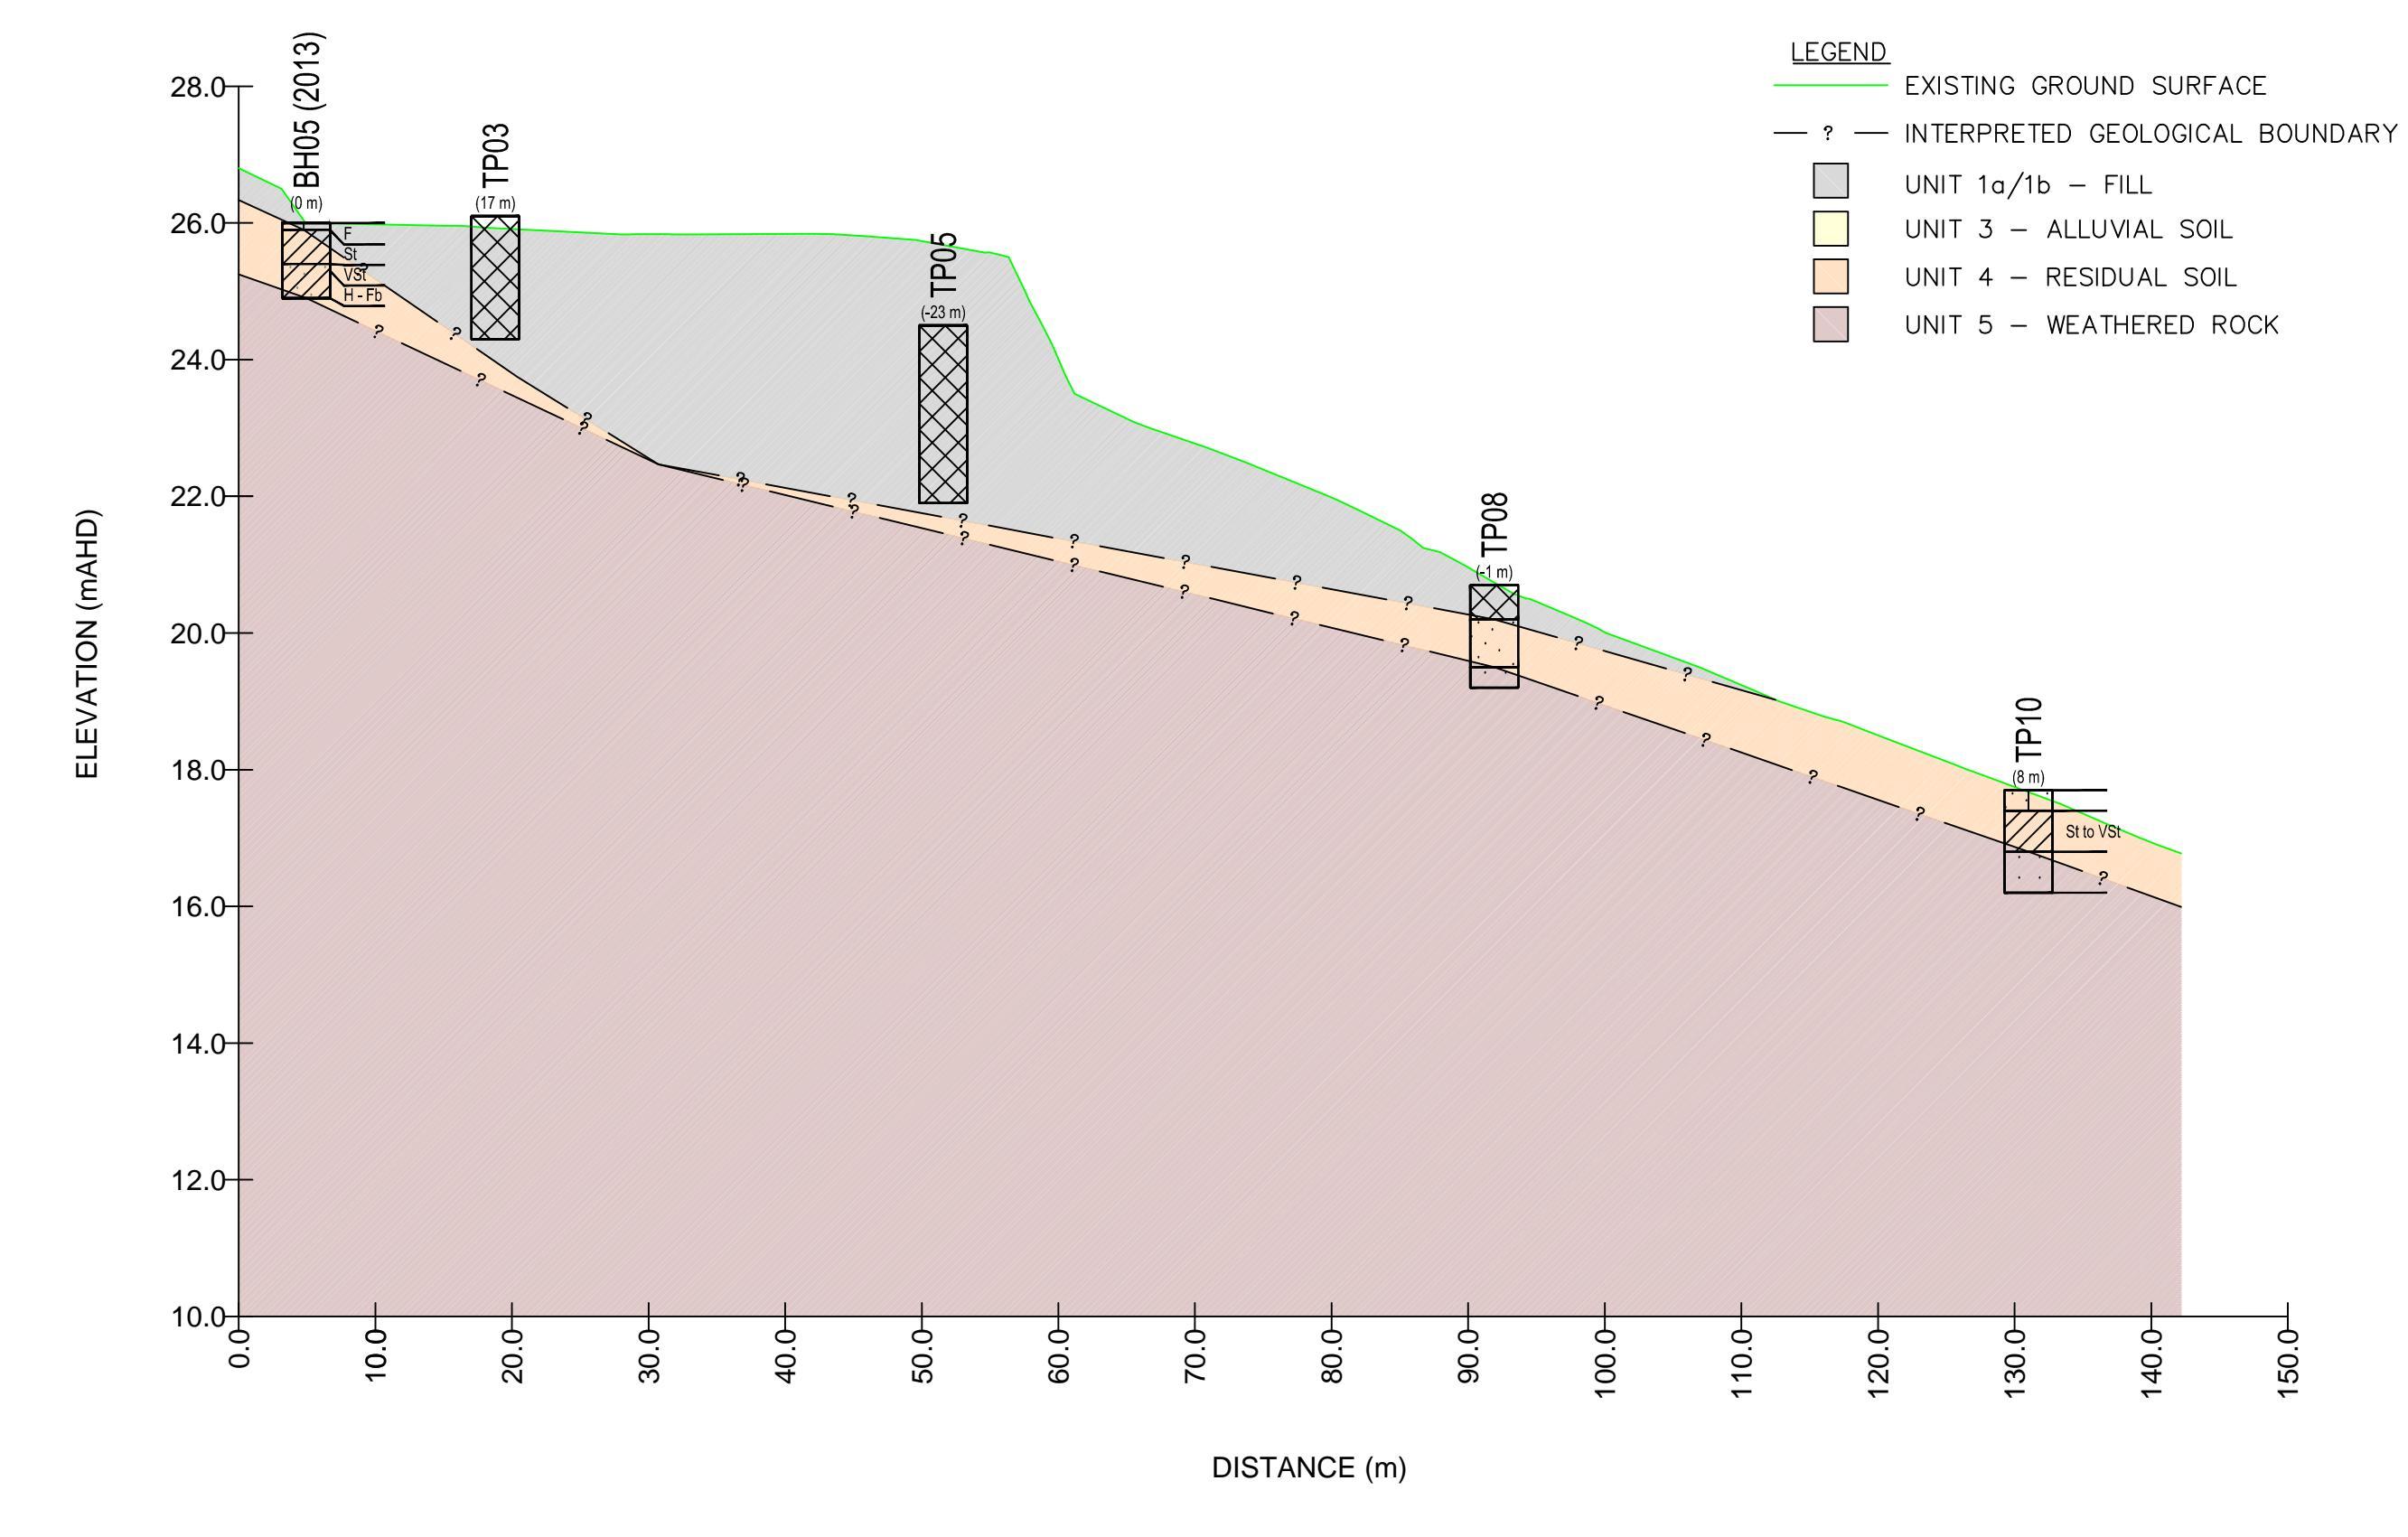
<u>END</u>	
	EXISTING GROUND SURFACE
	INTERPRETED GEOLOGICAL BOUNDARY
	UNIT 1a/1b — FILL
	UNIT 3 – ALLUVIAL SOIL
	UNIT 4 – RESIDUAL SOIL
	UNIT 5 - WEATHERED ROCK

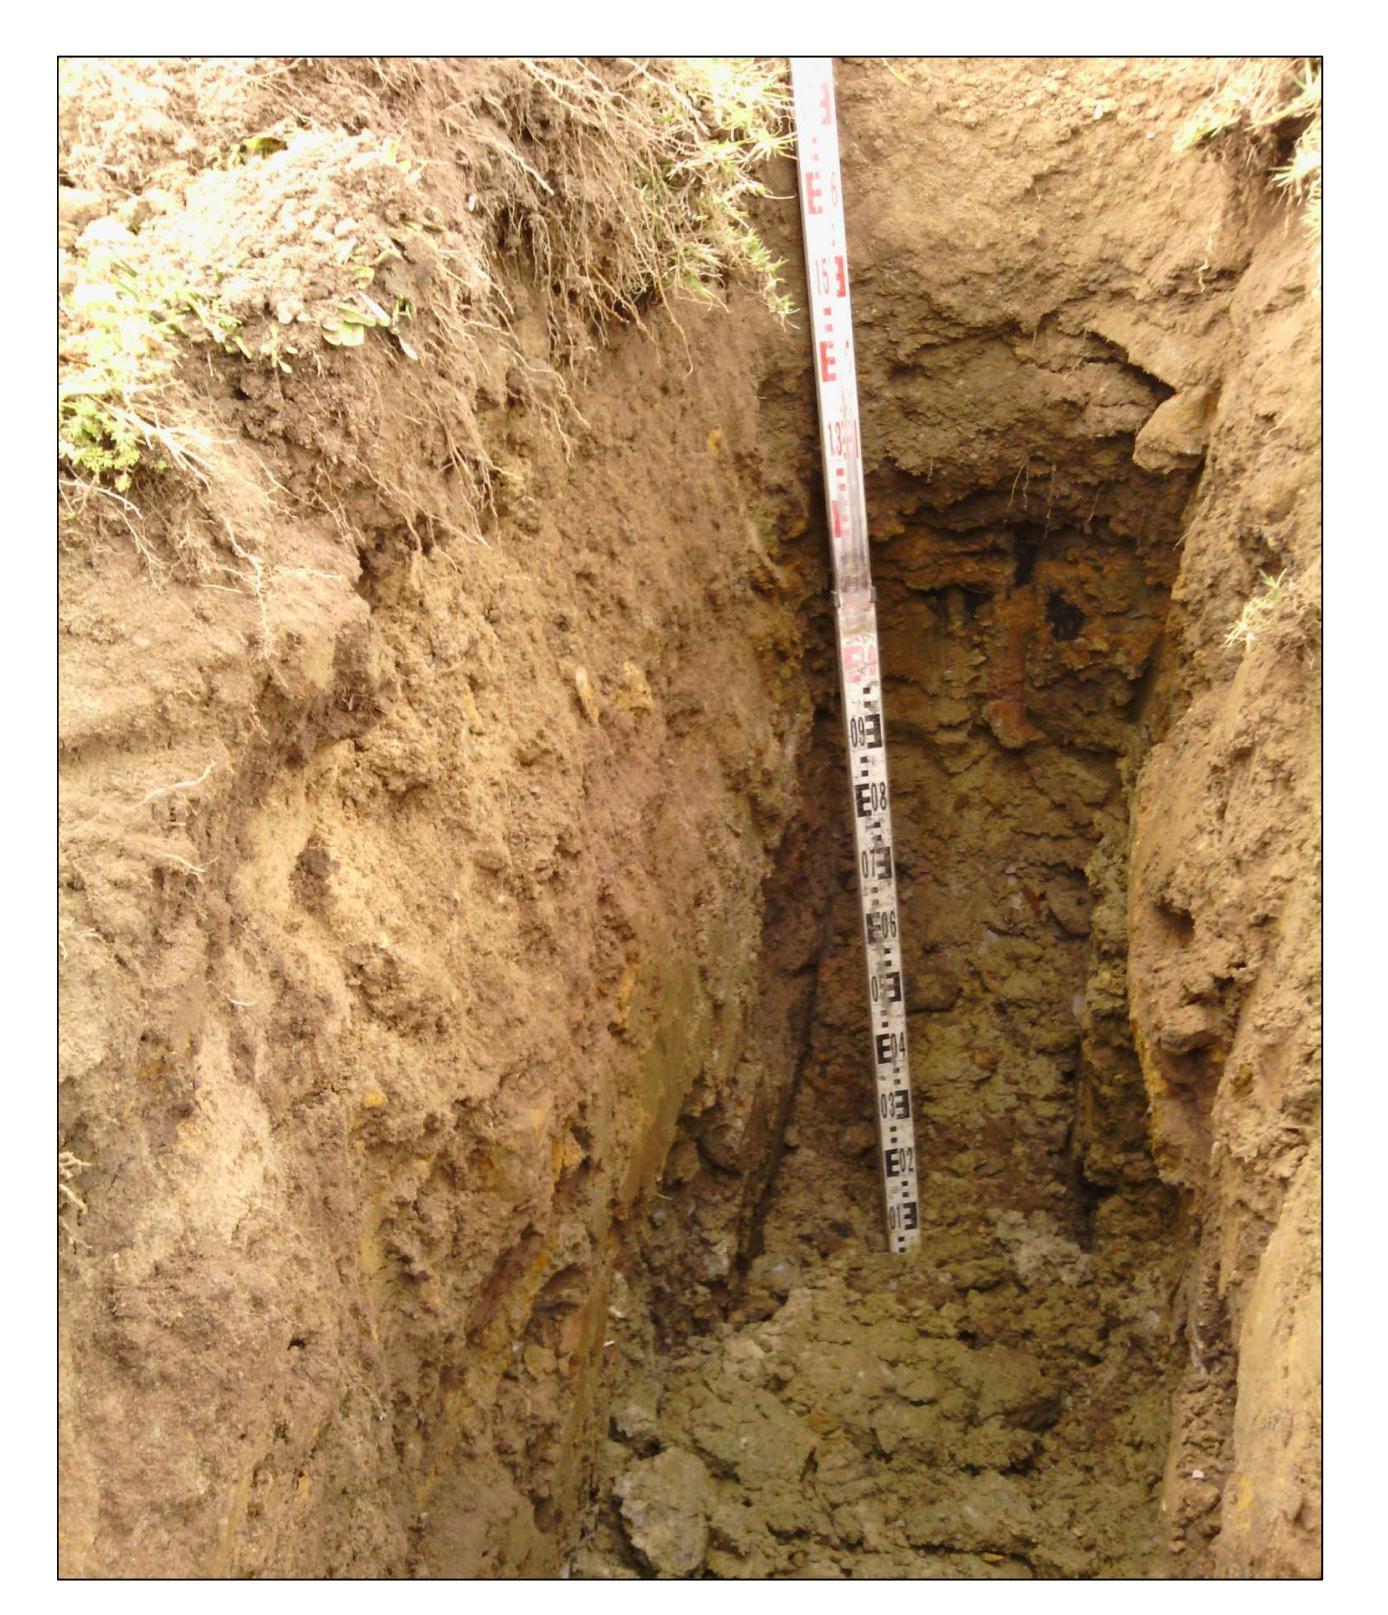
drawn	JR		client:	Appian G	Group	
approved	RJ	coffey	P	project:	Wyong Hospital R	edevelopment
date	27-Aug-14			Hamlyn Terra	ace, NSW	
scale	NTS	Concy	title:	Test Pit Pho	tographs	
original	A4		project no:	GEOTWARA22354AA	Location: TP02

**TP02** Profile

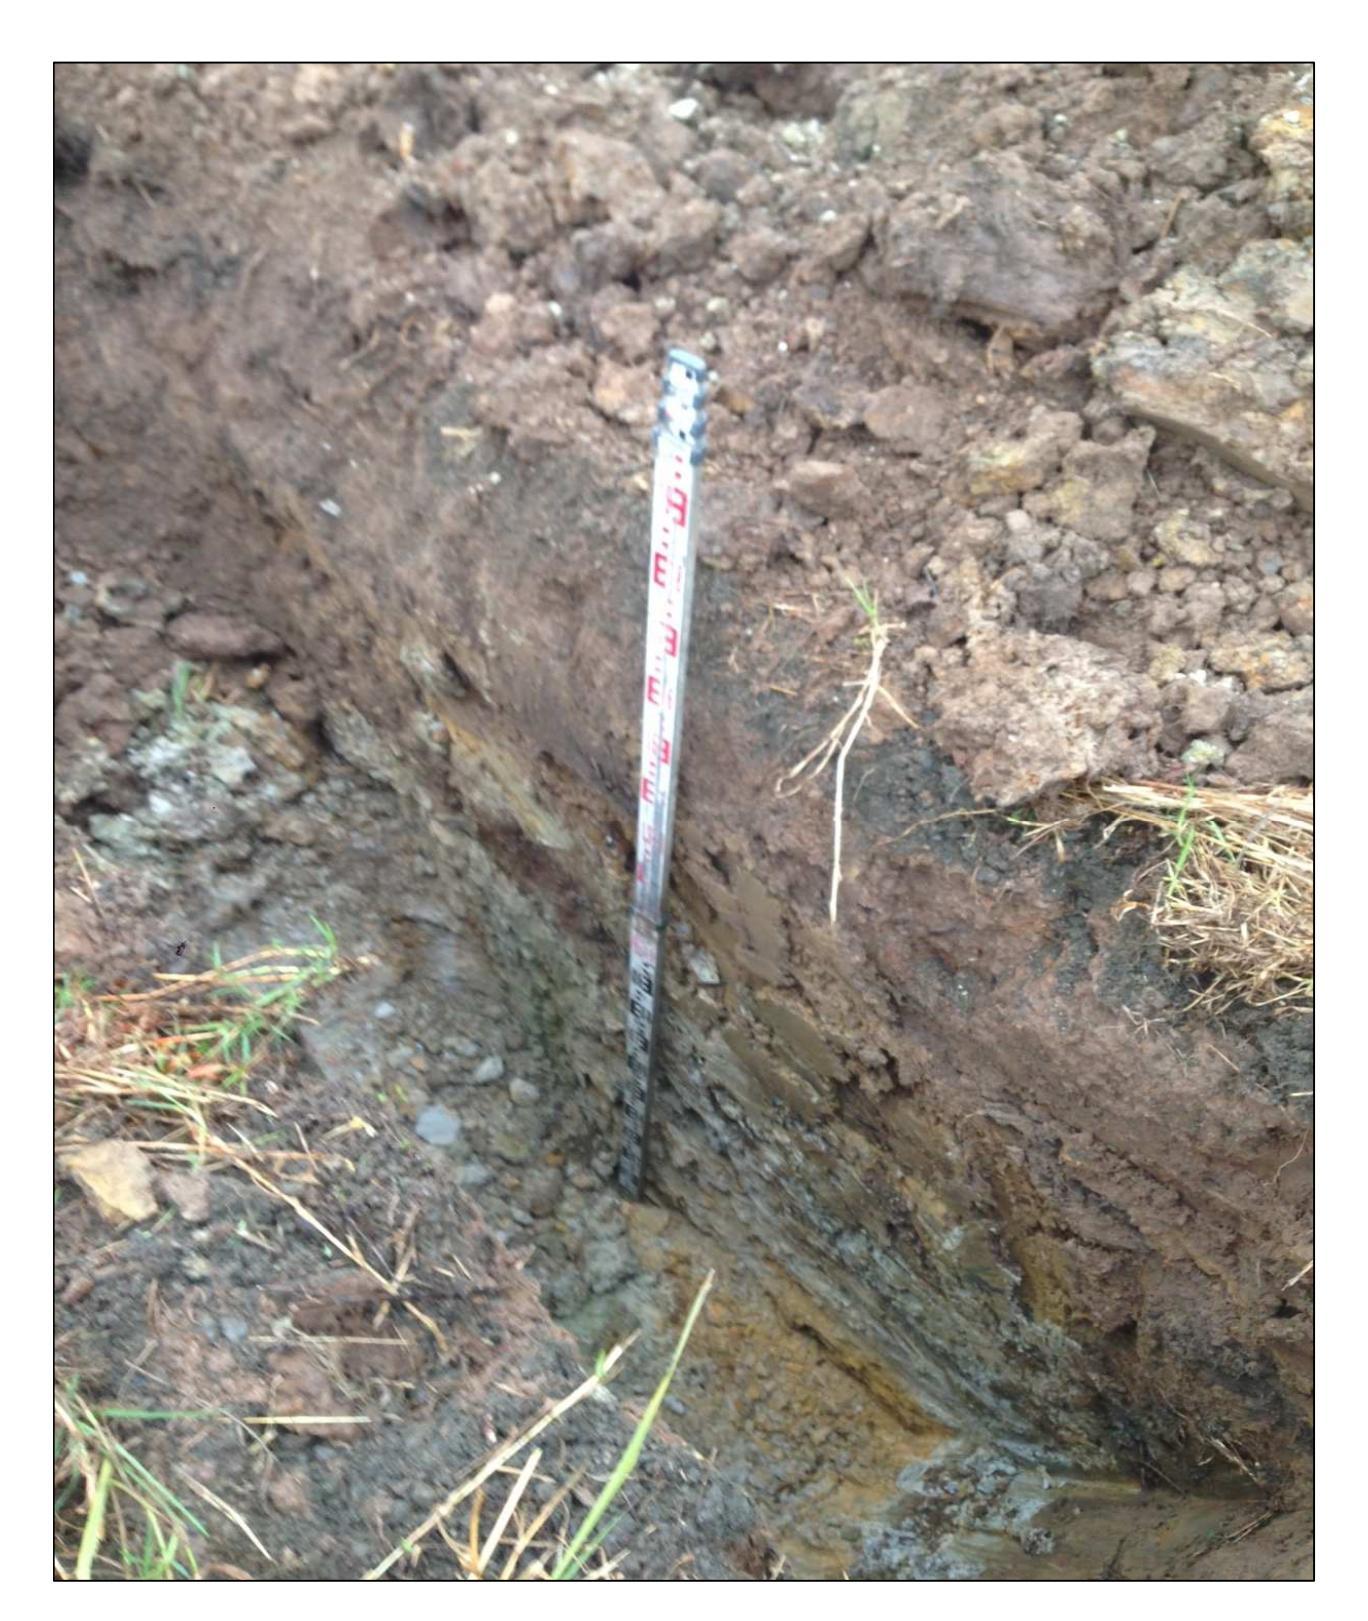
drawn	JR		client:	Appian G	Foup	
approved	RJ	coffev		project:	Wyong Hospital R	edevelopment
date	27-Aug-14			Hamlyn Terra	ace, NSW	
scale	NTS	concy	title:	Test Pit Pho	tographs	
original	A4		project no:	GEOTWARA22354AA	Location: TP03

**TP03** Profile

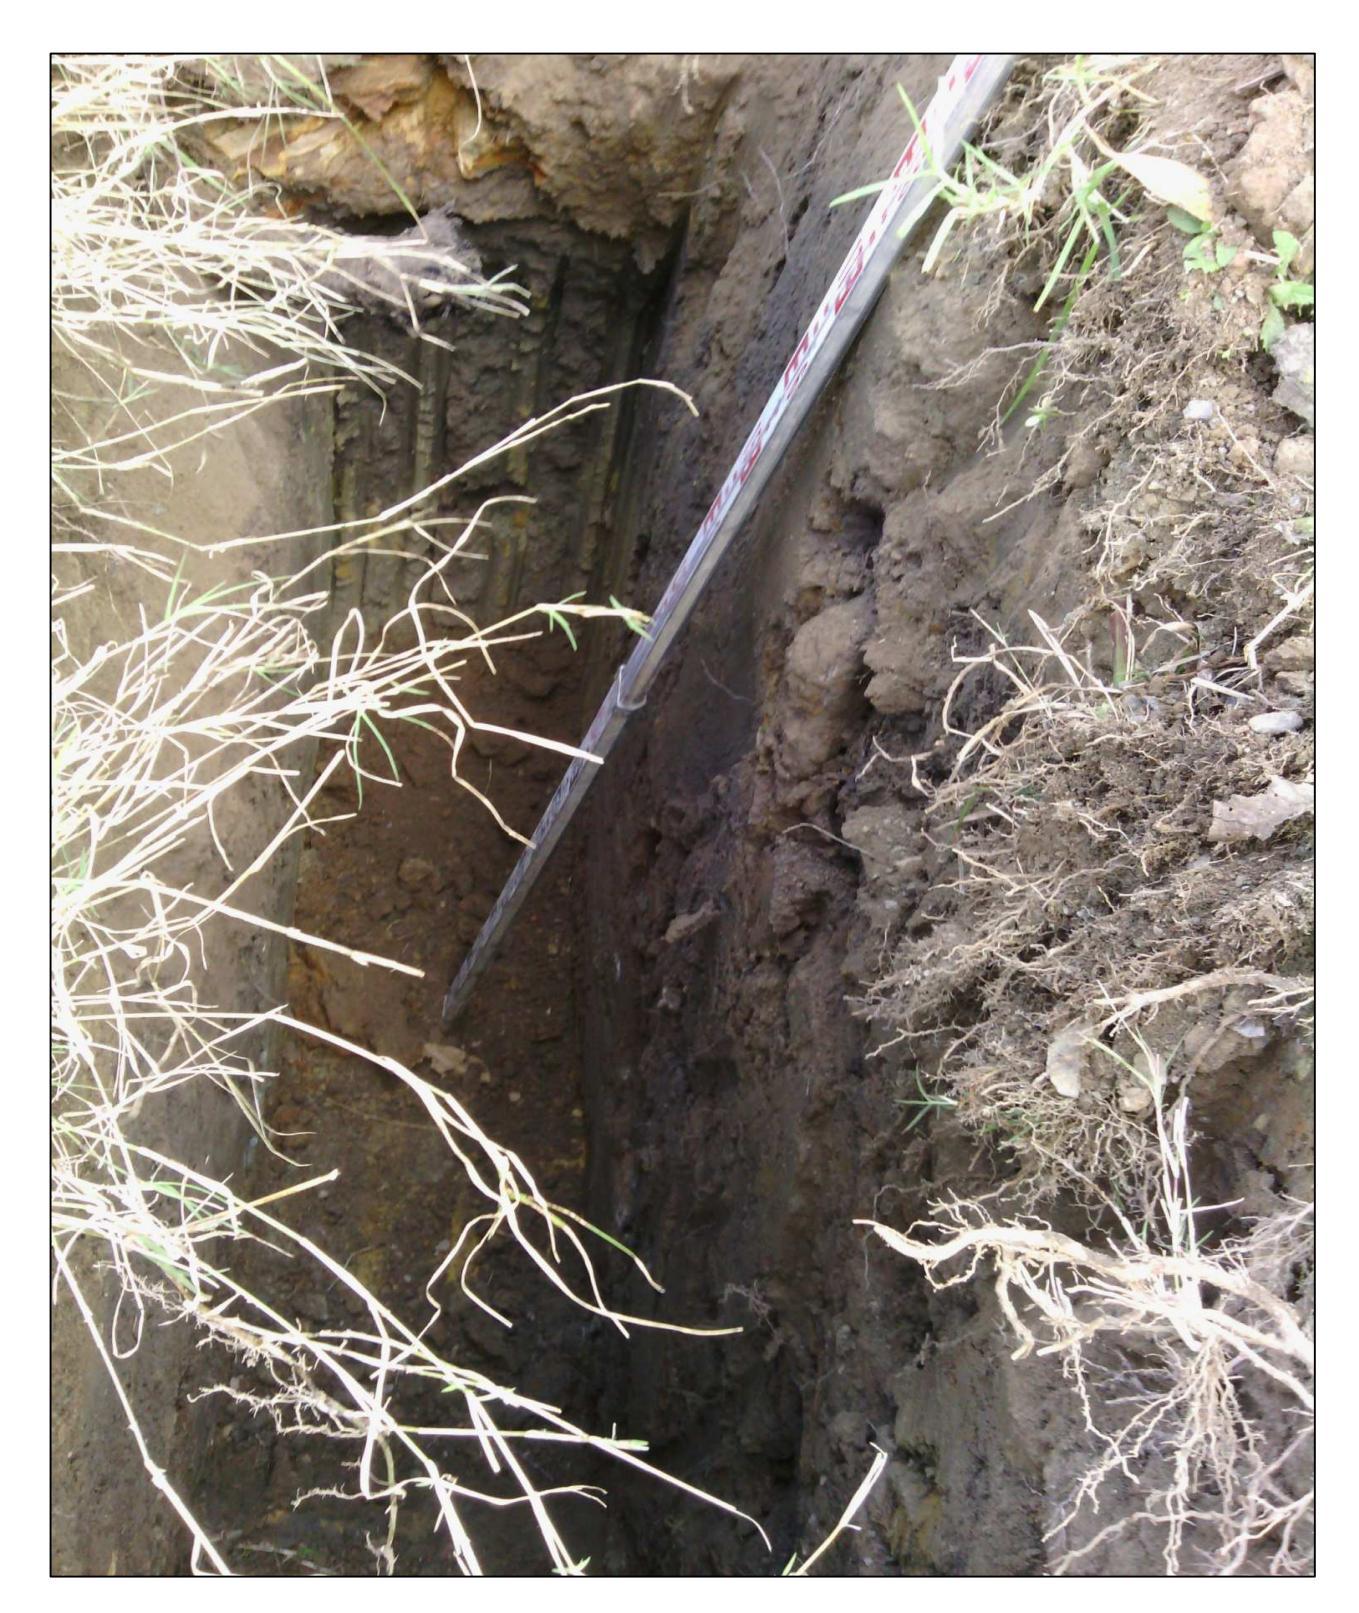
drawn	JR		client:	Appian G	iroup	
approved	RJ	coffey	P	project:	Wyong Hospital R	edevelopment
date	27-Aug-14			Hamlyn Terra	ace, NSW	
scale	NTS	Concy	title:	Test Pit Pho	tographs	
original	A4		project no:	GEOTWARA22354AA	Location: TP04

**TP04** Profile

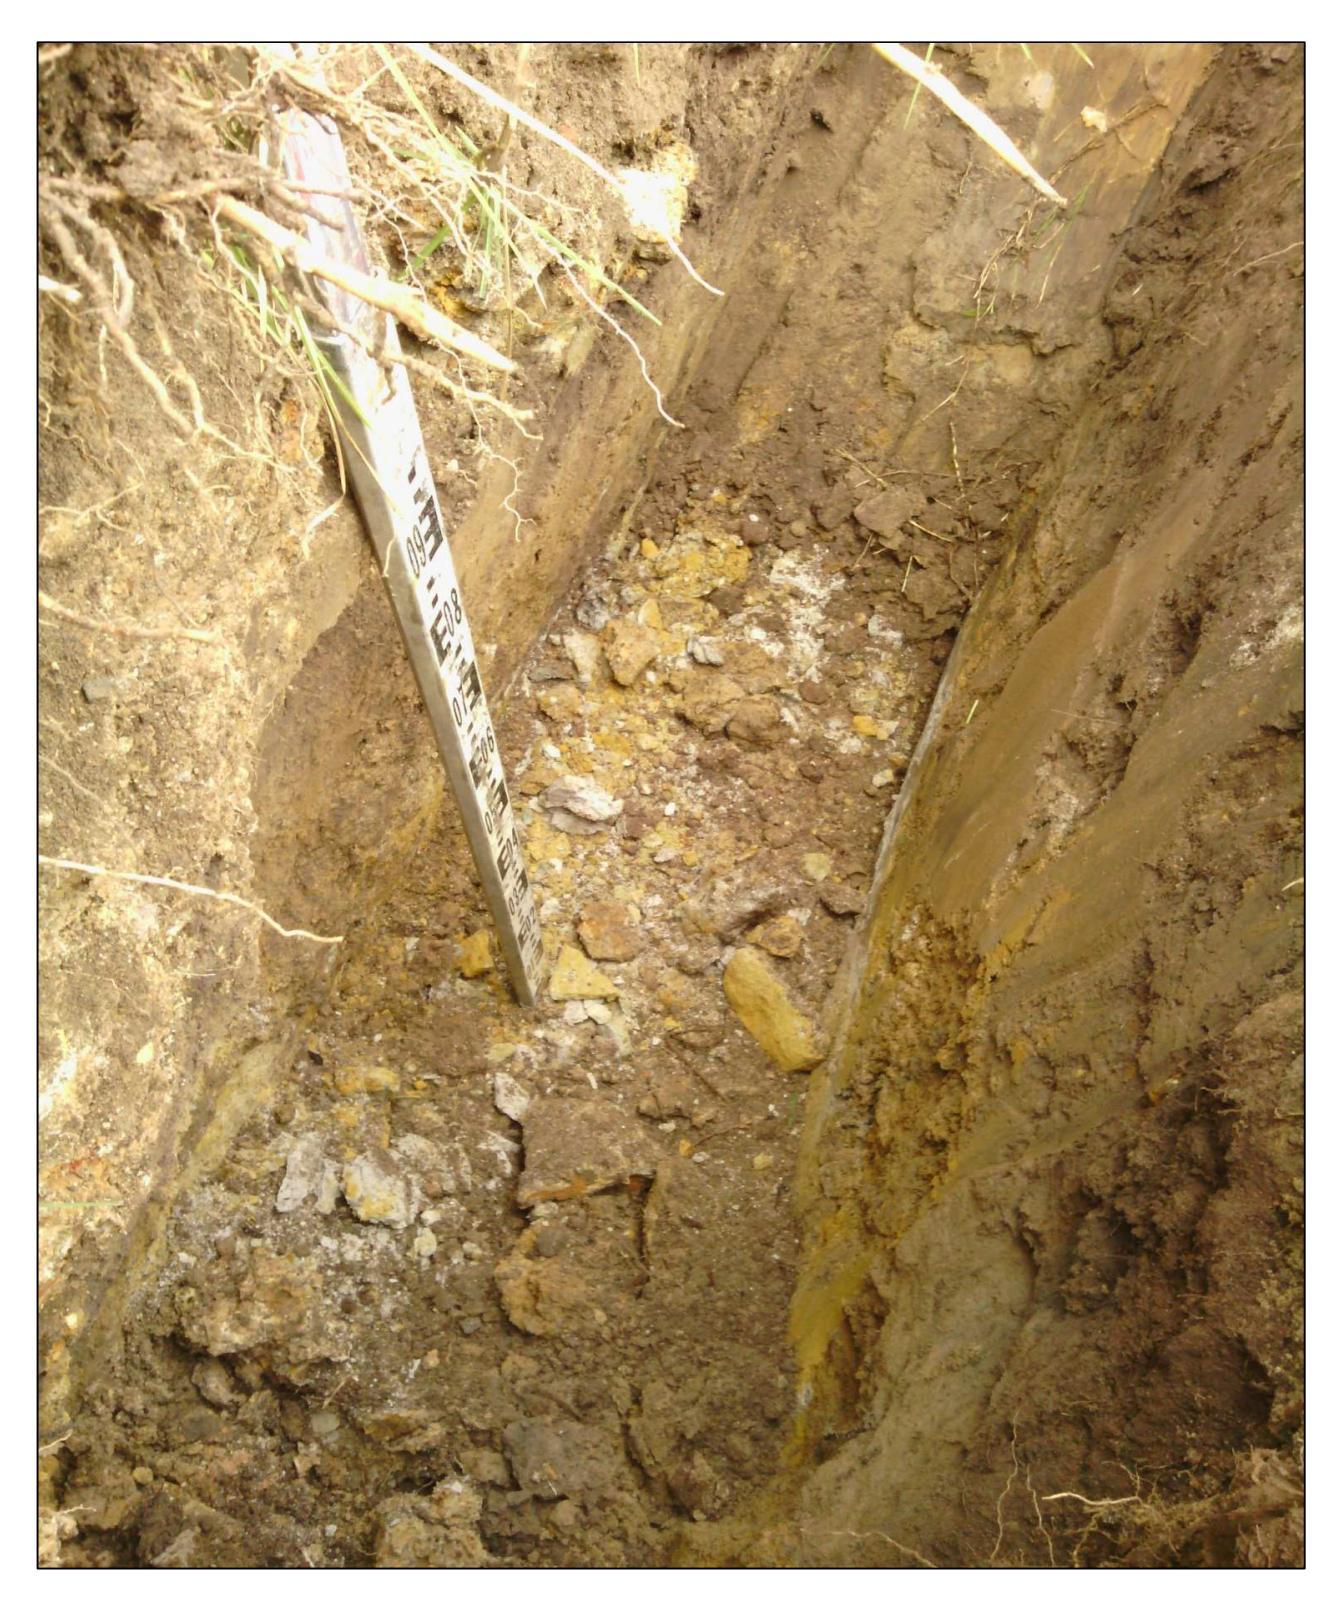
drawn	JR		client:	Appian Group	
approved	RJ	coffey	۲ مع	project:	Wyong Hospital Redevelopment
date	27-Aug-14			Hamlyn Terrace, NSW	
scale	NTS	Concy	title:	Test Pit Photographs	
original	A4		project no:	GEOTWARA22354AA Location: TP08

**TP08** Profile

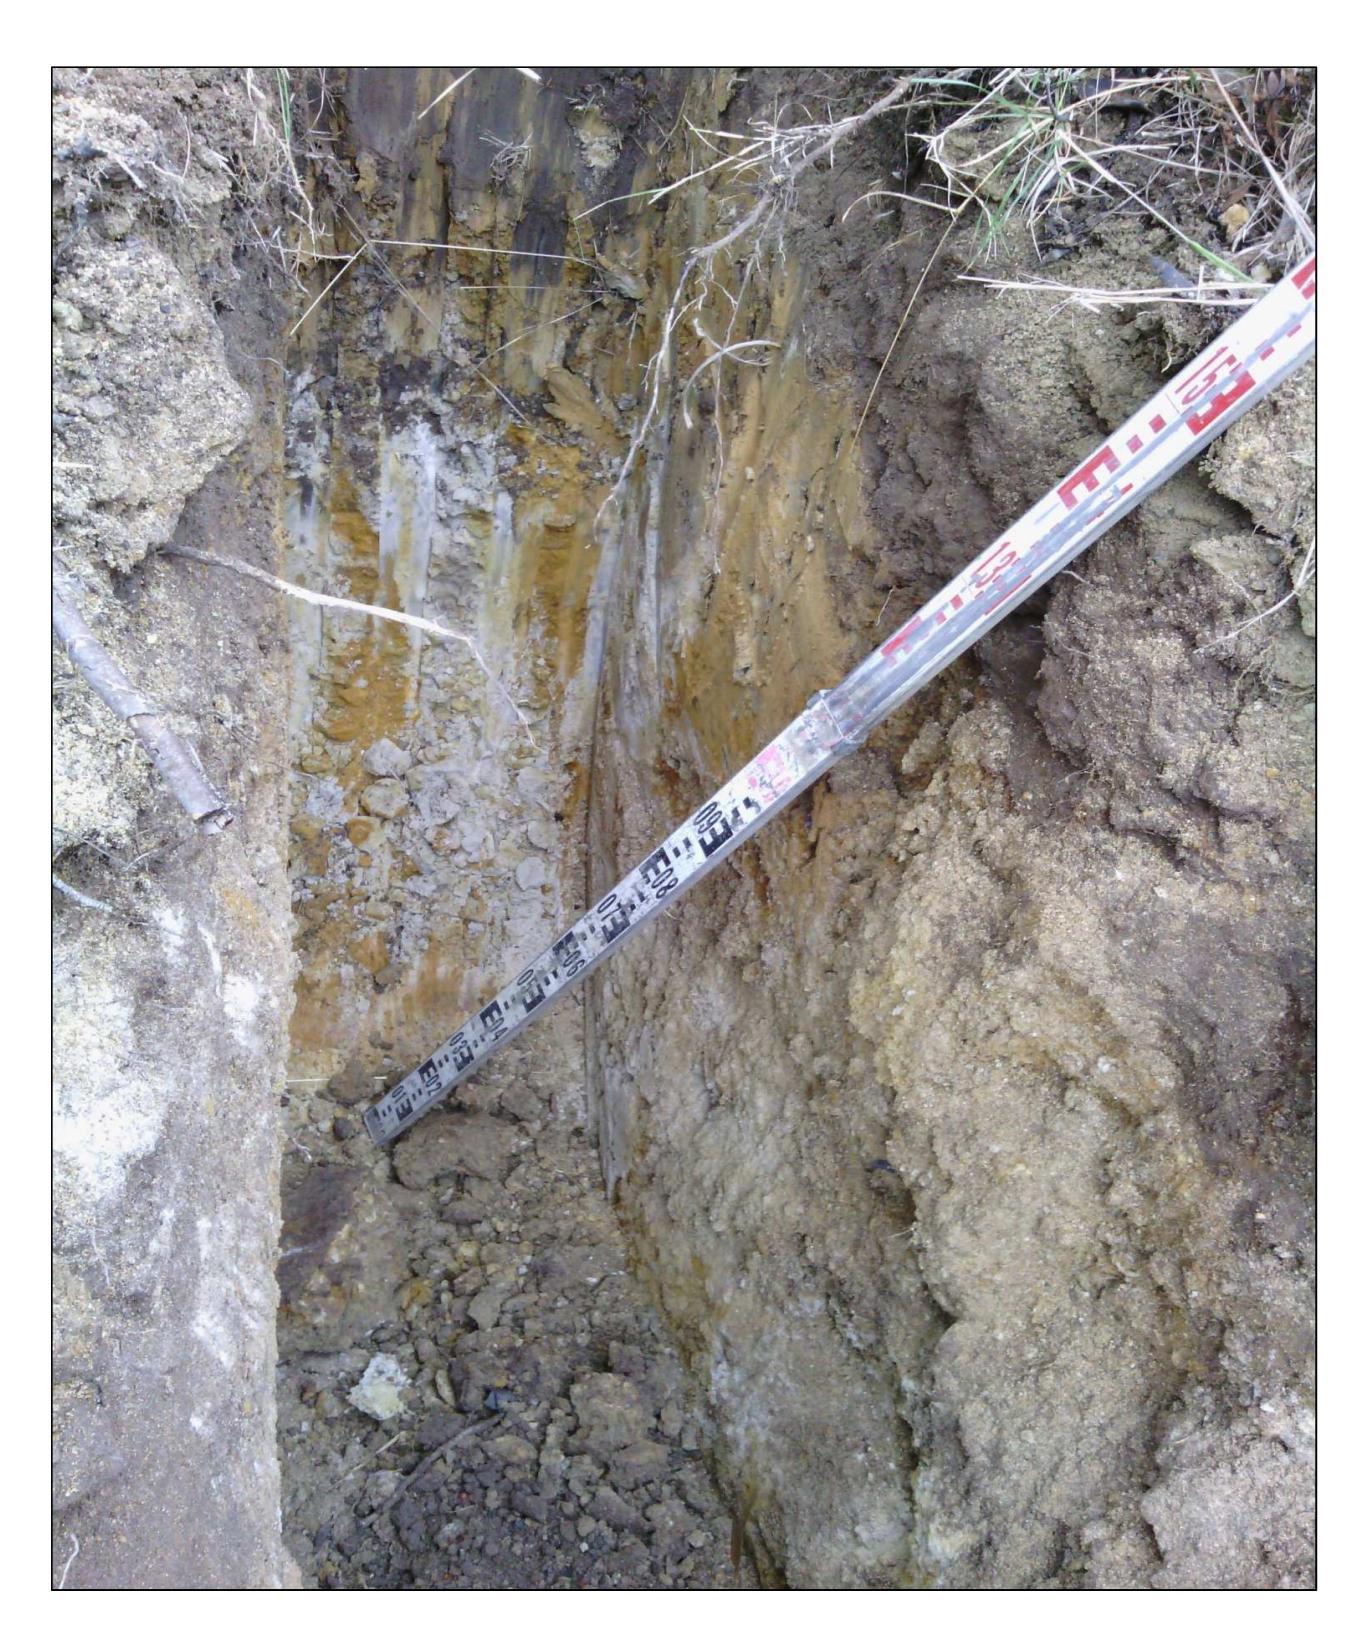
drawn	JR		client:	Appian G	Group	
approved	RJ	ee 🍾	project:	Wyong Hospital R	edevelopment	
date	27-Aug-14	cottey 🗸	Hamlyn Terrace, NSW			
scale	NTS	concy	title:	Test Pit Pho	tographs	
original	A4		project no:	GEOTWARA22354AA	Location: TP09

**TP09** Profile
