Soil conservation works and construction of a new ancillary construction road, MORUYA

Arboricultural Impact Assessment Report

Proposed soil conservation works and the construction of a new ancillary construction road.

Prepared for:	Health Infrastructure
Report No:	AE23-2545-REP-ISS-5
Prepared by:	Abel Ecology
Date:	27 October 2023

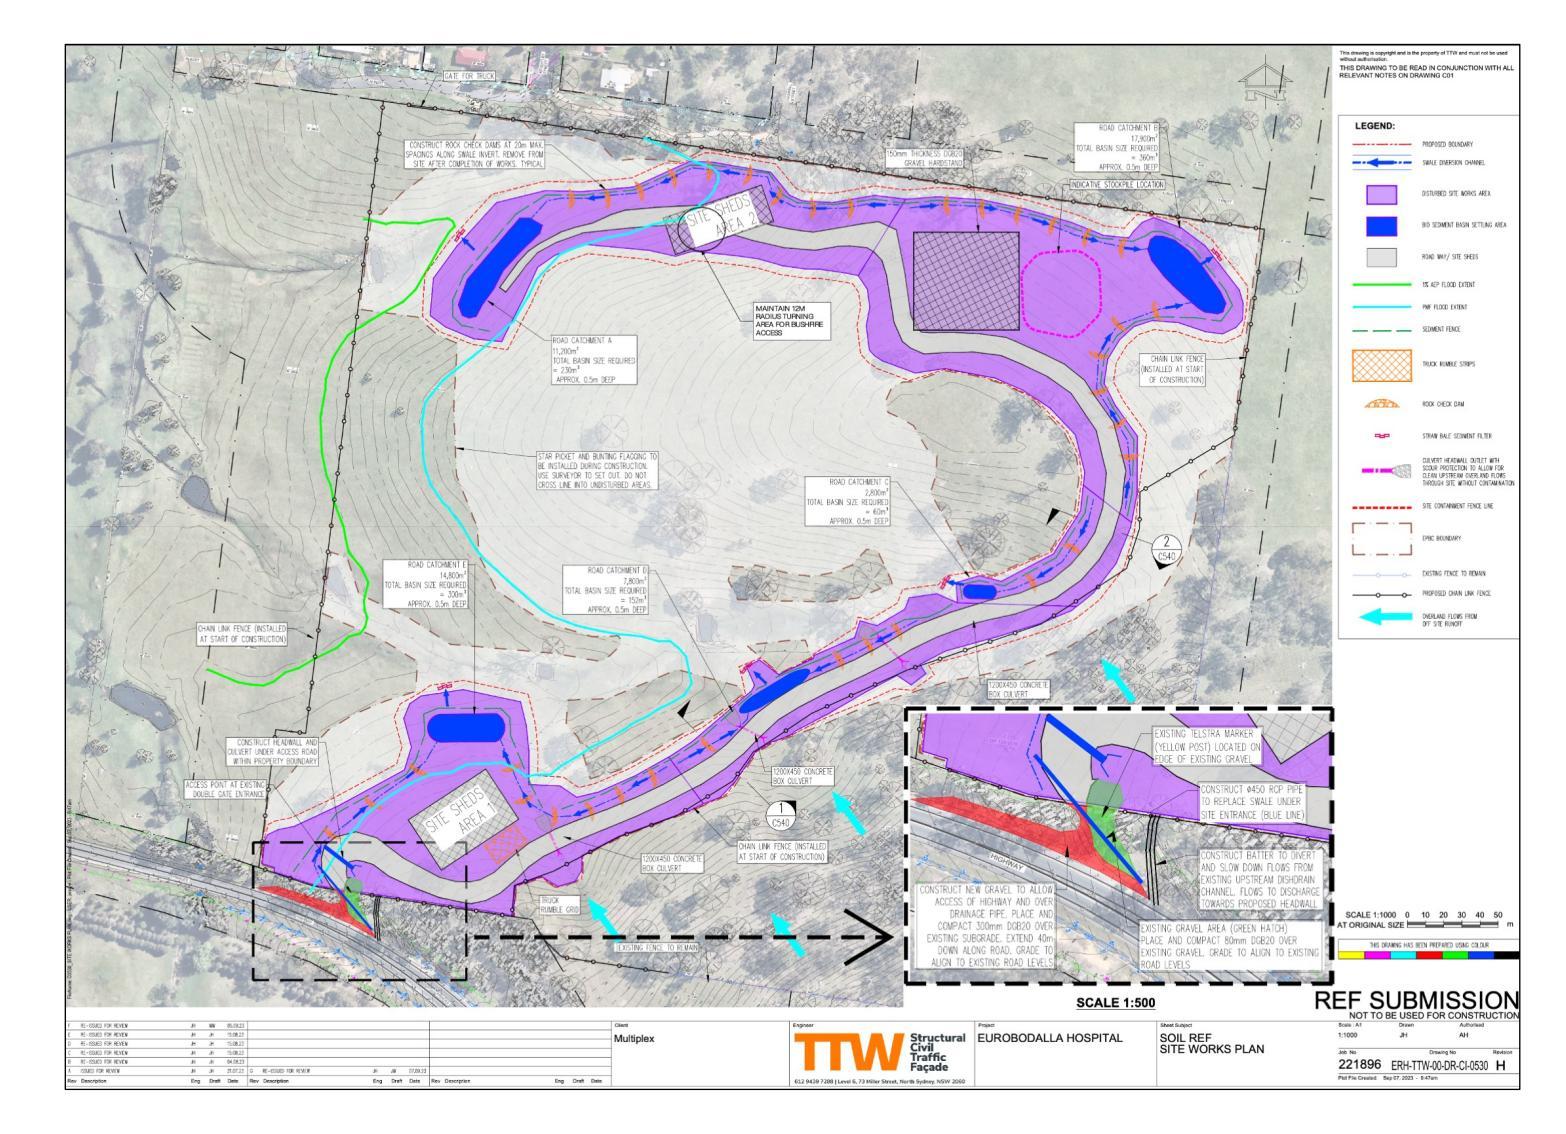
Figure 2. Proposed soil conservation and road construction planned for the site – Site Works Plan.

The works proposed (Figure 2) under this REF include the following:

- 1. Construction of five erosion and sediment basins, ranging between 60m³ and 360m³ in size,
- 2. Site sheds, stockpile areas, hard stand, and
- 3. Construction of an ancillary road into the site to facilitate construction access into the site.

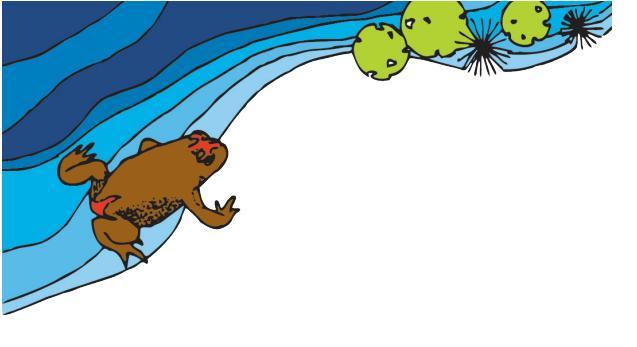
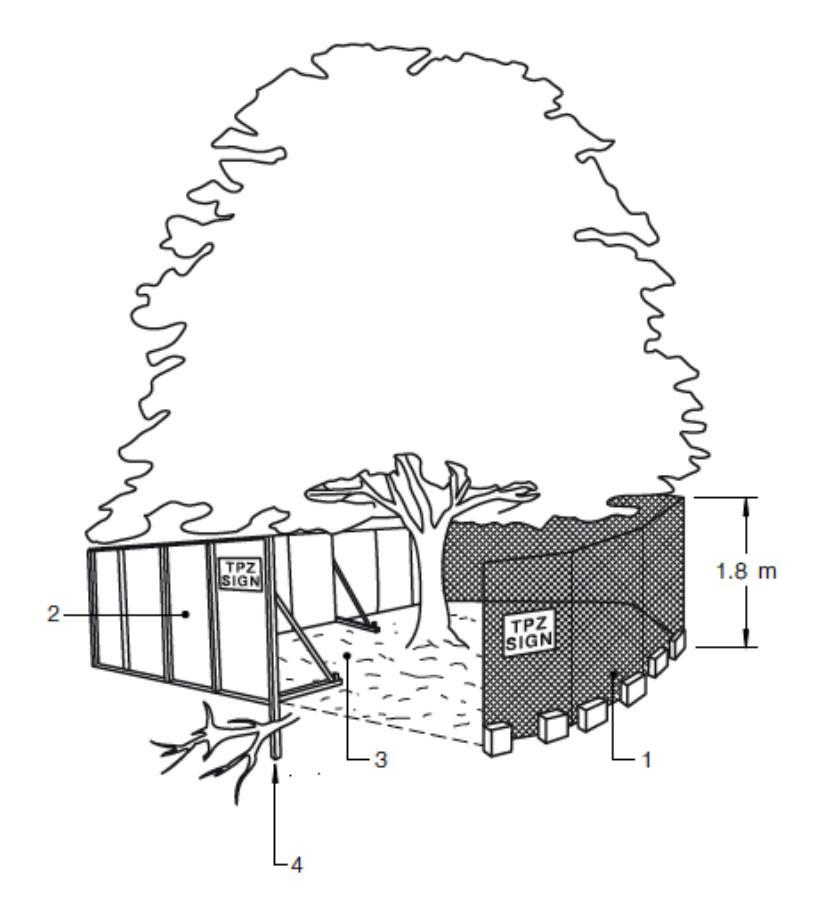
- 1 Chain wire mesh panels with shade cloth (if required) attached, held in place with concrete feet.
- 2 Alternative plywood or wooden paling fence panels. This fencing material also prevents building materials or soil entering the TPZ.
- 3 Mulch installation across surface of TPZ (at the discretion of the project arborist). No excavation, construction activity, grade changes, surface treatment or storage of materials of any kind is permitted within the TPZ.
- 4 Bracing is permissible within the TPZ. Installation of supports should avoid damaging roots.

- b) Construct tree protection fence(s) at the minimum TPZ radius, measured from the centre of the tree, prior to construction to prevent unnecessary root damage (See Figure 6 showing Tree Protection Fence diagram).
 Construct tree protection fences using chain wire mesh panels to a height of 1.8 metre. Fences are to be held in place with secure footing (Figure 6).

- b) Construct tree protection fence(s) at the minimum radius, measured from the centre of the tree, prior to construction to prevent unnecessary root damage (See Figure 6 showing Tree Protection Fence diagram). Construct tree protection fences using chain wire mesh panels to a height of 1.8 metre. Fences are to be held in place with secure footing (Figure 6).

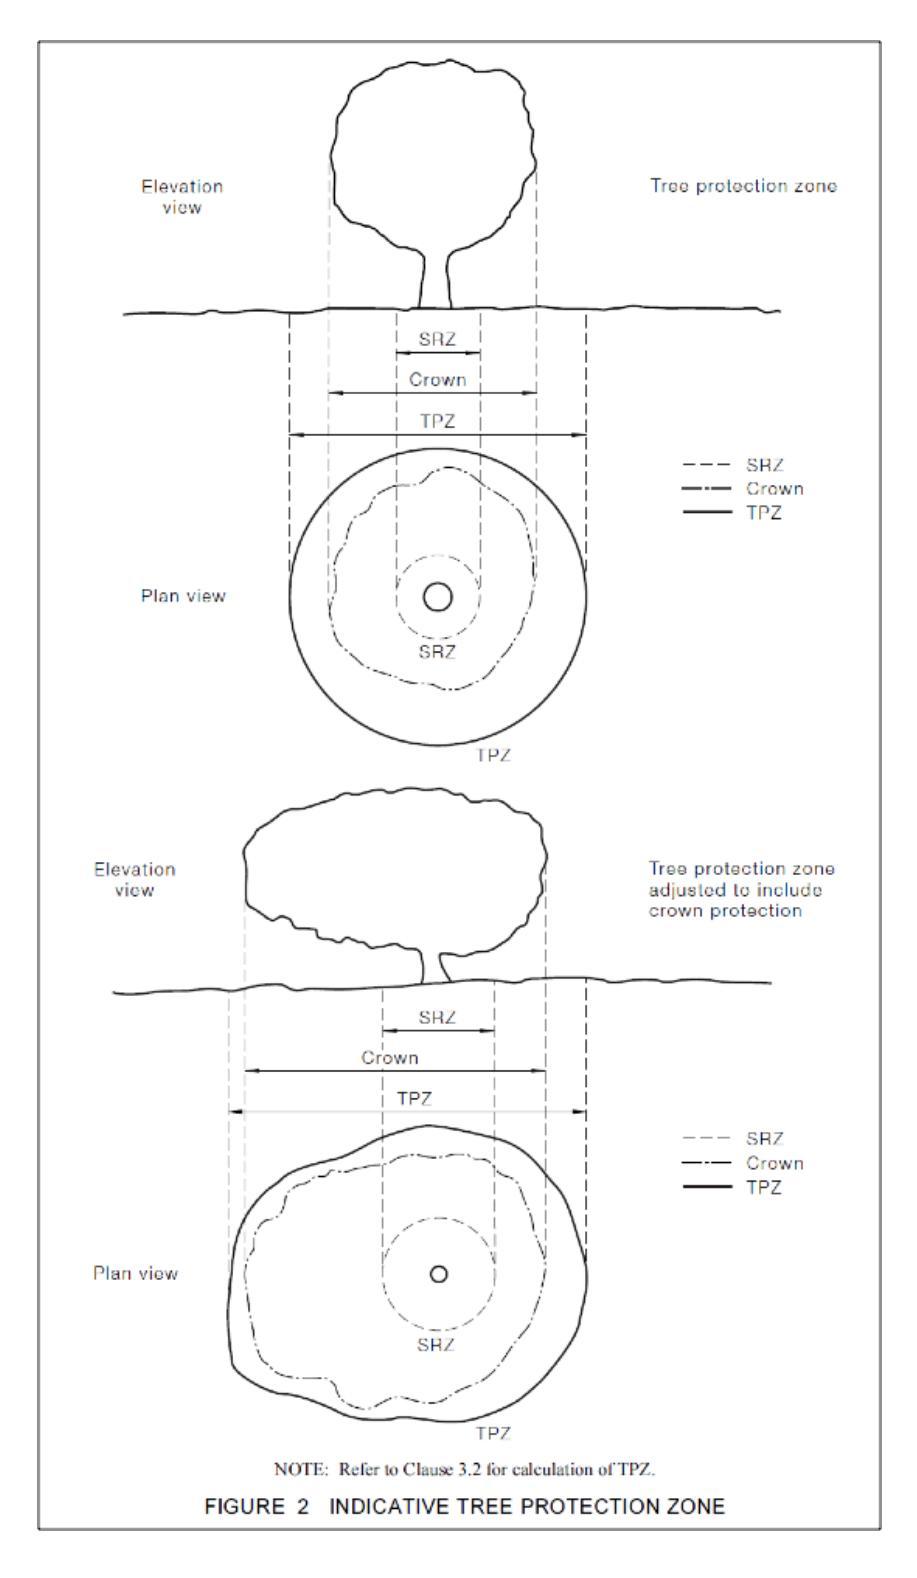
Appendix 4. Tree Protection Zone and Structural Root Zone

Extract from Section 3 of AS 4970-2009.
