ARBORICULTURAL IMPACT ASSESSMENT

TREE PROTECTION SPECIFICATION

REF: L&Co24018 | 11 March 2025 | v2.2

SITE ADDRESS | Northmead Public School, Moxhams Rd, Northmead NSW 2152

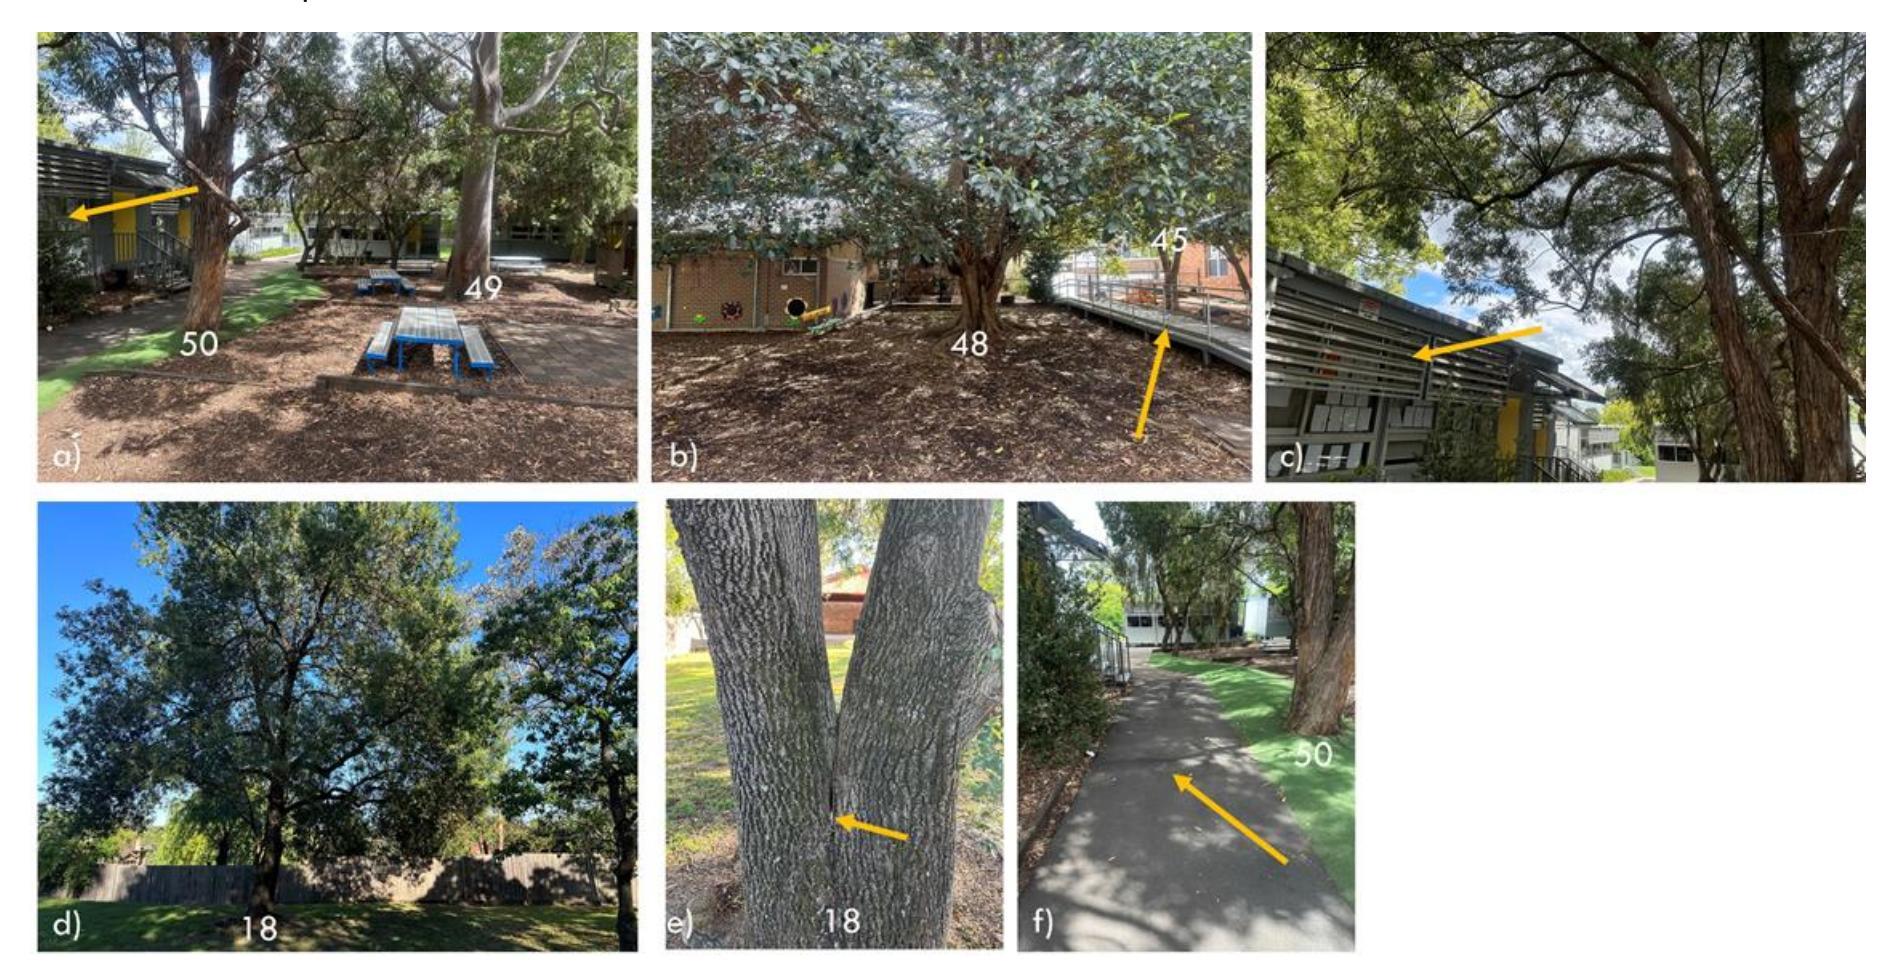
15.0 APPENDIX 10 | PLATES

a)Showing Trees 49 & 50 with existing demountables. b) Showing Trees 45 & 48 with existing suspended walkway. c) Showing demountable proposed for demolition. d-e) Showing Tree 18. f) Showing existing pathway in SRZ of Tree 50.
