Site Address: Wollongong Hospital, Loftus Street, Wollongong – redevelopment works

This Report has been commissioned by Health Infrastructure, on behalf of Wollongong Hospital concerning redevelopment works at the abovementioned site. The study area is an atrium, shown in Diagram 1. This is a desktop review of the proposed works and impacts to subject trees located within the study area for a REF submission.

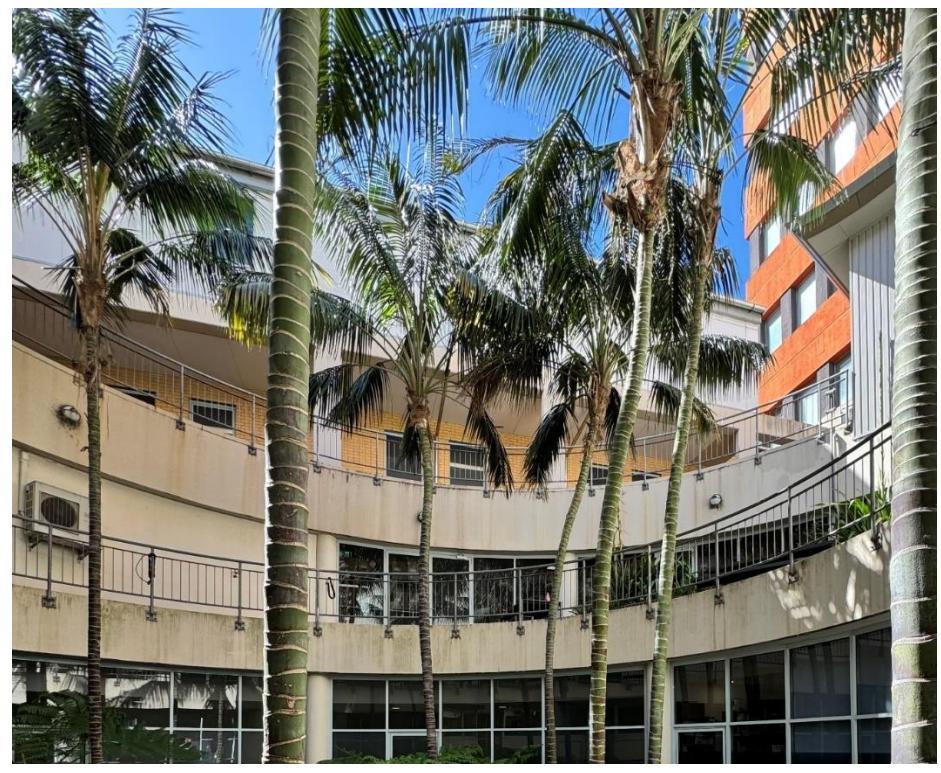
The central courtyard area contains nine (9) mature Kentia palms (*Howea forsteriana*). These palms appear to be in good health and condition, based on the images provided (Plate 1). The Kentia palm is not native to the Illawarra area, and is actually indigenous to Lord Howe Island group.

Plate 1: Image showing the palm canopies.

To achieve the proposed enclosed atrium space to build additional clinical services, these trees will be required to be removed.

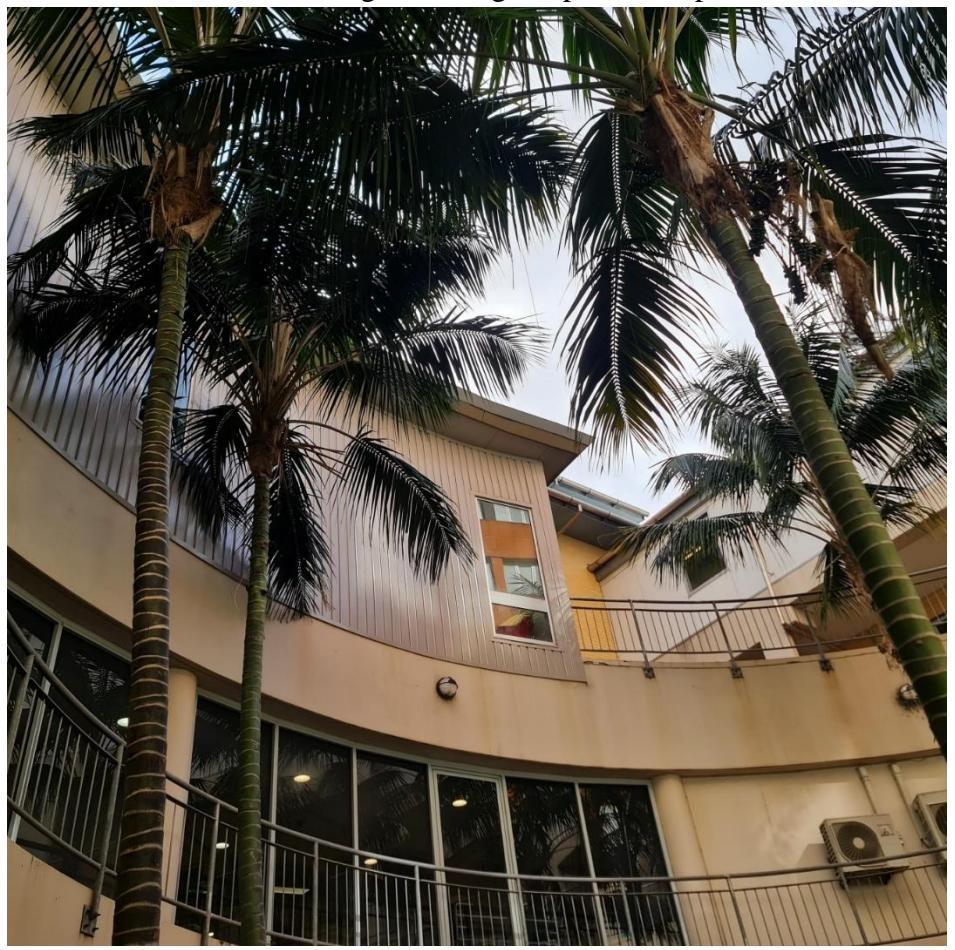
Plate 2: Image showing the palm canopies.

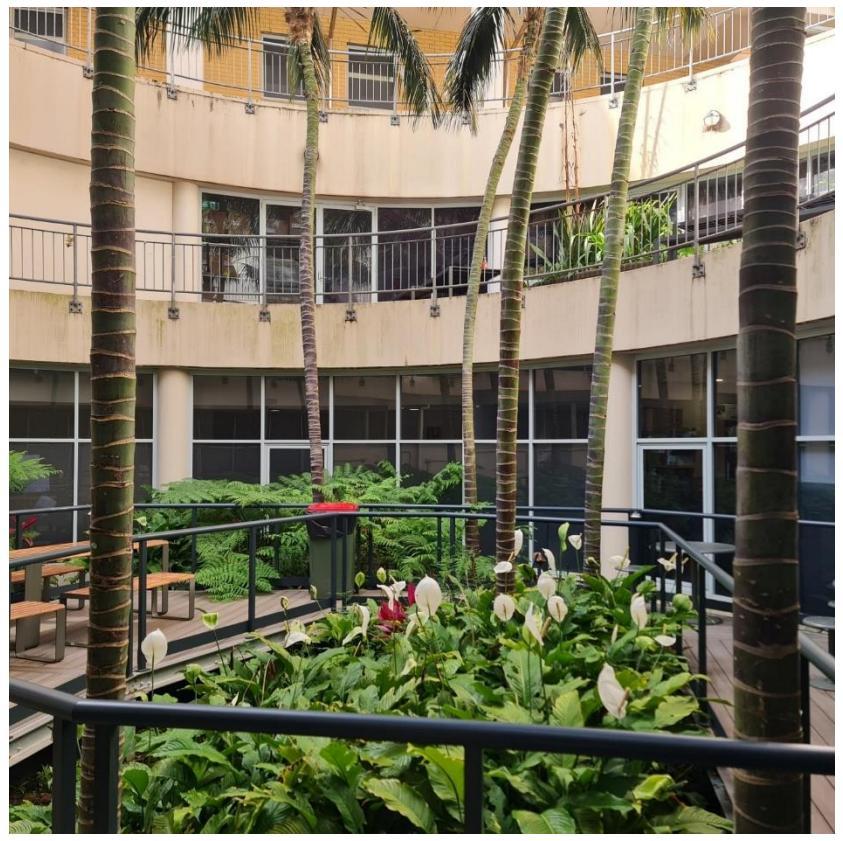
These specimens within the Hospital grounds are possibly 15-20 years old. A boardwalk area has been constructed below them (Plate 3).

Plate 3: Image showing the planting situation of the specimens.

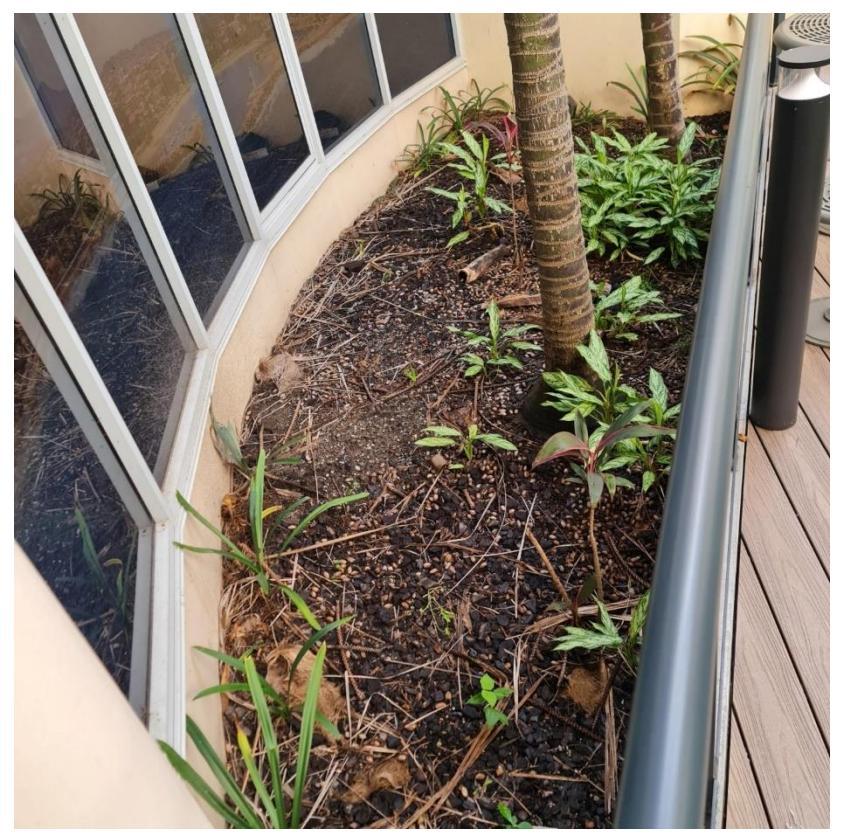
Plate 4: Image showing the grafted root zones of the palm canopies.
