# PRELIMINARY DESKTOP REVIEW -

**GEOTECHNICAL** Gillieston Public School redevelopment and new Public Preschool

17 January 2025

Prepared by: Stantec Australia Pty Itd

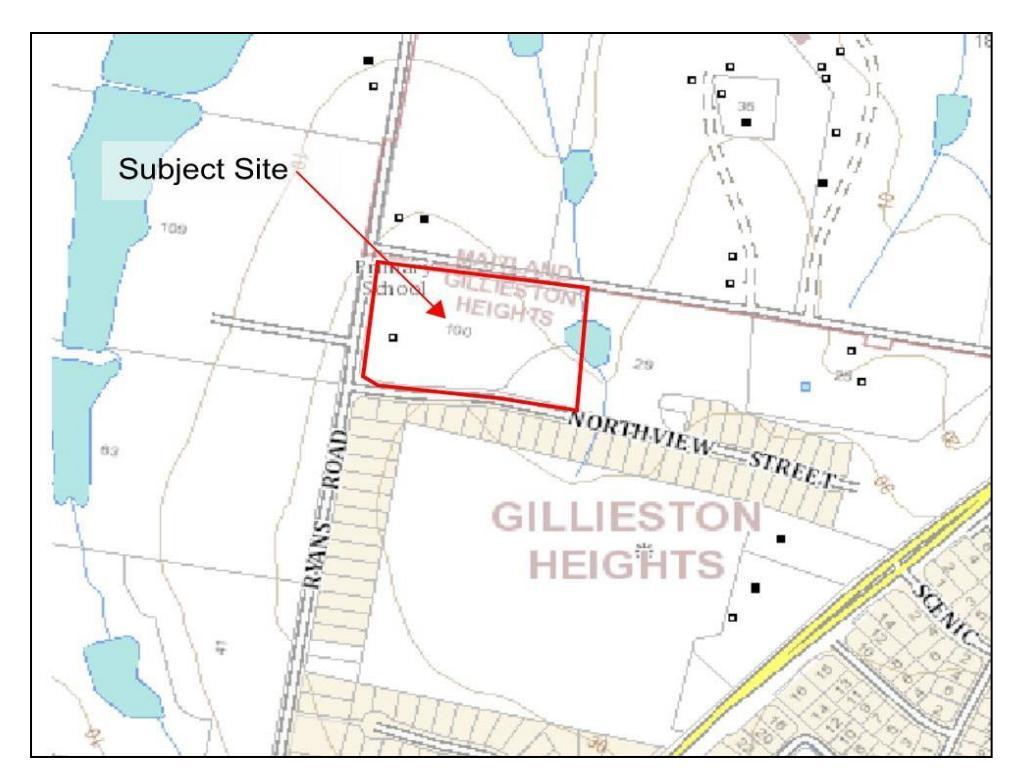
Figure 1 – Cadastral Map (Source: NSW Spatial Viewer, 2024)

The existing site context is shown in Figure 1 and Figure 2 below.

The Site is identified as 100 Ryans Road and 19 Northview Street, Gillieston Heights, legally described as Lot 51 DP 1162489 and Part Lot 2 DP 1308605.

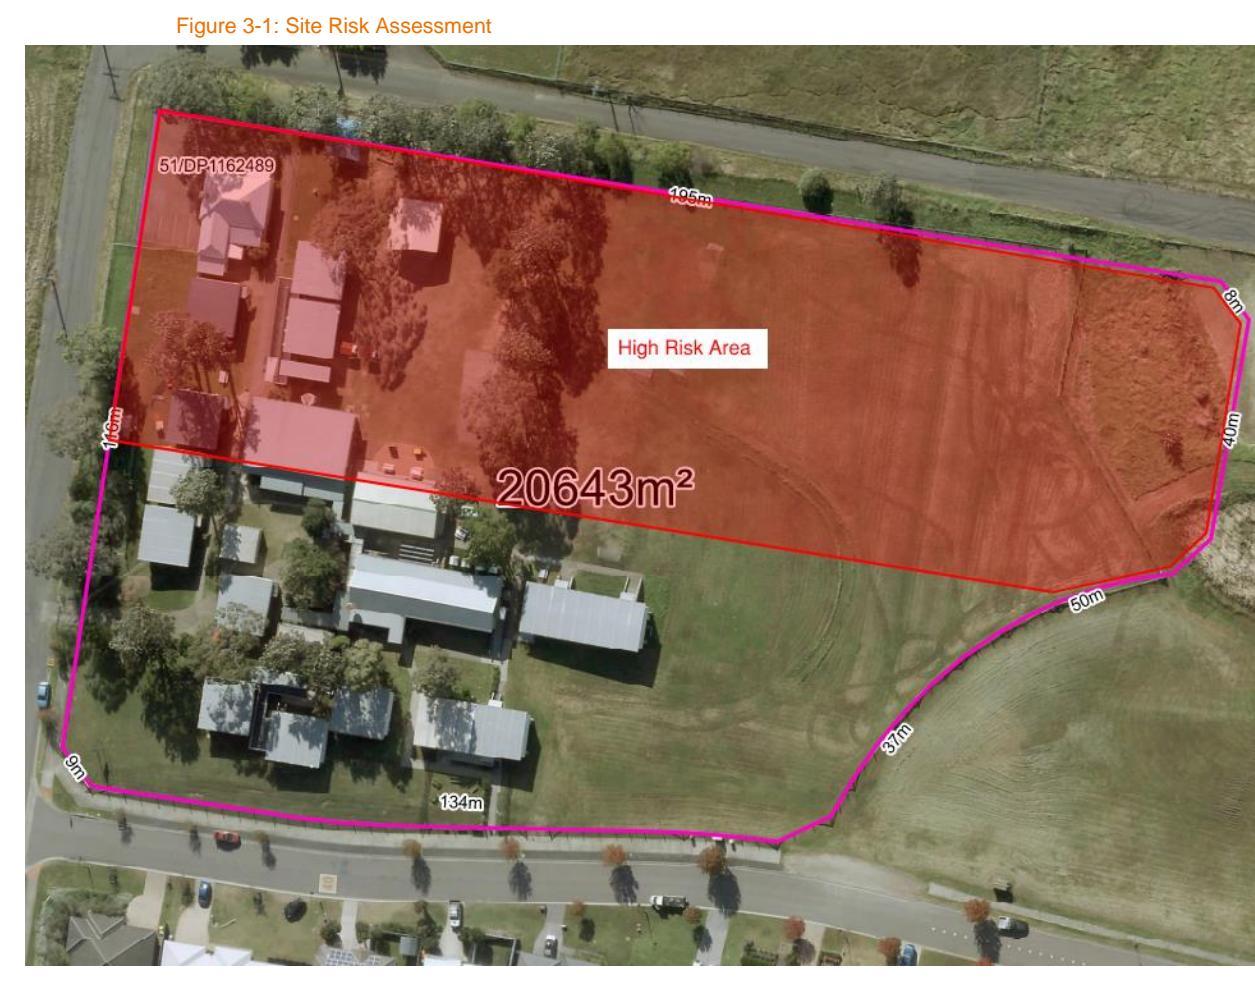
Table 4-3 Site Risk Considerations

Site risk assessment are listed below for DoE consideration and site plan is shown on the Appendix A.

High Risk Area
Cut and Fill operation	Minor levelling only across the site. Cut and fill operation will be required.
Subsurface condition	Possible relative thicker fill profile, overlying residual and sandstone. Residual soil is relative thicker and may encounter alluvial deposit at the north-western end of the site.
Expected foundation	Possible deep piers foundation required for foundation, pending to the fill and residual soil thickness.
Acid sulphate and Salinity	Low risk for ASS. Moderate to high salinity potential
Contamination	Higher potential due to the thicker fill profile and existing utilites.

High Risk Area
Conclusion	This area is considered as high risk for variable subsurface conditions and associated geotechnical constraints, such as variable structural foundation requirement, and vibration impact to nearby receivers.

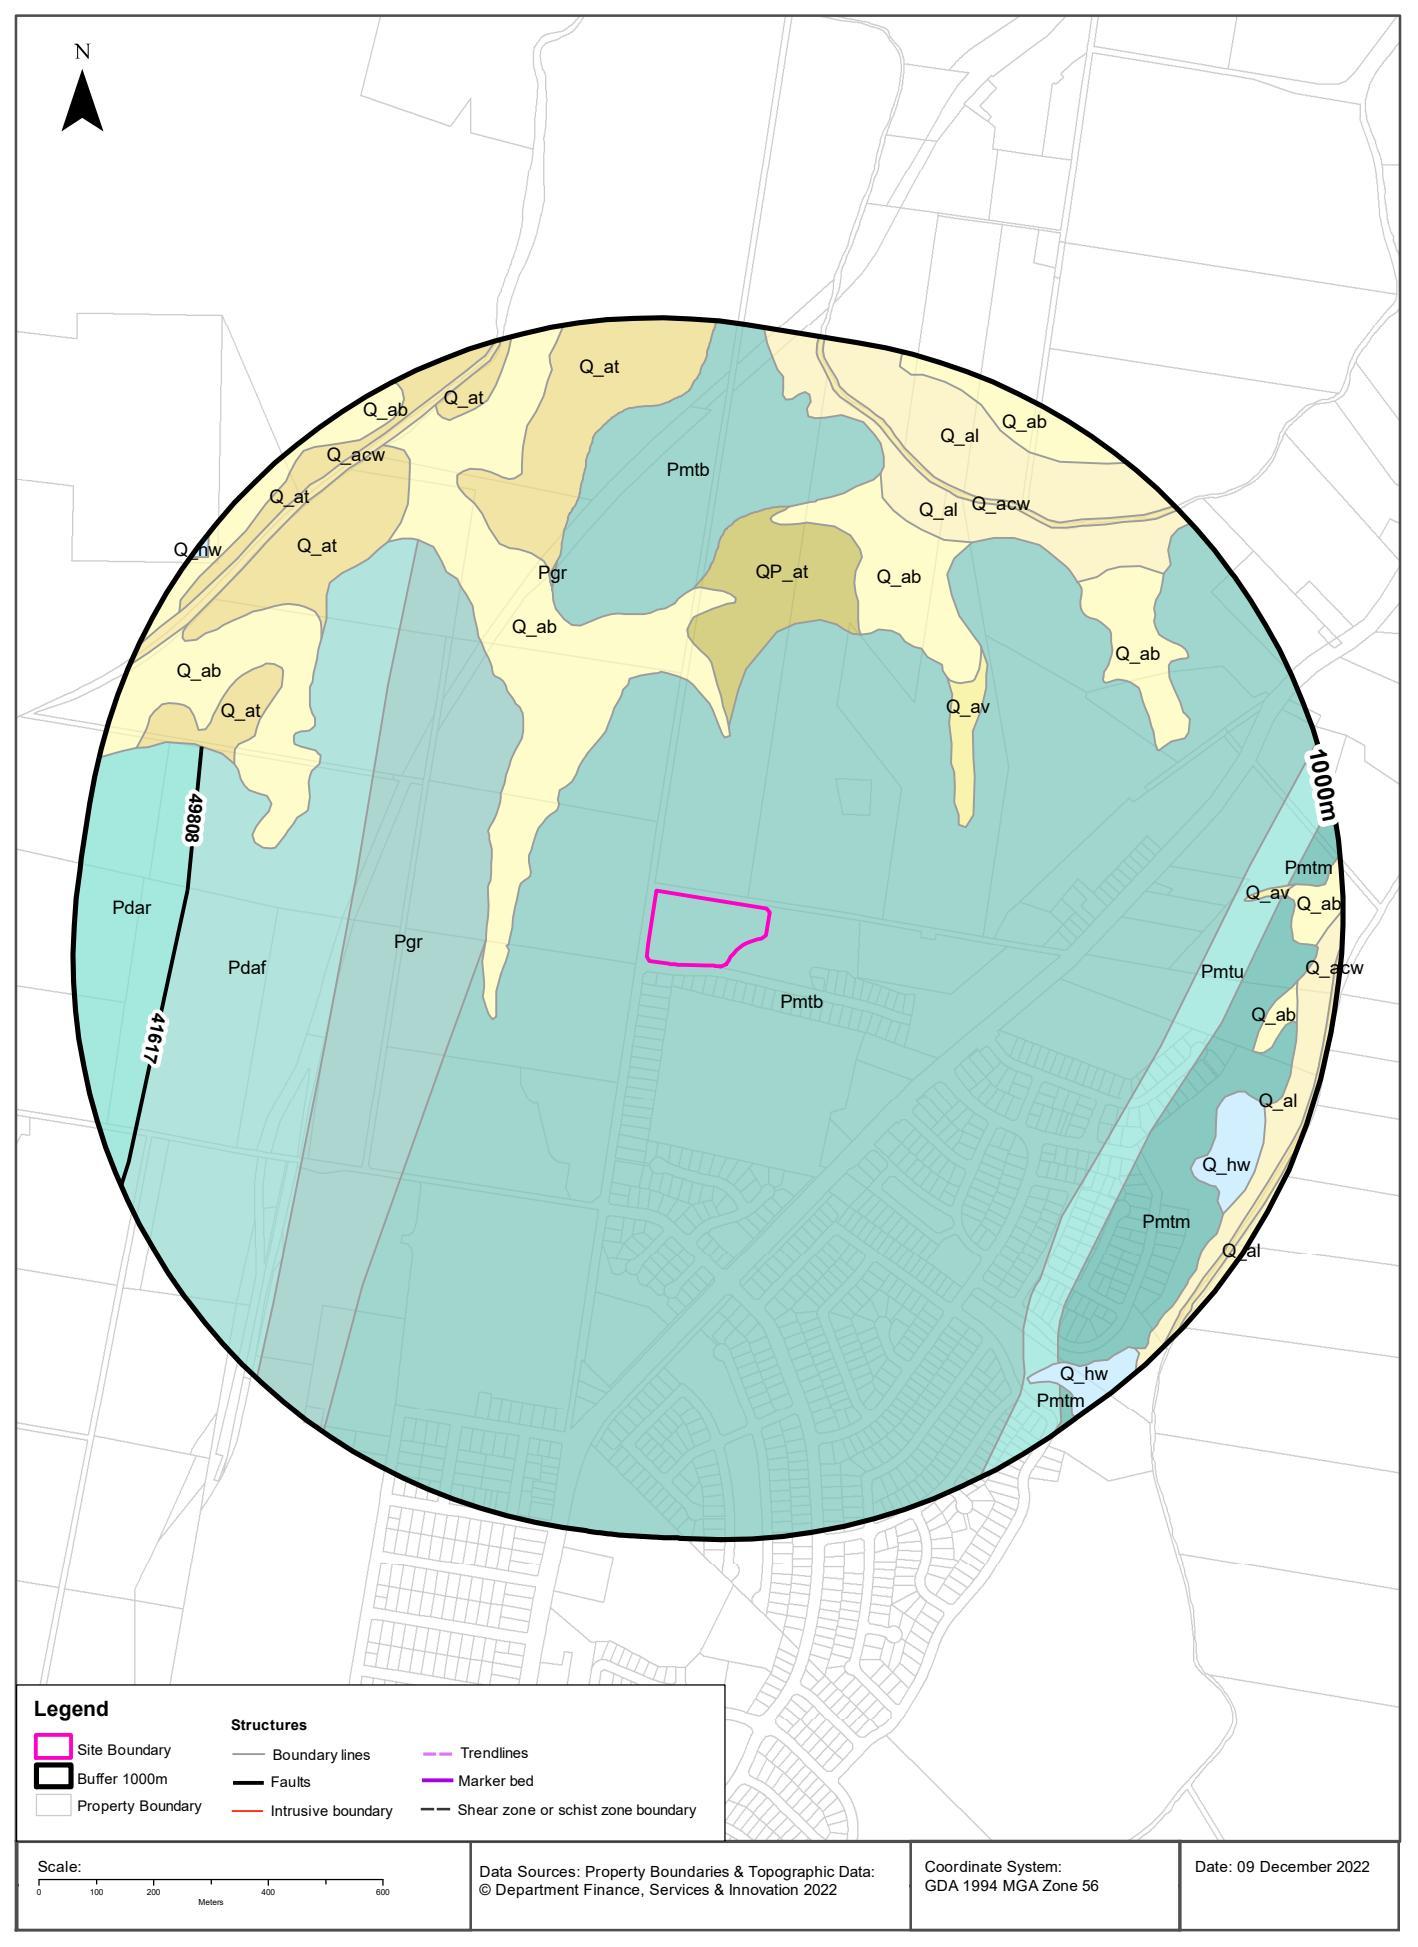
# Appendix B Geology

The 1:100,000 Geological Series Sheet provided in **Appendix – B** indicates that the site is underlain by Branxton Formation (Pmtb) with the lithology of conglomerate, sandstone, siltstone from Maitland Group. The site is also adjacent to:

- Alluvial backswamp deposits (Q\_ab) to the north west, described as Organic-rich mud, peat, silt, clay, and
- Alluvial terrace deposits (QP\_at) to north, described as silt, clay, (fluvially- deposited) fine to medium grained quartz-lithic sand, polymictic gravel from Quaternary age, and
- Alluvial valley deposits (Q\_av) to north east, described as silt, clay, (fluvially deposited) lithic to quartz-lithic sand, gravel from Quaternary age, and
- Greta Coal Measures (Pgr) to west, described as sandstone, siltstone, pellet claystone, coal, chert, sporadic conglomerate from Permian age, and
- Muree Sandstone (Pmtu) to east, described as fine- to coarse-grained sandstone, conglomerate, minor claystone from Roadian age.

- > Referenced to regional 1:100,000 Geological Series Sheet, the site is underlain by Branxton Formation (Pmtb) with the lithology of conglomerate, sandstone, siltstone from Maitland Group.

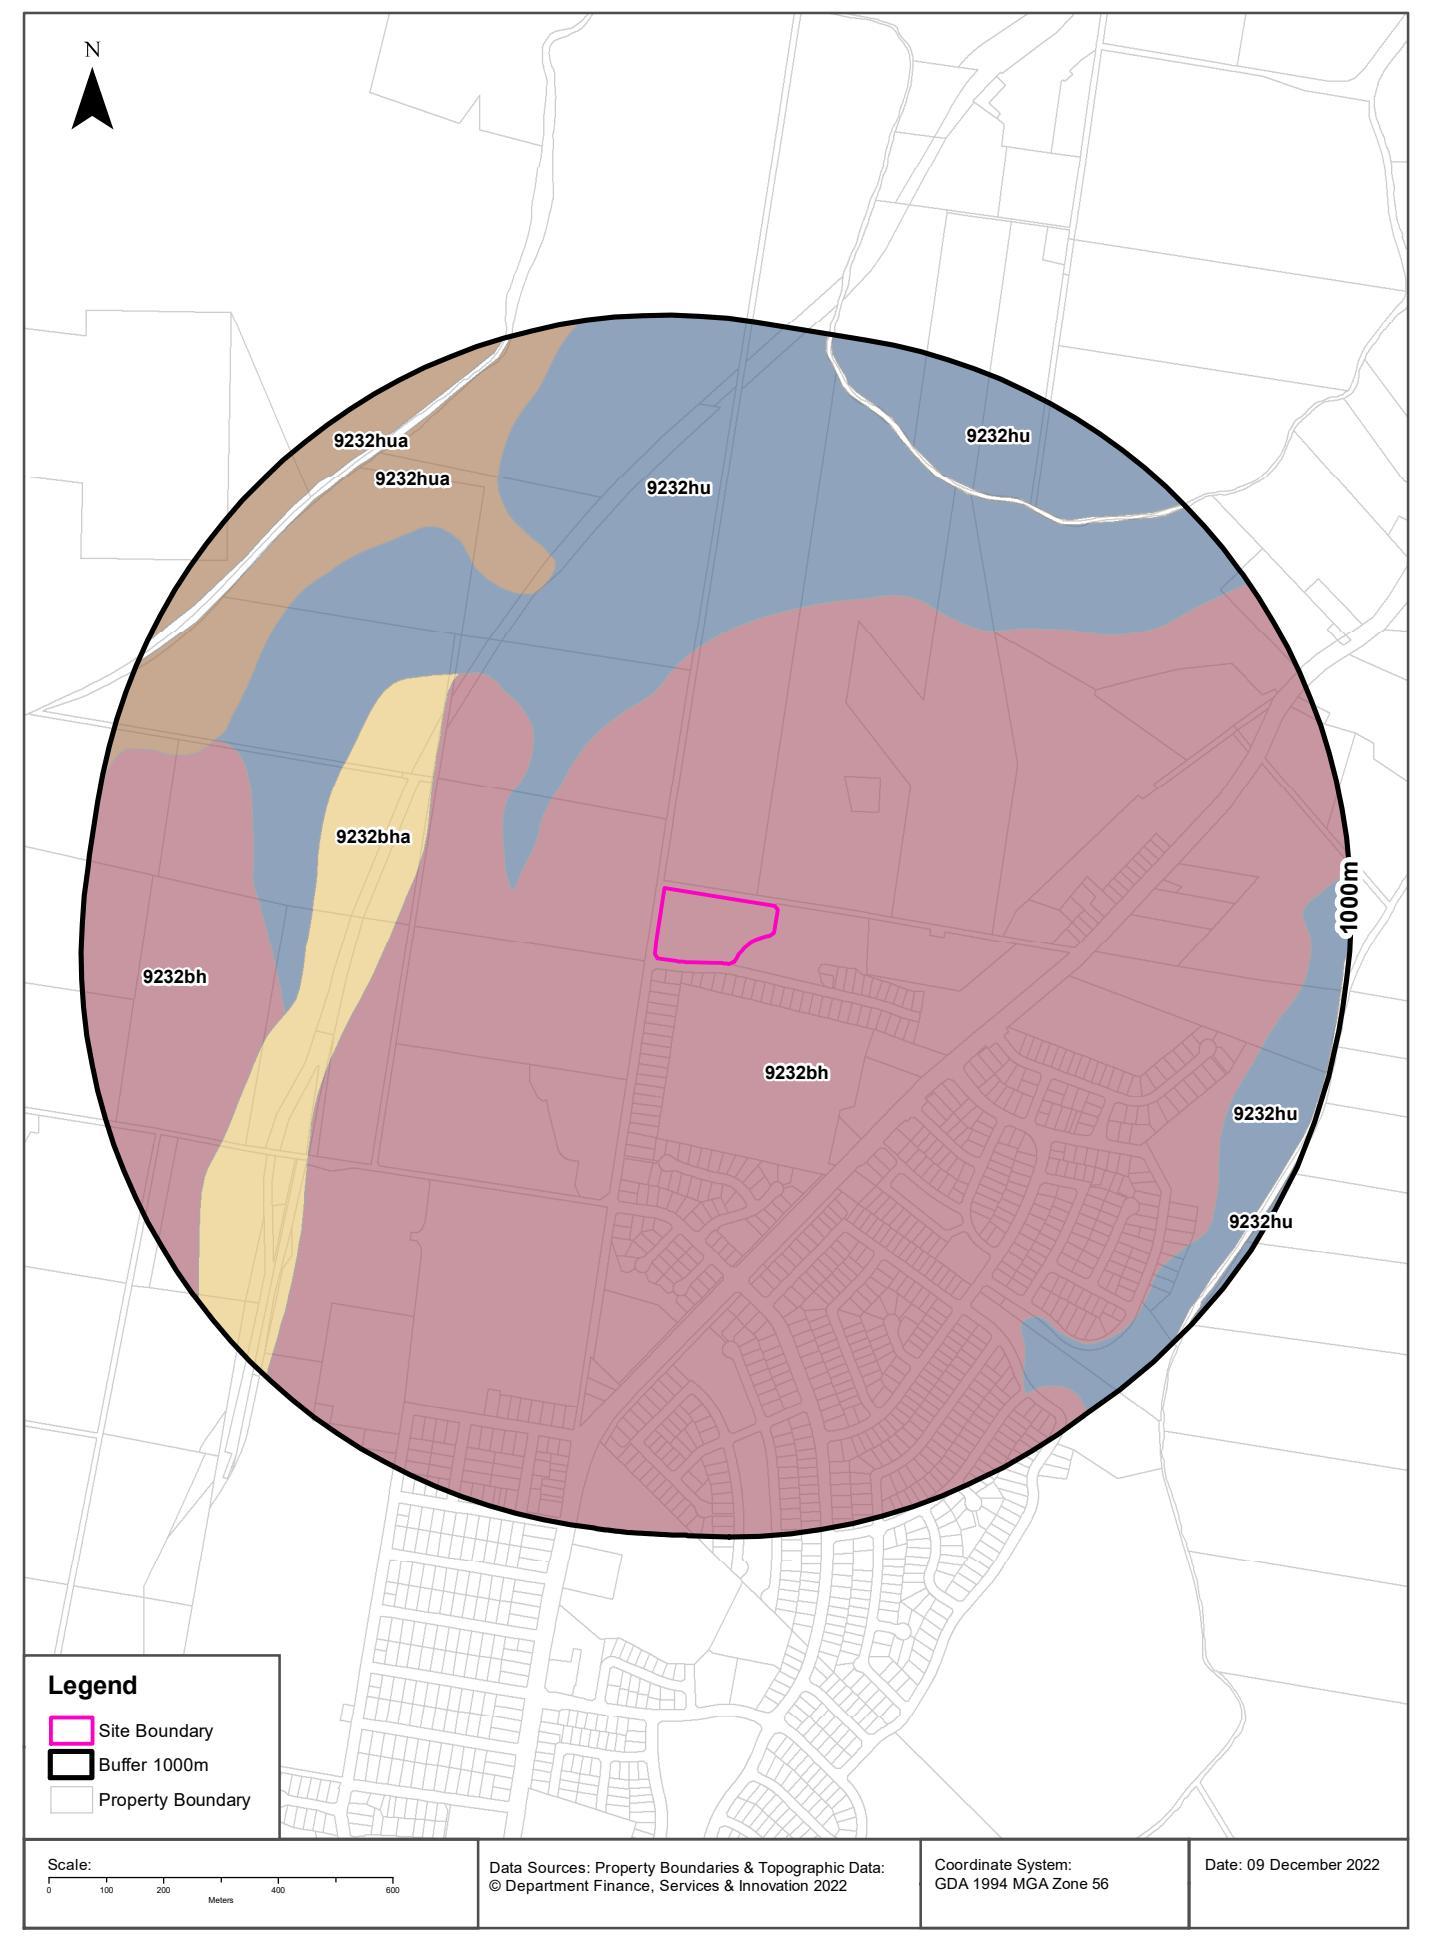
### Soils

The Central and Eastern NSW 1:100,000 Soil Landscape Sheet indicates that the site is entirely located on Bolwarra Heights (9232bh) depicts as moderately deep (<150cm) well-drained Yellow Podzolic Soils, Brown Podzolic Soils with some moderately deep (<100cm) well drained Lithosols on crests, moderately deep (<140cm) imperfectly drained yellow Soloths on lower slopes, also provided in **Appendix C**.

- > Referenced to regional 1:100,000 Soil Landscape Sheet, the site is predominantly located on Bolwarra Heights Landscape (9232bh), which soil contains moderately deep (<150cm) welldrained Yellow Podzolic Soils, Brown Podzolic Soils with some moderately deep (<100cm) well drained Lithosols on crests, moderately deep (<140cm) imperfectly drained yellow Soloths on lower slopes.

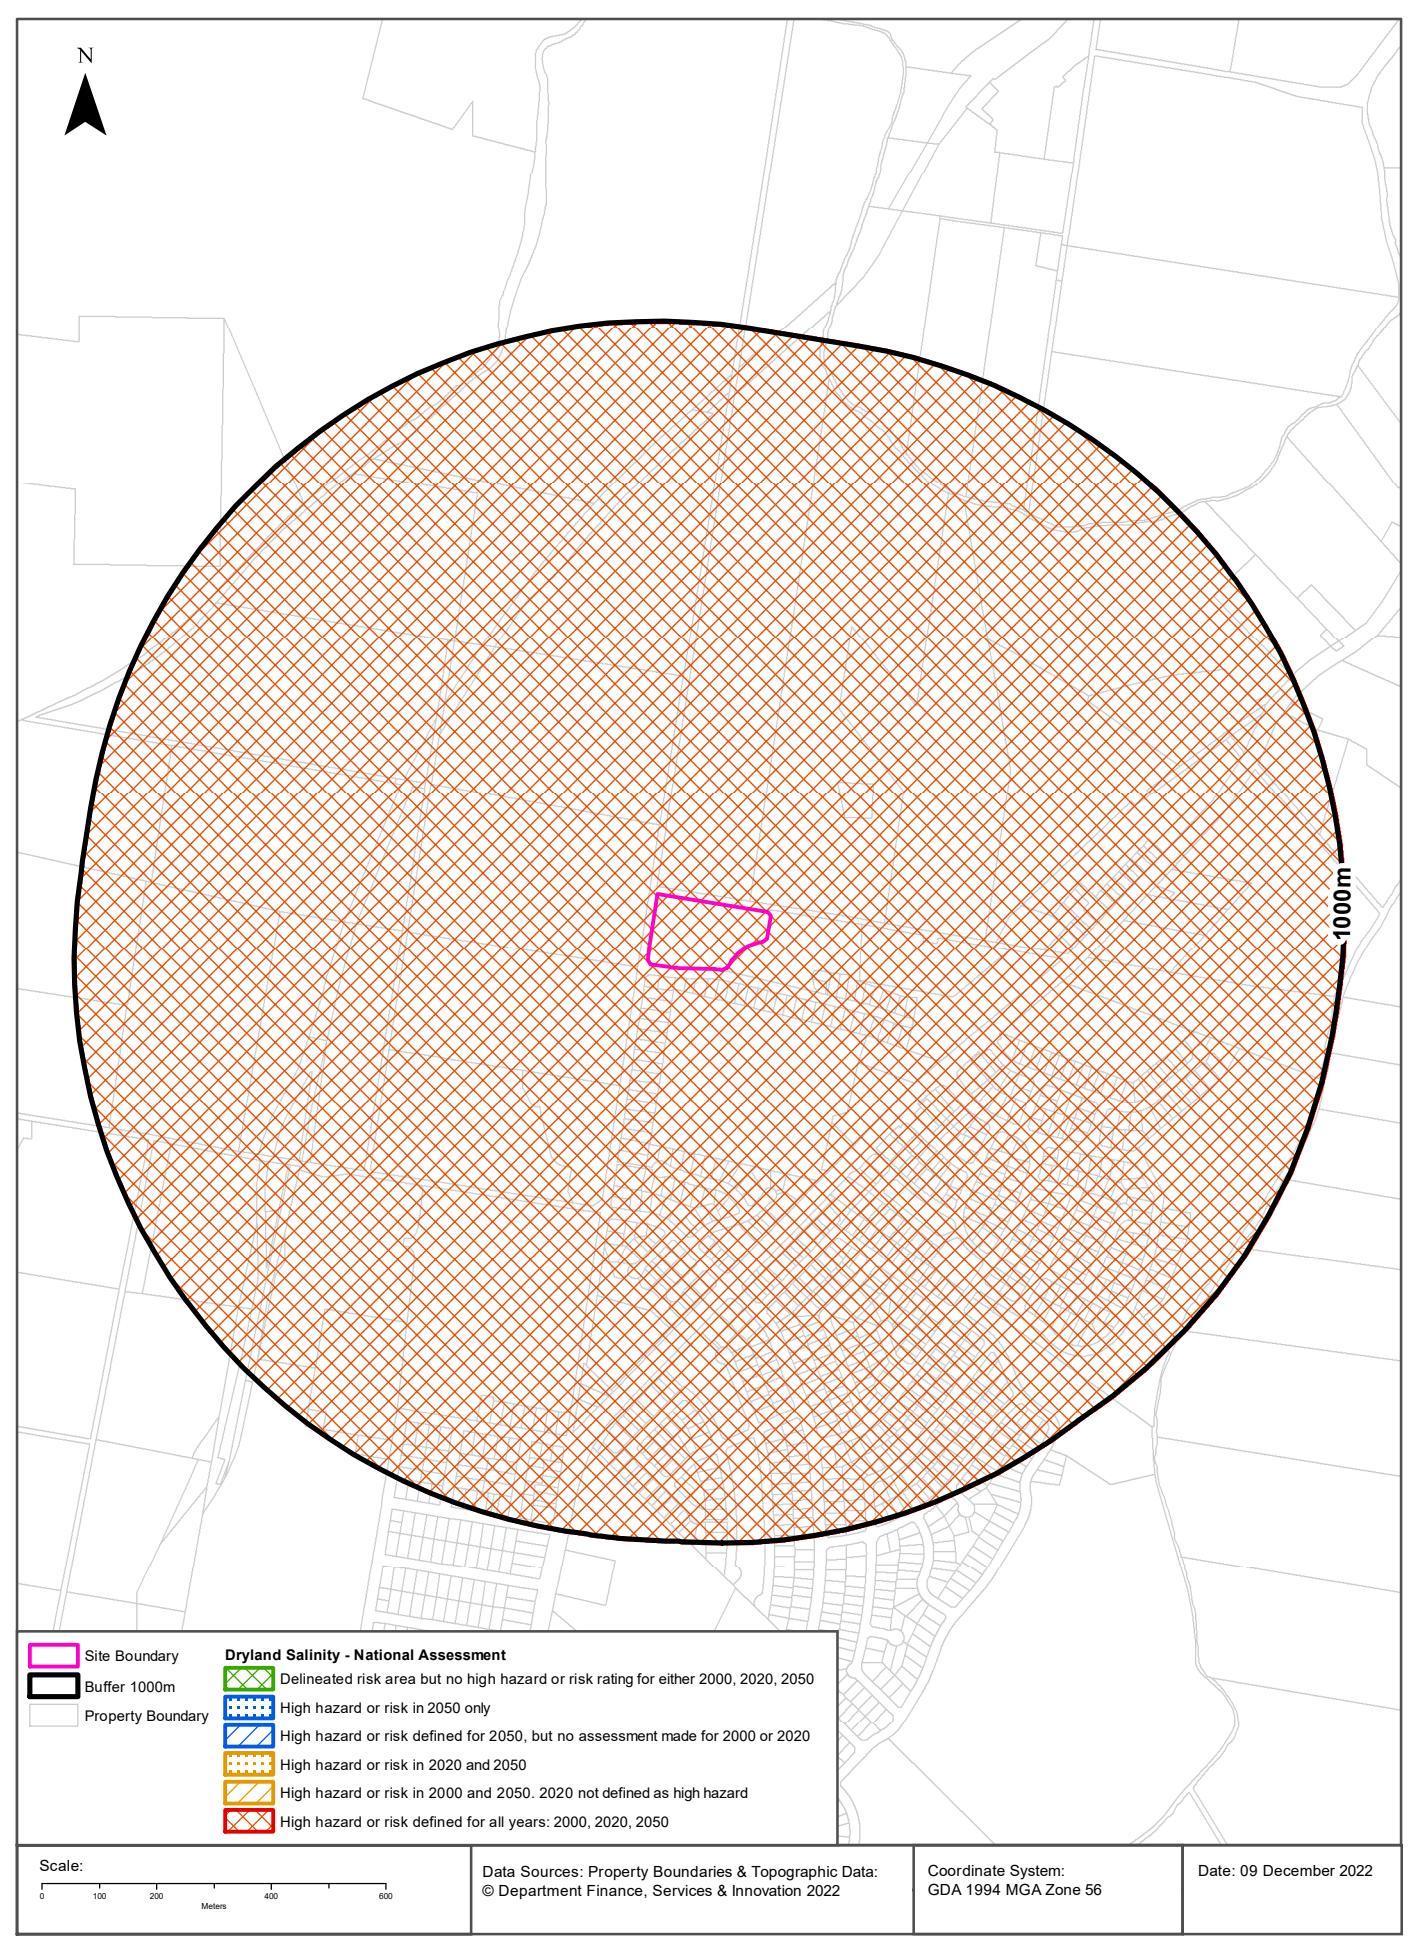
## **Dryland Salinity**

ltem	Details
Salinity	The Lotsearch report (LS038890 EP) with data sourced from National Land and Water Resources Audit demonstrates the existence of Dryland Salinity. The Dryland Salinity assessment result is given as High hazard or risk.

Assessment 2000	Assessment 2020	Assessment 2050	Distance	Direction
High hazard or risk	High hazard or risk	High hazard or risk	0m	On-site

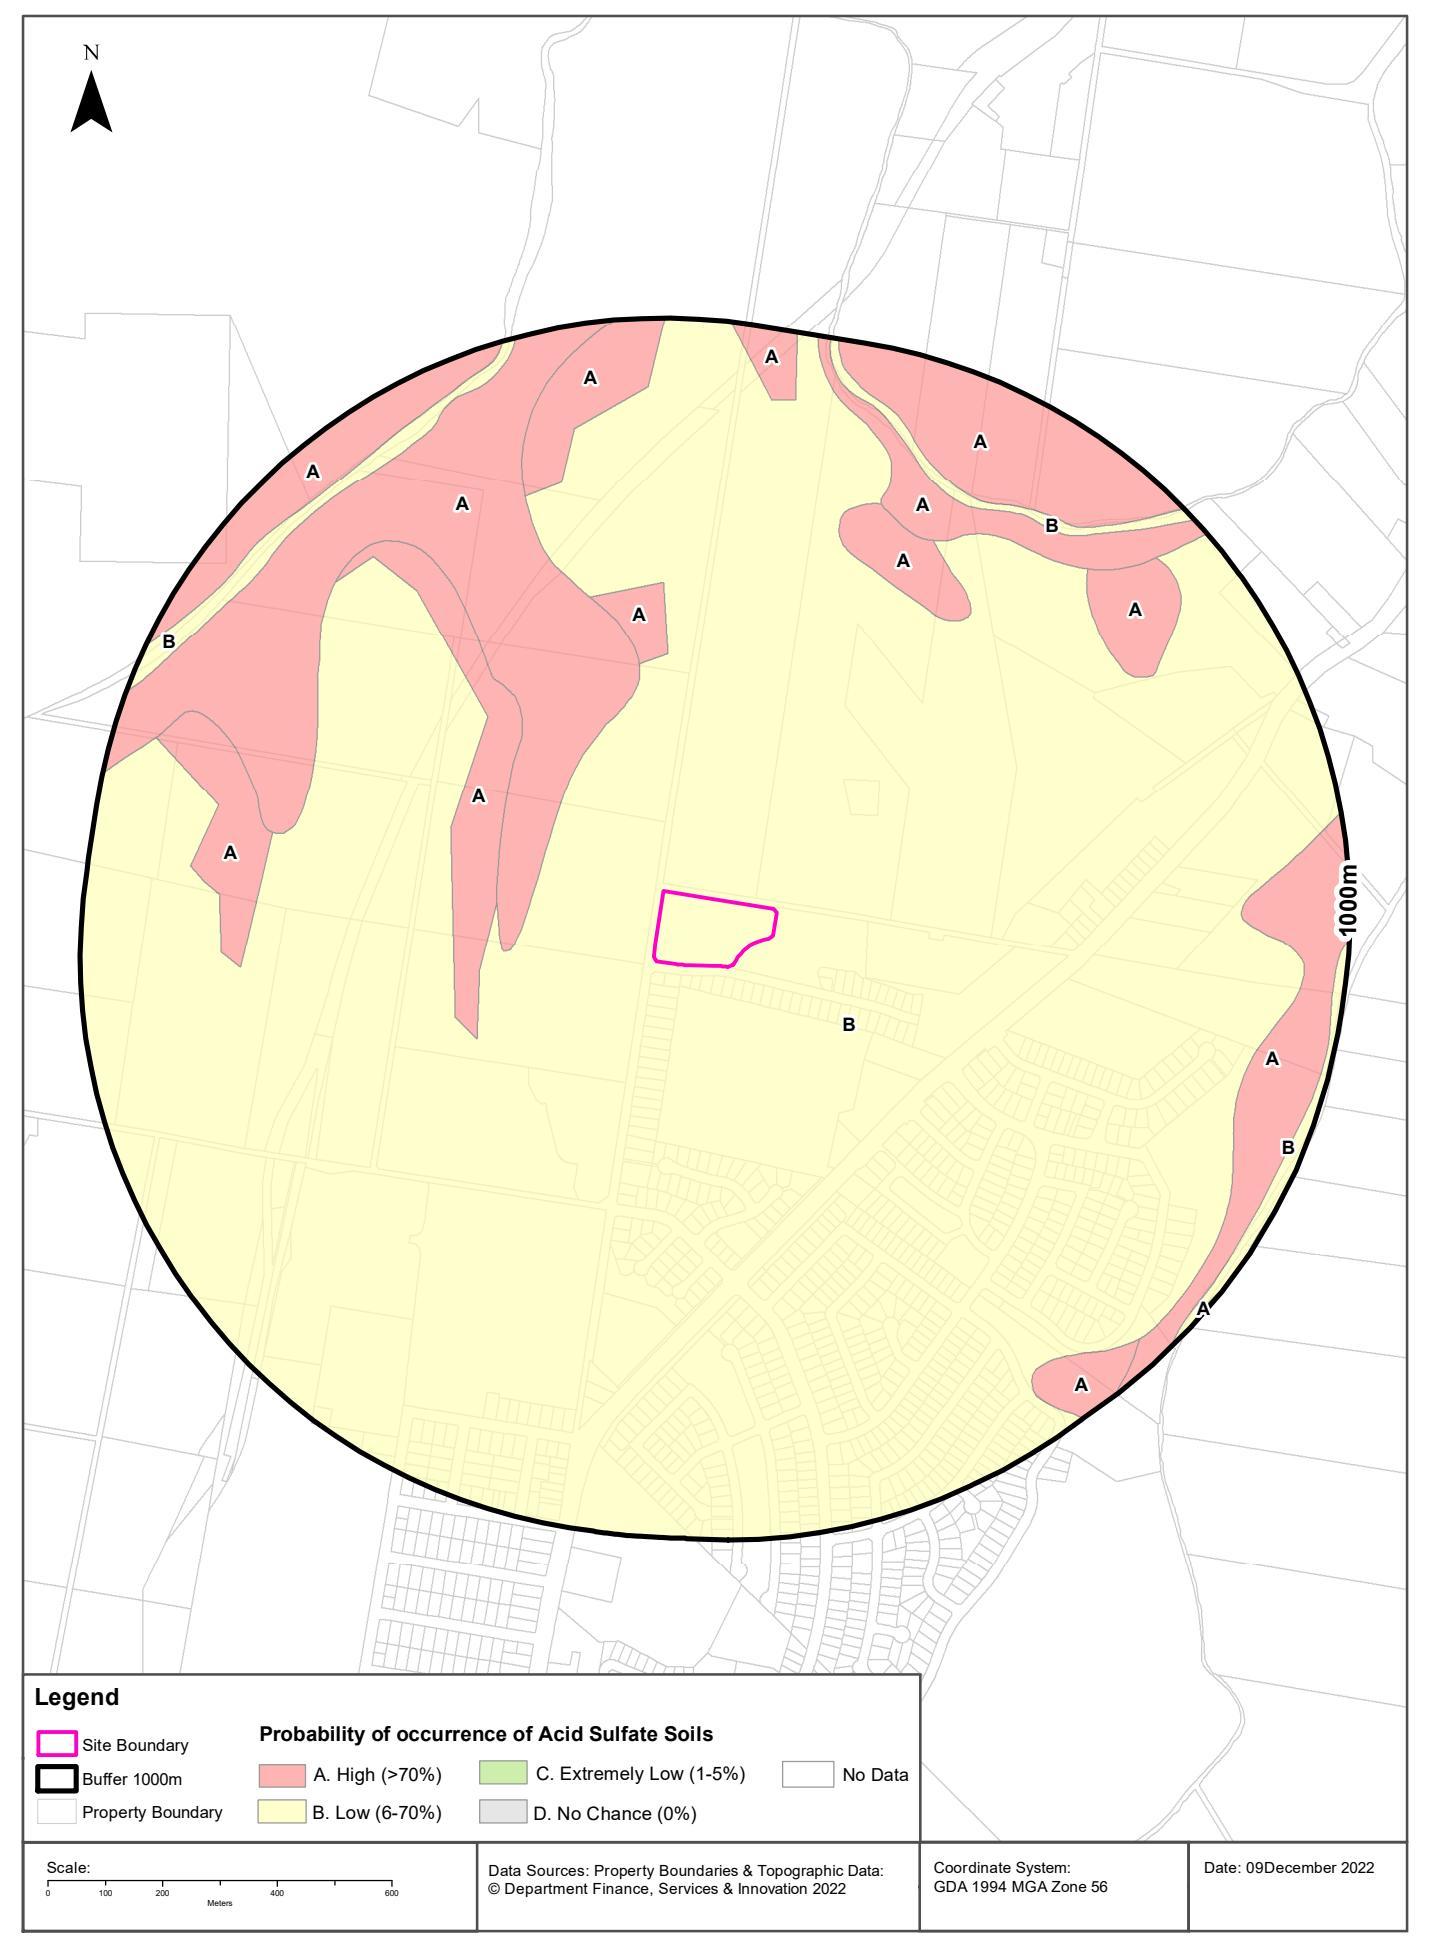
## **Acid Sulfate Soils**

With referenced to the Atlas of Australian Acid Sulfate Soils, it classifies the site as Class B depicting as low probability of occurrence, 6-70% chance of occurrence with occurrences in small, localised areas within proposed activity site. Acid Sulfate Soil risk map is provided in **Appendix E**.
