# **ARBORICULTURE IMPACT ASSESSMENT**

# **PROPOSED 2024 DEVELOPMENT AT**

# **FINLEY HOSPITAL NSW 2713**

Prepared for Capital Insight Pty Limited on behalf of Health Infrastructure NSW

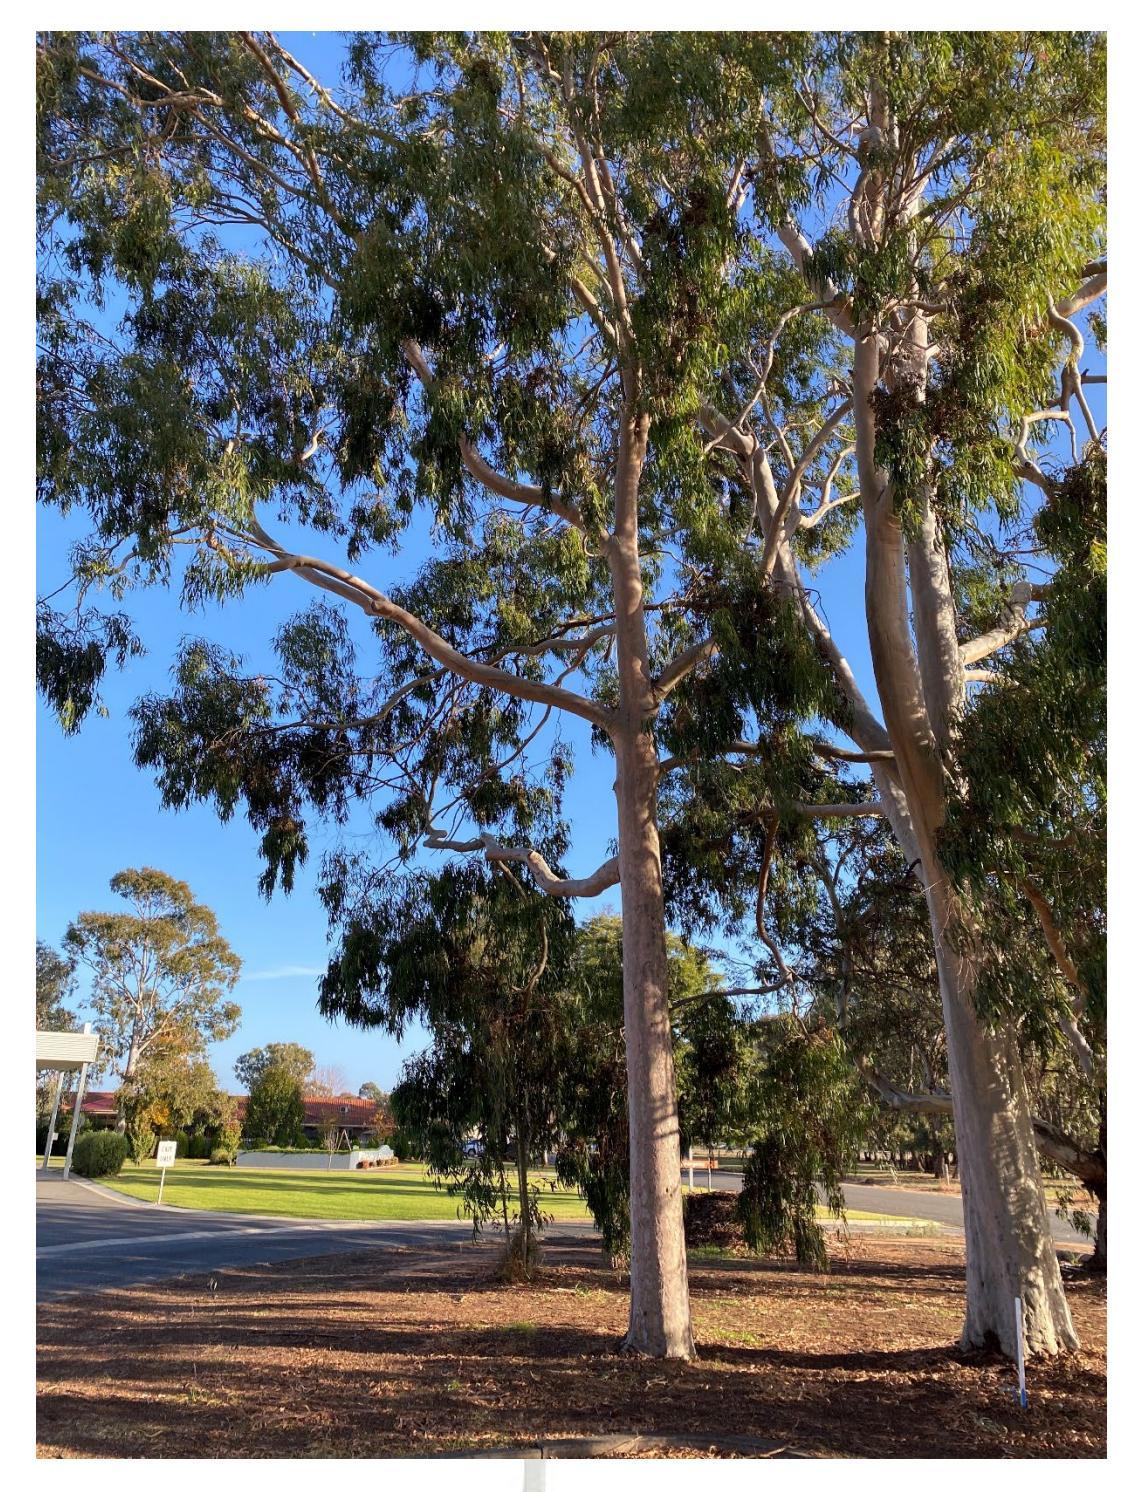
Photo 1 - Trees numbers 6 (to right) and 7 (to left) - Corymbia citriodora, (Lemon Scented Gum,) Tree 7 is Example of trees evaluated as 'Retain Priority', and Tree 6 is example of tree evaluated as 'Retain'.

Both trees are plantings of some age. NSW native trees and larger imposing trees in excellent condition with long life expectancy. Significant amenity and environmental values.

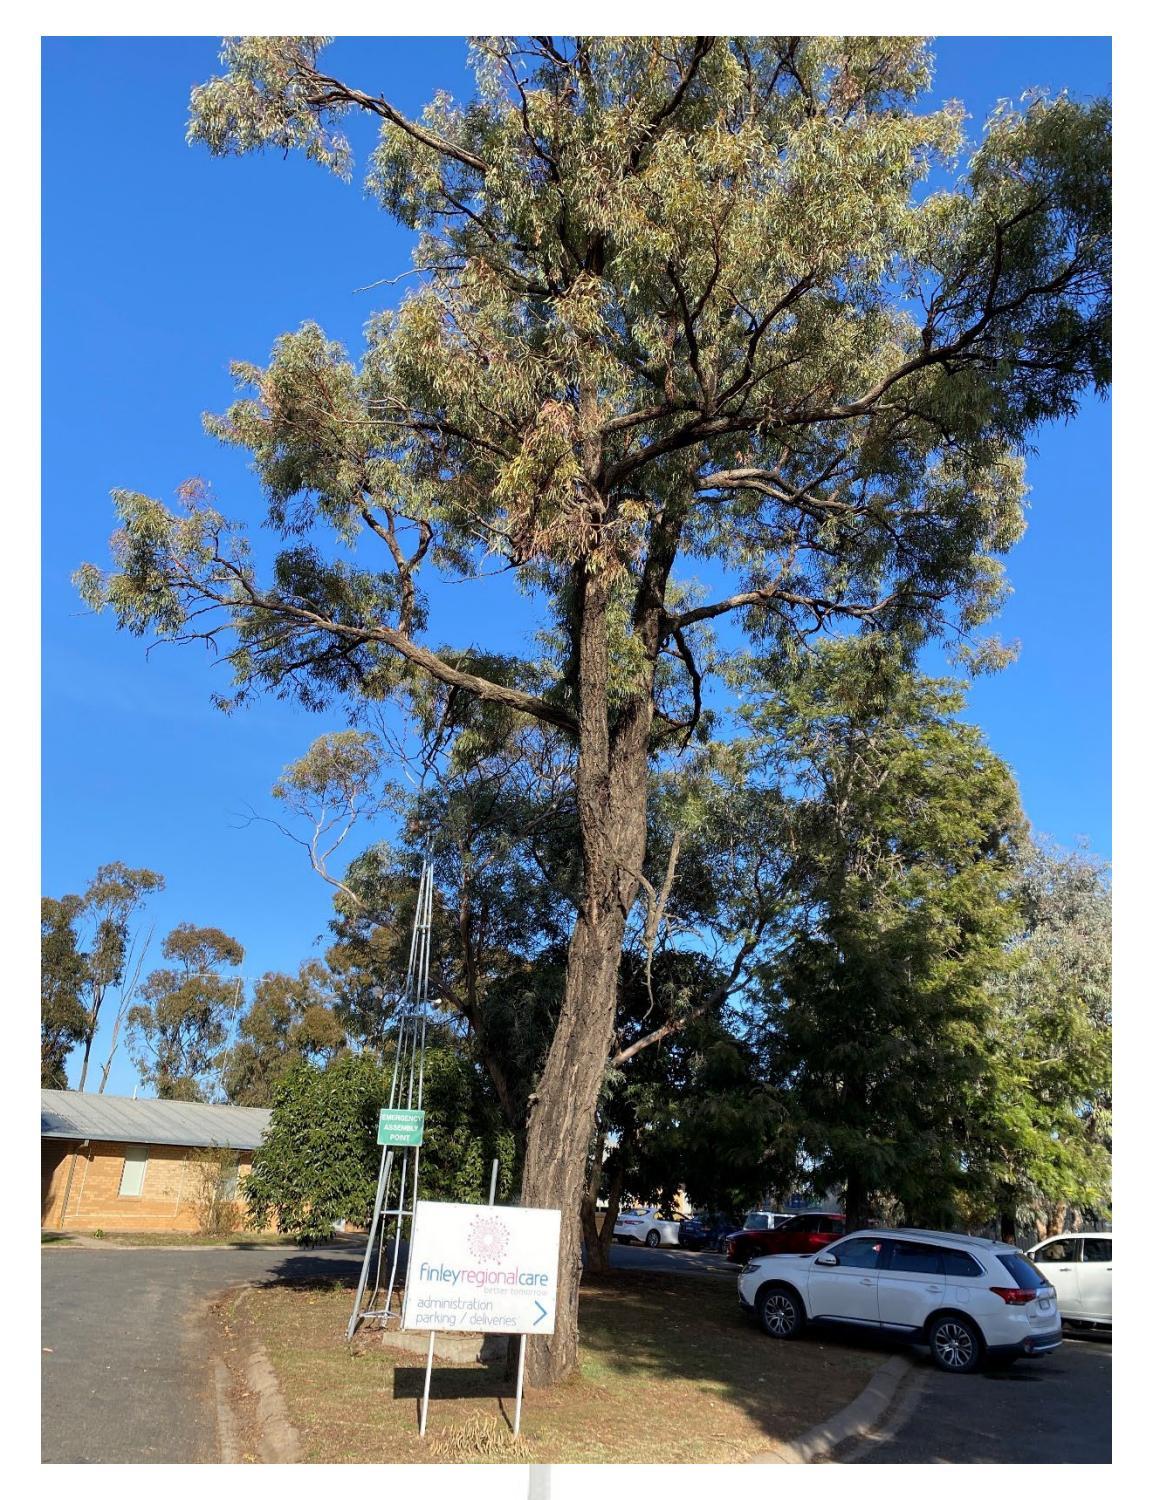
Photo 2 - Tree 16 - Eucalyptus crebra (Narrow-leaved ironbark). NSW native tree. Further example of tree graded as 'Retain'. A large tree in good condition with longer life expectancy.

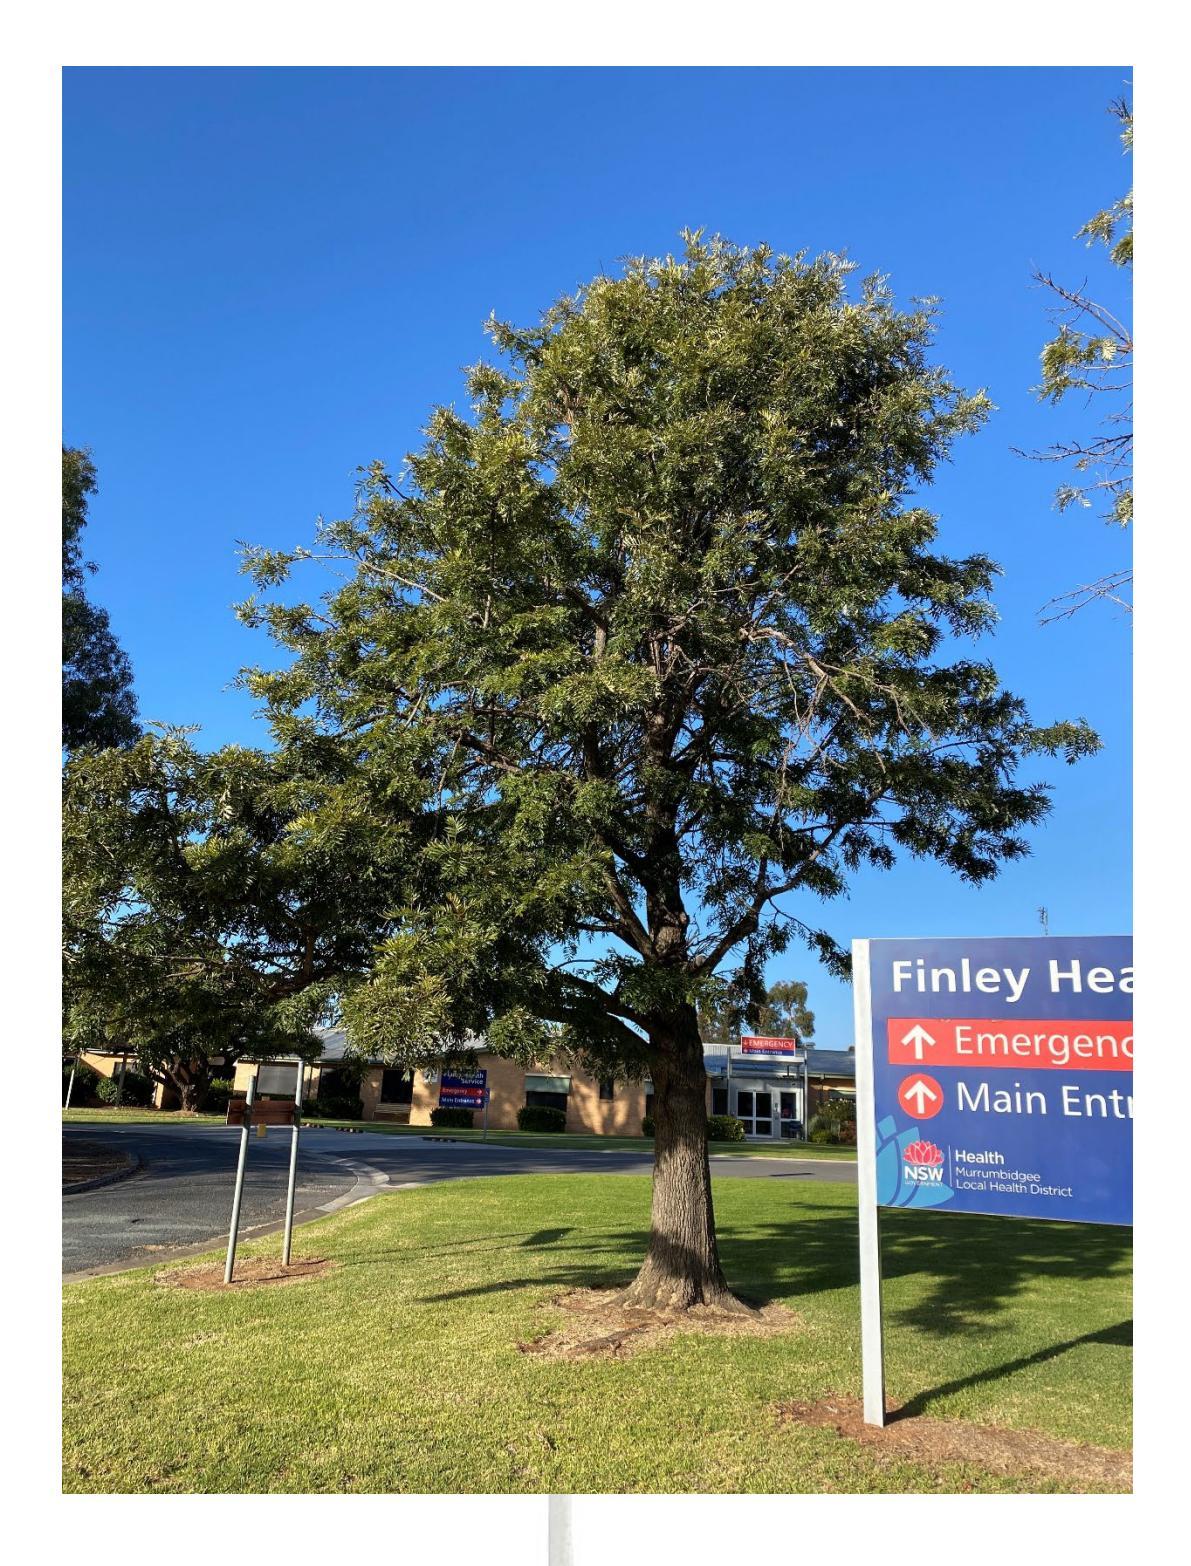
Photo 3 - Tree 10 Grevillea robusta (Silky Oak) - located at the front of the Hospital. Example of a tree graded as 'Retain if Possible'.

Example of a tree that has some useful life expectancy and reasonable amenity values; however if it is required to be removed there is no loss of a significant tree.

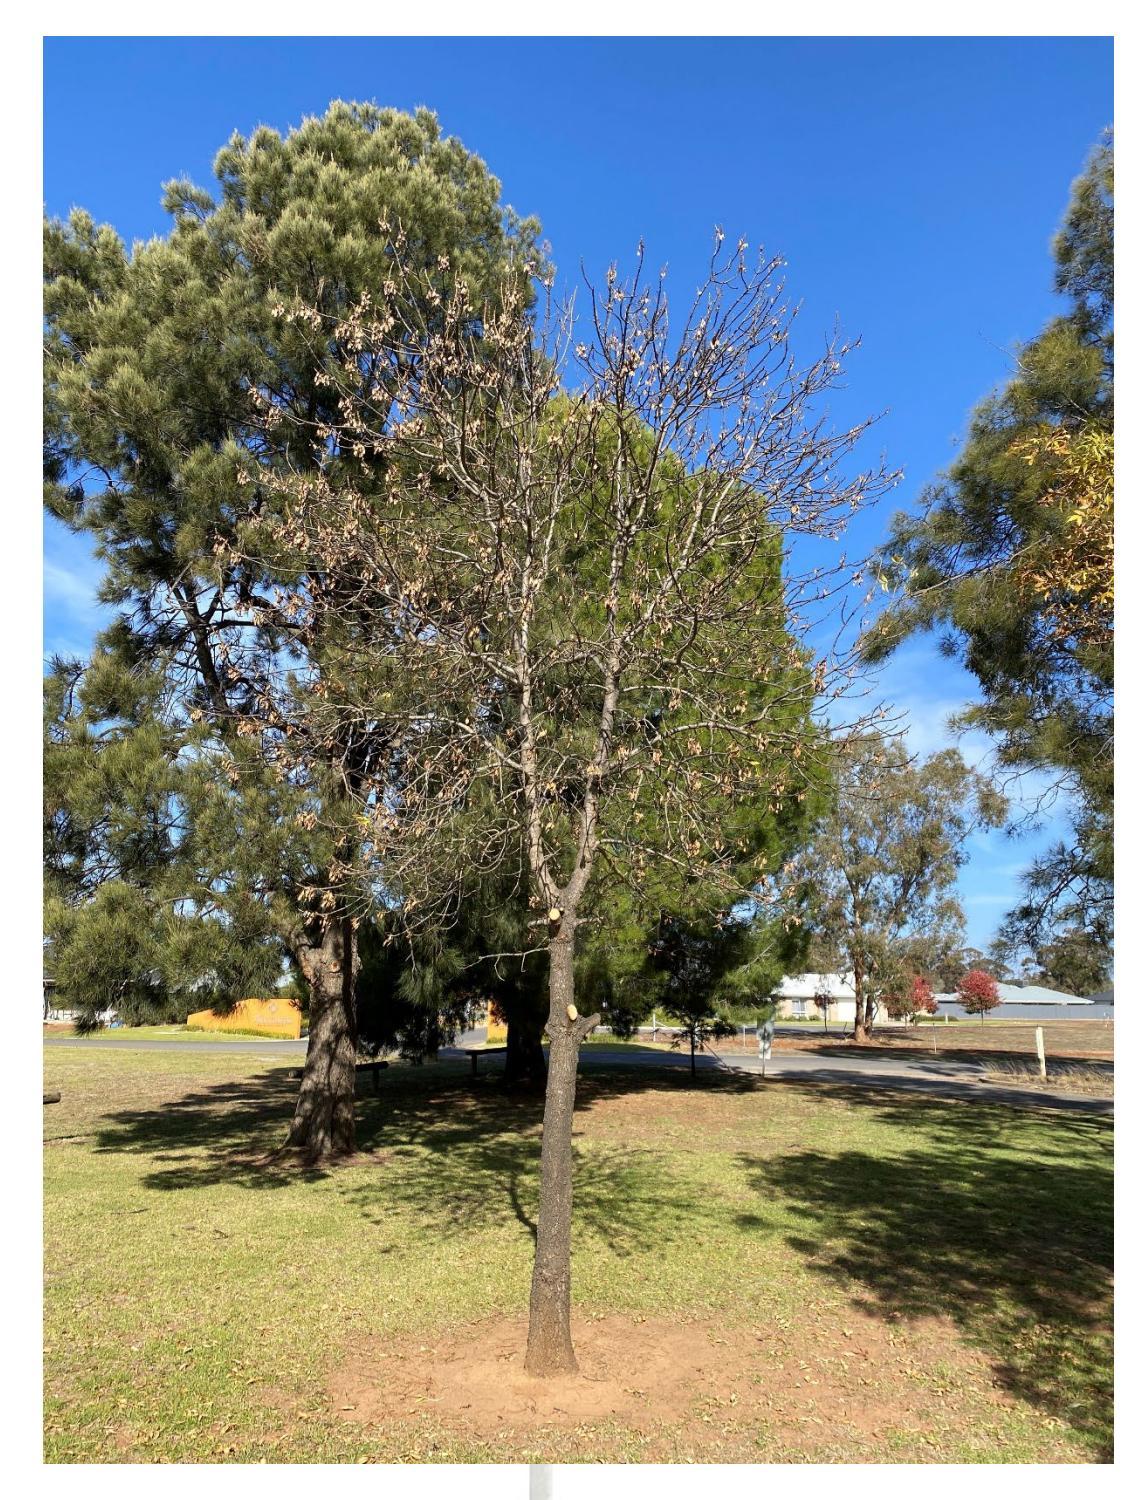
Photo 4 - Tree 61 - Fraxinus angustifolia subsp. oxycarpa (Desert Ash) Example of a tree graded as 'Remove'. A small tree where the impost of retention in a development is not justifiable as the tree can easily be replaced within 0-5 years.

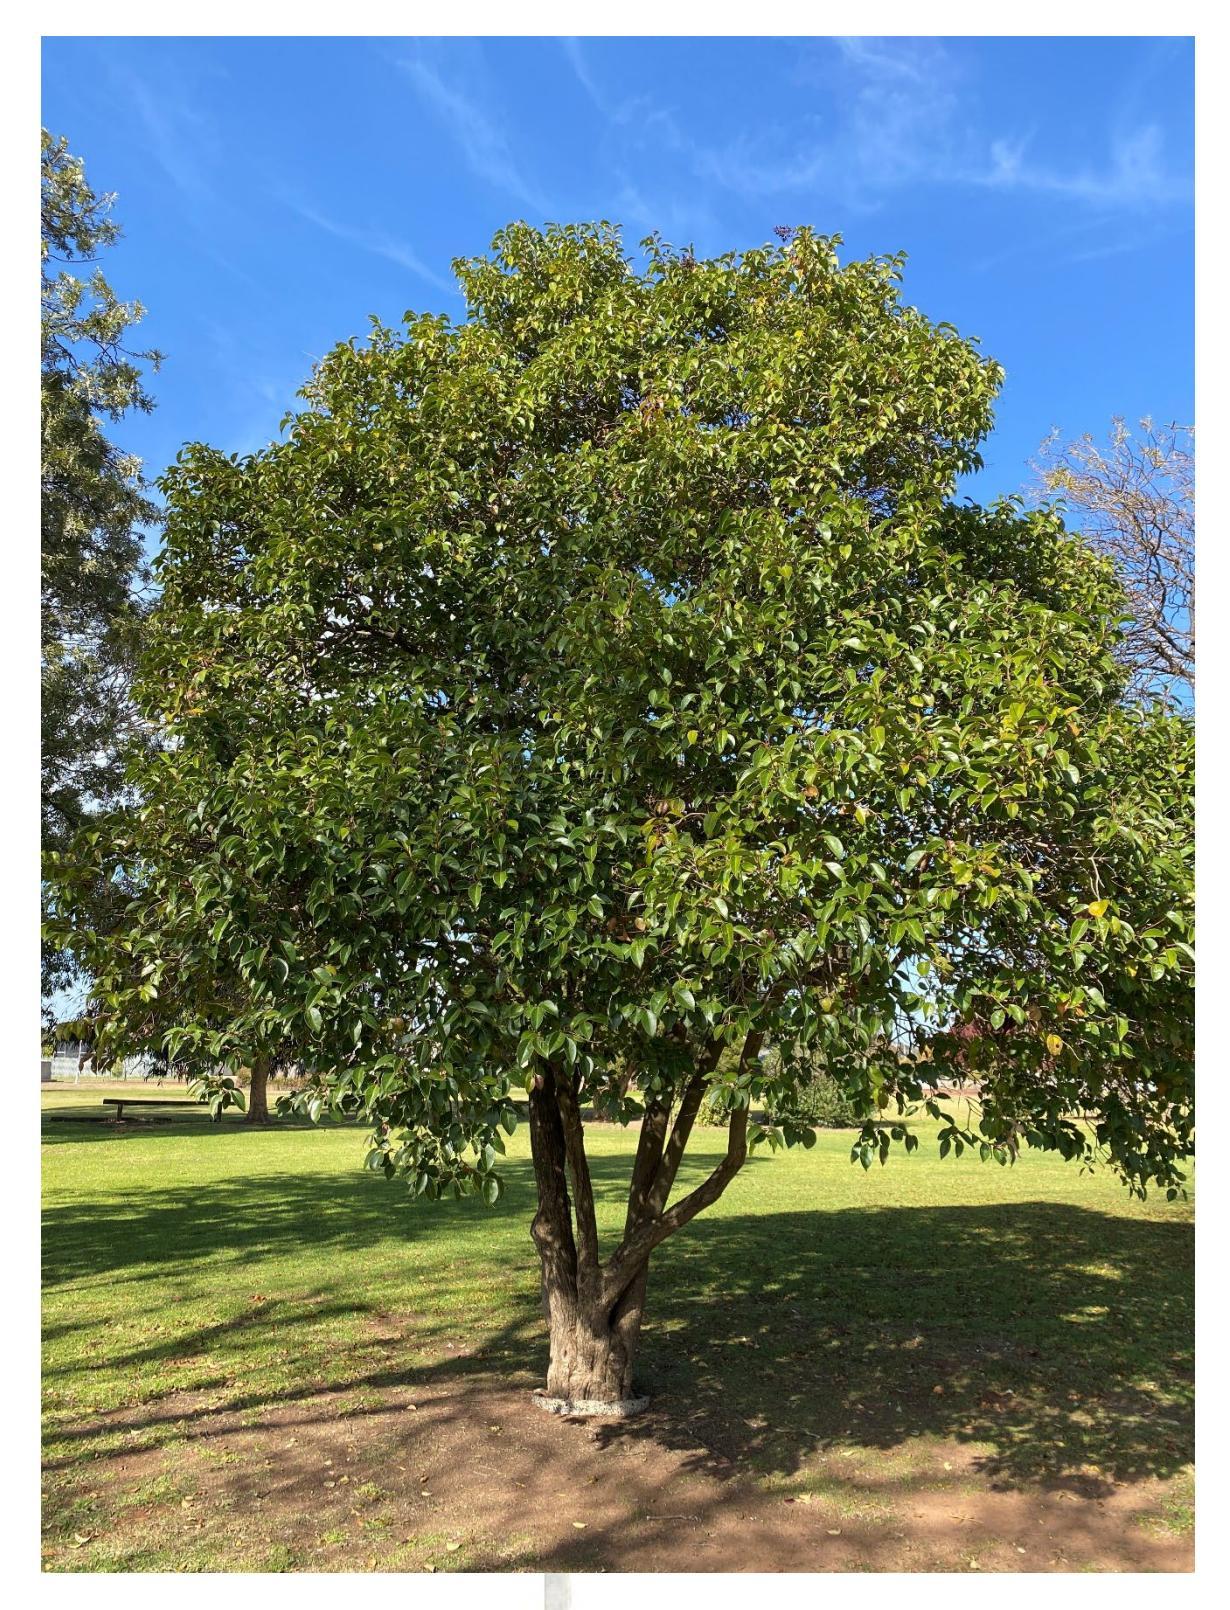
Photo 5 - Tree 14 - Ligustrum lucidum (Broad leaf privet) Example of a tree graded as 'Remove Priority'. A small tree that is considered a weed species. Its loss can easily be offset within a short period of time 3-4 years.

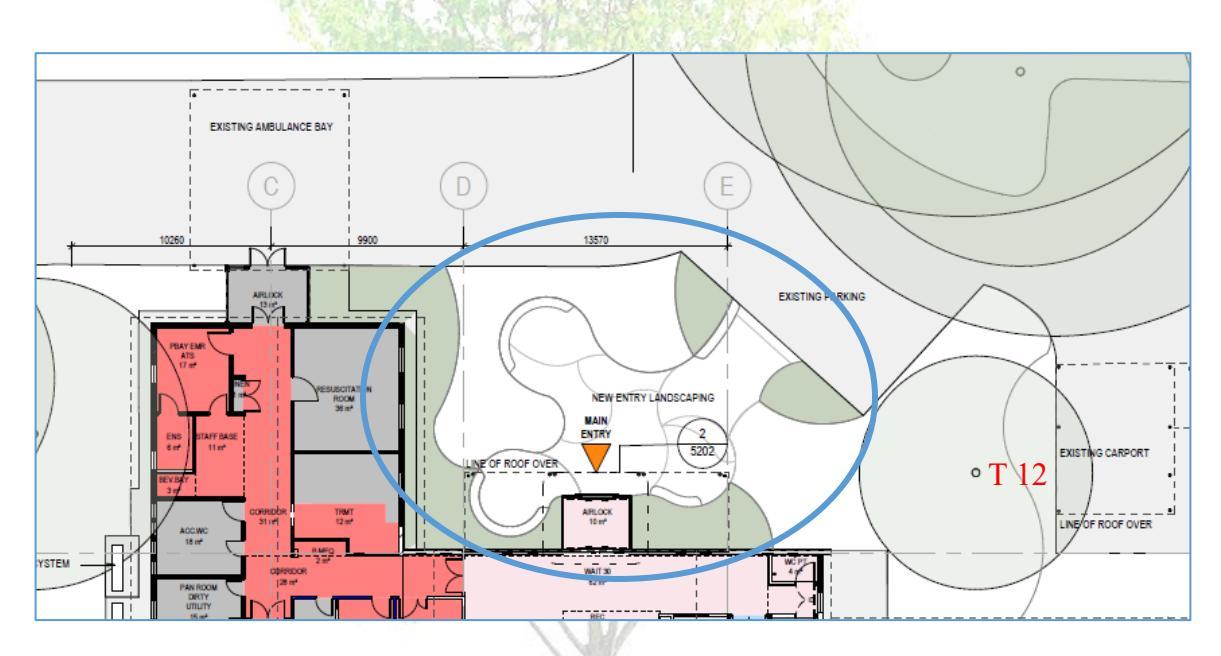
<u>Diagram 2 - new entrance upgrade and landscaping circled within floor plan.</u> Outside Tree Protection zone of tree12. Source adapted from provided floor plan as cited.

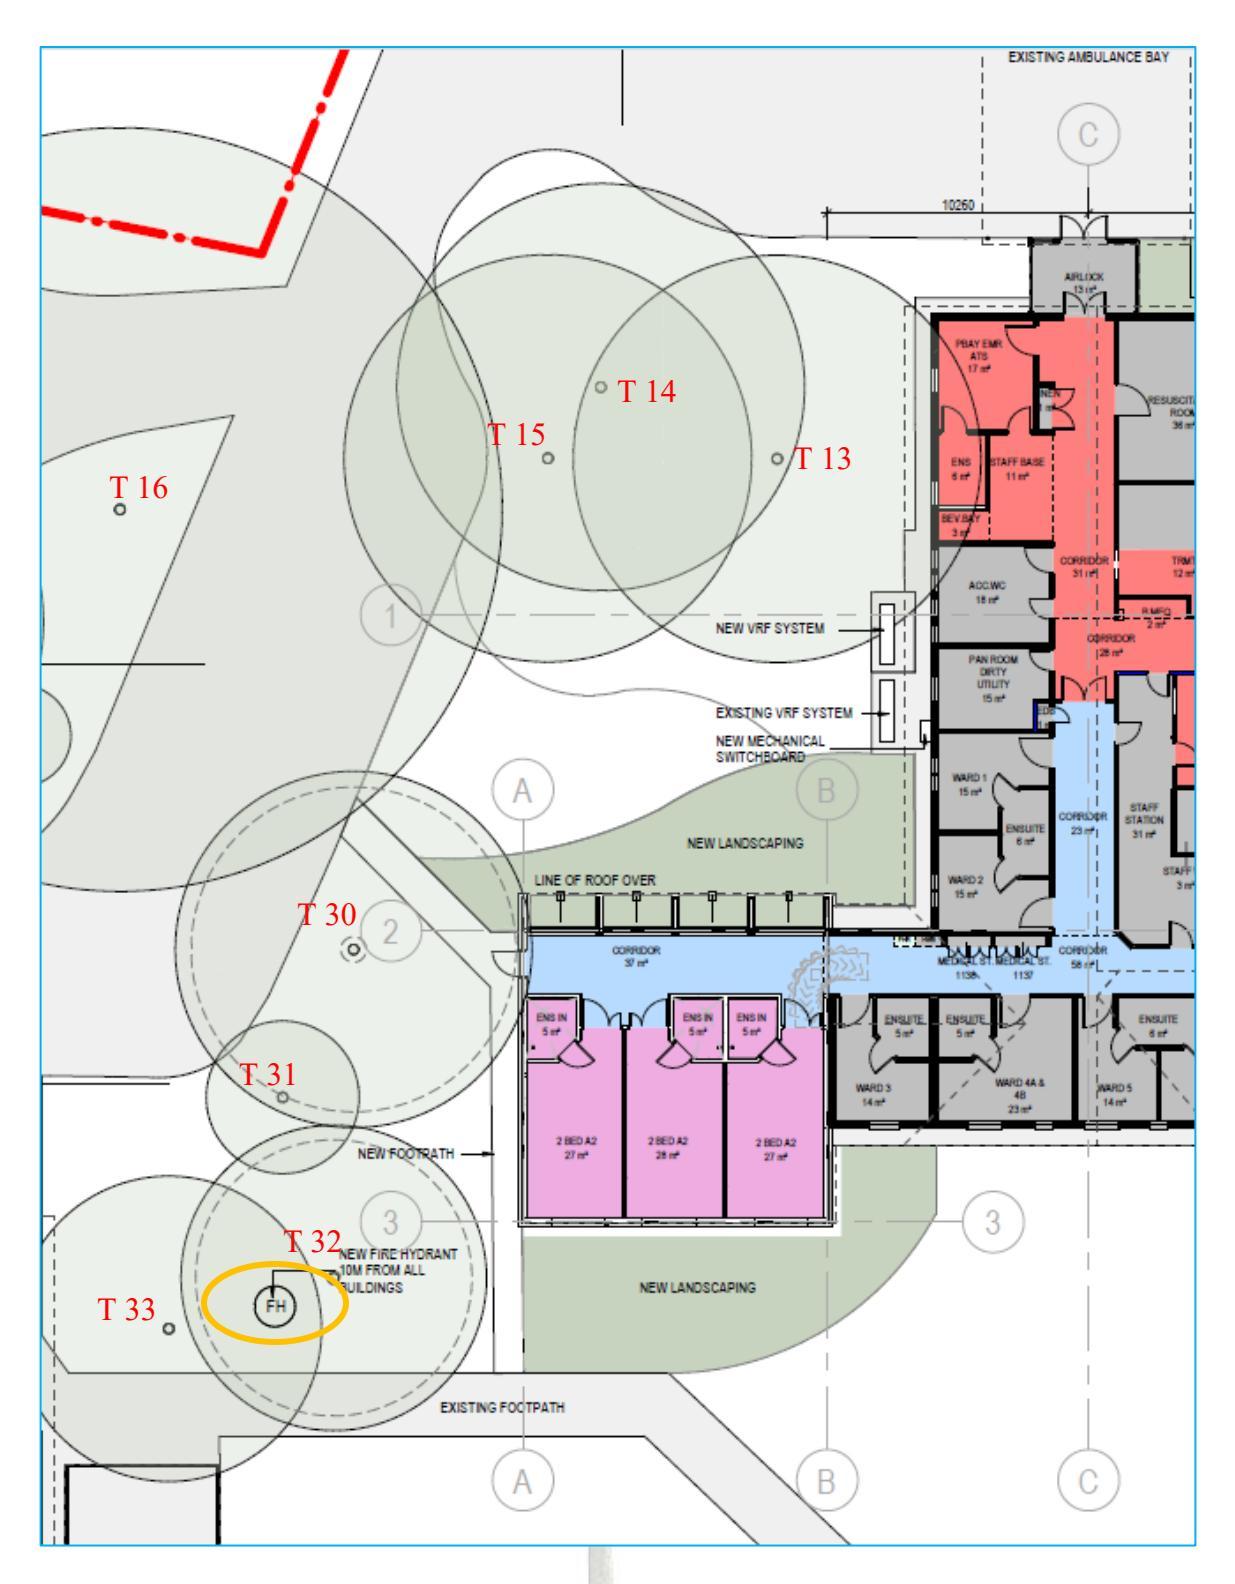
Diagram 3 - Proposed construction of 3 new inpatient rooms - highlighted in pink attached to existing building in grey. New fire hydrant location as circled is advised as being relocated to not impact the trees. Existing tree numbers have been added. Some general impacts will be required to be managed - footpath construction and general construction works close to the trees. Source - adapted from supplied cited drawing.

- ii. Temporary fencing should be installed around trees 30, 32 and 33 at the TPZ of 4 to 5 meters from the stems.
    - iii. If trenching for installation of the water service to the proposed fire hydrant is outside the tree protection zone then the impact the trees will be small.

- If the hydrant is required to be installed within the tree protection zones of either tree then trenching should not breach the structural root zone of tree 32 or 33 - limit 2.5

meters. If this is not feasible then the tree/s should be considered for removal and replacement.

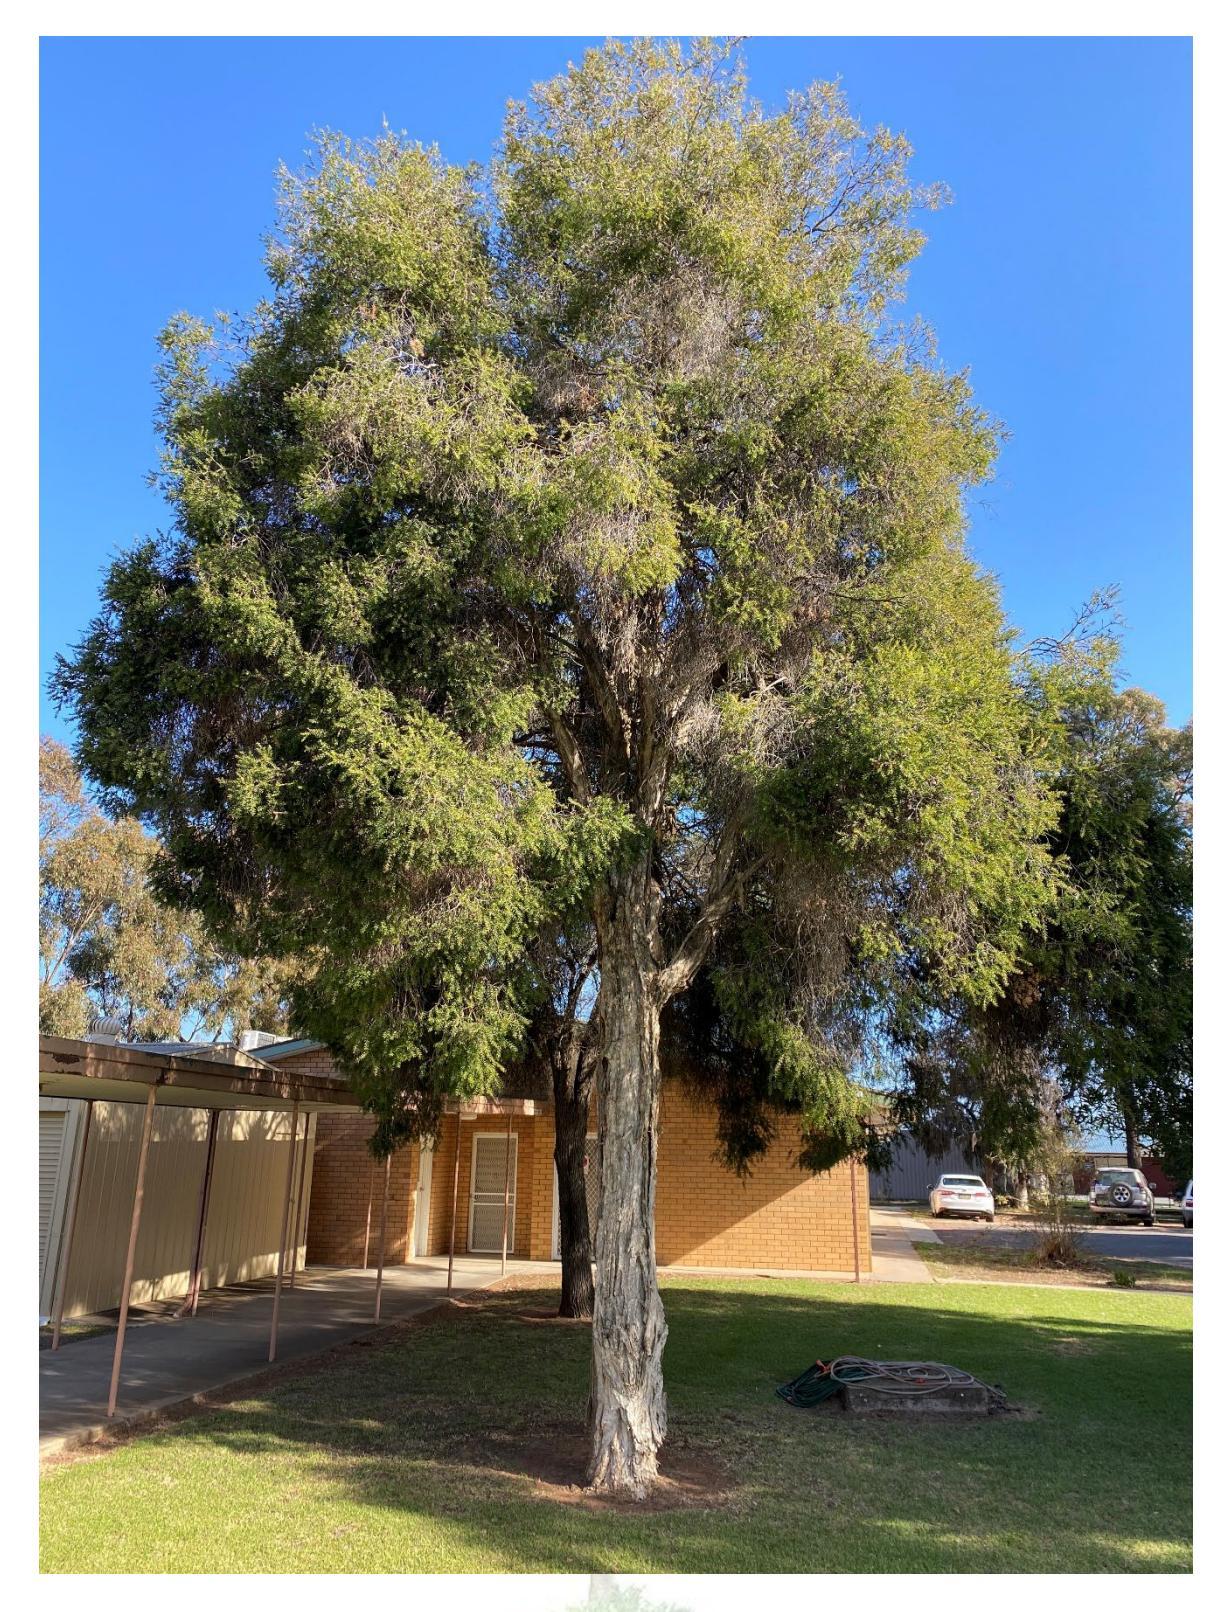
Photo 6 - Tree 32 foreground and tree 33 to rear. If the fire hydrant is relocated outside the tree protection zone distances then the impact to the trees will be minimal.
