Report Type: Acid Sulfate Soils Assessment

Project Location: 51 Masons Parade, Point Frederick, NSW Lot 51 in DP732632

Client Name: Brisbane Waters (NSW) Legacy Club (c/ Grindley Construction)

> 29 July 2020 Report No: 10827-ER-2-1

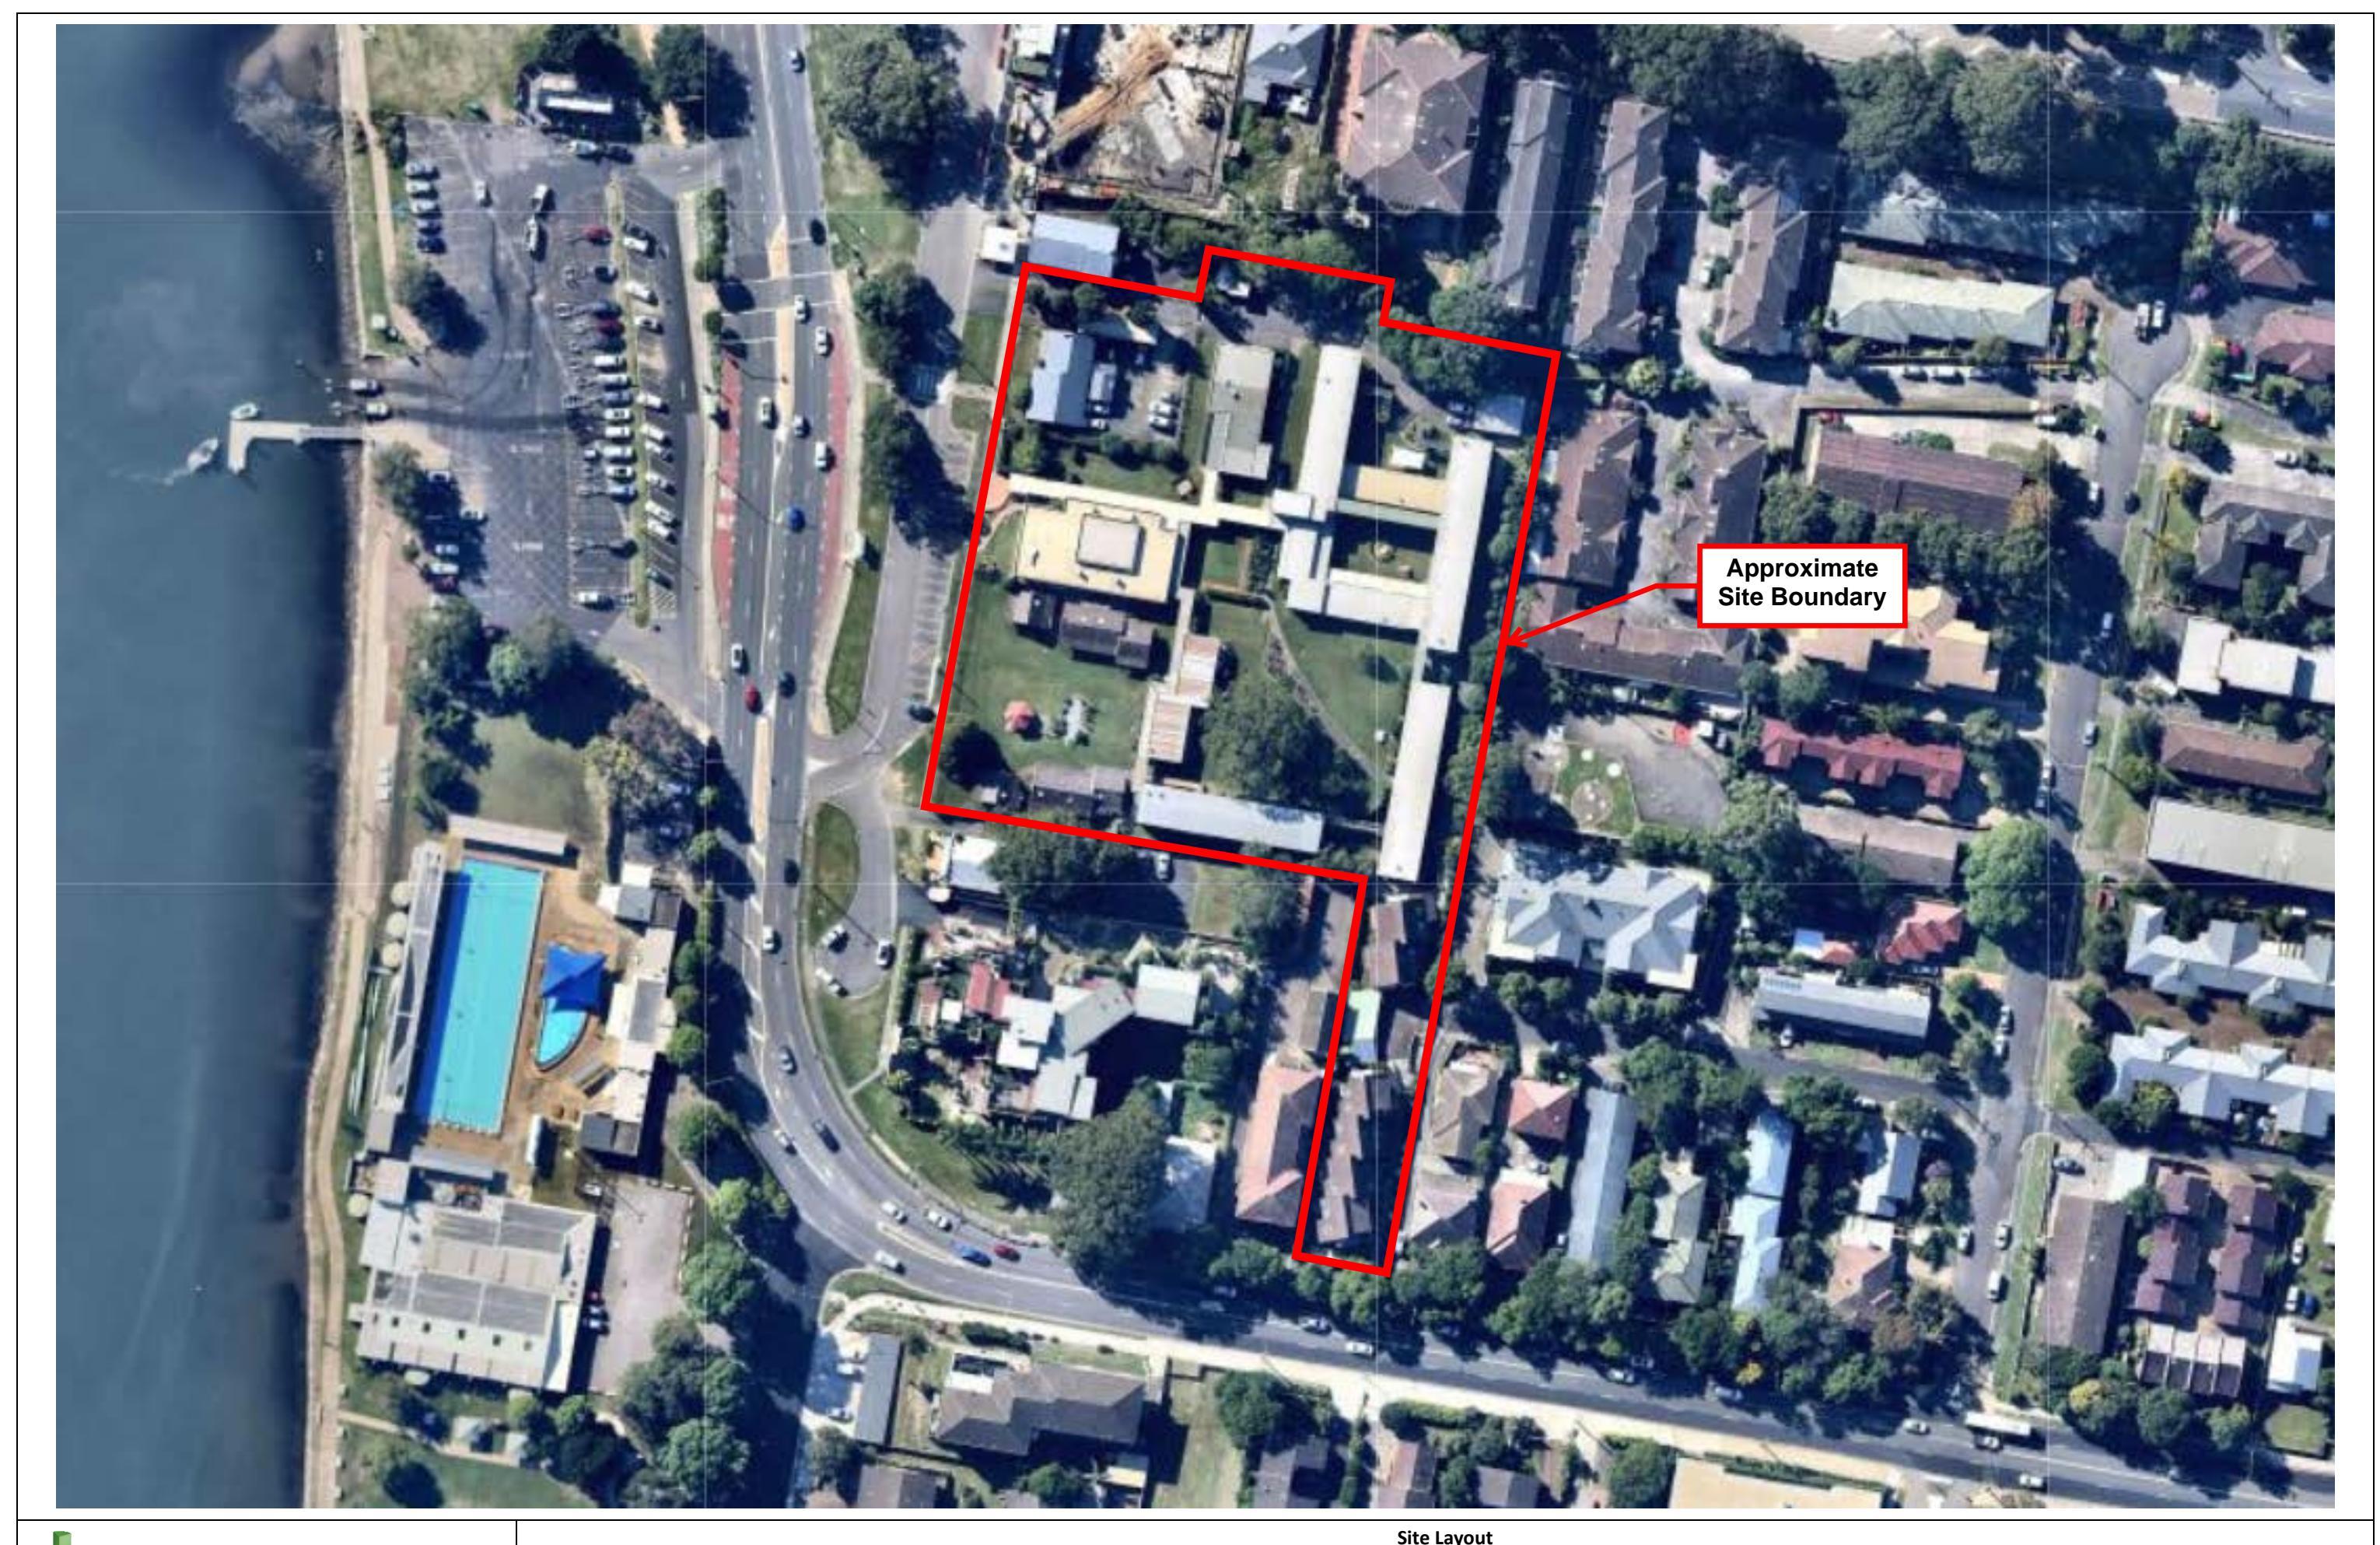
Site identification details and associated information is present in **Table 2-1**. The locality of the site is presented in **Figure 1**, with the general layout and site boundaries depicted in **Figure 2**.

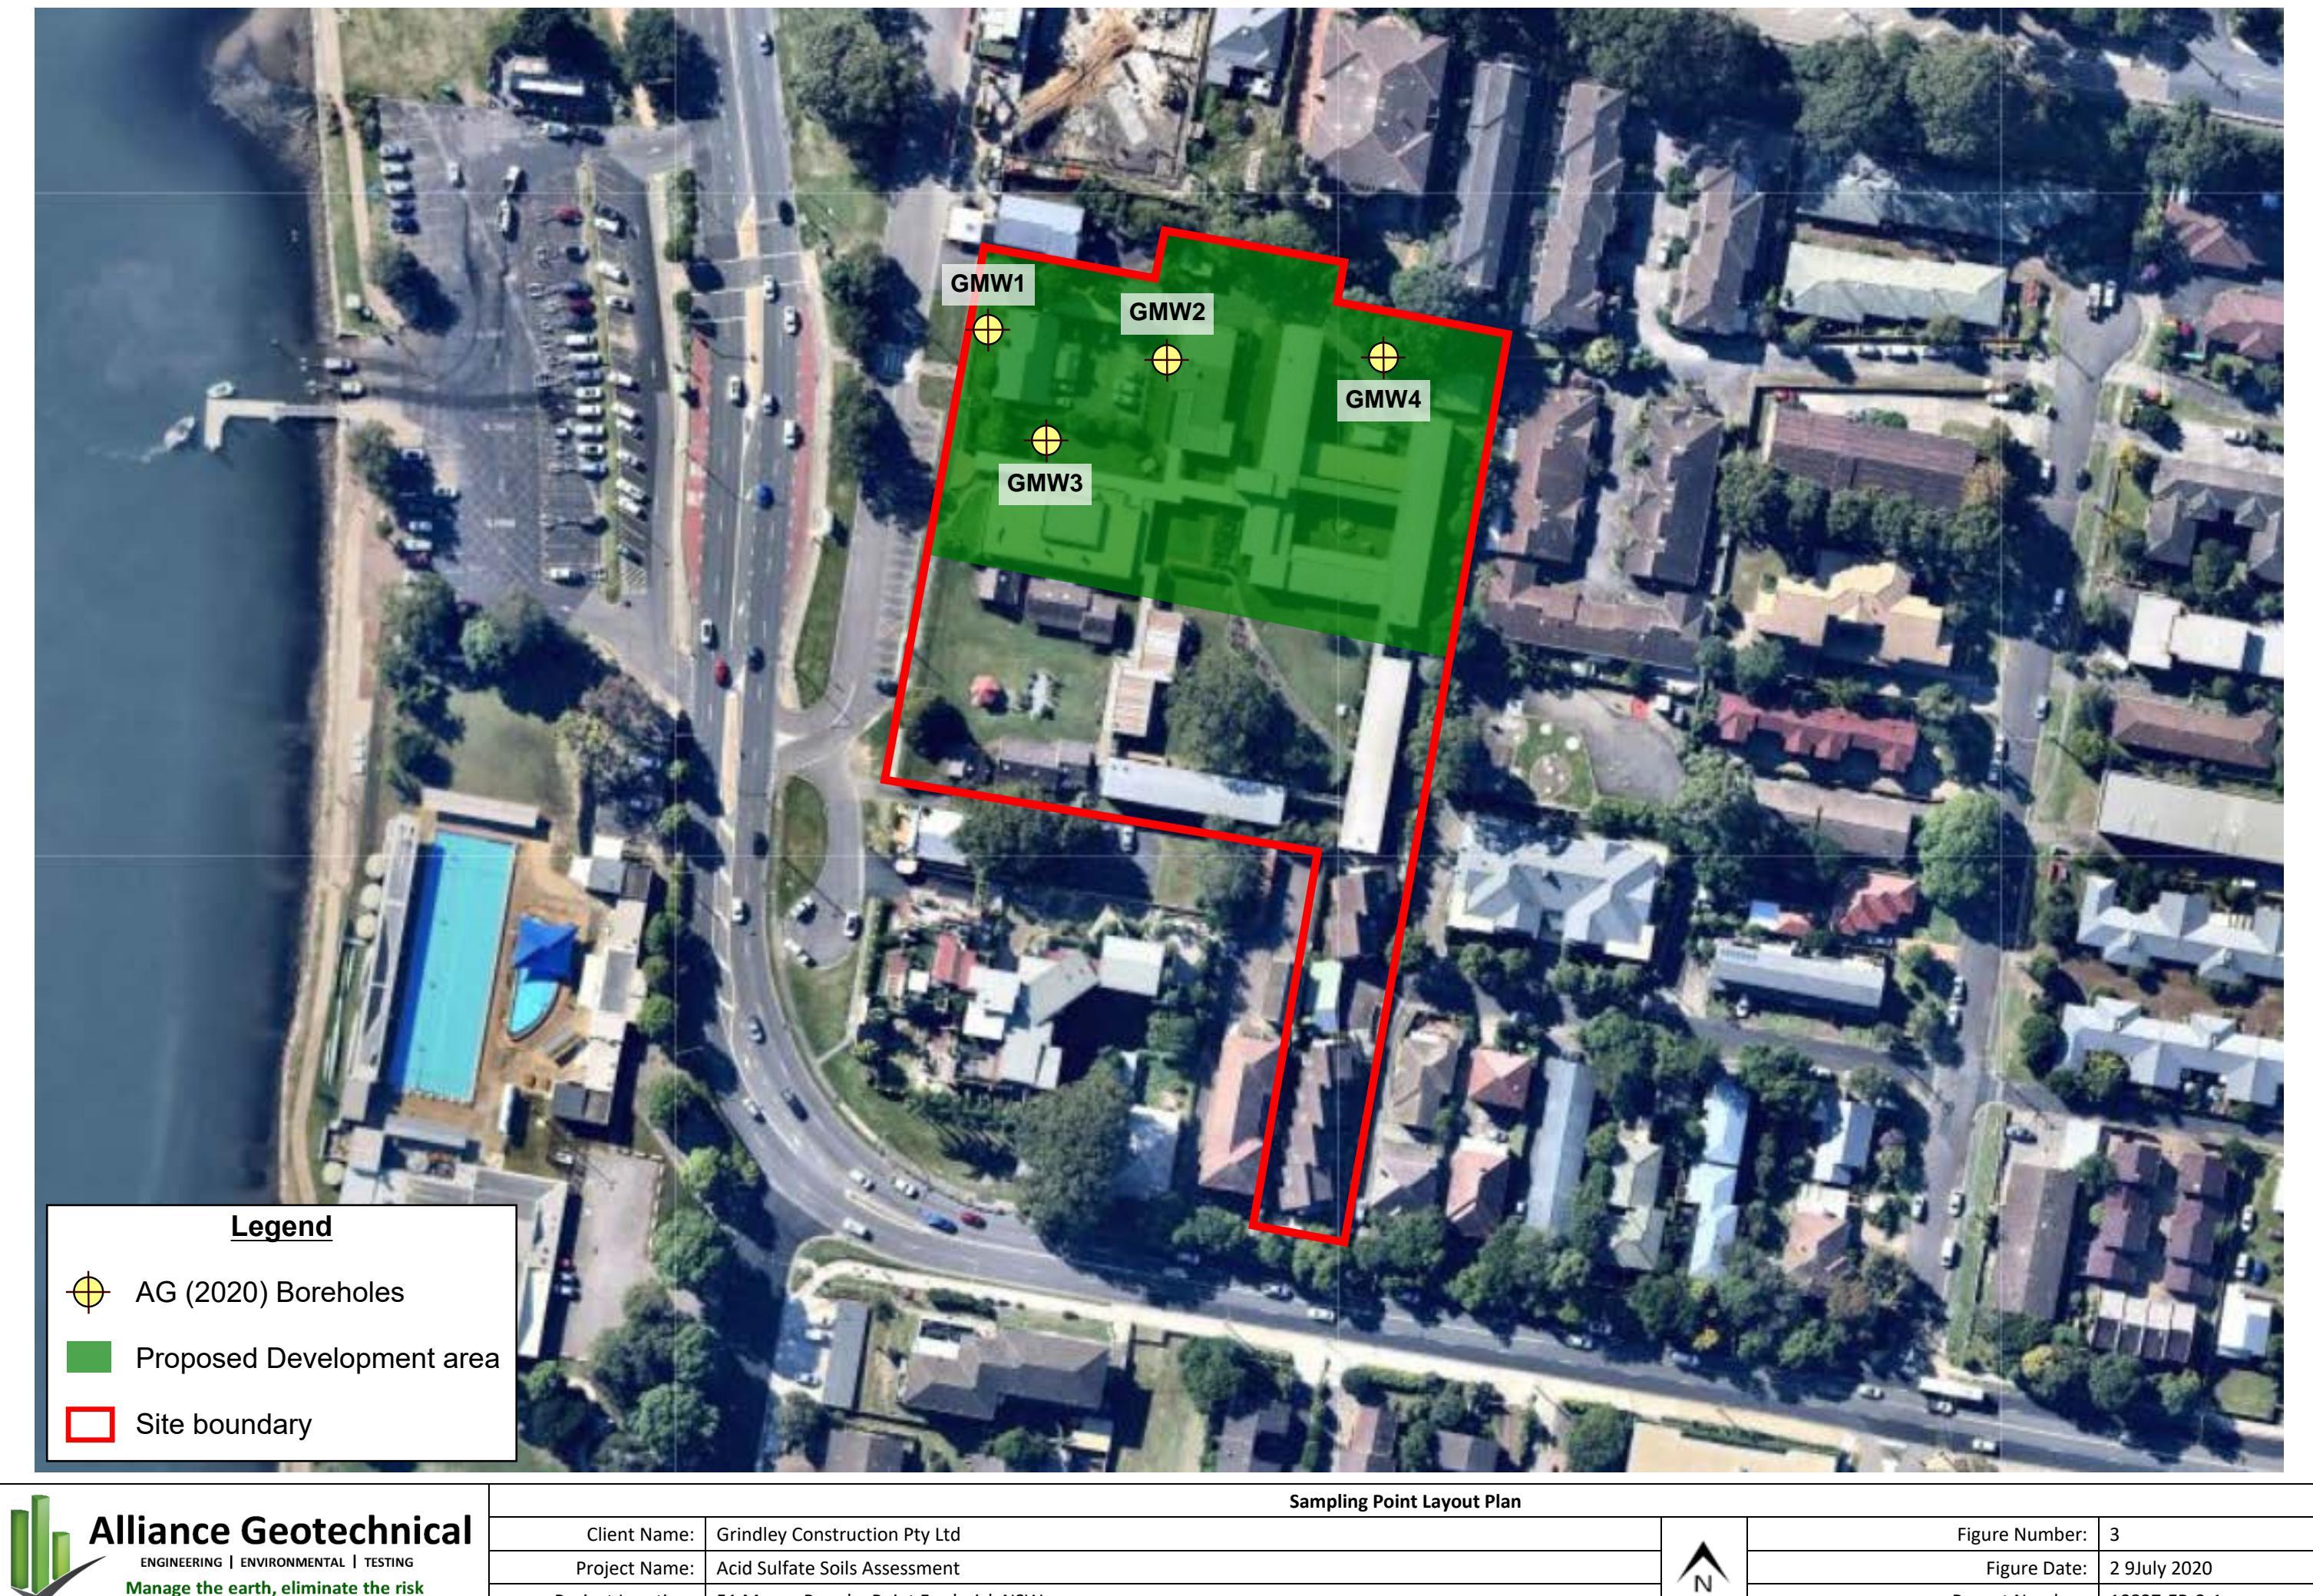
Figure Number:	3
Figure Date:	2 9July 2020
Report Number:	10827-ER-2-1

- Figure 3 Sampling Point Layout Plan
- Figure 4 Acid Sulfate Soils Impacted Areas
