REMEDIAL ACTION PLAN

Prepared For: Roselands Star Pty Ltd Address: 892 - 906 Canterbury Road, Roselands, NSW, 2196 Job No: AG-741 Date: 11-11-21

STAGE 3 RAP 892-906 CANTERBURY ROAD, ROSELANDS, NSW, 2196 PREPARED FOR ROSELANDS STAR PTY LTD AG DOCUMENT REFERENCE: AG-741rev0

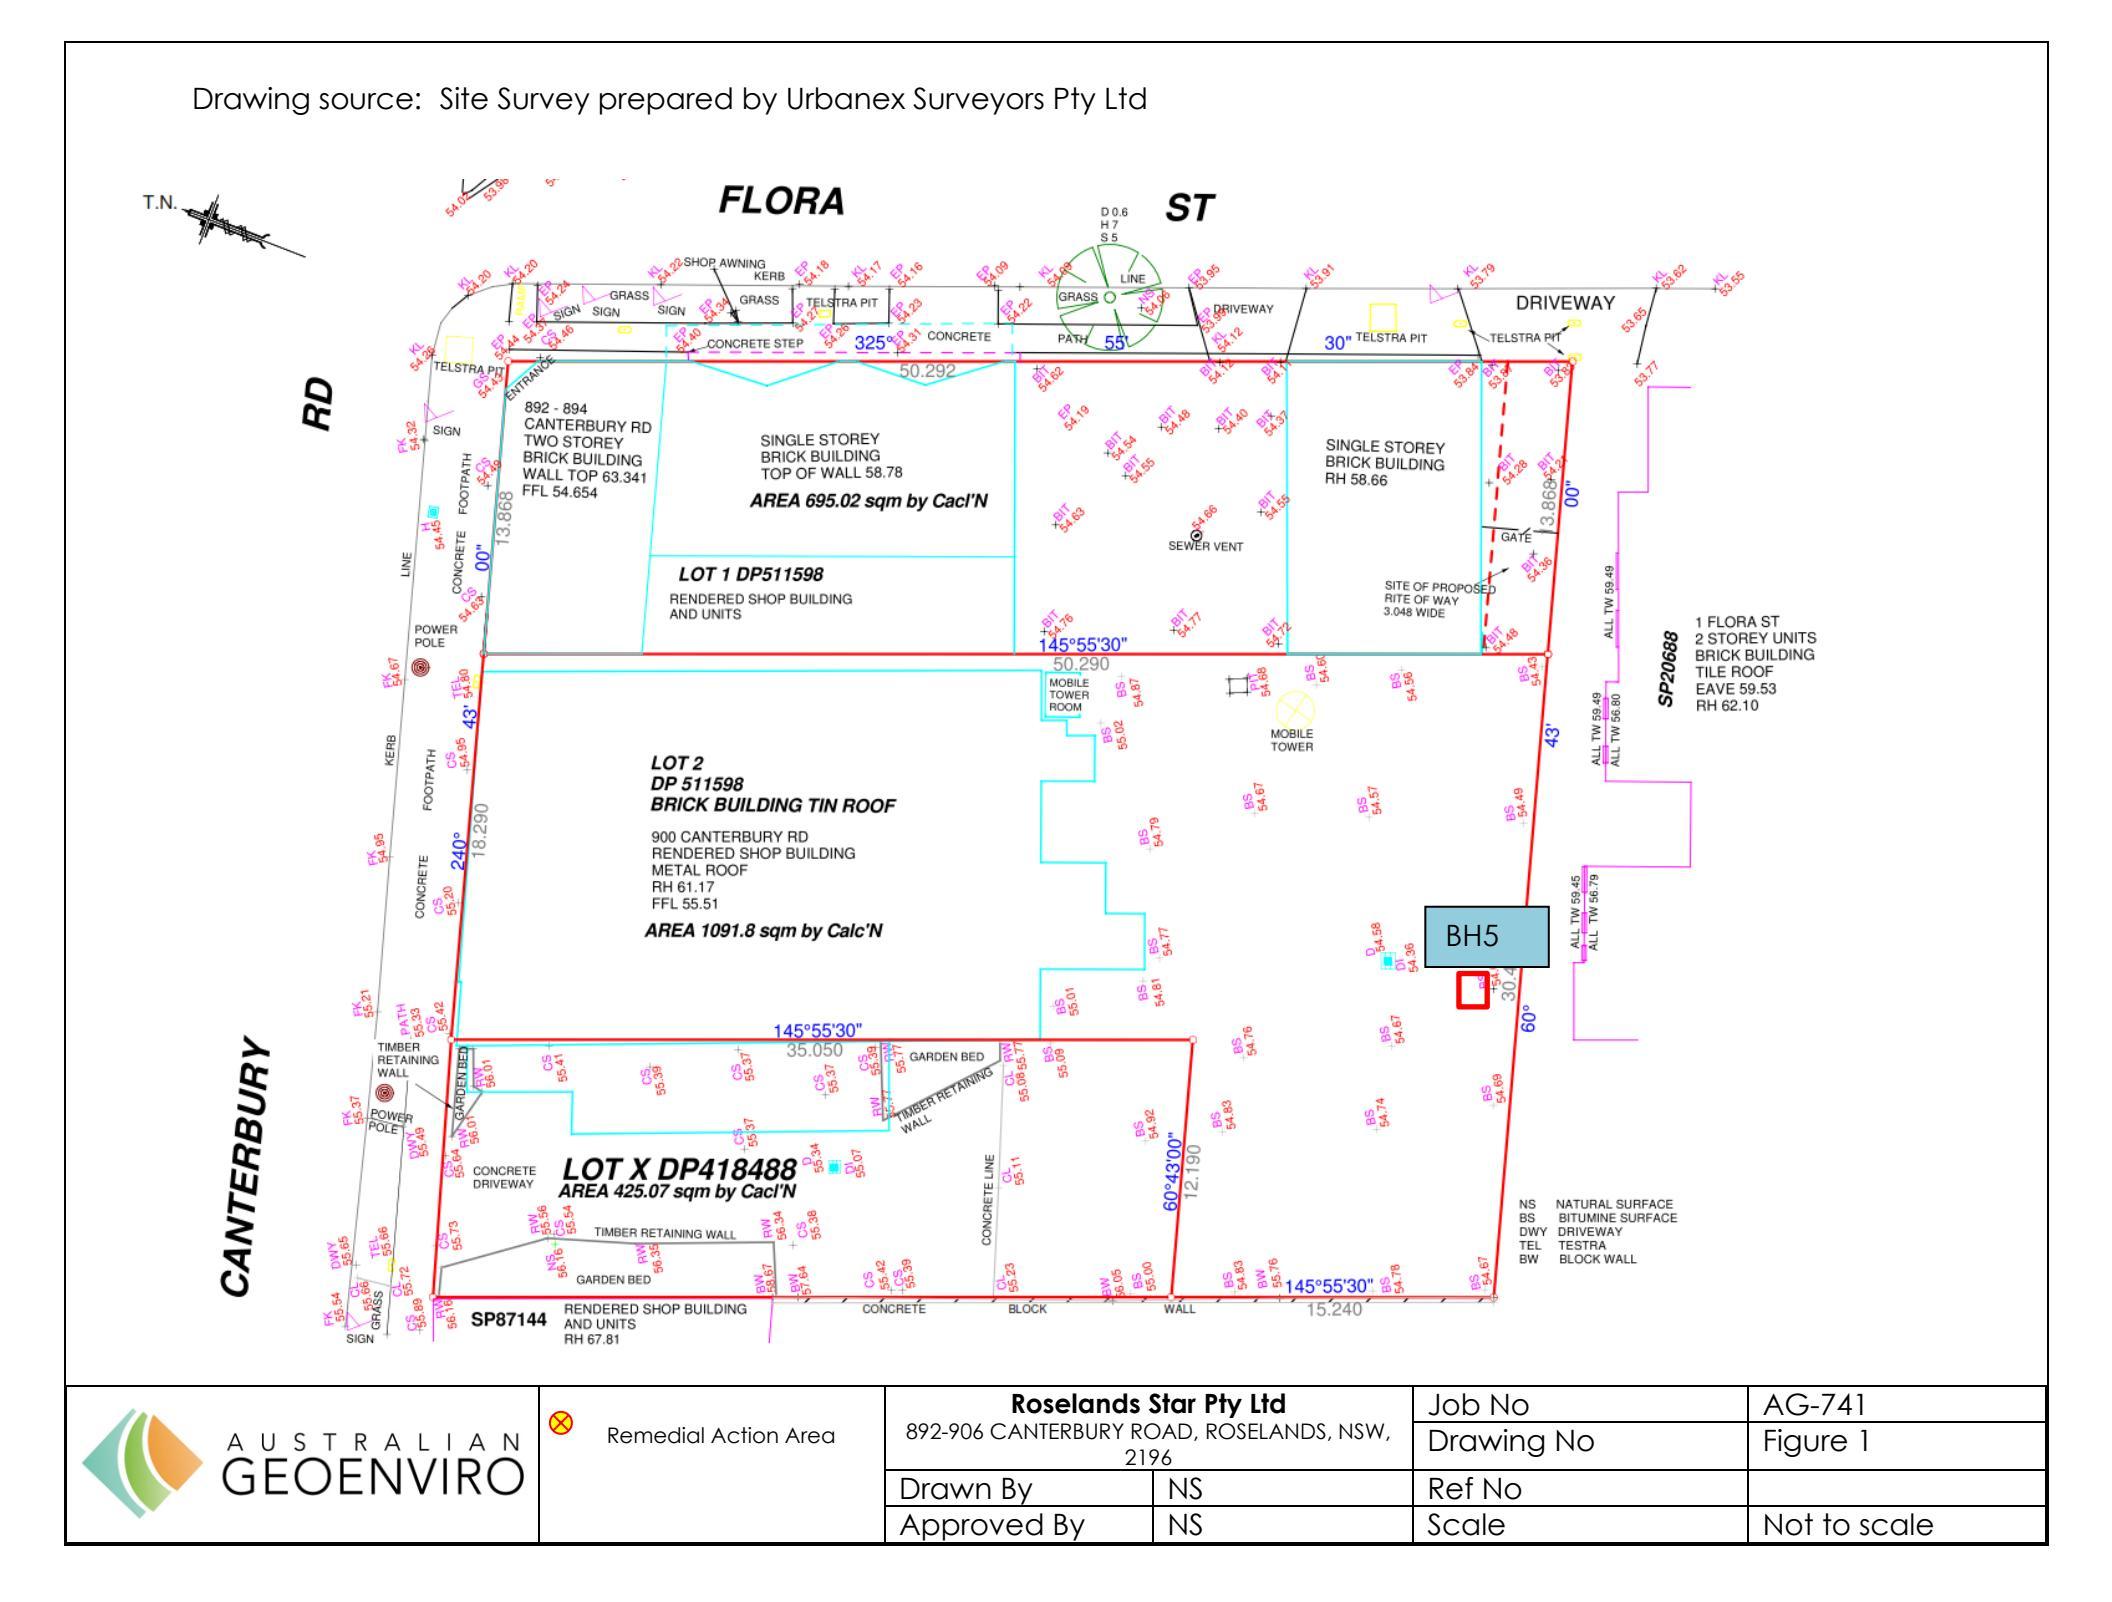
FIGURE 1 – REMEDIAL AREA AND PLANS

• The extent of remedial action is limited to borehole numbered 5.

BH5-0.5m which presented Chrysotile and Crocidolite asbestos found as 8-9mm x 1mm loose in sample and asbestos found in approximately 2x2x1mm cement sheet fragment.
