Arboricultural Impact Assessment

3 AYR STREET ASHBURY 6-11-22

> Leigh Brennan Tree Management Strategies

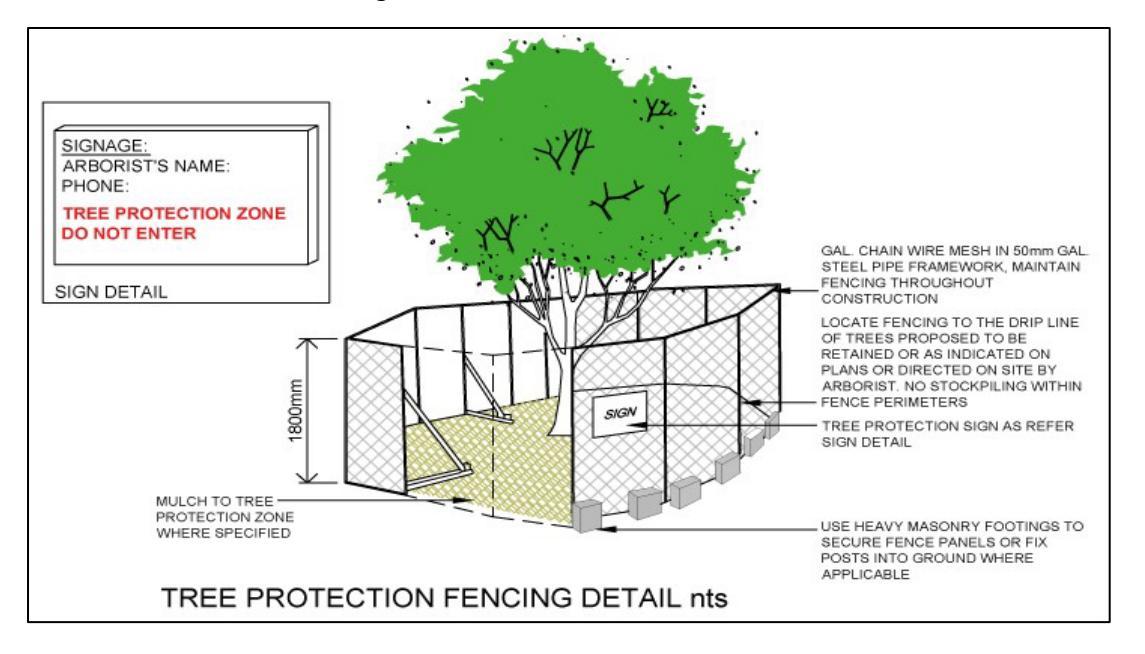
To ensure the protection of trees affected by the proposed development a Tree Protection Fence is required for Tree 1 as per the detail outline in (Figure 2).

The Tree Protection Fence needs to be erected throughout construction and may be dismantled when landscaping begins. The Project Arborist must certify the protection measures are in the correct location and to specification prior to the commencement of construction.

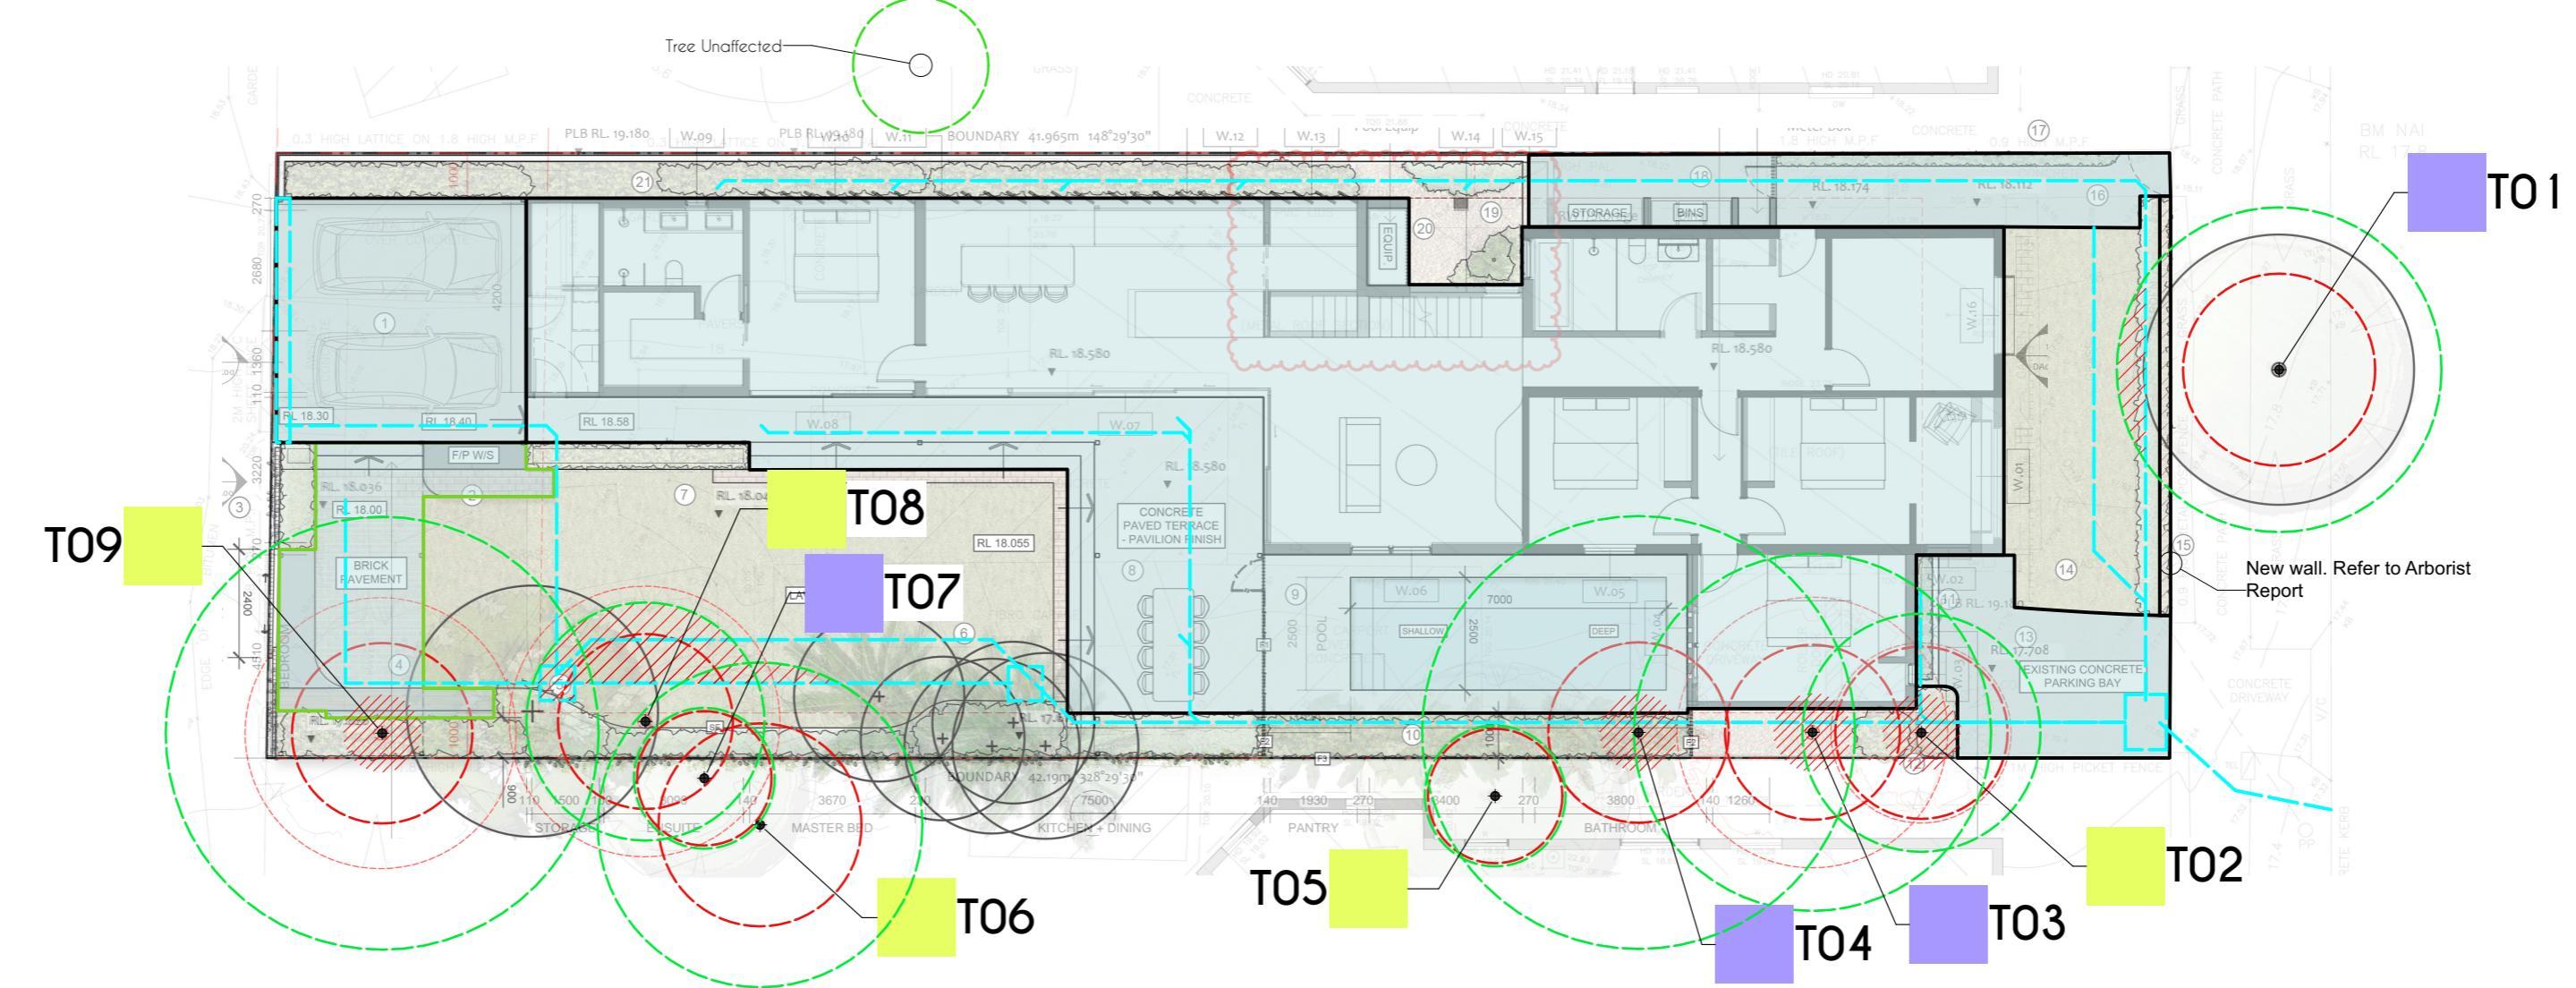
Tree Impact Plan - Appendix 2

TPZ = 40.72sqm Incursion Zone(stormwater) 1.78sqm Incursion Zone(stormwater) 1.08sqm Incursion = 4.37%

T02, T03, T04 Trunk Impact (Stormwater)

TPZ = 40.72sqm Incursion = 2.65%

SRZ = 11.82sqm Incursion Zone(stormwater) 2.82sqm Incursion = 23.86%

TPZ = 29.9sqm Incursion Zone(stormwater) 6.83sqm Incursion = 22.84%

Tree 1 located on the council verge is given a medium retention value and has a minor incursion of 4.37% to its TPZ by the proposed stormwater design. The minor incursion to Tree 1 is deemed acceptable considering adequate tree protection measures are allowed for, refer to the Tree Impact Plan (Appendix 2) and the Tree Management Plan (Section 3) of this report. Tree 1 has a potential additional impact from the proposed new boundary wall that requires sensitive construction in the form of pier and beam construction to ensure minimal impact, refer to the Tree Impact Plan (Appendix 2) and the Tree Management Plan (Section 3) of this report.

Trees 3 and 4 located within the subject site are given a medium retention value and have total incursions to their TPZ's that requires their removal to support the proposed development, refer to the Tree Impact Plan (Appendix 2).

Tree 6 located in the neighbouring property is given a low retention value and has a minor incursion of 2.65% to its TPZ by the proposed stormwater design. The minor incursion to Tree 6 is deemed acceptable considering adequate tree protection measures are allowed for, refer to the Tree Impact Plan (Appendix 2).

Trees 2, 8 and 9 located in the subject site are given a low retention value and have major or total incursions to their TPZ's by the proposed development that requires their removal, refer to the Tree Impact Plan (Appendix 2).

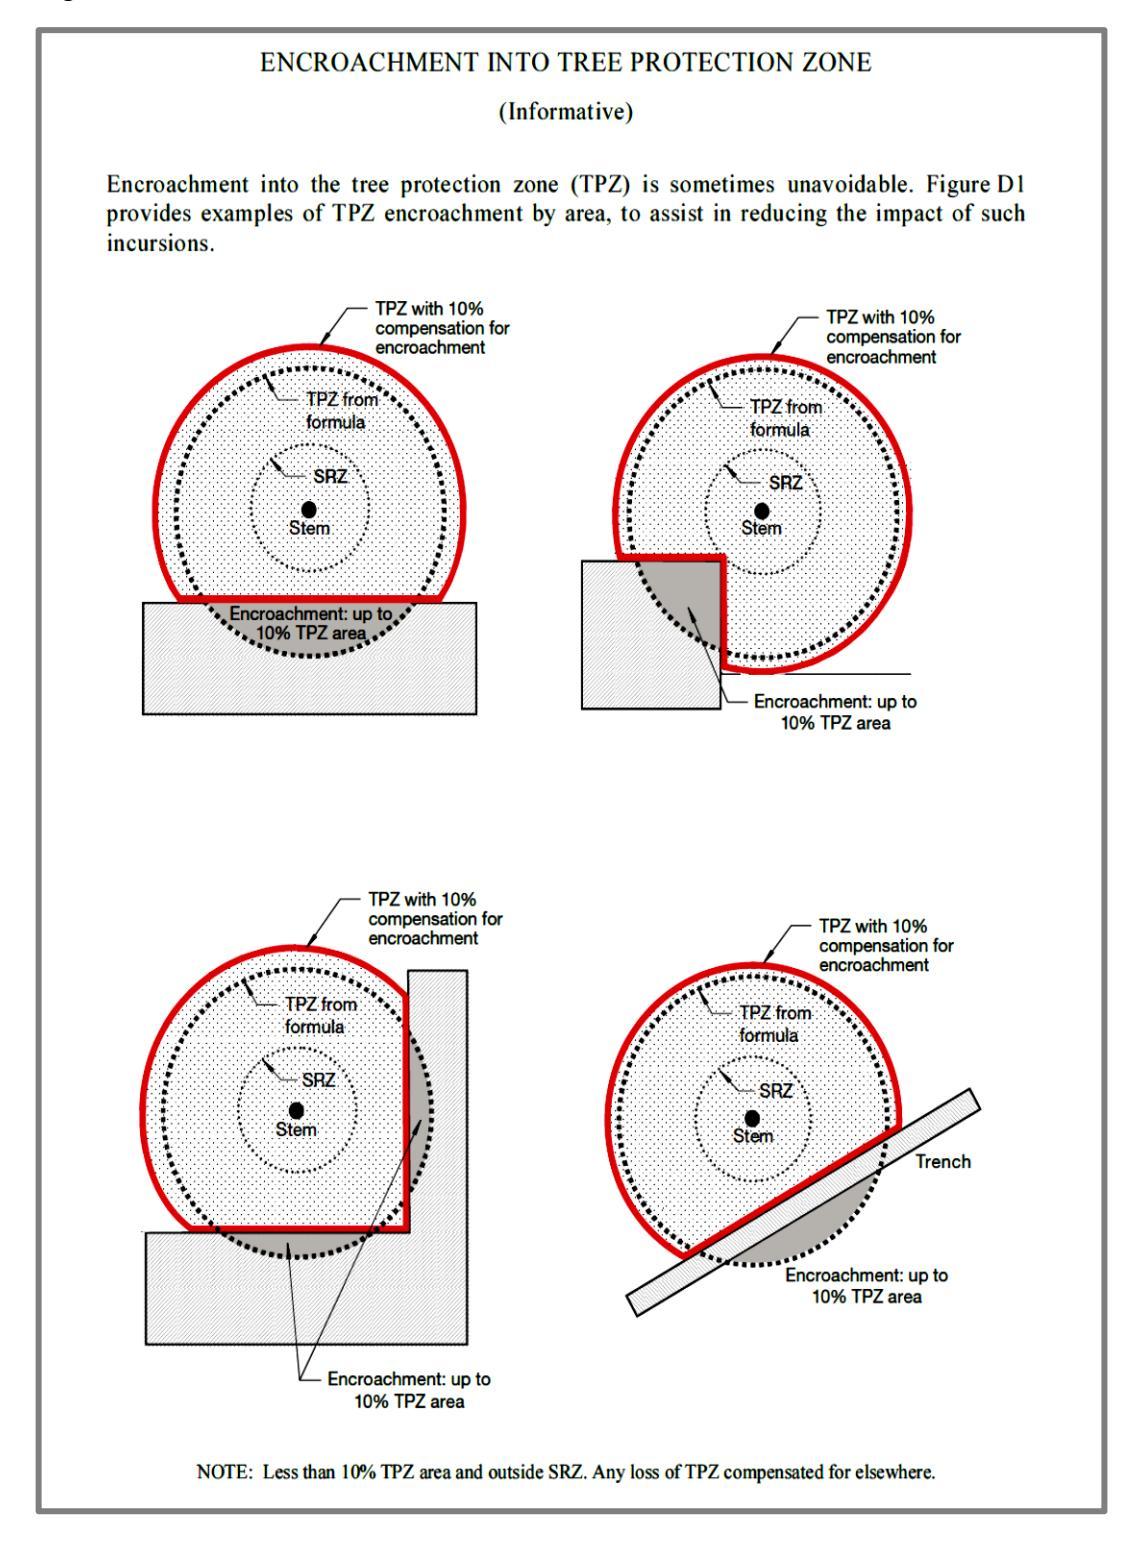
Figure 3

It may be possible to encroach into or make variations to the standard TPZ. Encroachment Includes excavation, compacted fill and machine trenching.

If the proposed encroachment is less than 10% of the area of the TPZ and is outside the SRZ, detailed root investigations should not be required. The area lost to this encroachment should be compensated for elsewhere and contiguous with the TPZ. Variations must be made by the project arborist considering relevant factors. (Figure 3) demonstrates some examples of possible encroachment into the TPZ up to 10% of the area.
