ARBORICULTURAL IMPACT REPORT

Site Address: 113-115 Faraday Rd. Padstow

Report Issue Date (By Author): 15.11.2023 - DA Issue

Job No: 6221

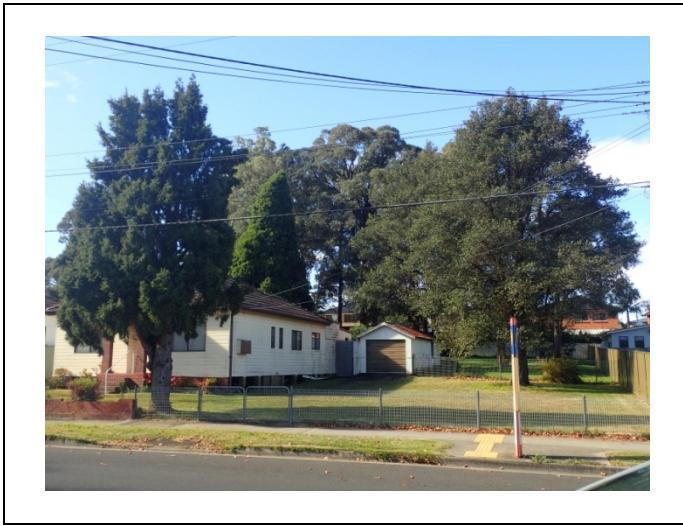
Plate 1 – Street view – T22 left

- 8.6.1 T20 has significant dieback and crown lifting.
- 8.6.2 T22 has a co-dominant stem removed and internal decay.

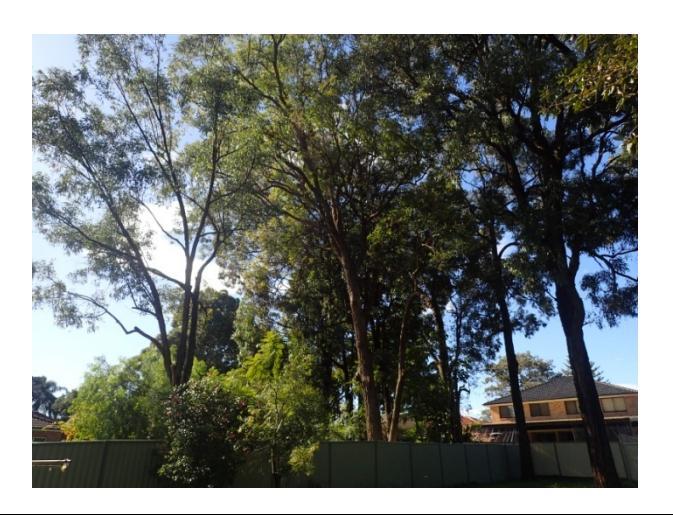
Plate 2 – T1-T5 and T19

- 8.1 T1-T6 and T8 are not impacted by the proposed development. These trees will be subjected to wholesale tree protection measures.
- 8.2 T9 is the largest specimen on site. A co-dominant stem has been removed. Proposed encroachment is 14.03% which is acceptable from Authors perspective. This encroachment can easily be reduced by applying contiguous compensation as per Appendix of AS4970-2009. Response to Section 3.3.4 of AS4970-2009 as follows:-

- 8.3 T10 T13 are not impacted by the proposed development. These trees will be subjected to wholesale tree protection measures.
 - 8.3.1 T12 is senescent. Retain as part of existing community.
 - 8.3.2 T13 is suppressed with north eastern lean.
- 8.4 T14-T18 are proposed to be removed to facilitate development.
 - 8.4.1 T14 has a sparse crown and small percentage of deadwood.
 - 8.4.2 T15 has been previously lopped.
 - 8.4.3 T18 is suppressed.
- 8.5 T19 has less than 5% TPZ encroachment. Boundary fence will adequately protect specimen.

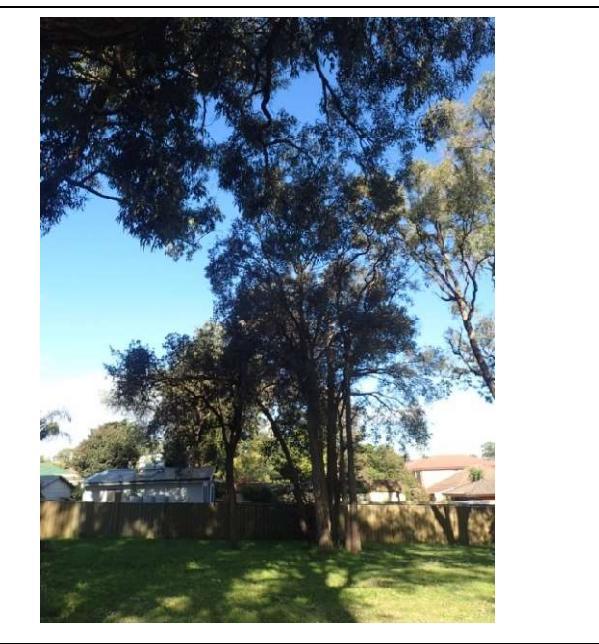
Plate 4 – T8-T13
