BUSHFIRE ASSESSMENT REPORT

PROPOSED ALTERATIONS & ADDITIONS

Lot 1 DP 1085253 No. 6 Pipit Place Perisher Valley, 2624

> 27 February 2025 Reference: S024012

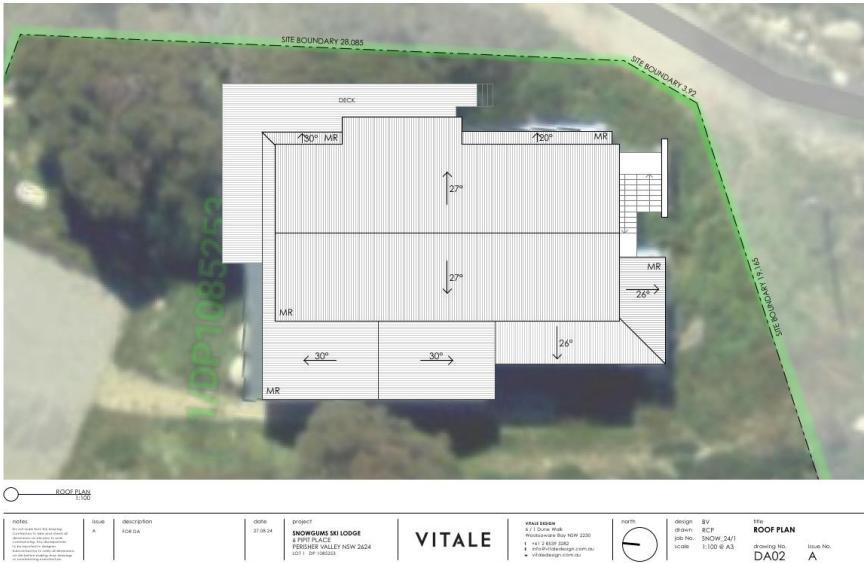
Figure 2: Extract of the Roof Plan prepared by Vitale Design.

Figure 2 shows an extract of the Roof Plan prepared by *Vitale Design* which has been submitted as part of this application. Materials have been included in the submitted Architectural Plans including custom orb Shale Grey metal roof sheeting, metal gutters and downpipes, and paint to match existing. There are no physical works proposed. Access for works is via Pipit Place.

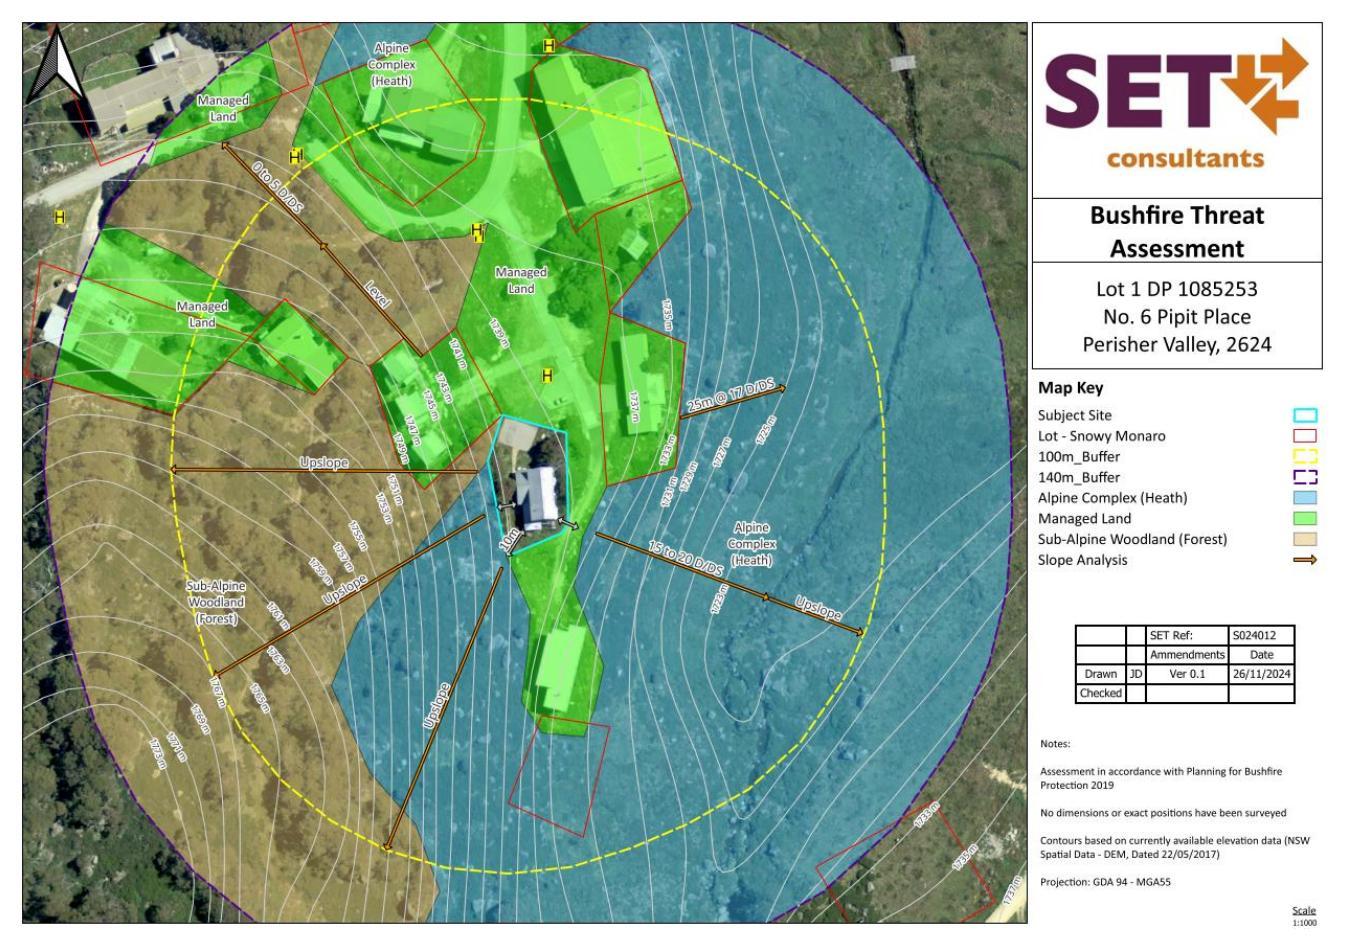
Figure 6: Extract of the Bushfire Threat Assessment Plan.

The details of the predominant vegetation in all directions, to a distance of 140m from the subject site are provided in **3.2**. Vegetation forming a bushfire threat to the proposed development comes from sub-alpine woodland located west of the subject site and alpine complex (heath) located east of the subject site. It is noted that several adjoining properties contain existing cabin, infrastructure, and access roads which are classified as managed land for the assessment.

However, in accordance with Planning for Bushfire Protection (PBP 2019), the sub-alpine woodland would be classified as forest.

Table 2 provides a breakdown of the vegetation type, slope class and the required APZ for the proposed development. The APZs have been calculated for the Snowy Monaro Rural region using a FFDI of 50 (Alpine Area – Perisher Valley). The distance for the asset protection zone/separation distance has been measured in accordance with Table A1.12.1 PBP 2019 (Determination of BAL, FFDI 50 – Alpine Areas) which is between each of the vegetation stands identified (from the edge of the foliage cover) and the building. The separation distances have been measured onsite using a Nikon Forestry Pro Range Finder and Clinometer.

Direction	Dominant Vegetation Type	Effective Bushfire Slope	APZ Required (m)	Minimum Recommended APZ (m)	BAL	Comments
South	Forest	Upslope	67m	To the Boundary	BAL-FZ	APZ established. Continued maintenance recommended.
East	Alpine Complex (Heath)	15 to 20° Downslope	49m	To the Boundary	BAL-FZ	APZ contained within subject site and managed portion of Pipit Place.
West	Forest	Upslope	67m	To the Boundary	BAL-FZ	APZ established. Continued maintenance recommended.

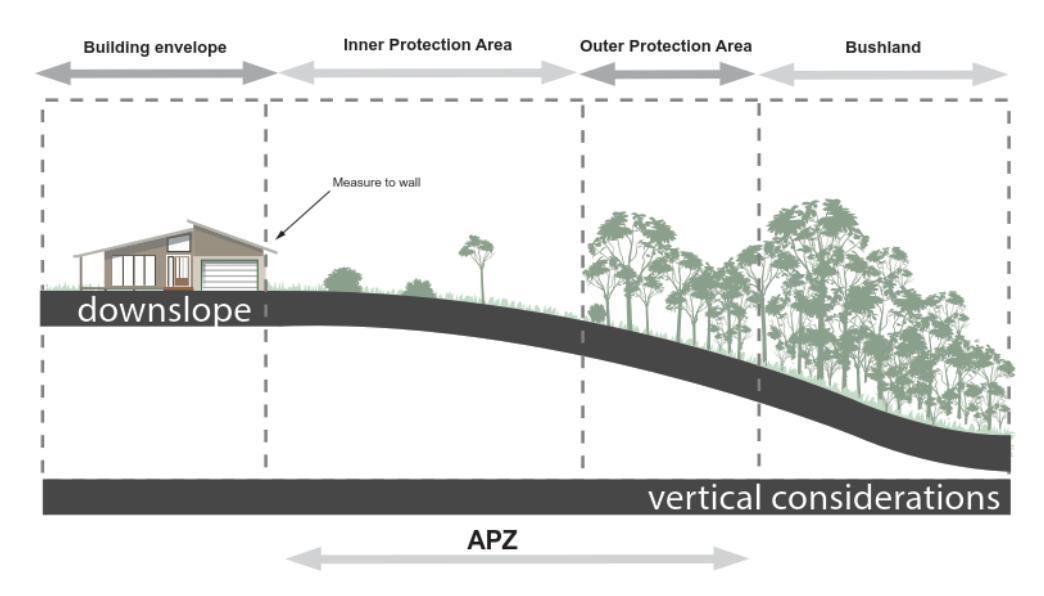
Figure 8: Diagrammatic representation of an Asset Protection Zone.

The existing managed land within the subject lot shall continue to be maintained (no additional clearing is required) as an Inner Protection Area - IPA (Figure 10) for the life of the development and comply with section 7.4 and Appendix 4 of Planning for Bush Fire Protection 2019 and the NSW Rural Fire Service's document 'Standards for asset protection zones', as outlined below:

- tree canopy cover should be less than 15% at maturity;
- trees at maturity should not touch or overhang the building;
- lower limbs should be removed up to a height of 2m above the ground;
- tree canopies should be separated by 2 to 5m; and
- preference should be given to smooth barked and evergreen trees.

- grass should be kept mown (as a guide grass should be kept to no more than 100mm in height); and
- leaves and vegetation debris should be removed.

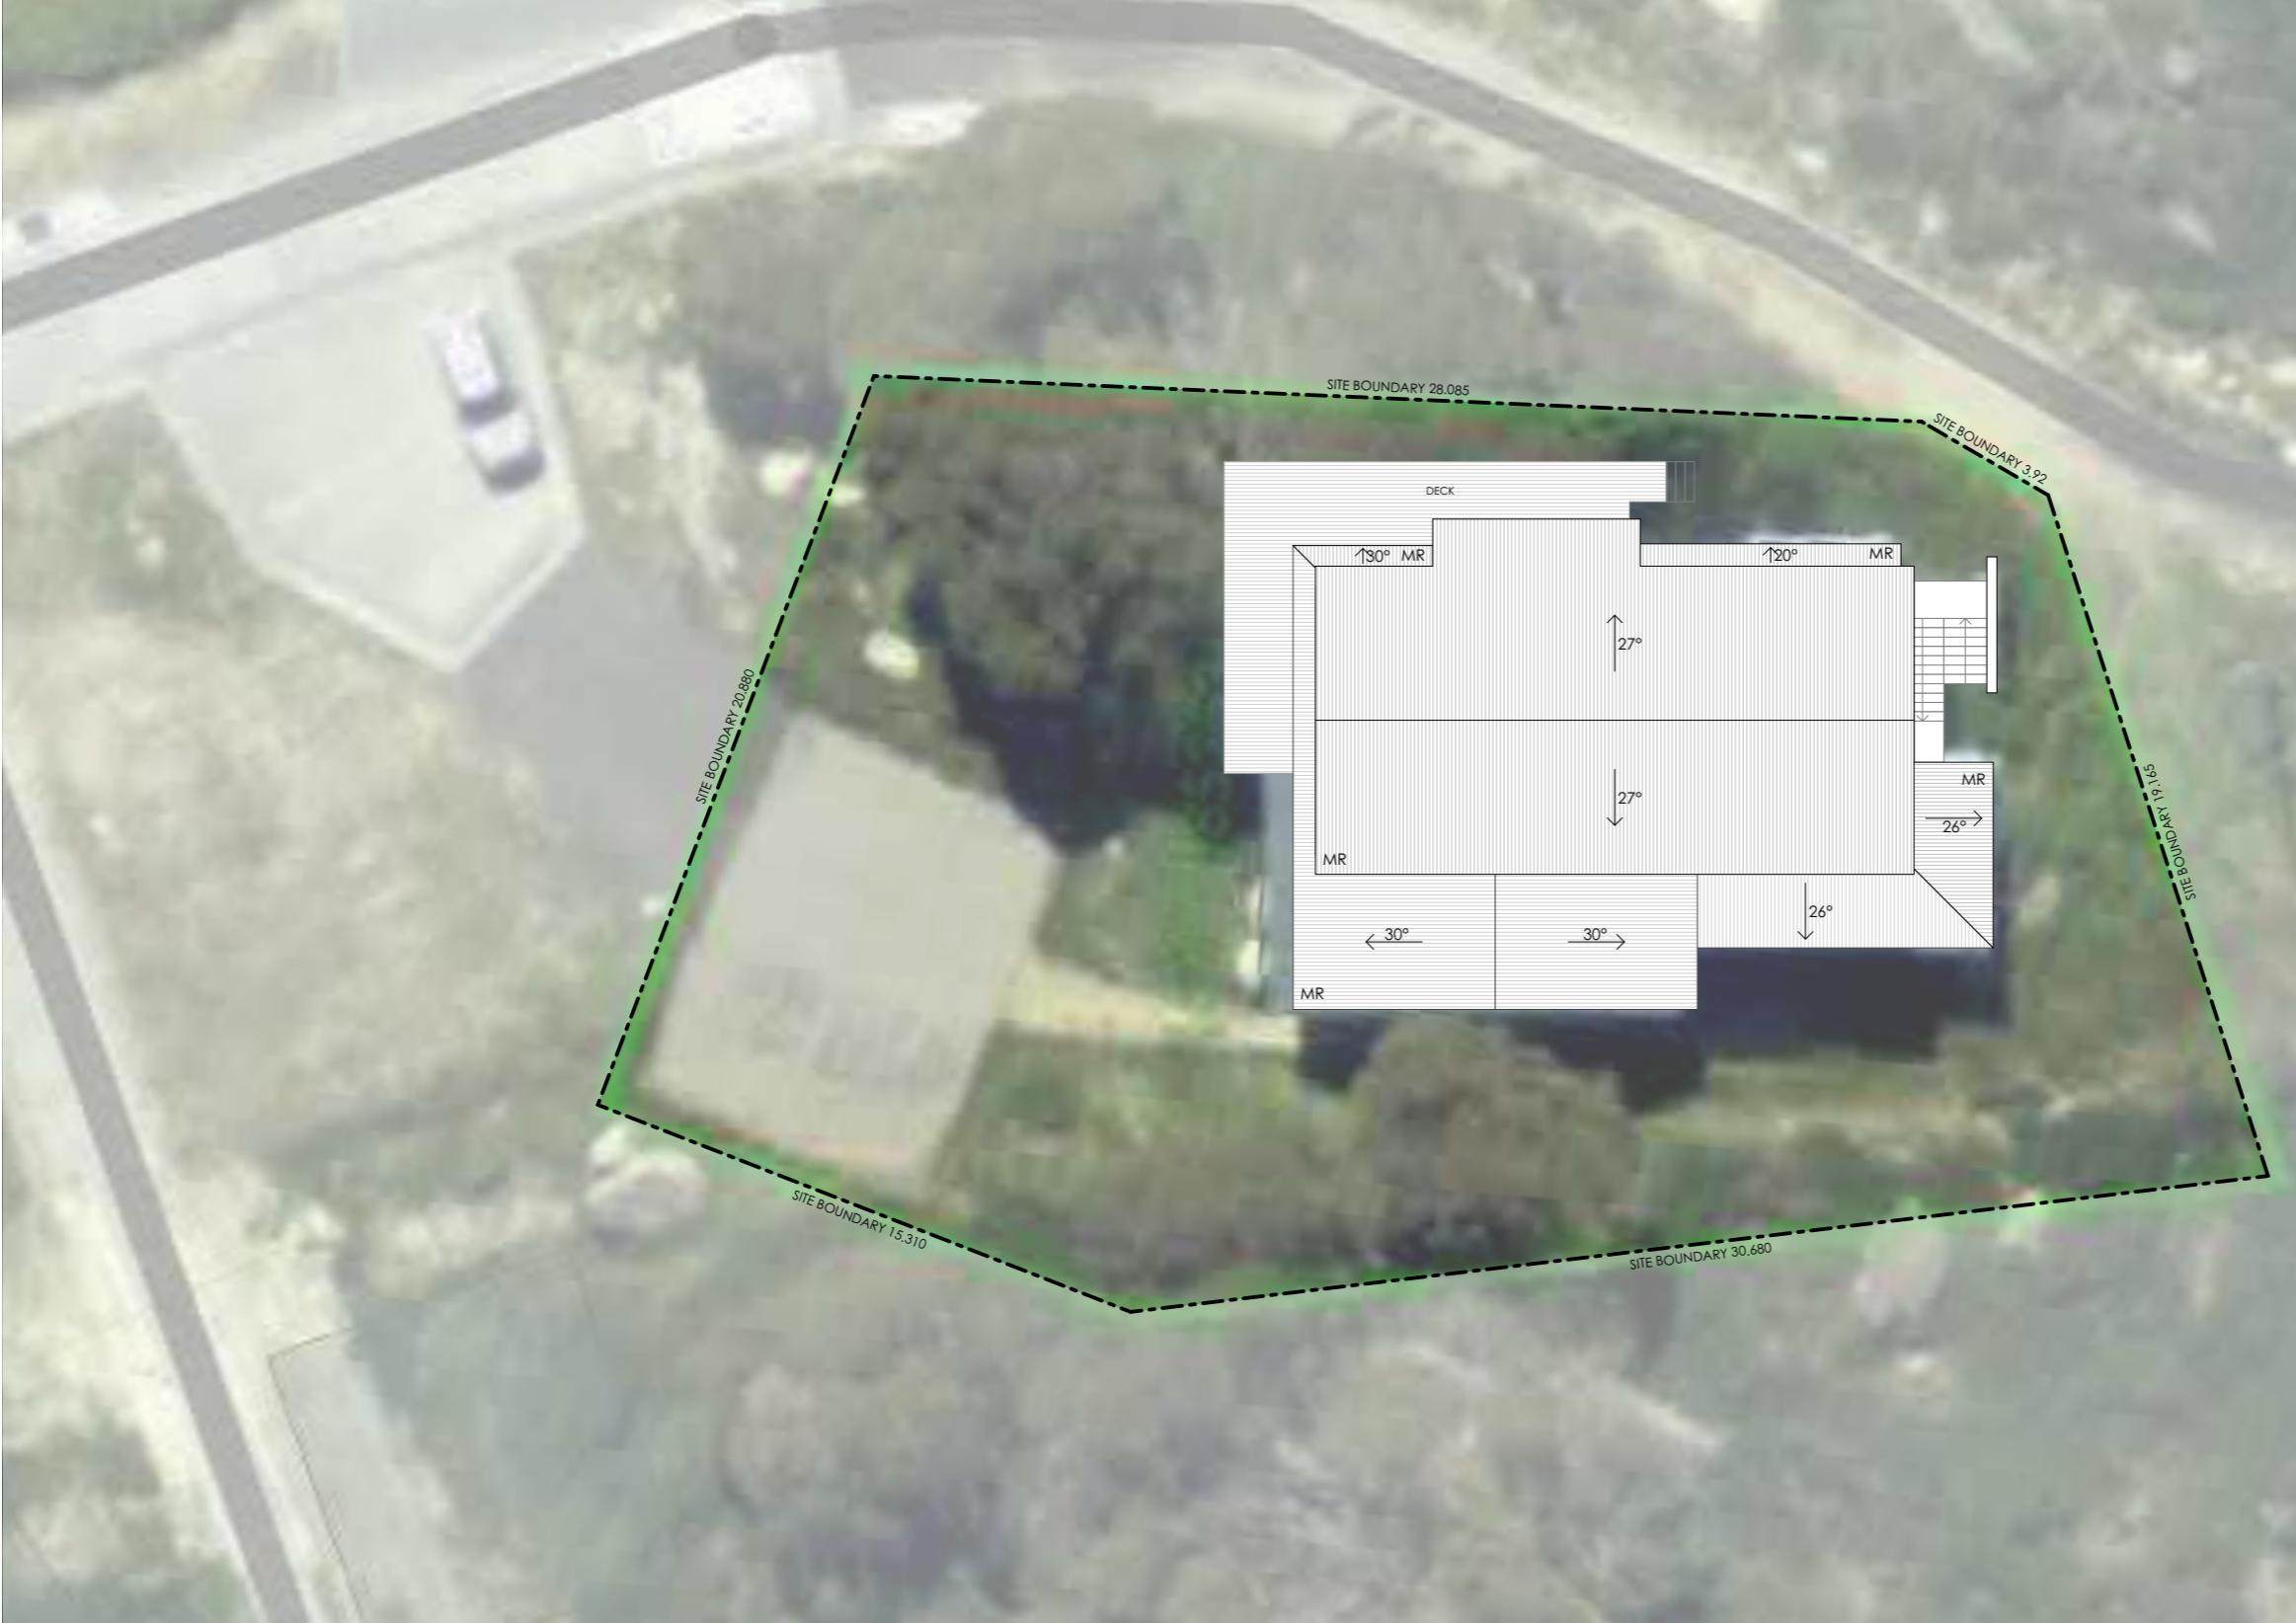
SITE PLAN 1:200

KEY CODE FINISH MR Replac Replace existing roof with Colorbond metal roof sheeting, gutters + downpipes, colour to match existing

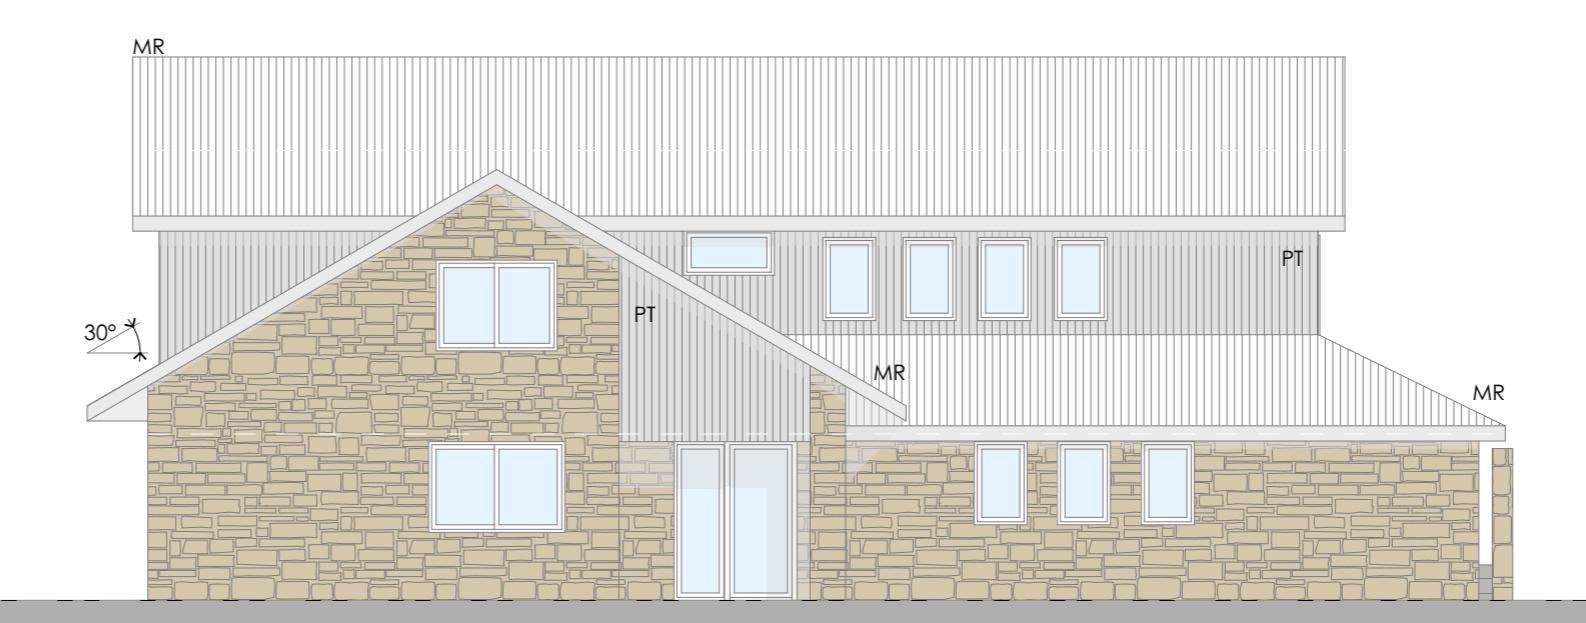
WEST ELEVATION 1:100

MR Replace roof with Custom Orb - Shale Grey, replace metal gutters + downpipes, repair eaves, colour to match existing

ΡT Painting exterior surfaces - colour to match existing

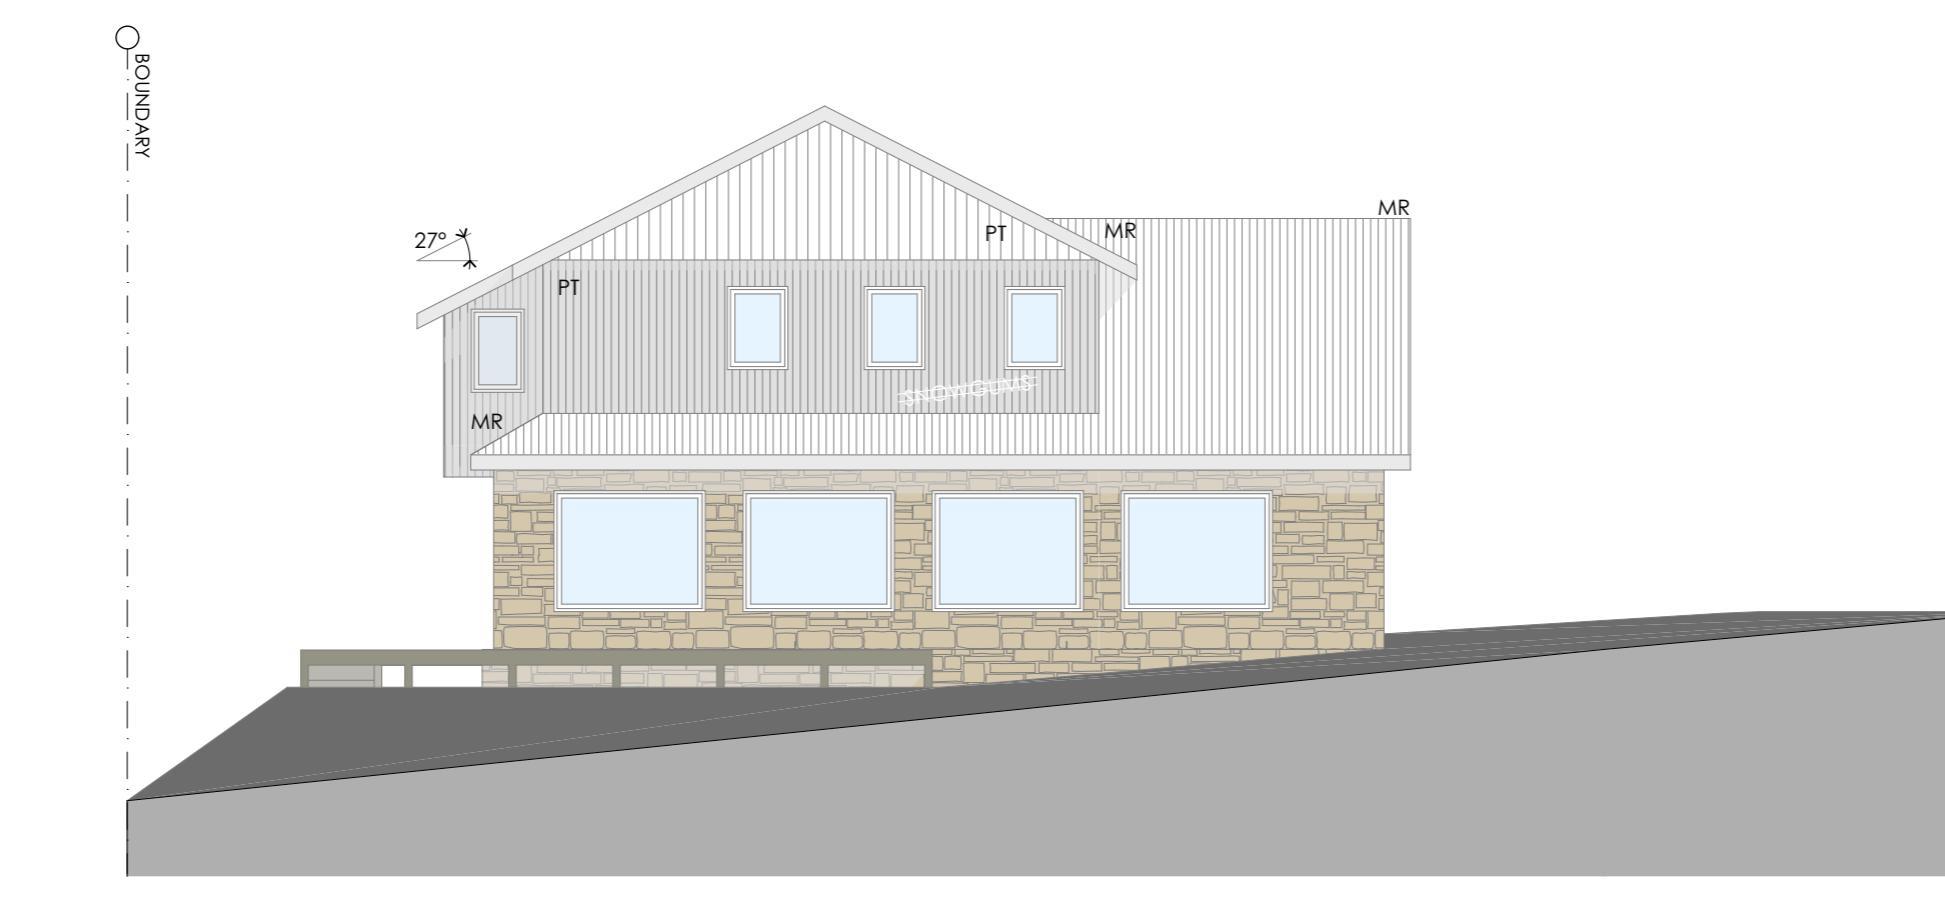
NORTH ELEVATION 1:100

MR Replace roof with Custom Orb - Shale Grey, replace metal gutters + downpipes, repair eaves, colour to match existing

ΡT Painting exterior surfaces - colour to match existing

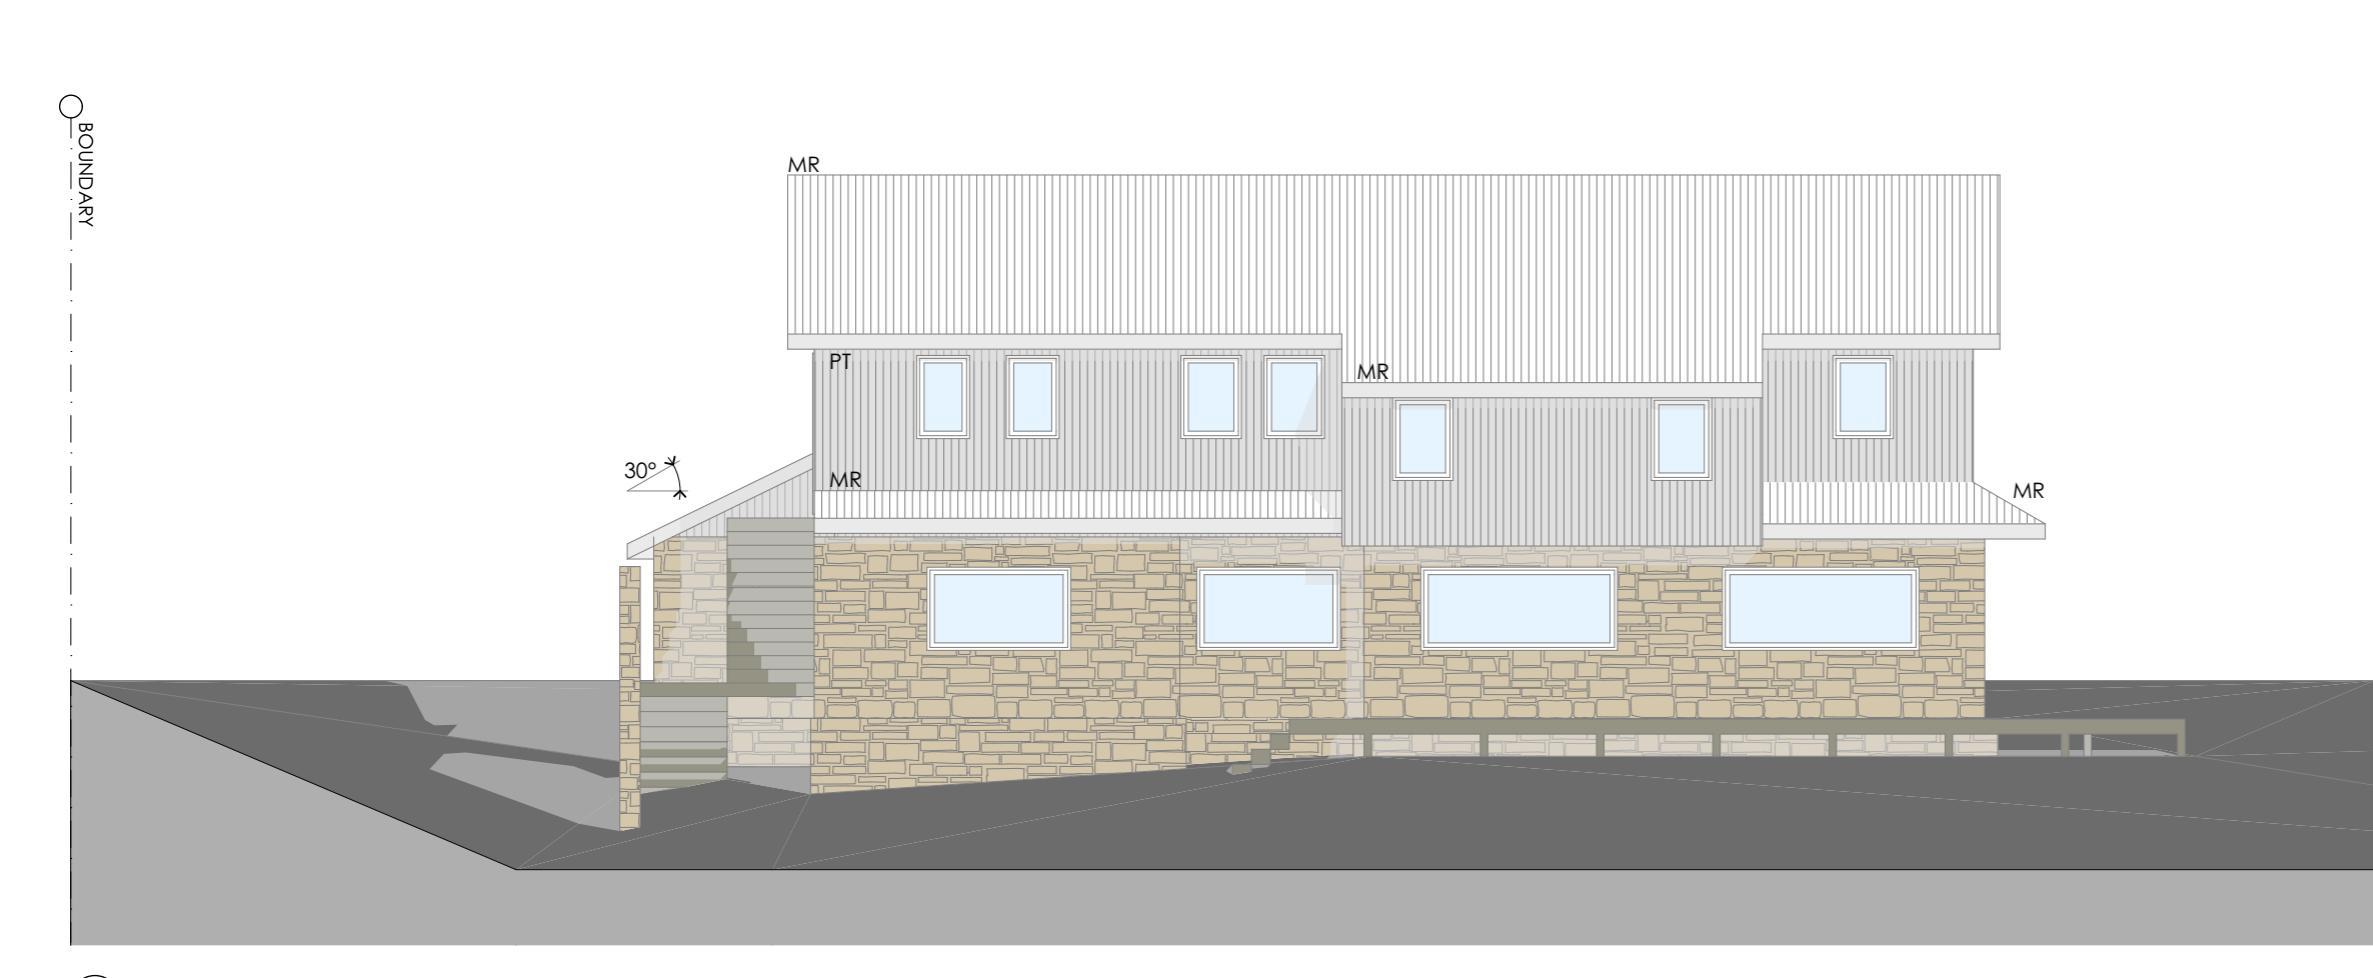
EAST ELEVATION 1:100

MR Replace roof with Custom Orb - Shale Grey, replace metal gutters + downpipes, repair eaves, colour to match existing

ΡT Painting exterior surfaces - colour to match existing
