Arboricultural Impact Assessment Report

83 Tempe St, Greenacre NSW 2190

Built Wise Projects Prepared by Rameh Zaoud AQF Level 5 Consulting Arborist 09th of February 2025 Version 1 of 1

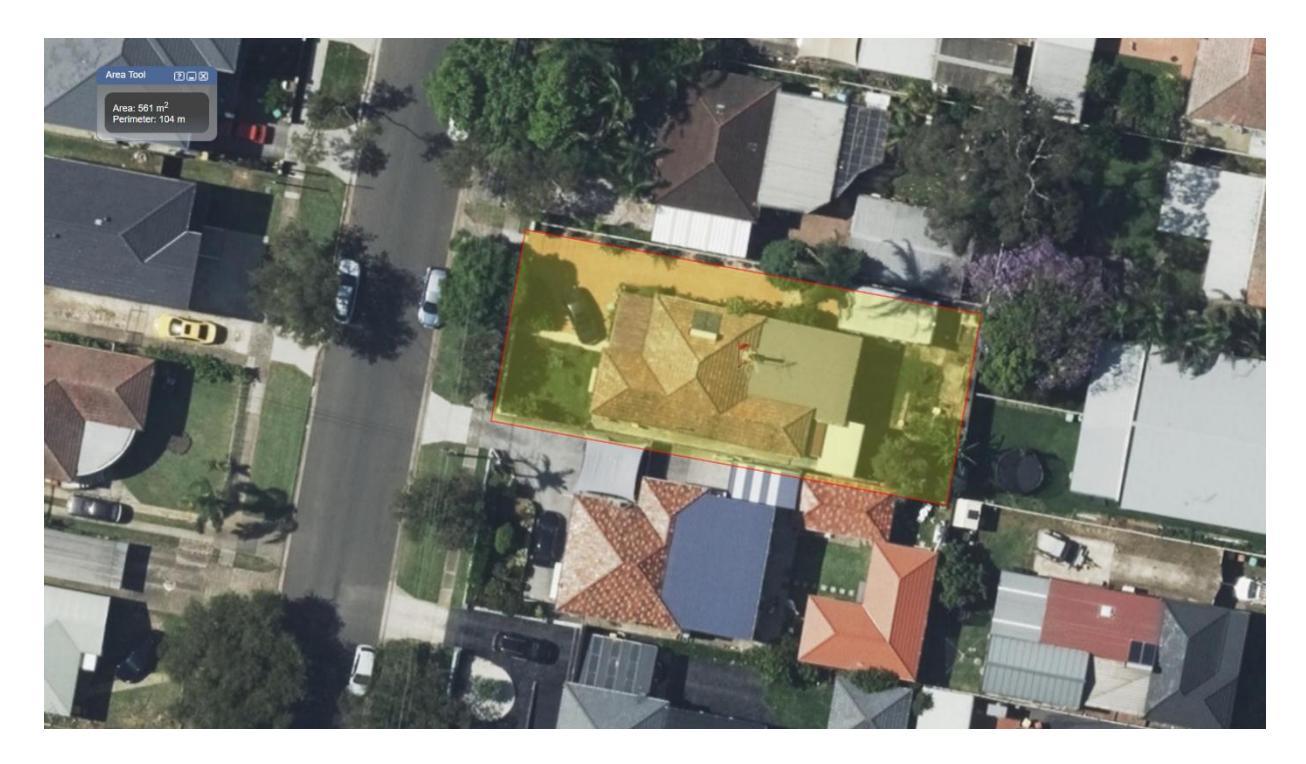
Figure 1 - Aerial view of subject site (source: SIX Maps)

The subject site is a residential dwelling known as 83 Tempe St, Greenacre NSW 2190. The subject site is approximately 561m2 in land size. The site land is zoned category R4: High Density Residential pursuant to the *Canterbury-Bankstown Local Environmental Plan 2023 (pub. 23-6-2023)* and is legally defined as Lot 154/4 in Deposited Plan 845.

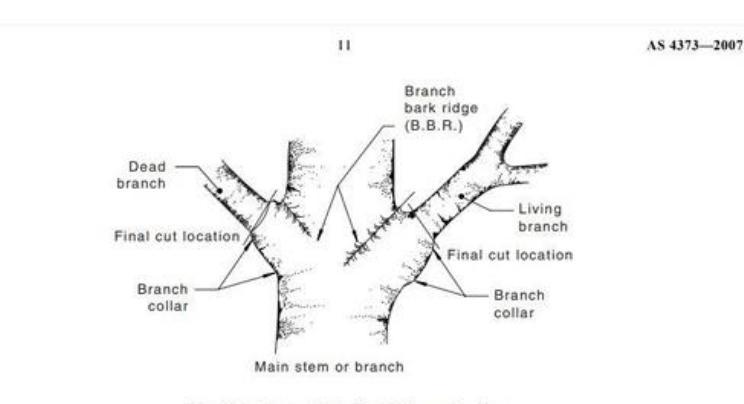
(a) Up to but not including the branch collar

NOTE: When removing dead wood from a tree, make the final cut as close to the branch collar as possible. Do not damage living tissue. The branch collar is the best guide for the final cut when removing a living branch. However, if there is no branch collar use the branch bark ridge as depicted in Figure 1(b).

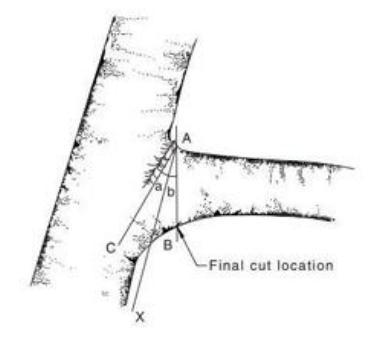
(b) In the absence of a collar using the branch bark ridge

NOTE: On living branches where the branch collar cannot be located, the branch bark ridge can be used as a guide. Line A-X is a line parallel to the stem or trunk occurring just outside the branch bark ridge. Line A-C indicates the angle of the branch bark ridge and Line A-B represents the angle and location of the final cut. Angle 'a' should equal angle 'b'.

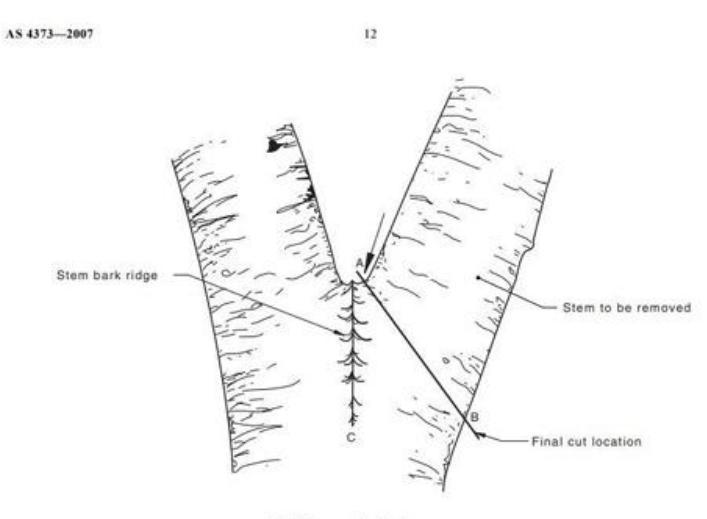
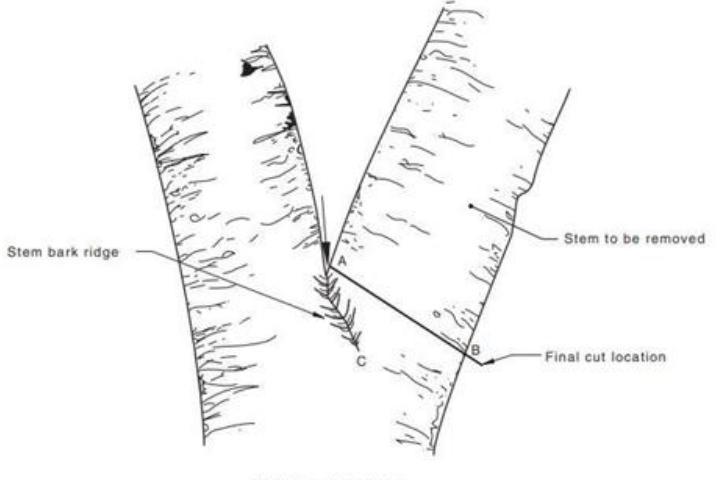
(a) With extruded bark

(b) With included bark

NOTE: Line A-B represents the angle and location of the final cut, point C the bottom of the stern bark ridge. Point B is opposite Point C and represents the bottom of the final cut. These figures are a guide only (see Clause 5.4(c)).
