Doc No: Perisher Front Valley SEMP Revision 1 Date: 17 February 2025

PROJECT: Proposed Indara Telecommunications Facility at Perisher Front Valley

1.1 Purpose of this Site Environmental Management Plan (SEMP)

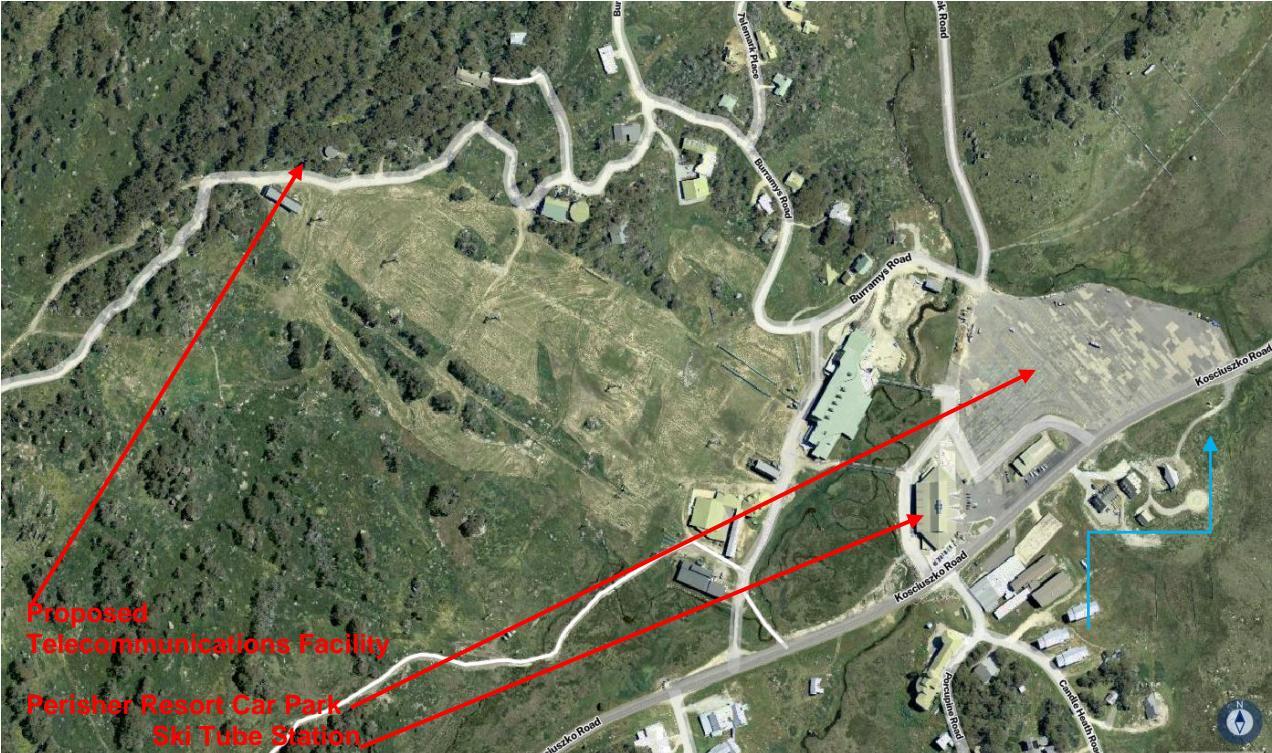
Figure 1: Aerial image showing location of proposed Telecommunications Facility (NSW Six Maps)

The proposal is install a new telecommunications facility for the Telstra mobile phone network. It predominantly consists of a new 20m high monopole, a new telecommunications equipment shelter on a raised platform, antennas, cabling and associated telecommunications infrastructure. Please see **Figure 1** below for the proposed location of the proposed telecommunications infrastructure and refer to **Figure 2** below demonstrating the proposed location of the new telecommunications facility at a smaller scale.

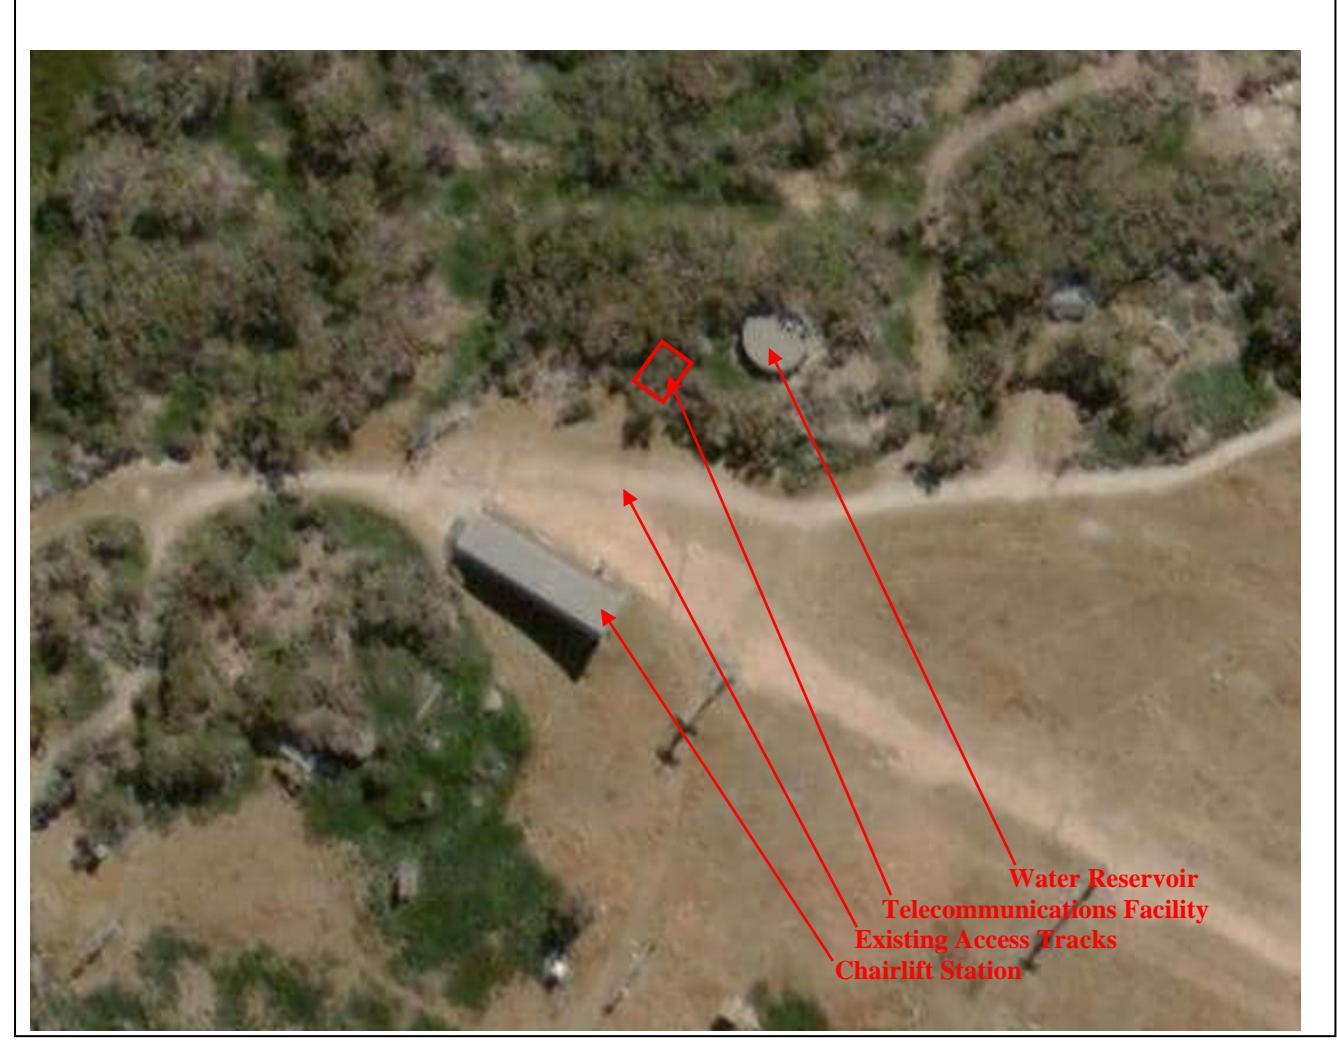
Figure 2: Indicative location for Indara Telecommunications Facility at Mt Selwyn

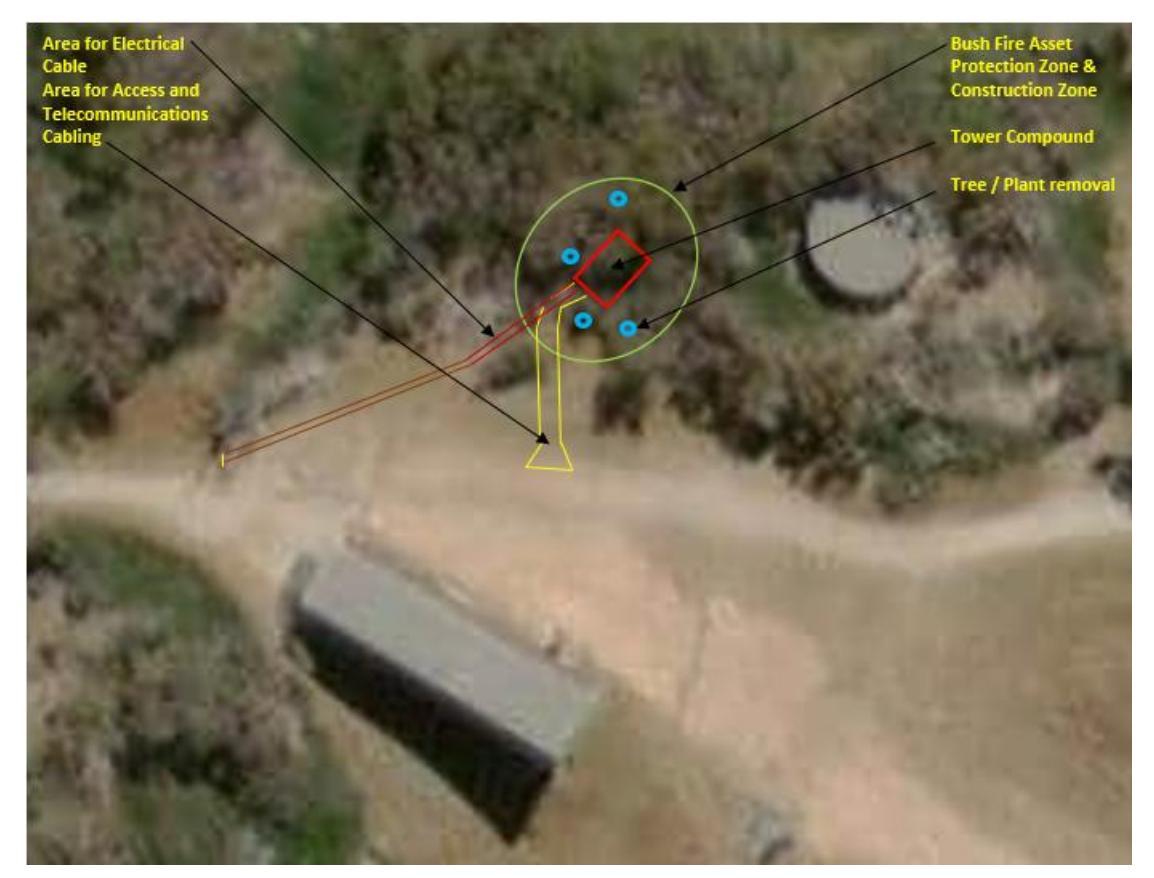
Figure 3: Construction Zones for the Telecommunications Facility at Mt Selwyn

A construction zone will be established prior to works commencing showing the areas where construction activities can occur on a temporary basis and where the infrastructure will be located. This will include areas for material and machinery storage. Erosion and sedimentation controls will be established prior to works commencing and they will remain in place for the entirety of the works. Please refer to the plan below in Figure 3.

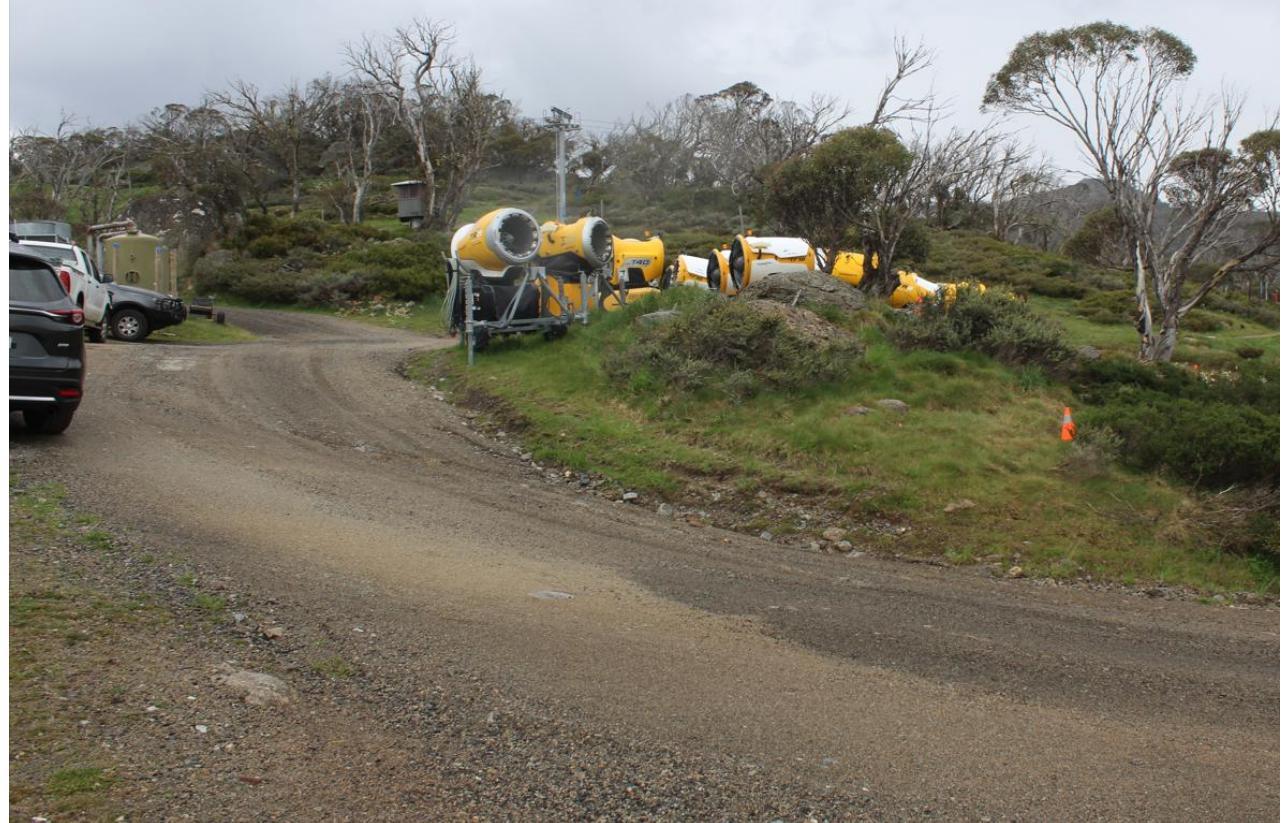
Figure 5: Existing Vehicle Access Track off the Perisher Car Park to the Village 8 Express Chairlift Station that wil be used to get to Telecommunications facility.

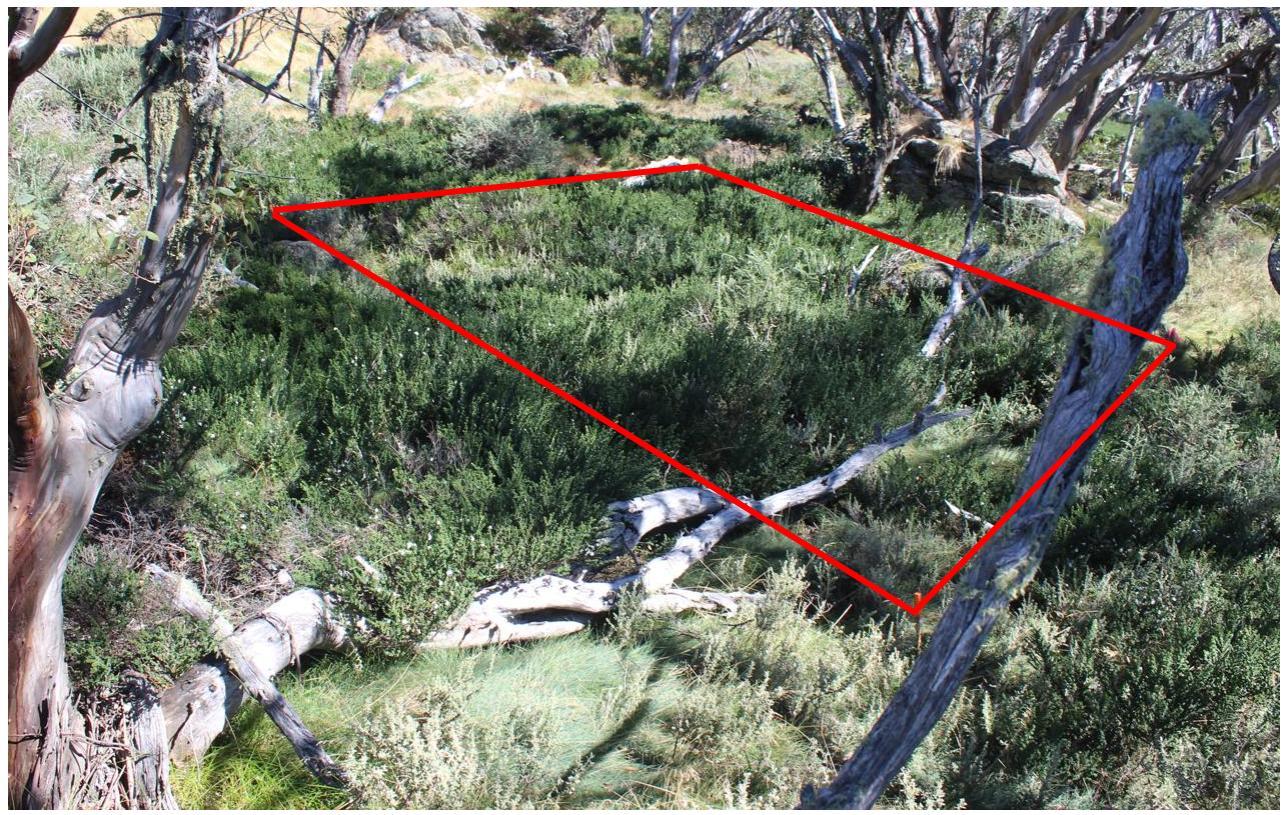
Figure 6 : Photo showing indicative location of compound for telecommunications facility

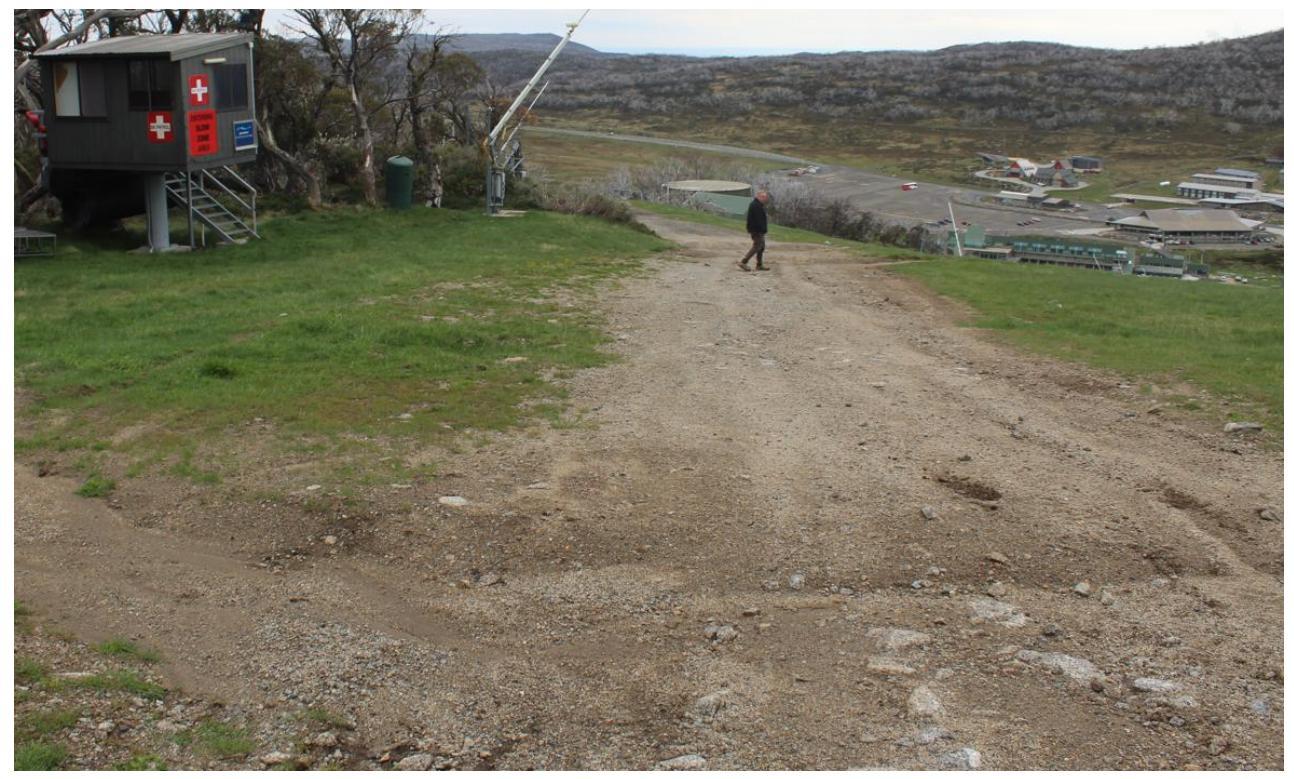
Figure 7 : Photo showing existing access track to compound for telecommunications facility
