# ARBORICULTURAL IMPACT ASSESSMENT

# 330 EDGAR STREET CONDELL PARK 2200 (REVISION 1)

Prepared for: Sprint (Aust) Pty Ltd

10/11/2024

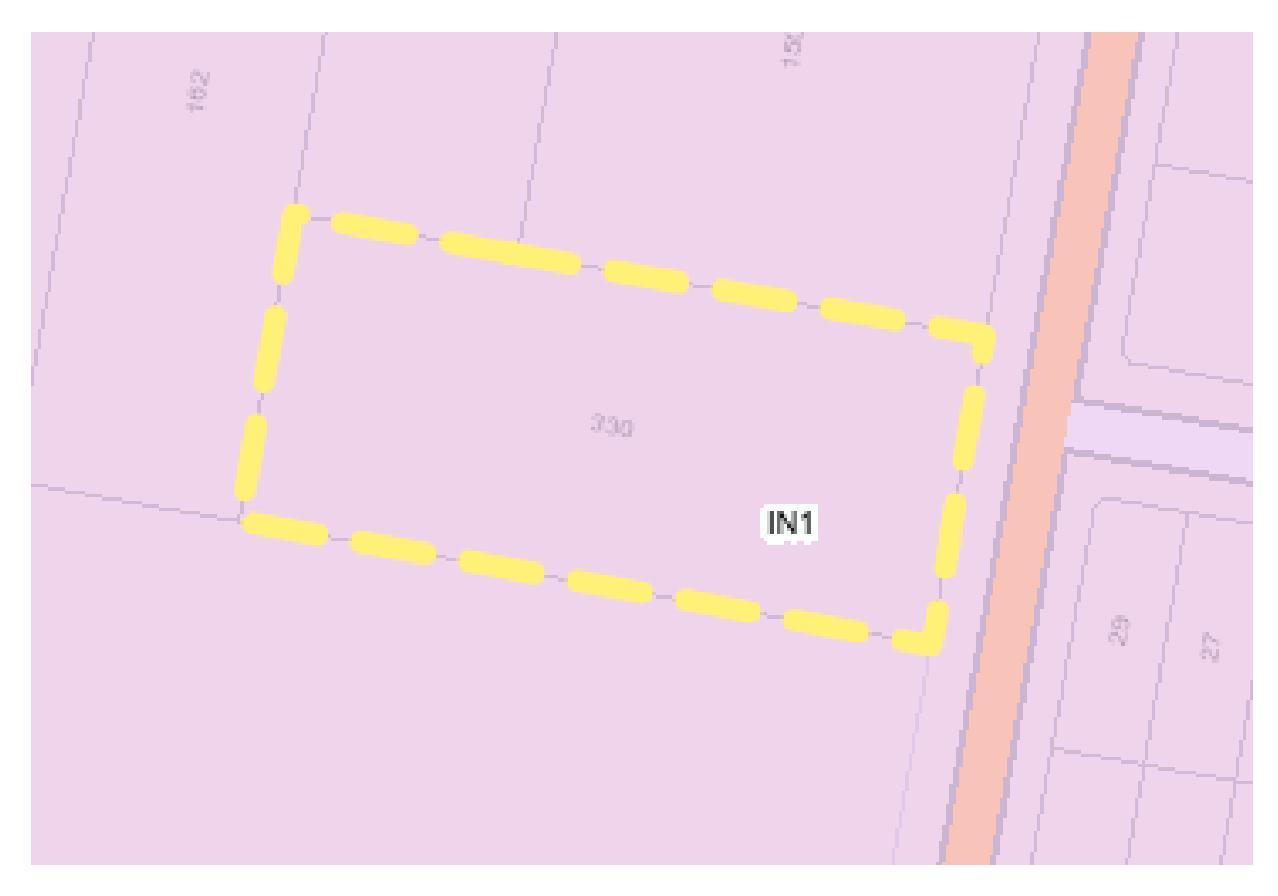
Figure 2: The subject site border by dotted yellow lines (NSW Planning Portal 2019).

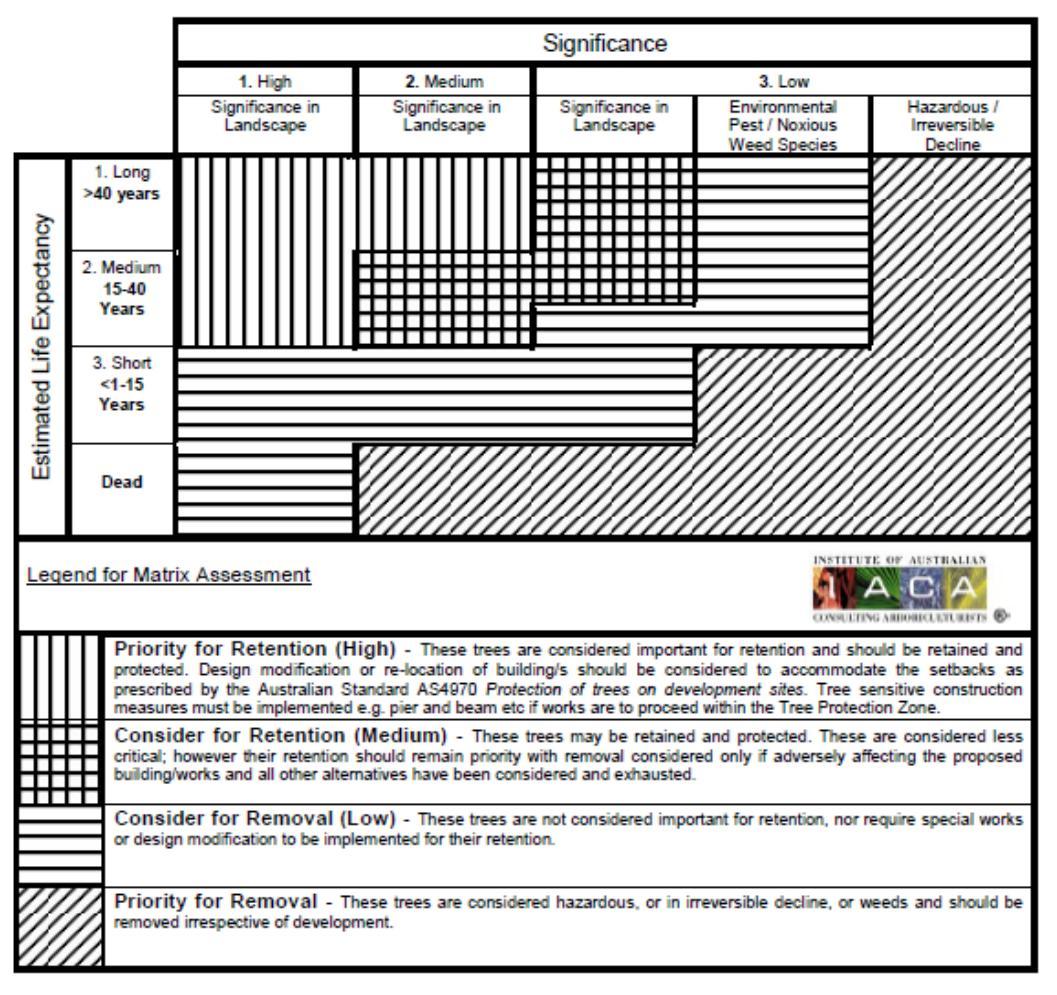
#### Table 1.0 Tree Retention Value - Priority Matrix.

This rating system will assist in the planning processes for proposed works, above and below ground where trees are to be retained on or adjacent a development site. The system uses a scale of *High*, *Medium* and *Low* significance in the landscape. Once the landscape significance of an individual tree has been defined, the retention value can be determined. An example of its use in an Arboricultural report is shown as Appendix A.

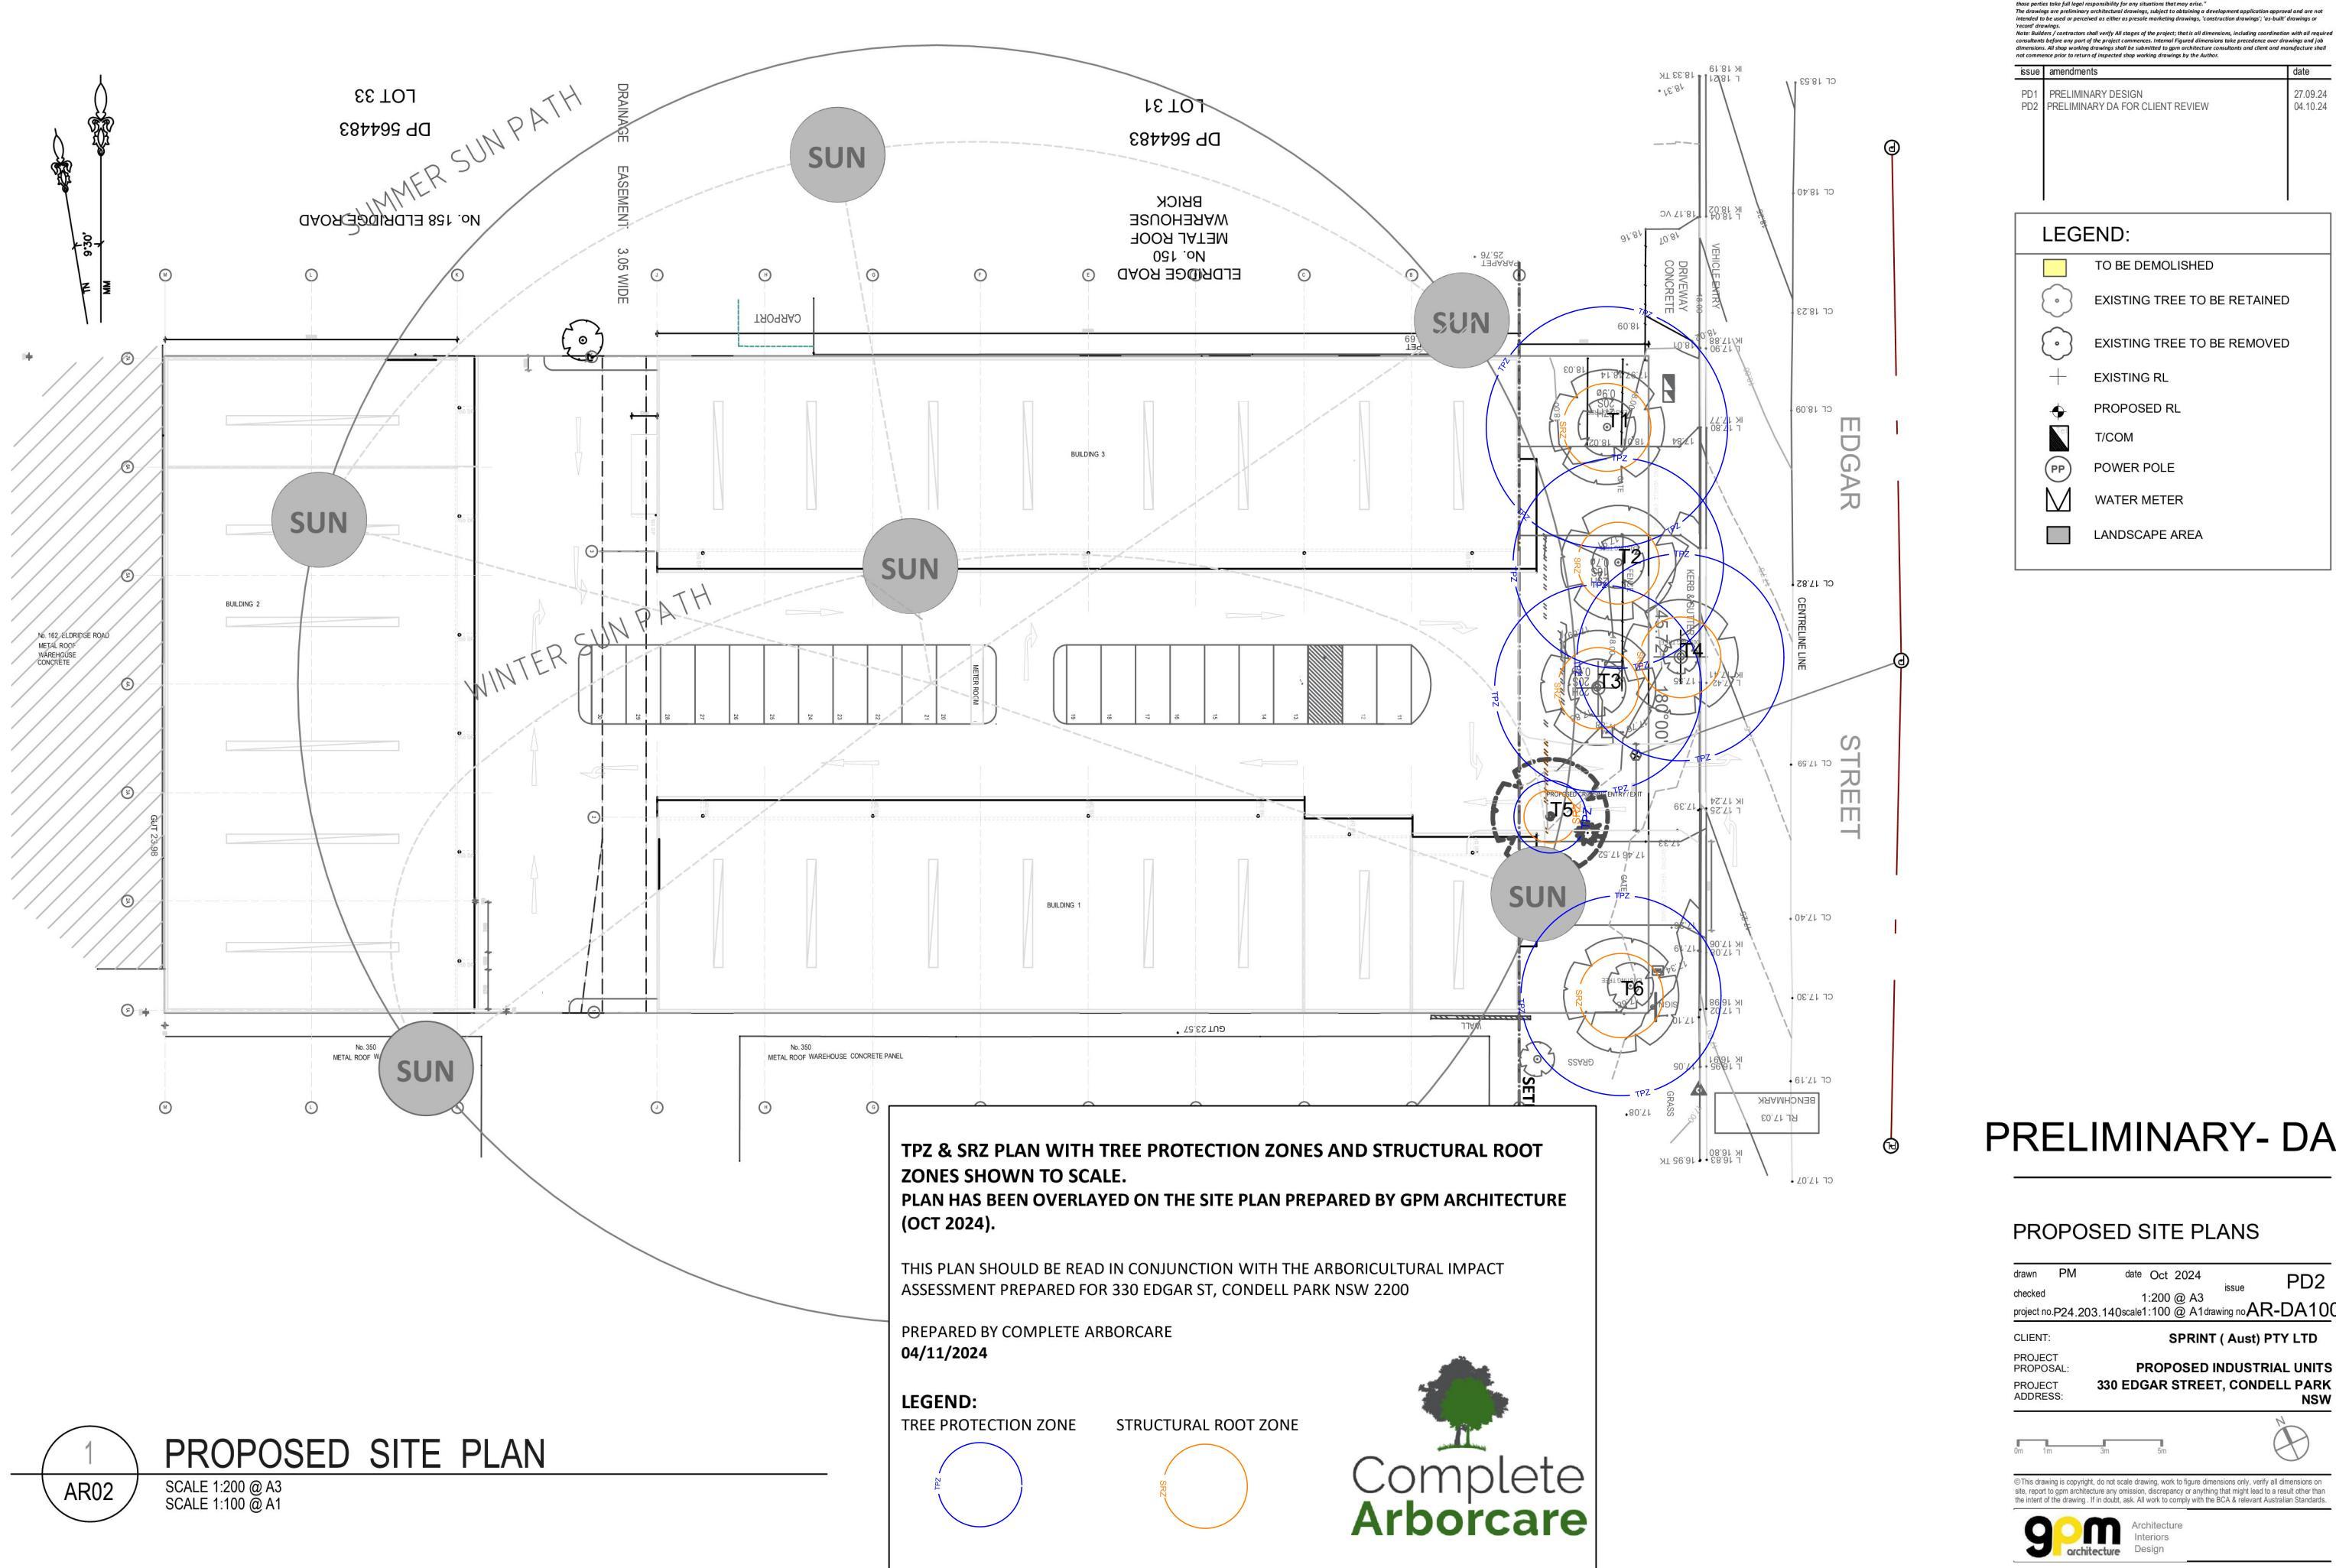
Tree No.	Proposed encroachment into TPZ and/or canopy	Likely Impacts from the proposed construction (Discussion)
1,2,4 & 6	Minor <10% TPZ encroachments. No canopy encroachments.	It has concluded that no long-term tree impact will occur from the completed works.
3	A major TPZ encroachment of 15-20%. No canopy encroachment.	Possible loss of non-woody & woody roots, resulting in a reduced ability to uptake water/air & potentially compromising tree health.
5	A major 100% TPZ encroachment.	Tree death.

- 9.1 To allow for the proposed development to be undertaken, tree **T5** must be removed (subject to council approval).
- 9.2 To determine possible impact upon tree T3, non-destructive root investigation will be required under project arborist guidance to confirm impacts from the proposed crossover entry exit. If roots are discovered that can be pruned (which are to be ≤50mm Ø) pruning methods must be undertaken in accordance with Section 9 (Root Pruning) of AS 4373-2007.If roots >50mmØ are uncounted, appropriate arboricultural advise will be provided

- 9.4 It is recommended that trees **T1-T4 & T6** have protection fencing installed before any of the proposed works commence. This protection must stay in place until the completion of all works & must be compliant with Section 4.3-4.4 (Protective Fencing & Signs) of AS 4970 (See Appendix C).
