Remediation Action Plan

614-632 High Street, Penrith NSW

E24300.E06_Rev03 18 May 2022

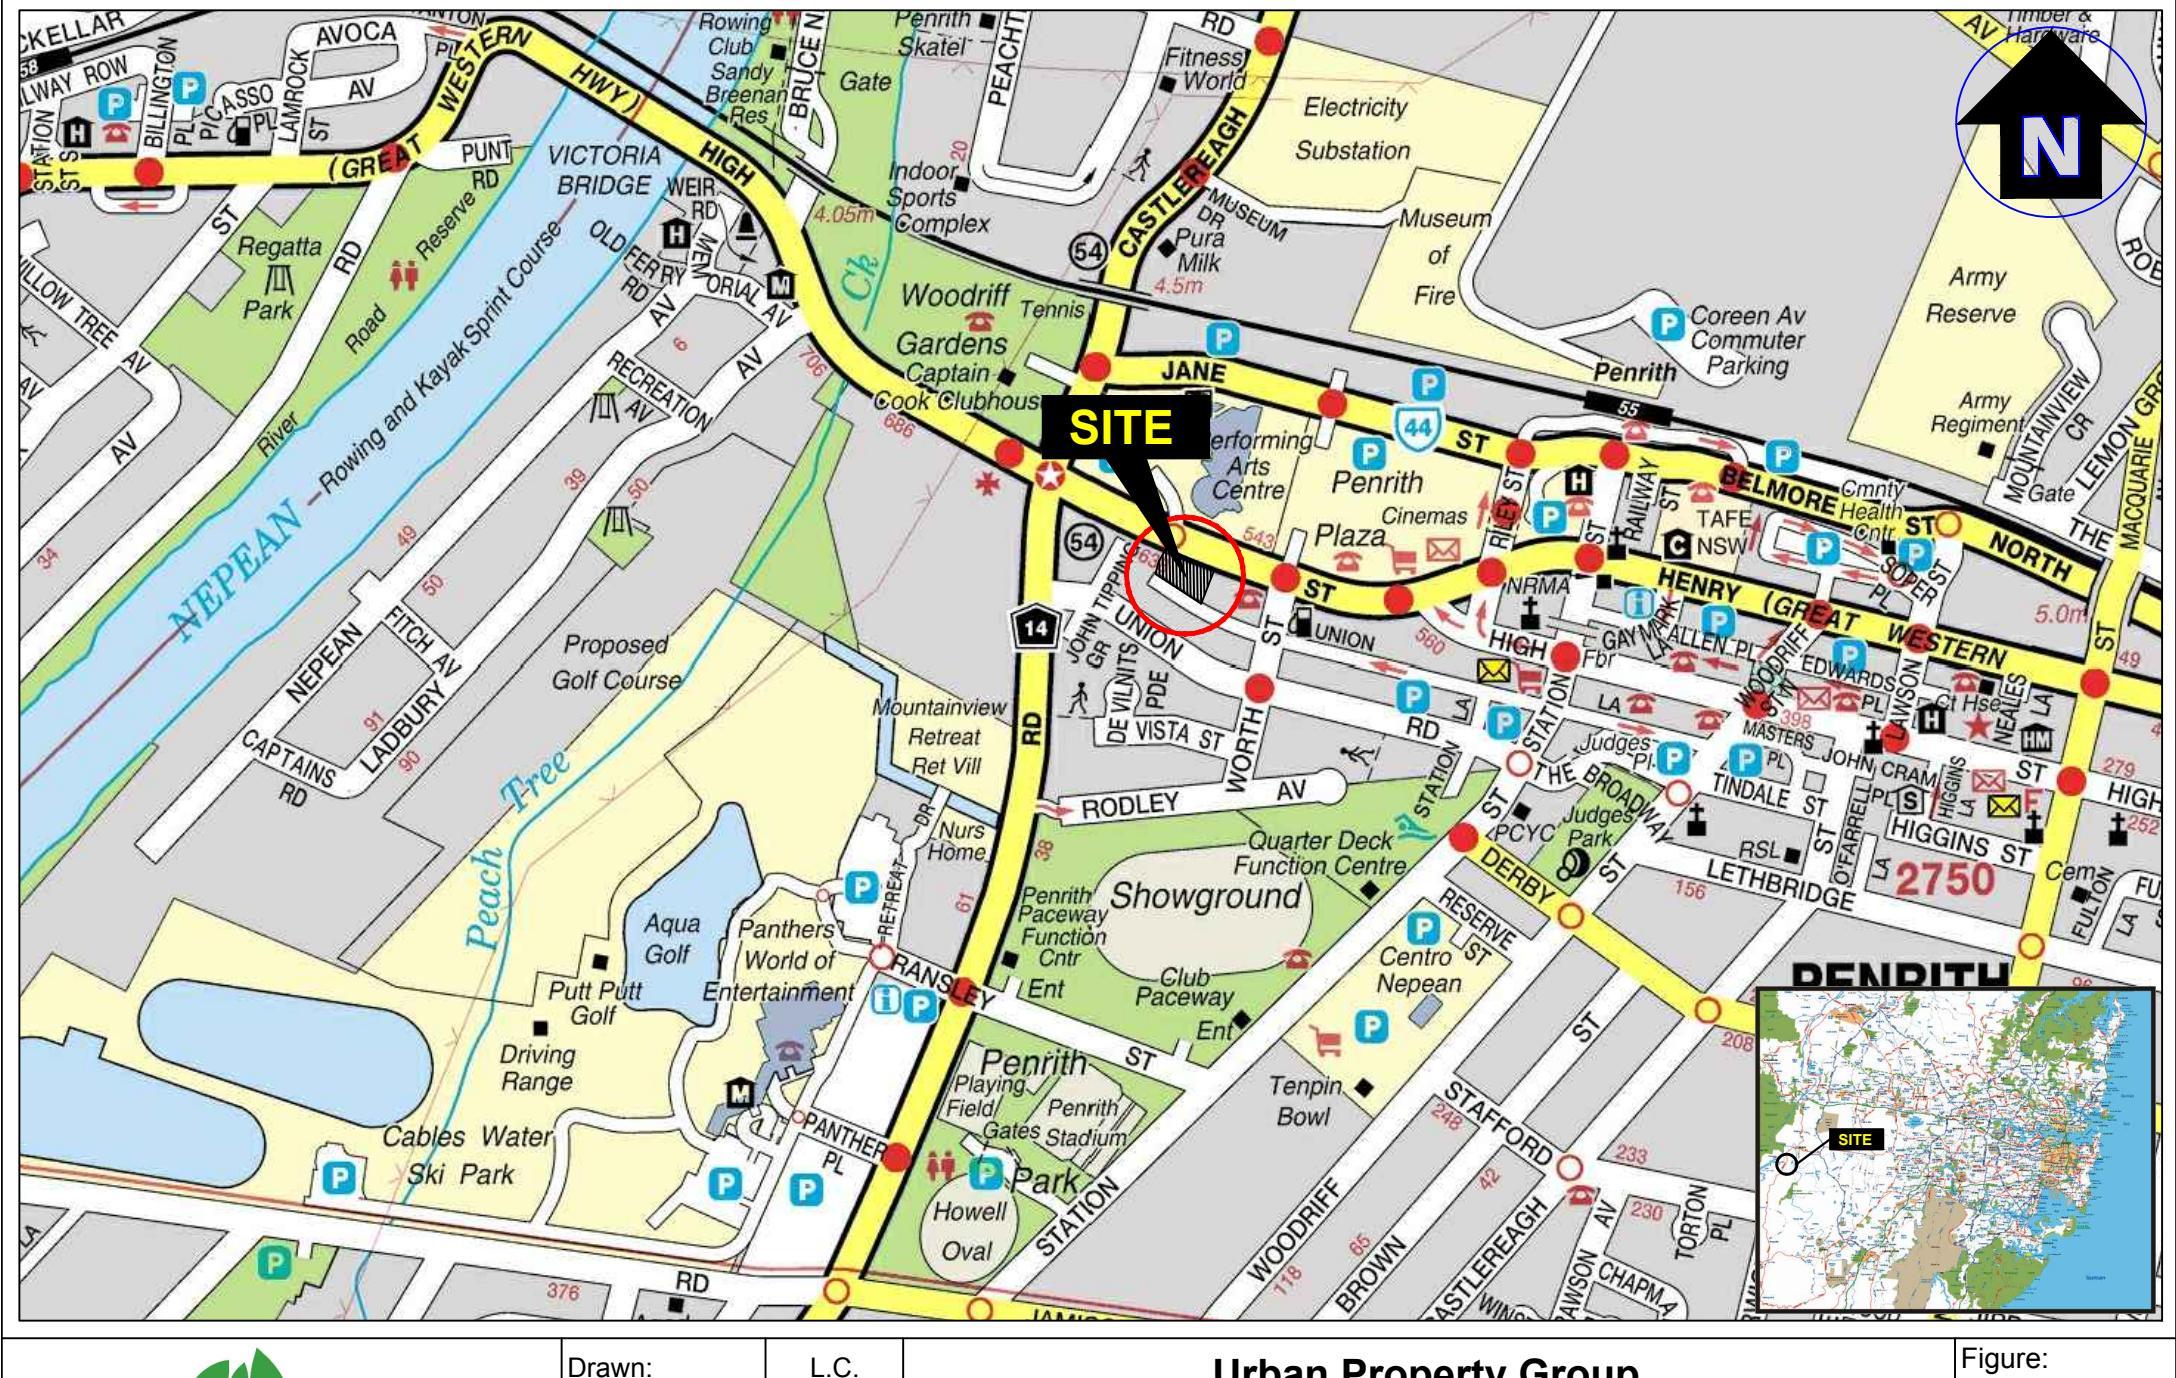
Site Locality Plan

This site is located within the Local Government Area of Penrith City Council (**Appendix A**, **Figure 1**). It comprises Lot 10 in Deposited Plan (DP) 1162271, covering a total area of 4730m², and at the time of drafting this plan was a semi-sealed asphalt parking area with a partially completed display suite in its eastern portion (**Appendix A**, **Figure 2**).
