Re: INTERIM ADVICE LETTER NO. 1 – GREEN SQUARE REMEDIATION ACTION PLAN

Requested by:	Mike Williams on behalf of Landcom			
Request/Commencement date:	26 February 2007			
Auditor:	Graeme Nyland			
Accreditation No .:	9808

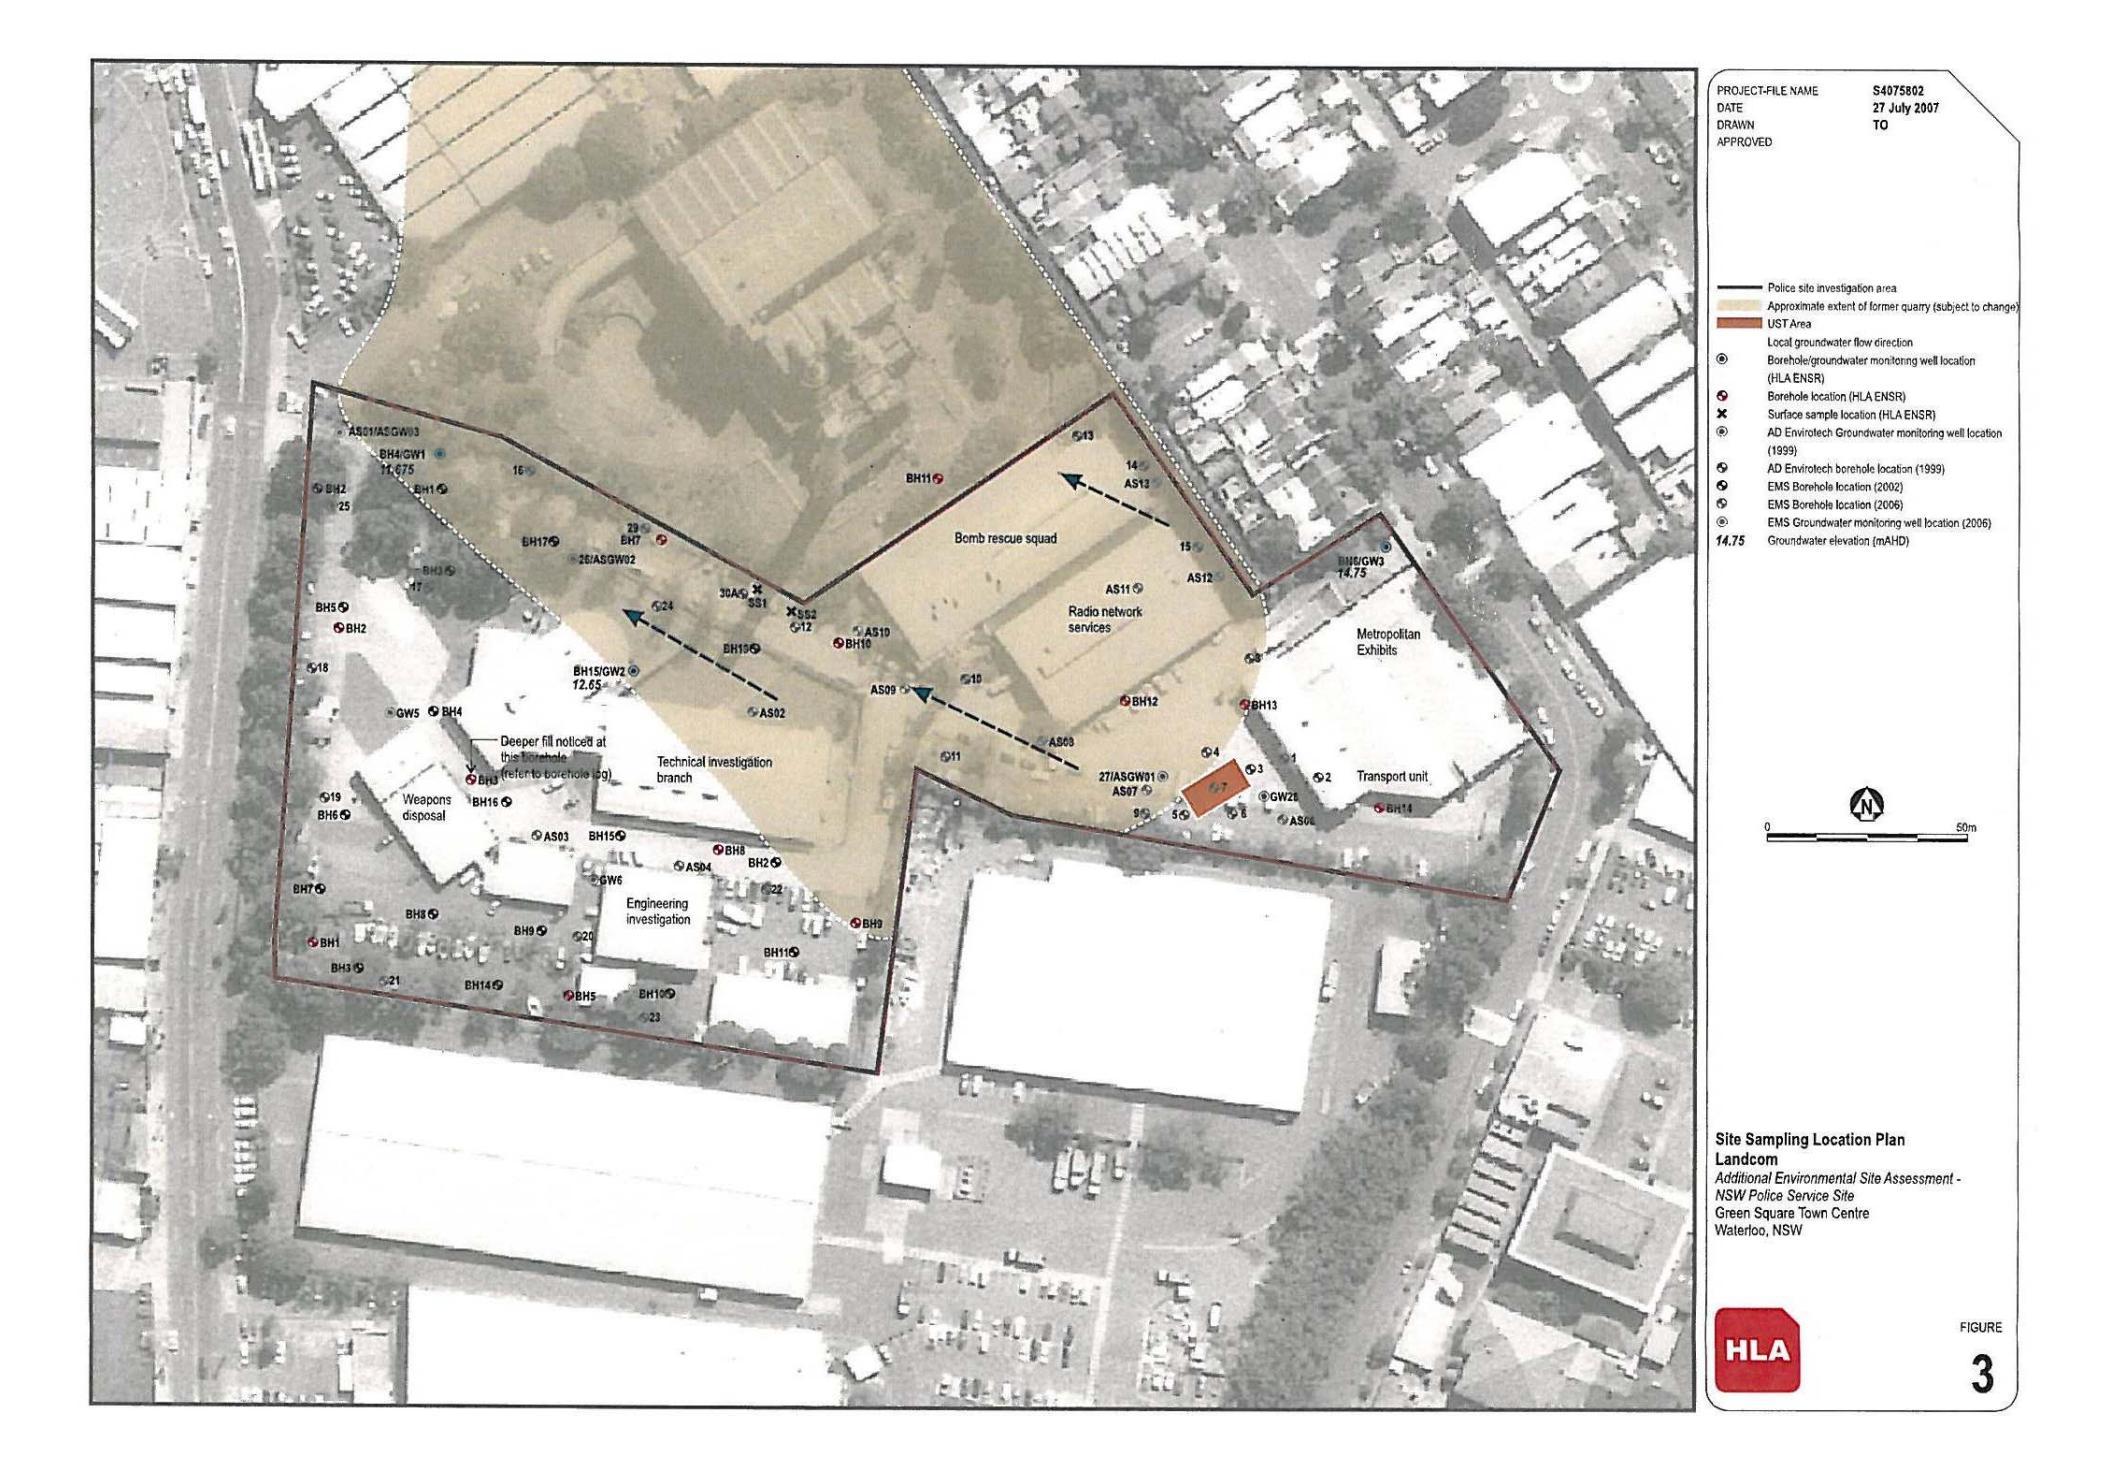
Attachment 1:Police SiteAttachment 2:Incinerator SiteAttachment 3:Bourke Street Council Depot

There were three separate investigations carried out on the three properties incorporating the Green Square Site by HLA (Bourke Street Council Depot, the Former NSW Police Site and the Incinerator Site). Investigation locations are shown on Attachments 1-3.

All results above the criteria were found within the footprint of the former landfill site, except for four locations. Two locations (AS04 and AS06) contained asbestos at 0.2m and 0.6m respectively and two locations (BH3 and BH8) contained organochlorine pesticides both at a depth of 0.2-0.4mbgl.

Where there were suspected UST's (near BH15 and AS03), no TPH and BTEX concentrations were detected. Where there is known UST storage, TPH was detected in small concentrations in AS07, which is located down slope of the UST's.

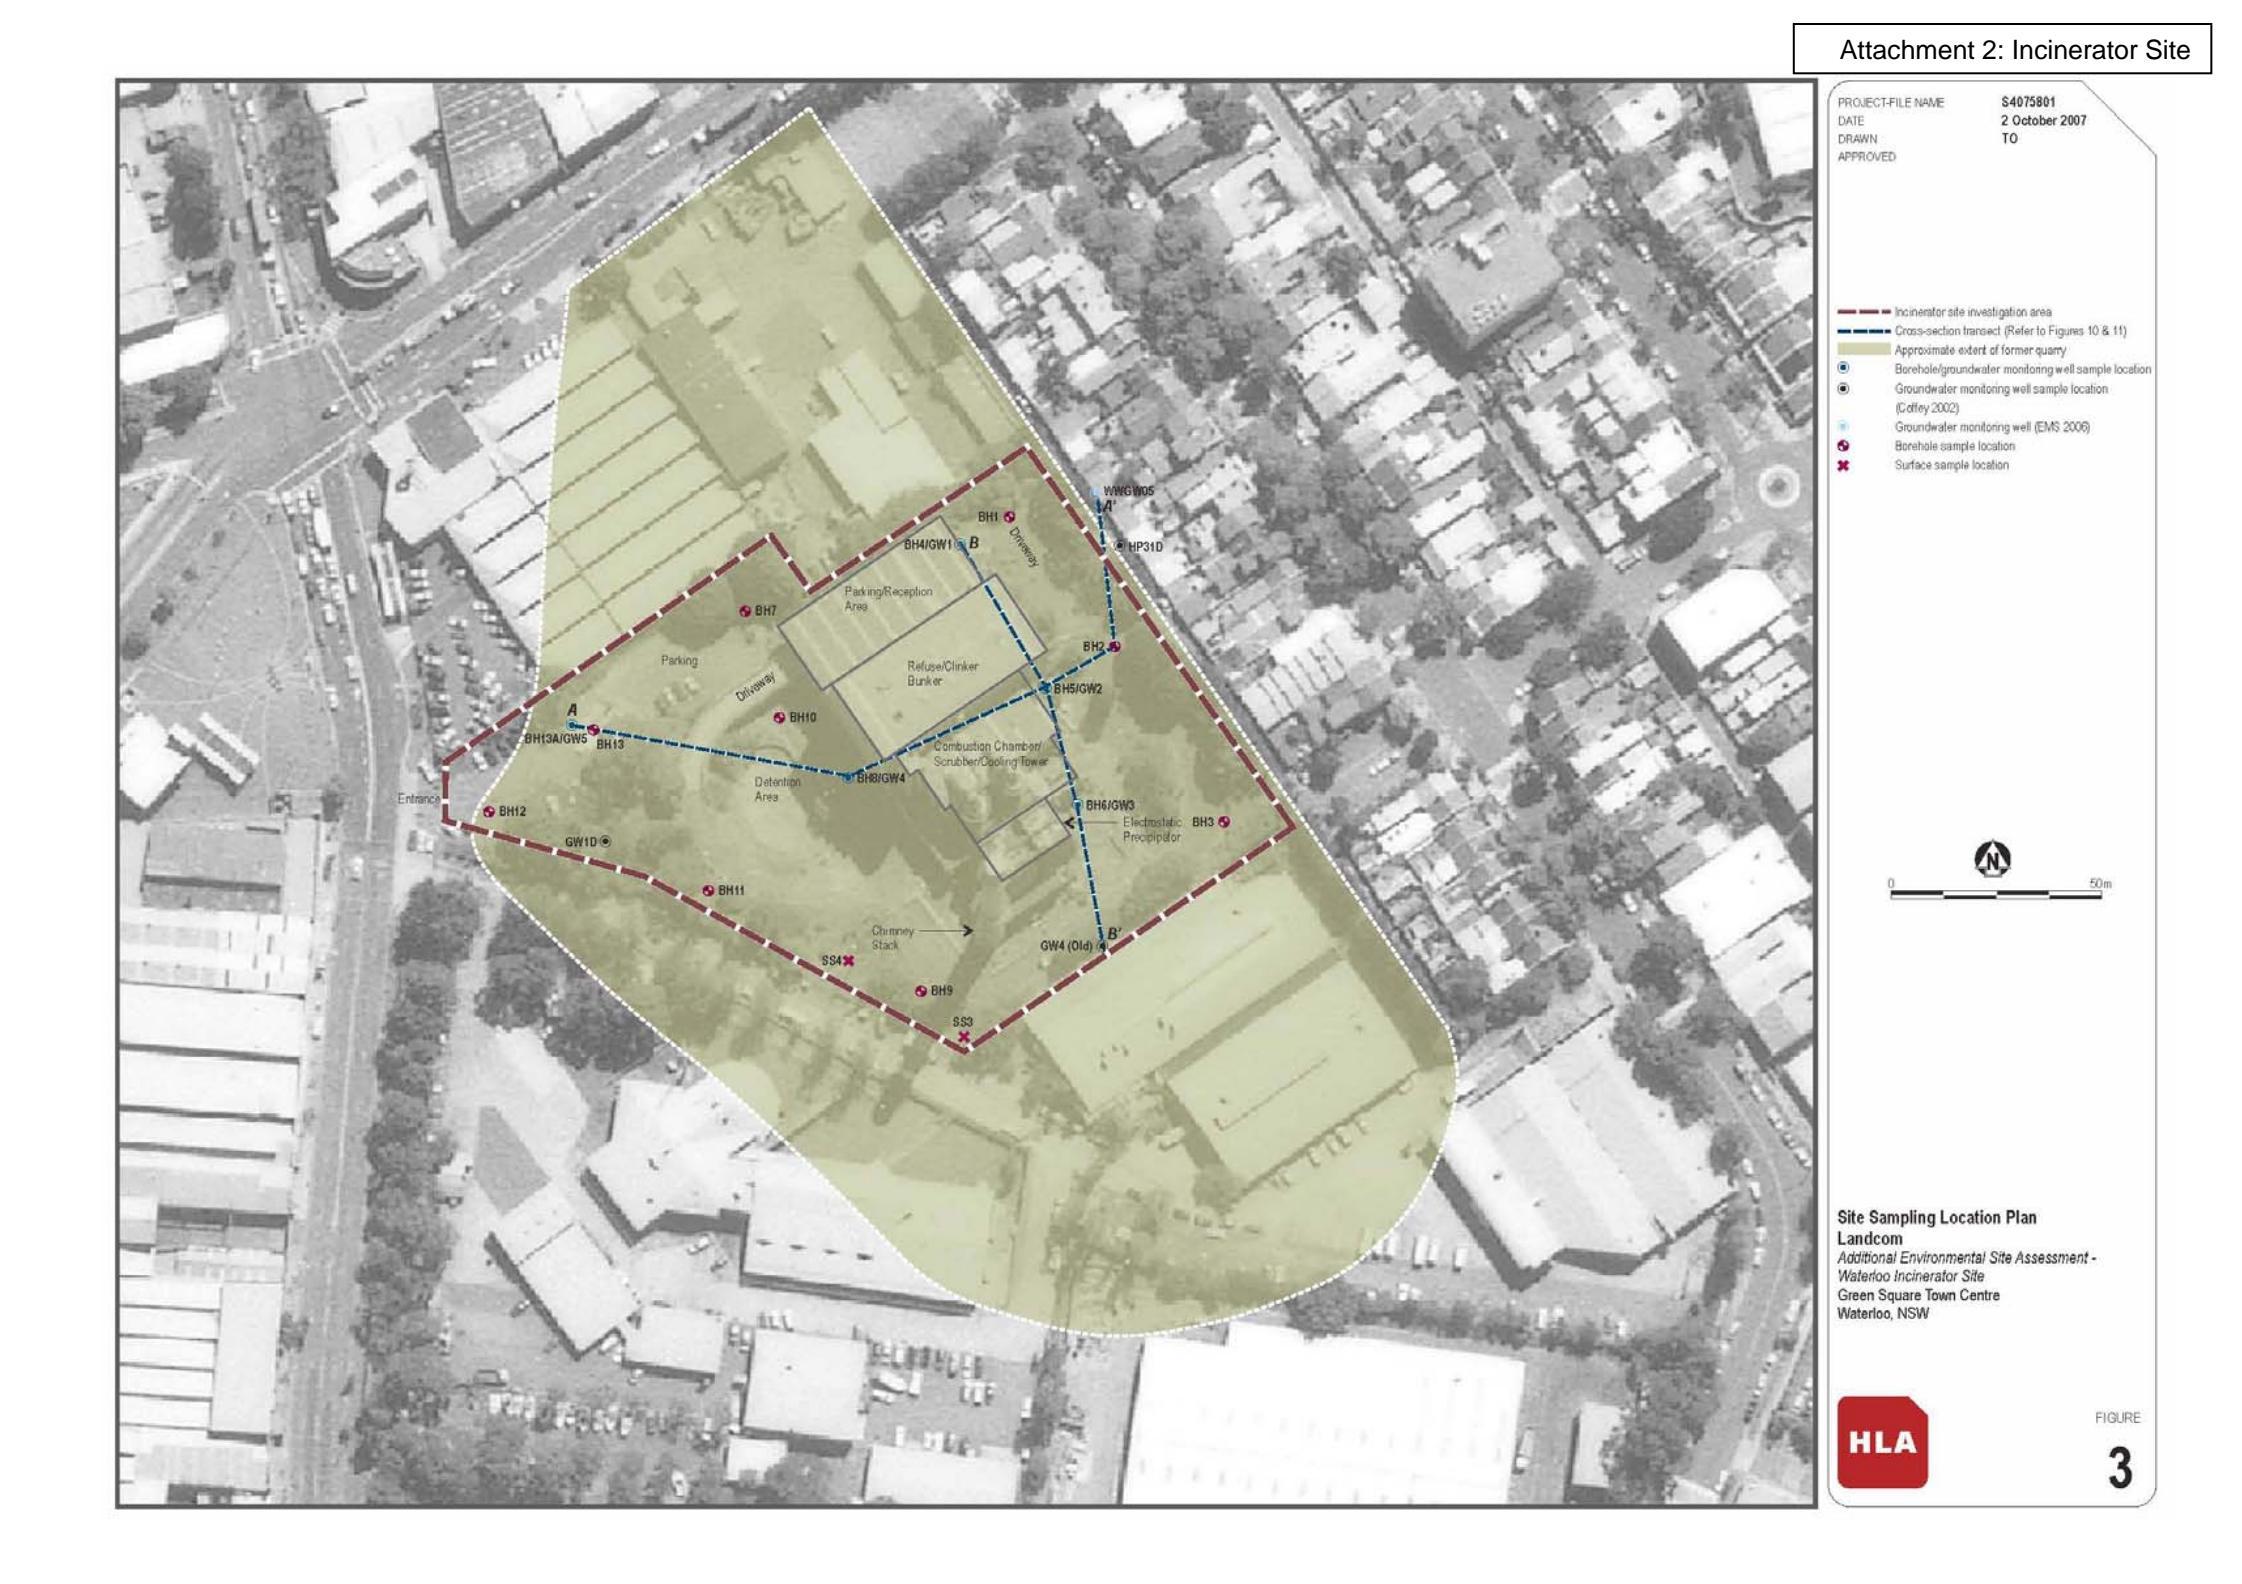
The entire area of the 'Incinerator Site' is covered by the footprint of the former quarry and landfill. There were exceedances in lead, TPH, PAH's and asbestos at a variety of depths, likely to be associated with the previous landfill activities.

Asbestos detected within the landfill material, over the three sites, appears to be randomly distributed. The greatest depth of detection was at 10mbgl (BH4 of the Incinerator Site). The shallowest depth of detection for asbestos was 3mbgl in BH1, which additionally detected asbestos at 9mbgl.

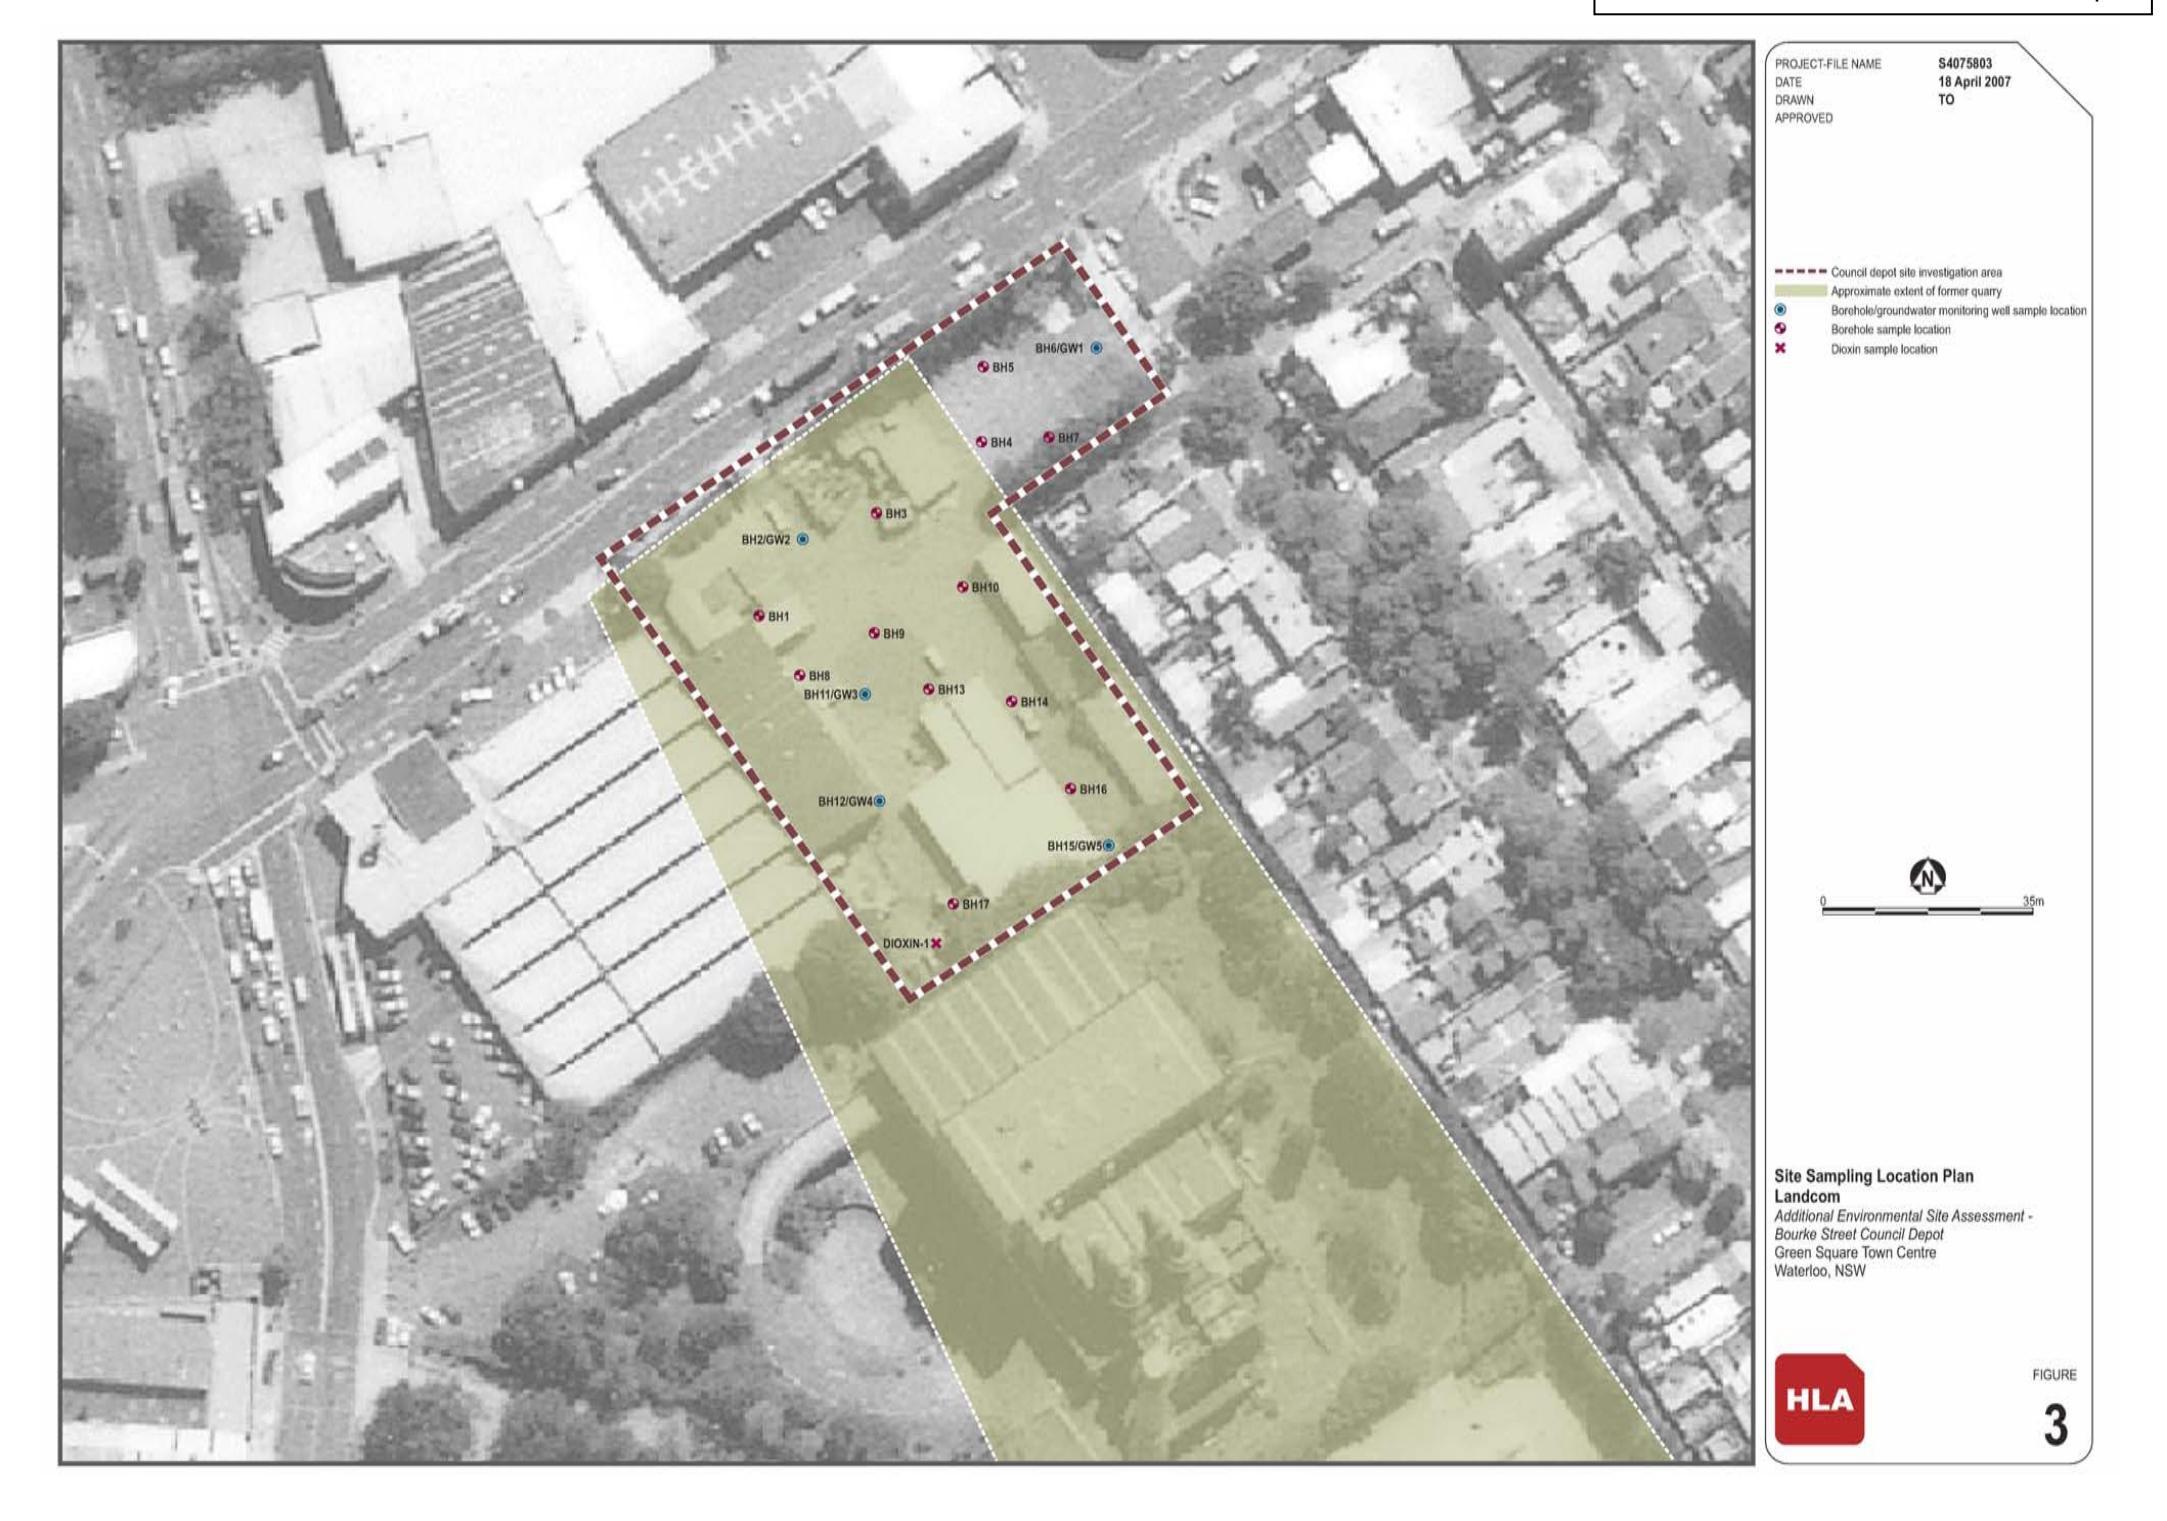
Attachment 3: Bourke Street Council Depot

All exceedances including TPH, PAH and lead across the Bourke Street Council Depot were located within the former landfill area. There were four boreholes (BH4, BH5, BH6, BH7) drilled to the north-east out of the former landfill footprint. All of the results returned results below the land use criteria, with only minor detections of PAH's and TPH's.

of these impacts to soil. Elevated TPH concentrations were reported in the vicinity of the former USTs and in association with a thin layer of gravel fill under the bitumen surface that had reported very strong tar/naphthalene odour (TPH C10-C36 at 6230 mg/kg at 0.1-0.3m).

There were only 2 detections of TPH C_6 - C_9 (maximum 260mg/kg at 11.2-11.6mbgl). These were detected at the Bourke Street Council Depot in the vicinity of the UST's (which are understood to have been removed). There were no detections of BTEX in soil samples, but there were elevated PID readings recorded in the field.

Shallow landfill material reported elevated concentrations of benzo(a)pyrene (maximum of 40 mg/kg) and PAHs (maximum of 463 mg/kg) in association with elevated TPH concentrations and a tar/naphthalene odour (Bourke Street Council Depot).
