Georges Cove Marina Due Diligence Report

Aboriginal and historical due diligence report

Prepared for Mirvac | 23 April 2018

Report J17305RP1 | Prepared for Mirvac | 23 April 2018

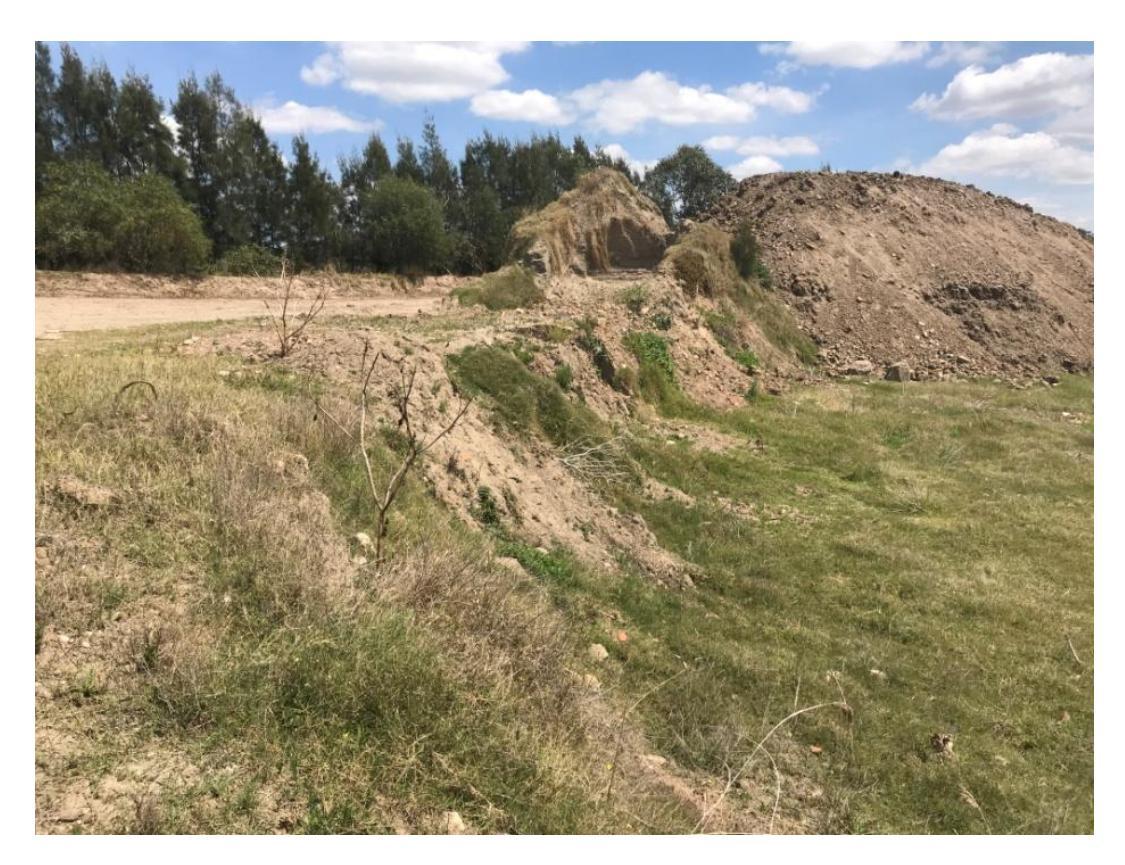
Plate 2.1 Evidence of excavation in foreground, and introduced fill in background. View north

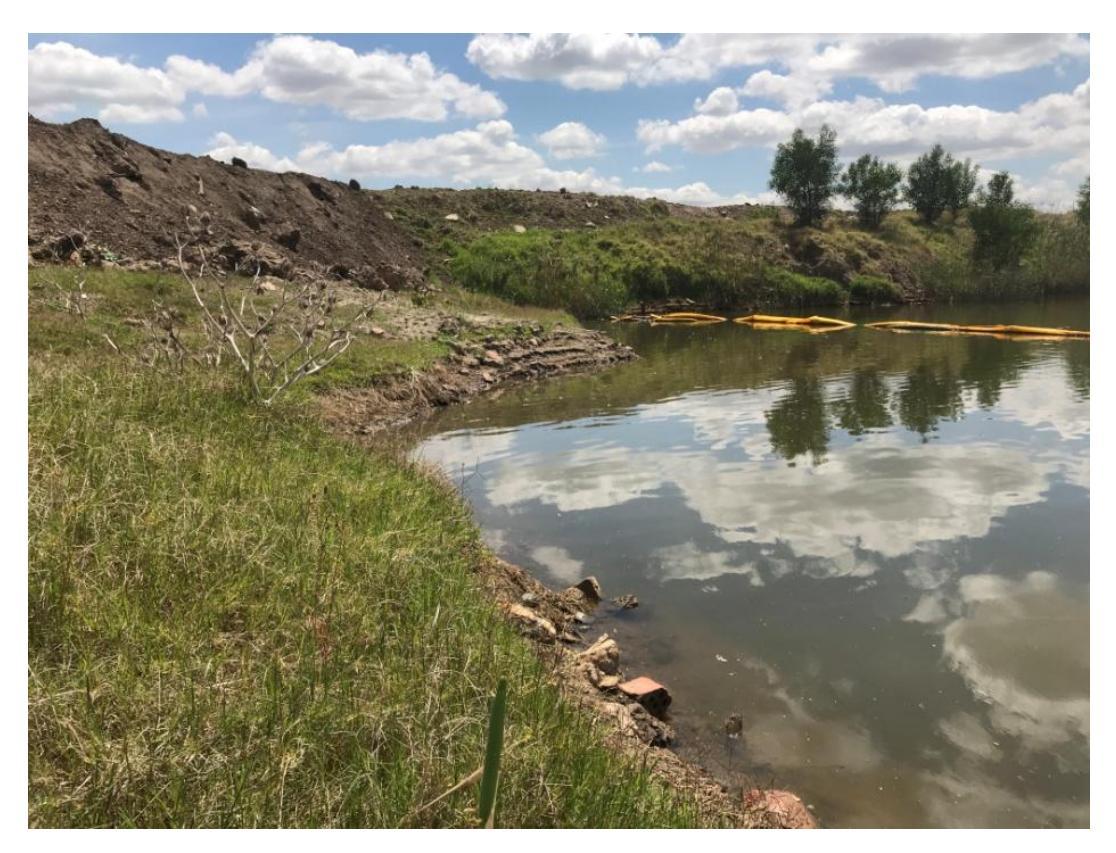
The northern project area has also been subject to a large amount of disturbance through earthworks that include substantial excavation and fill activities (Plate 2.2 and Plate 2.3). This level of disturbance has removed all the natural landforms.

Plate 2.2 Evidence of excavation and introduced fill in the northern project area. View north.

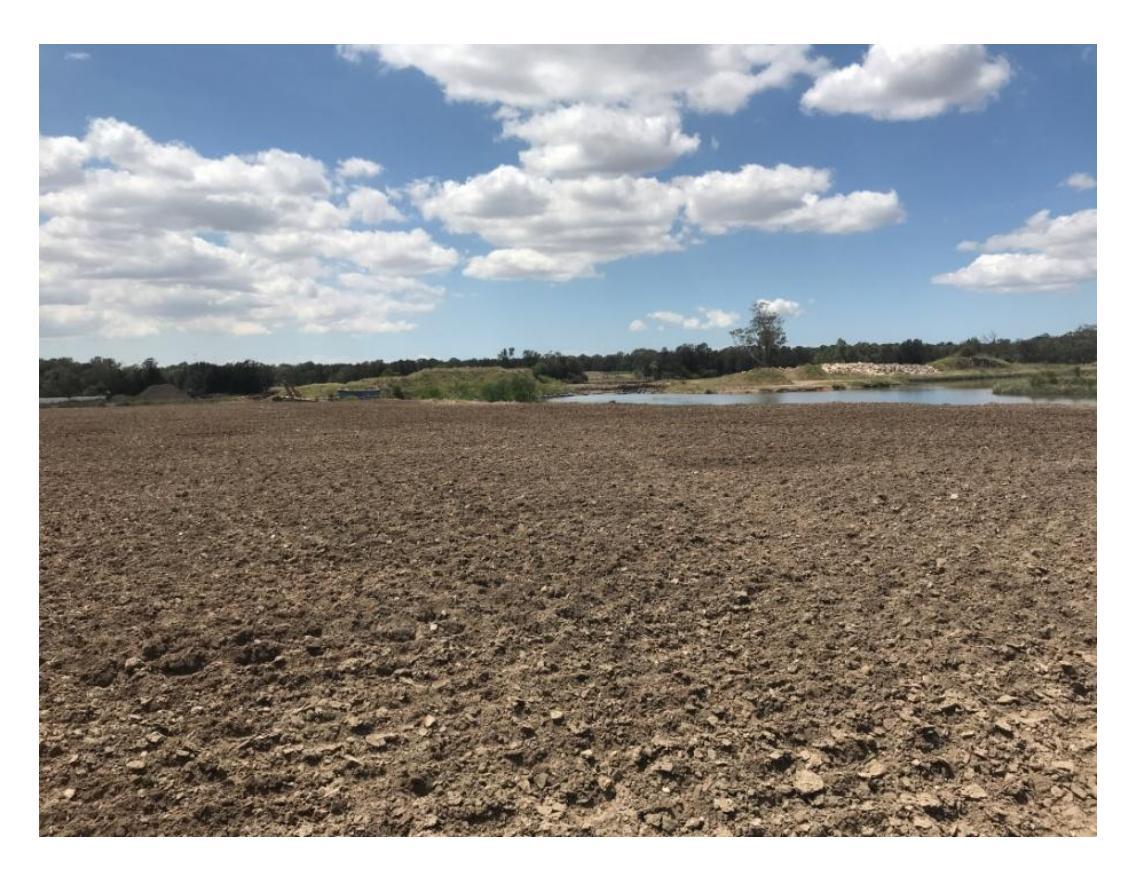
Plate 2.3 Northern project area showing evidence of excavation and introduced fill. View east.

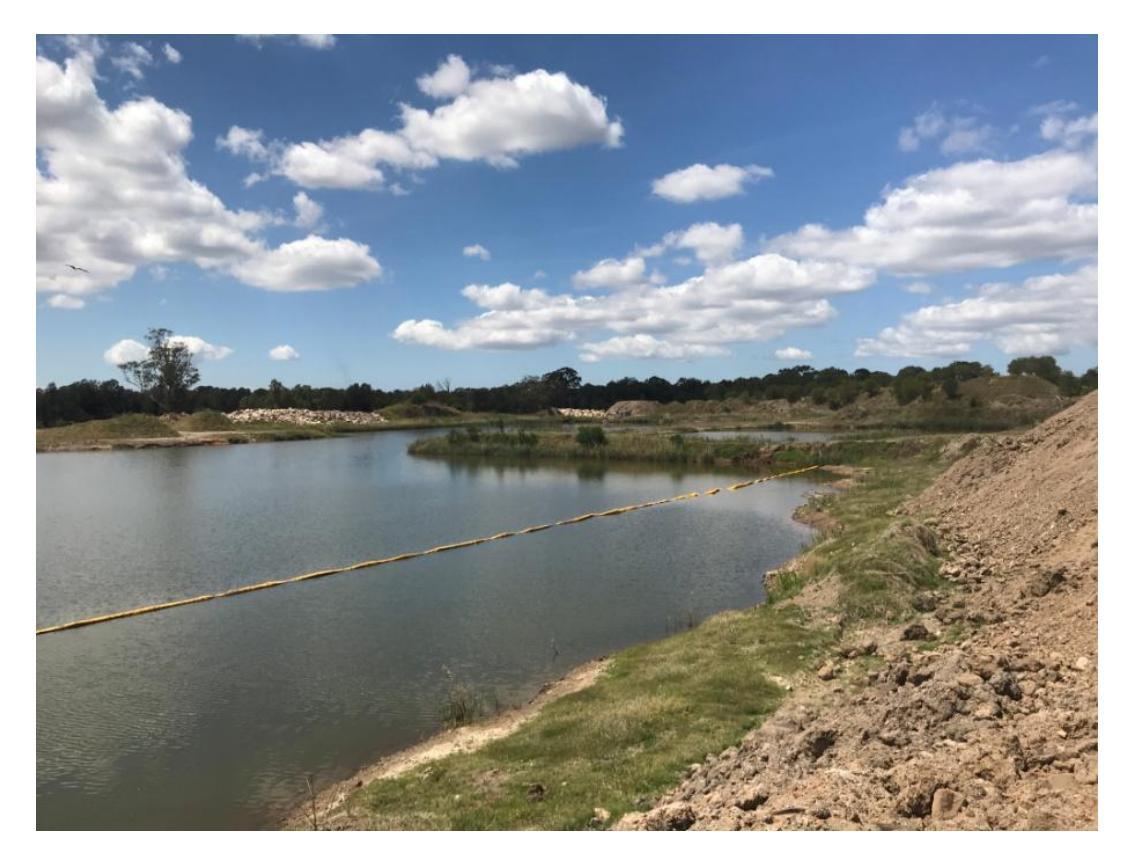
Due to the amount of degradation of native soils, transference via fill in the past and prior development of the area in large there is limited natural vegetation in the project area (Plate 2.4). There are isolated clumps of reeds and shrubs with grass coverage along the edge of the water body; no mature trees were present in the project area.

Plate 2.4 Example vegetation in the project area. View south-east

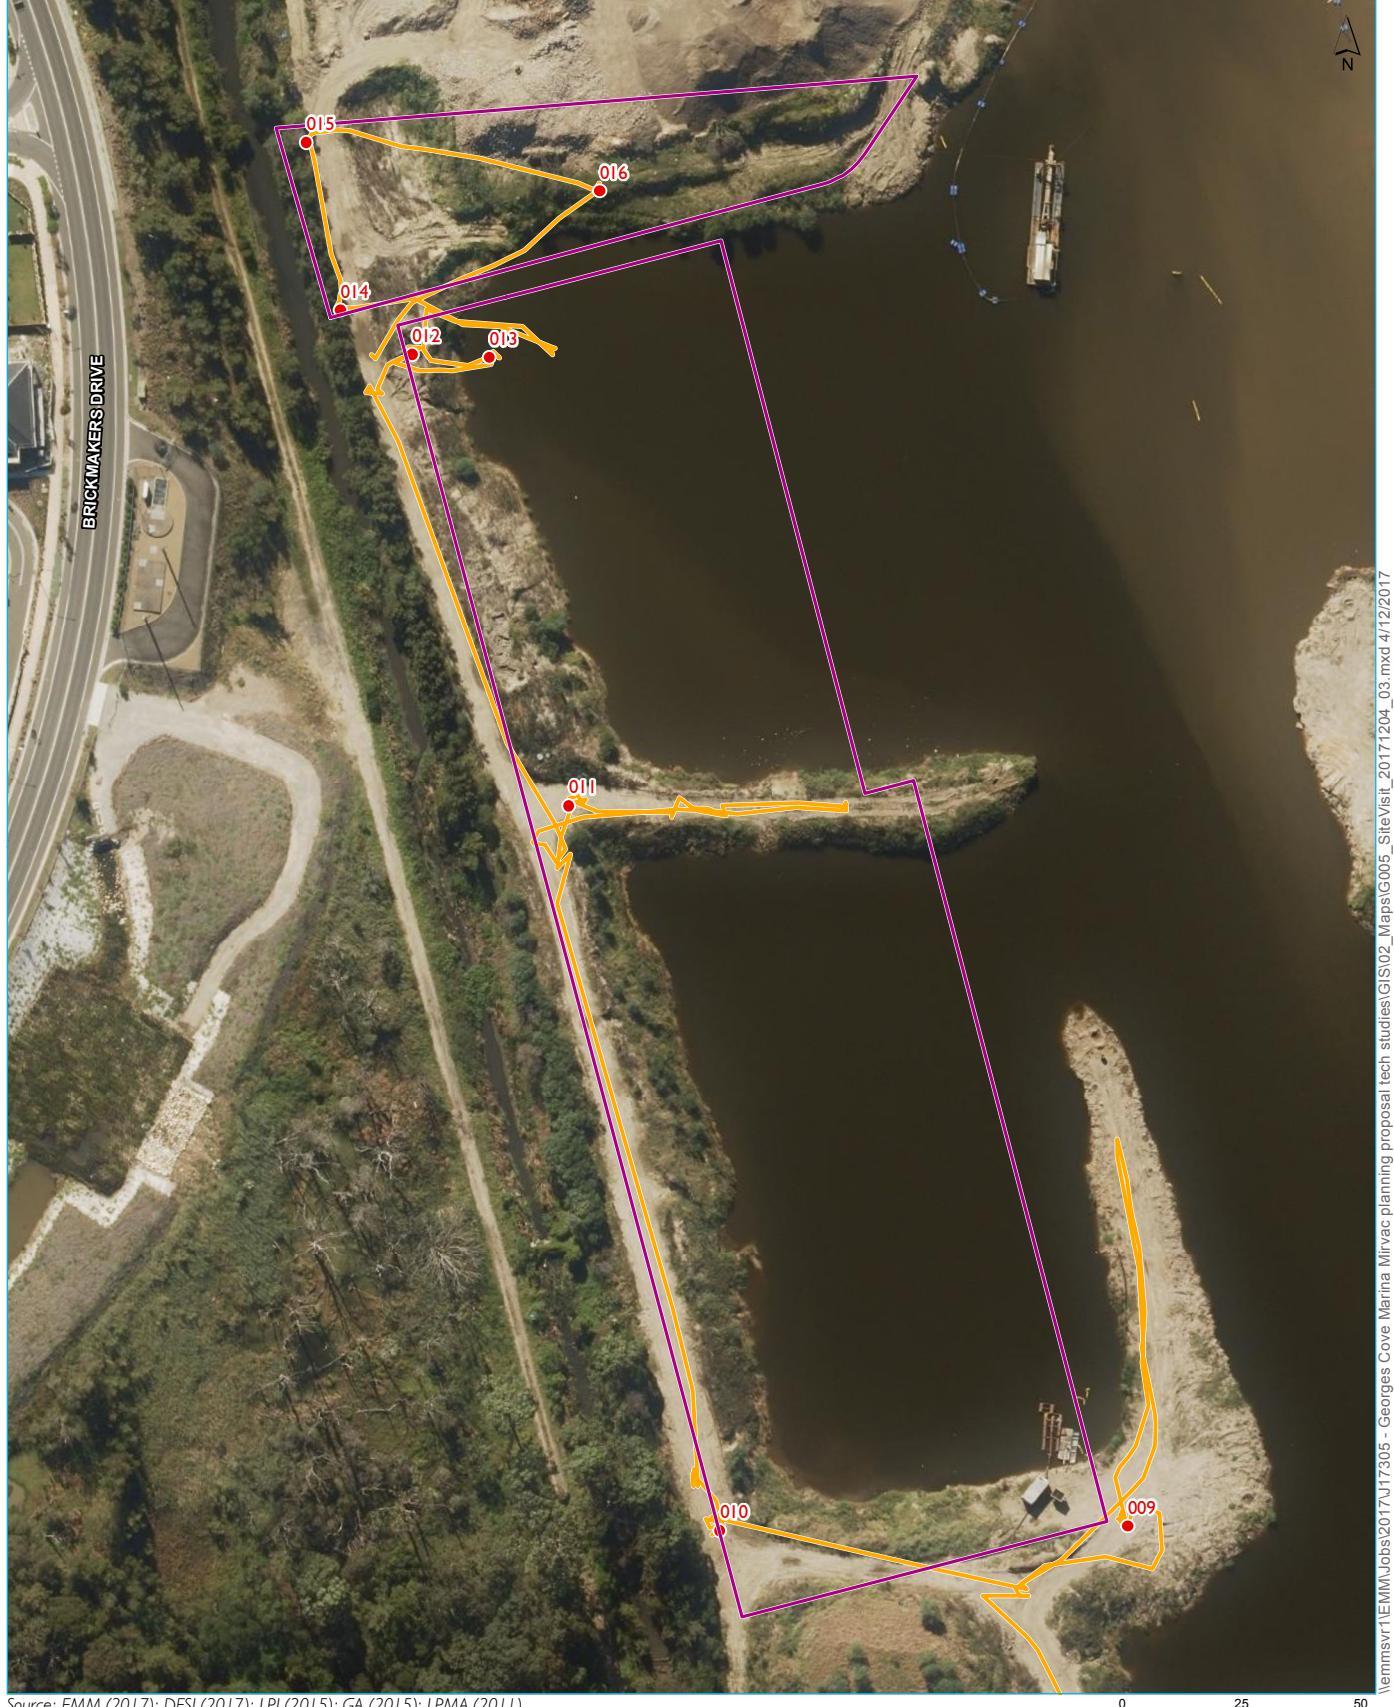
Figure 4.1

A pedestrian survey was carried out on the 10 November 2017 in good weather (Figure 4.1). A large portion of the project area was covered in water. The site has been highly disturbed, and a large amount of previous work has been carried out, including the transference of fill and deep excavation. Ground visibility was approximately 15% and the exposure approximately 5-10%. The project area held no mature trees, and a relatively small amount of native vegetation (approximately 5%).

Site inspection record
