Hairy-joint Grass Survey in Area 5 BILS on Gulgan Road Byron Shire Council

Thank you for the opportunity to complete the Hairy-joint Grass (*Arthraxon hisipidus*) survey to support the Gulgan Road Area 5 BILS Planning Proposal.

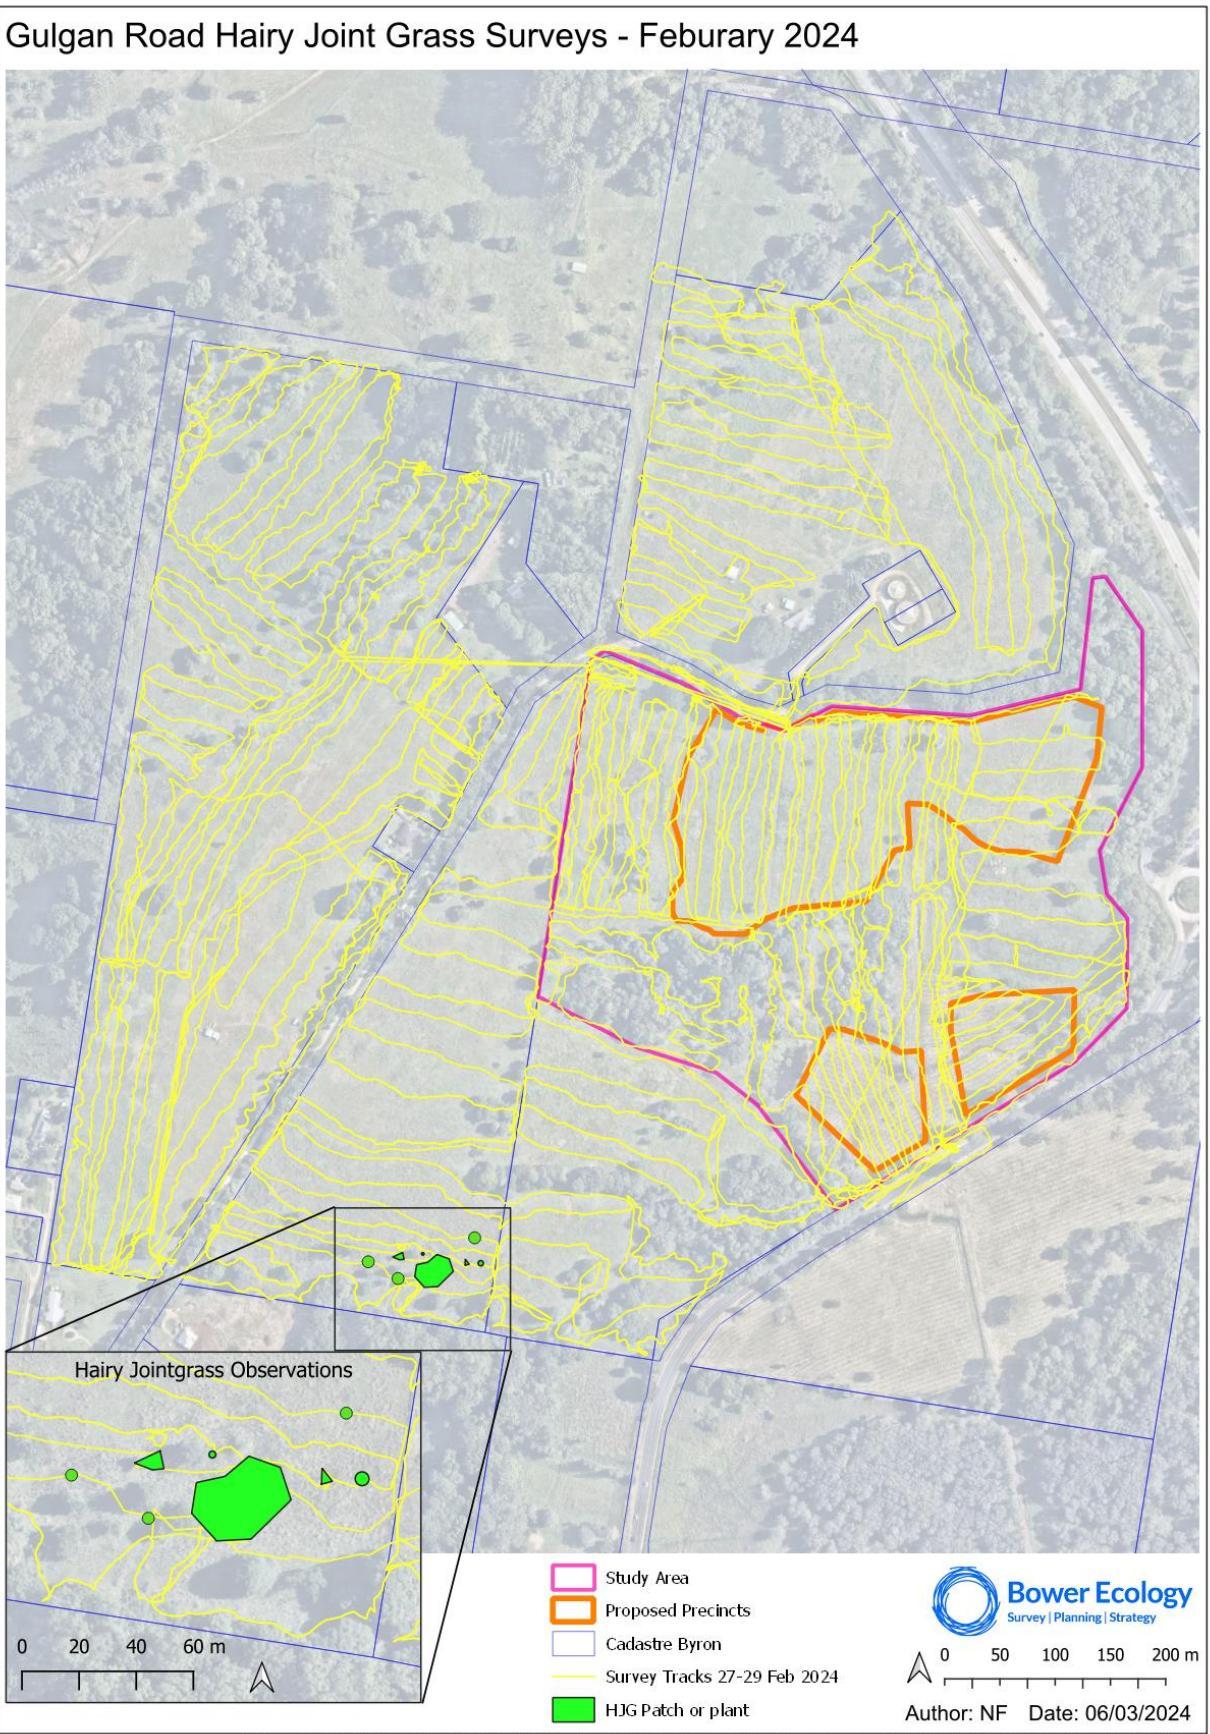
A targeted HJG survey was then conducted across areas of suitable habitat utilising transects widths of approximately 10m wide, in accordance with the NSW threatened flora guidelines. In areas such as higher, flatter paddocks generally not suitable for HJG, transects utilised widths of approximately 20m wide. Attachment A shows the tracks of the surveys and provides an indication of the terrain of the site.

Across the greater survey area however, patches / clumps of HJG were found at 7 micro-sites in one locality in the south of the survey area (see Attachment A). This area was a steep descending slope adjacent to a small pond which is located outside the site boundary.

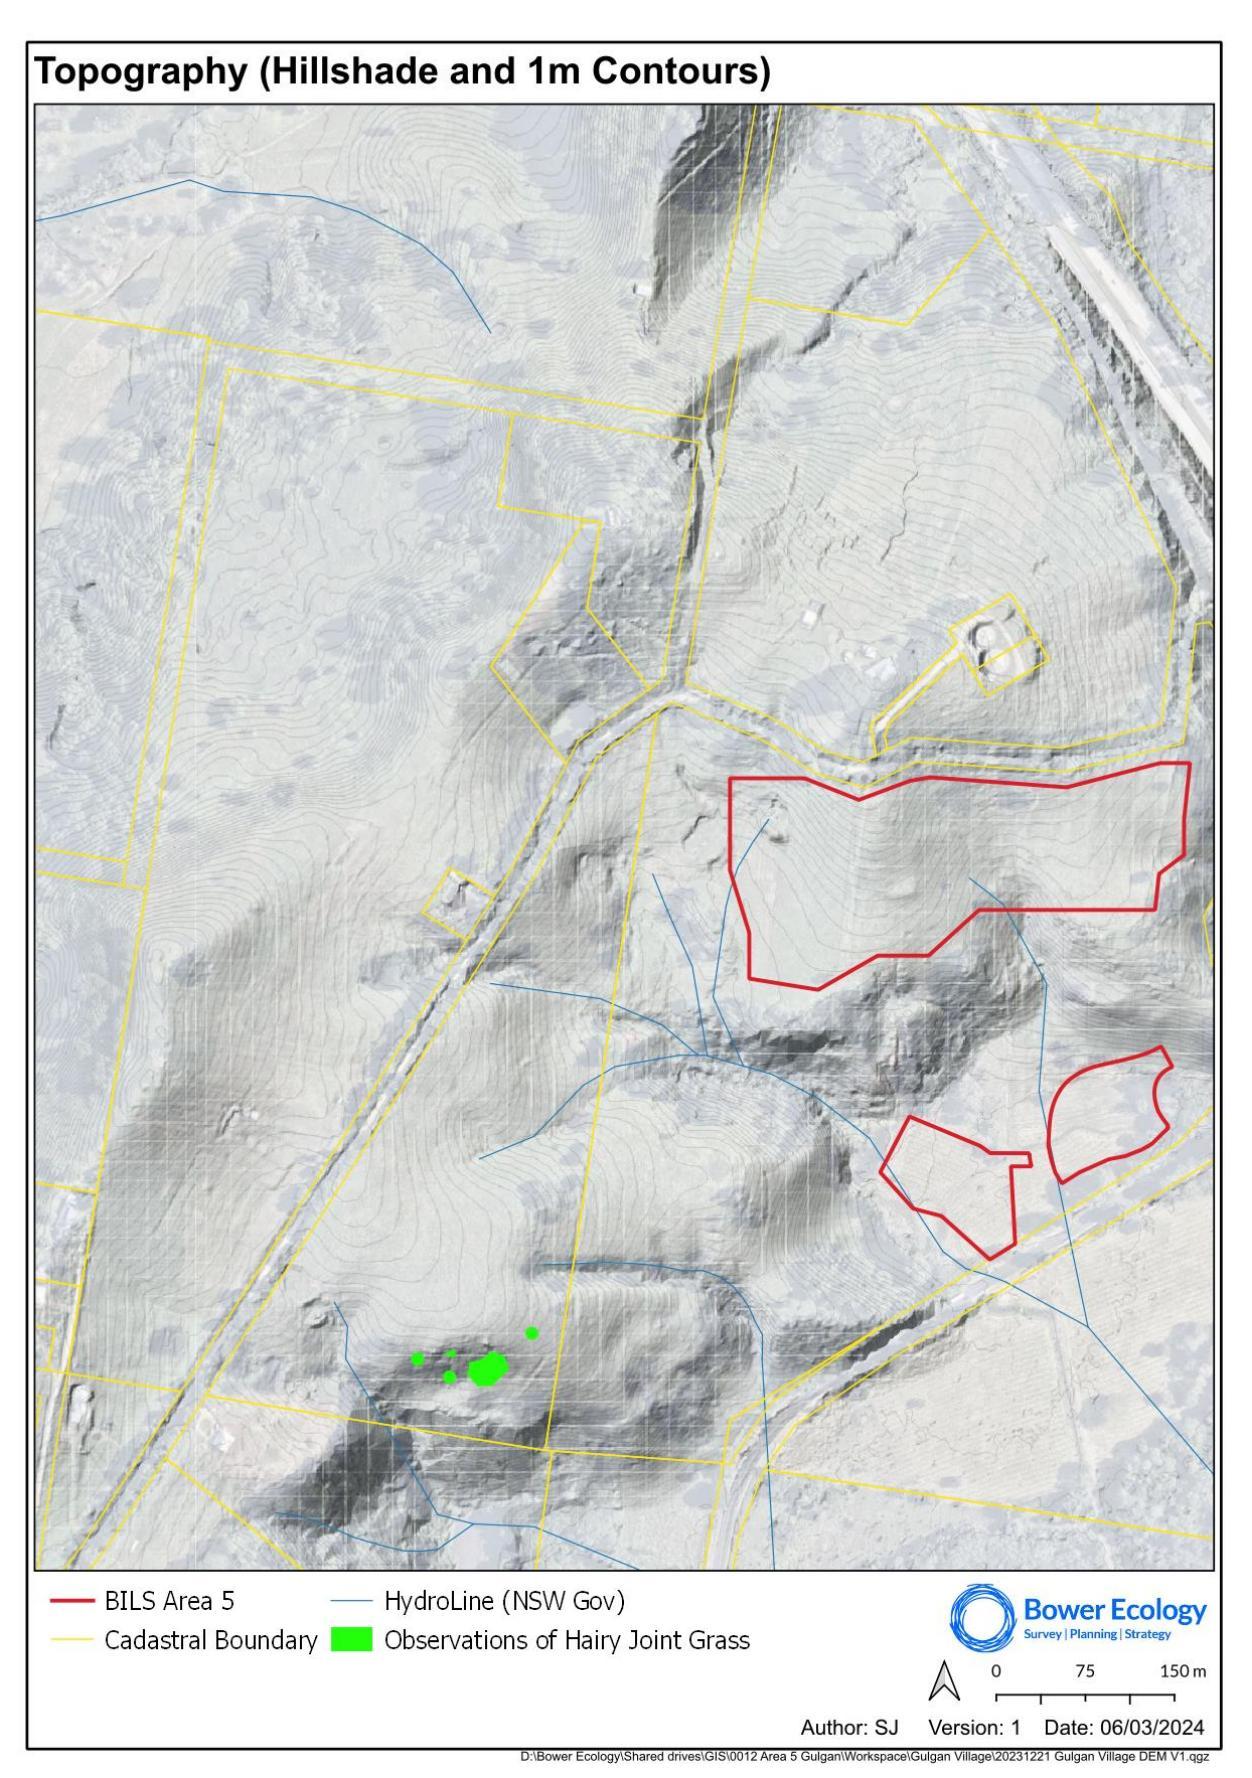
The targeted survey found HJG in areas consistent with what would be considered suitable habitat for the species. Given the topography of the area and the survey results, the species is not anticipated to be impacted (directly or indirectly) by the current proposed project design (see Attachment B).

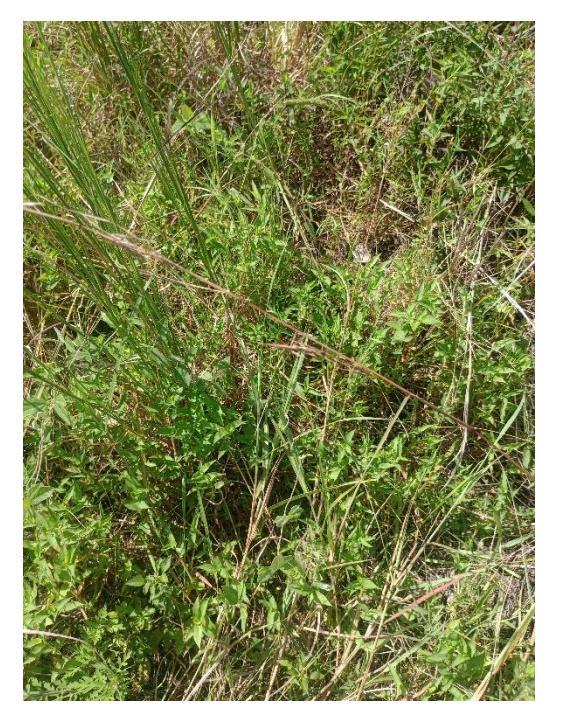
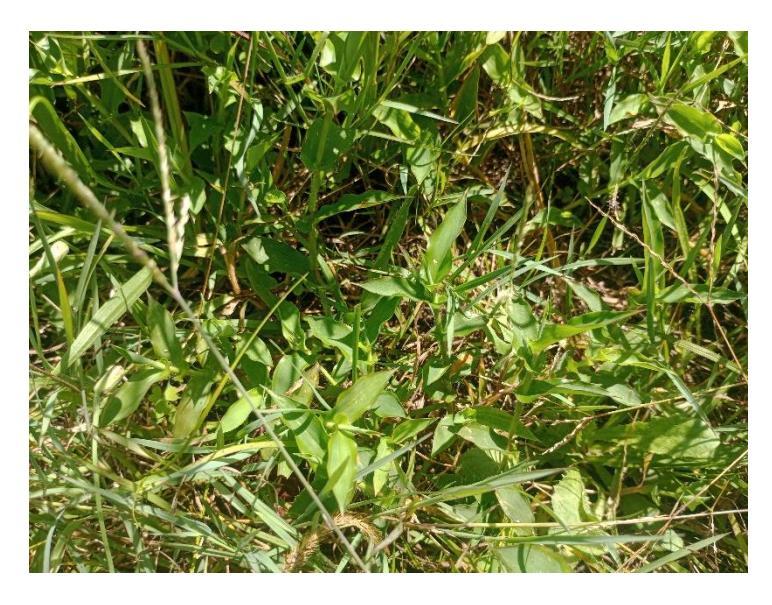
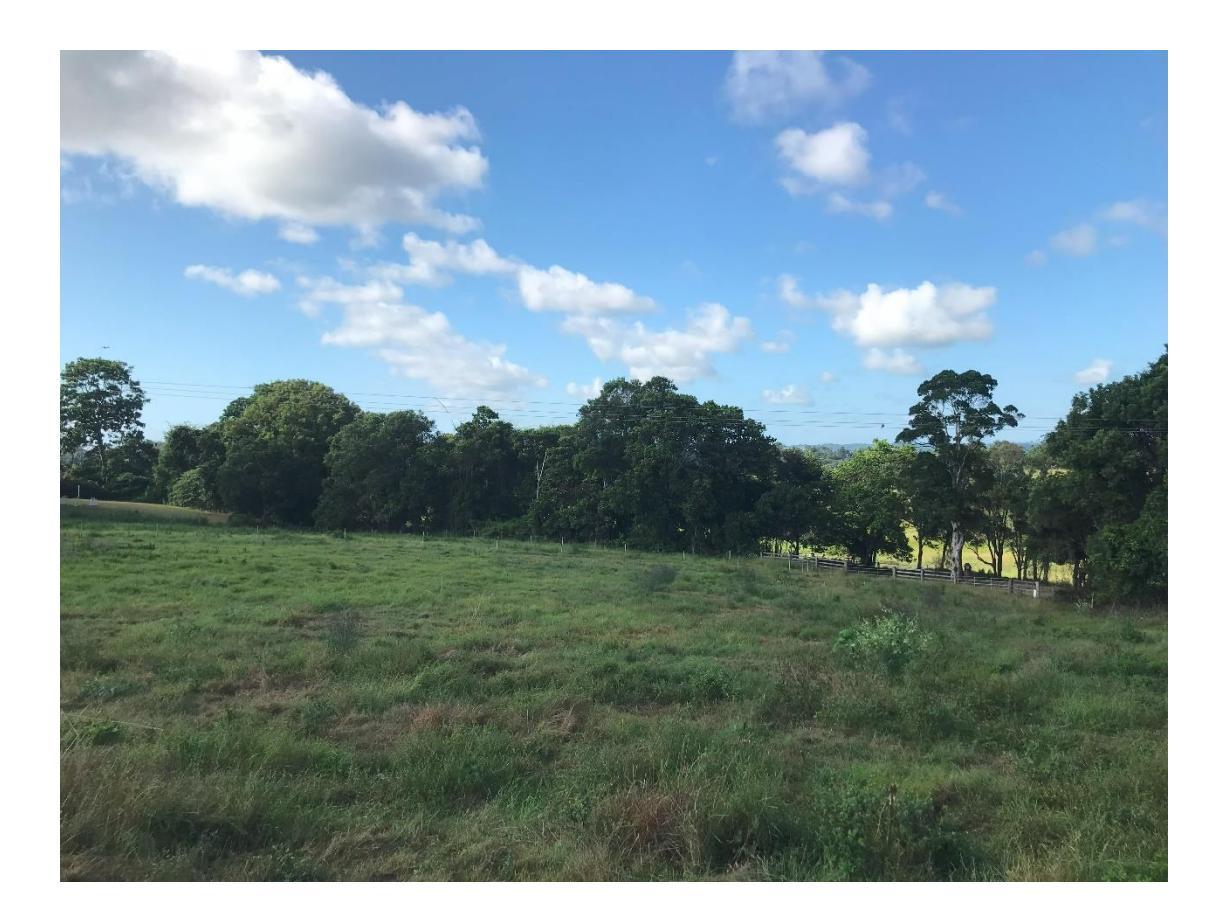
Attachment C: Photographs of HJG taken on site, and the associated habita

Approximately 250 individual plants were identified across the total 7 micro-sites. HJG was found in damp soil, and among sedges and other grasses (including exotic species) that are adapted to wetter environments.

Photographs of the species and the associated habitat is provided in Attachment C.
