CIC Australia Pty Ltd

Jumping Creek Development - Site Environmental Management Plan

Mine Site Area 3

2 November 2015

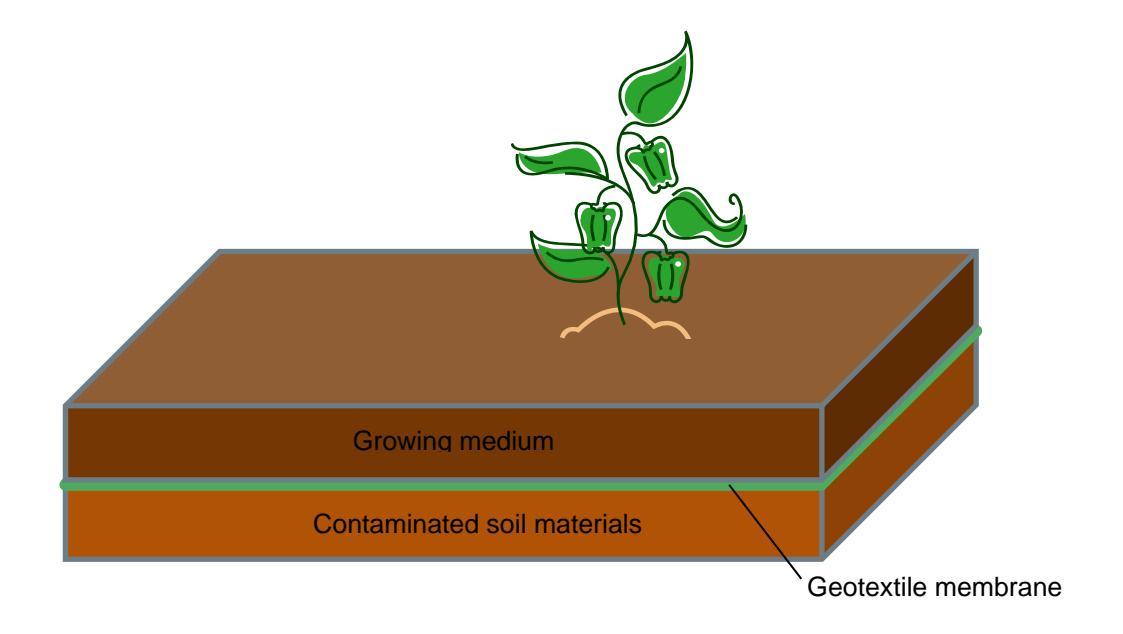
Figure 4.1 Shallow Rooted Vegetation and Tree Plantings above the Geotextile Membrane

Under this option the suitable growing medium would be placed above the geotextile membrane; either directly on top of the geotextile membrane or on top of previously placed growing medium. If it is necessary to remove previously placed soils above the geotextile membrane, care should be taken when removing the soils not to penetrate or damage the integrity of the geotextile membrane.

A sketch diagram showing this option is presented below in Figure 4.1.

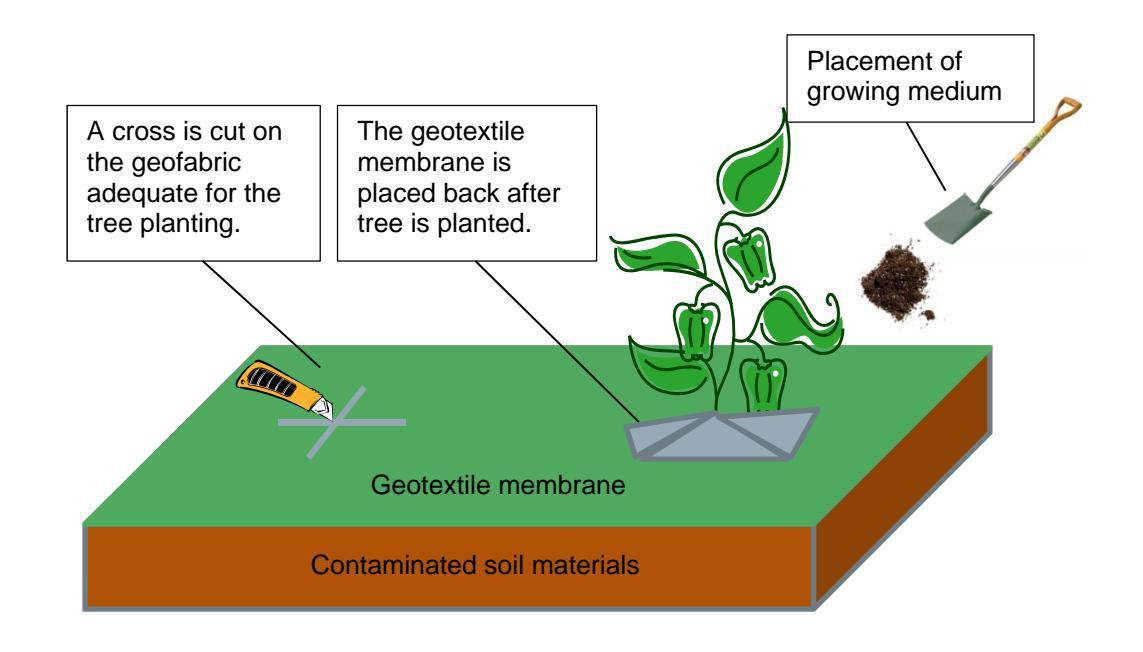
Figure 4.2 Deep Rooted Vegetation and Tree Plantings below the Geotextile Membrane

Under this option the deeper tree roots can be planted directly into the fill beneath the geotextile membrane or the fill can be removed and replaced by growing medium. Care should be taken in the

Once the vegetation and/or tree has been planted the geotextile membrane must be placed around the tree. Growing medium is to be placed on top of the geotextile membrane to natural ground level.

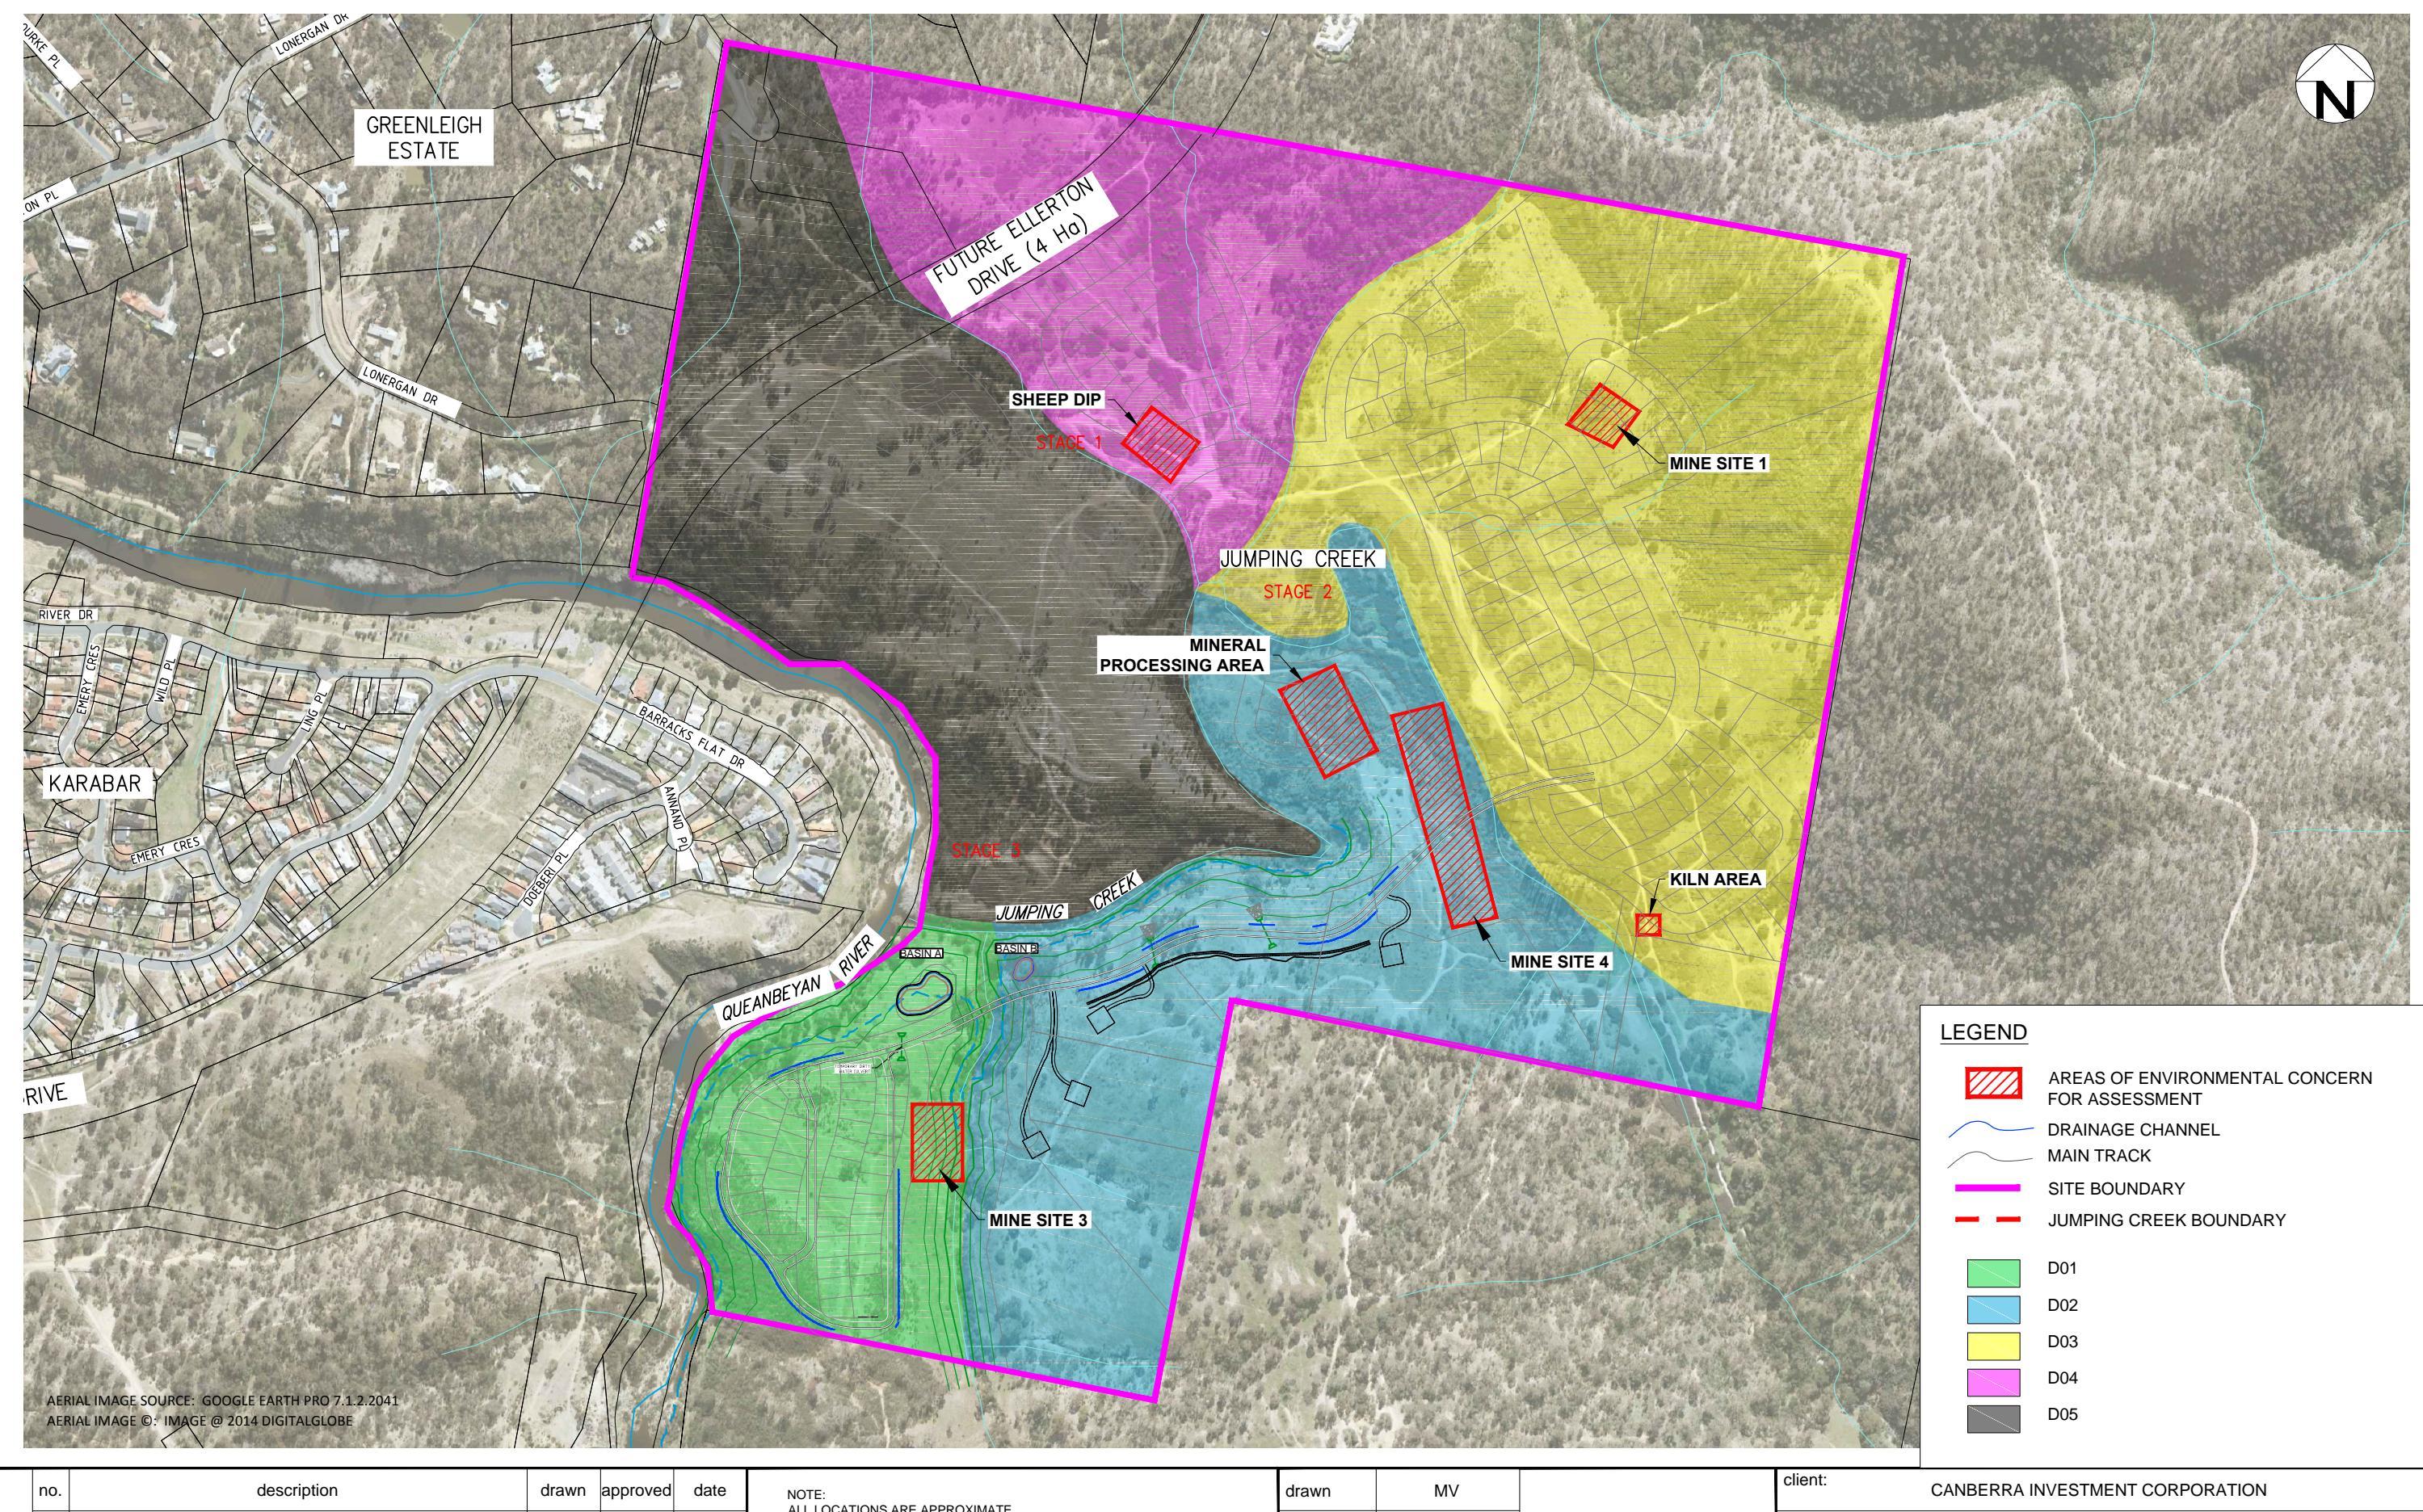
no: ENAURHOD04744AA-R01-D03	figure no:	FIGURE 2	^{rev:} A

MINE SITE EXCLUSION ZONES

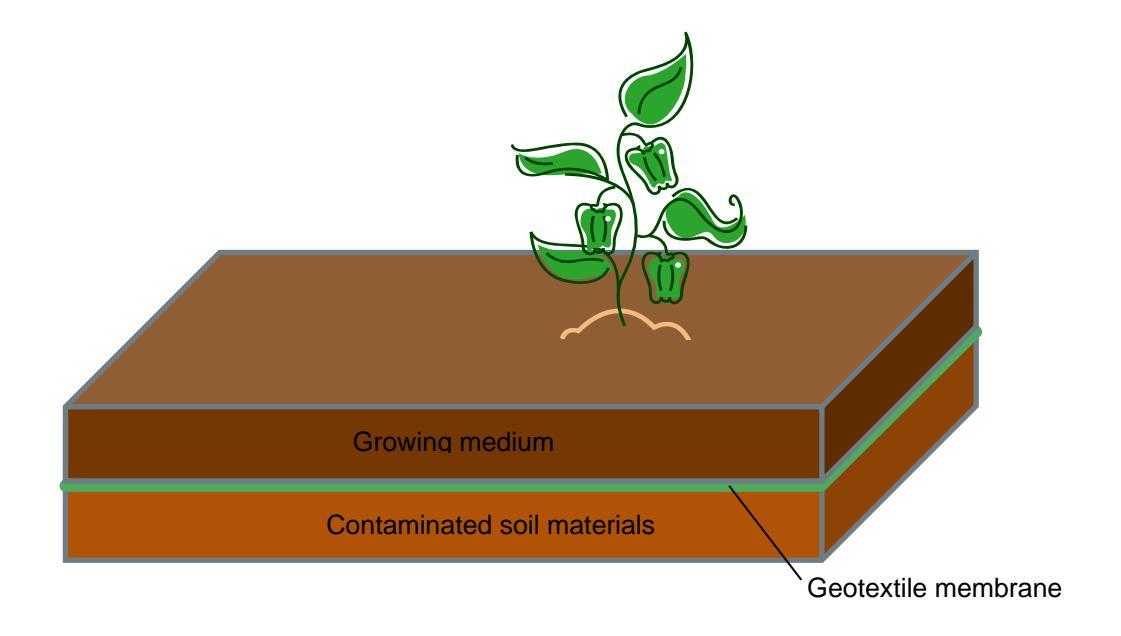
Figure 4.1 Shallow Rooted Vegetation And Tree Plantings Above The Geotextile Membrane

Under this option the suitable growing medium would be placed above the geotextile membrane; either directly on top of the geotextile membrane or on top of previously placed growing medium. If it is necessary to remove previously placed soils above the geotextile membrane, care should be taken when removing the soils not to penetrate or damage the integrity of the geotextile membrane.

A sketch diagram showing this option is presented below in Figure 4.1.

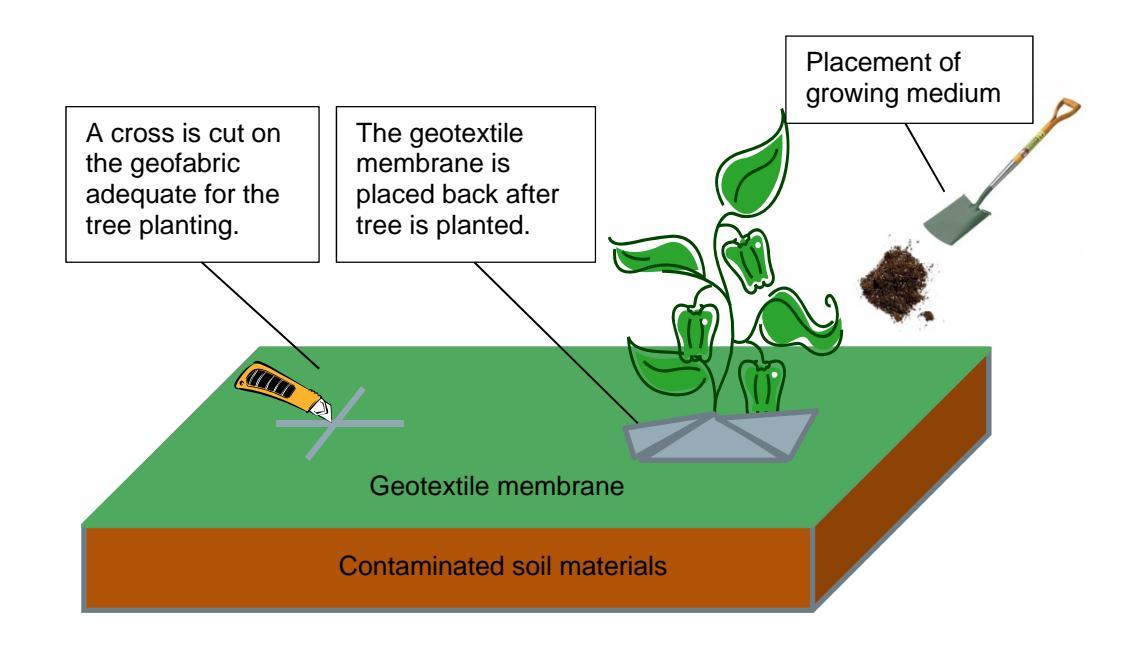
Figure 4.2 Deep Rooted Vegetation and Tree Plantings Below The Geotextile Membrane

Under this option the deeper tree roots can be planted directly into the fill beneath the geotextile membrane or the fill can be removed and replaced by growing medium. Care should be taken in the

Once the vegetation and/or tree has been planted the geotextile membrane must be placed around the tree. Growing medium is to be placed on top of the geotextile membrane to natural ground level.

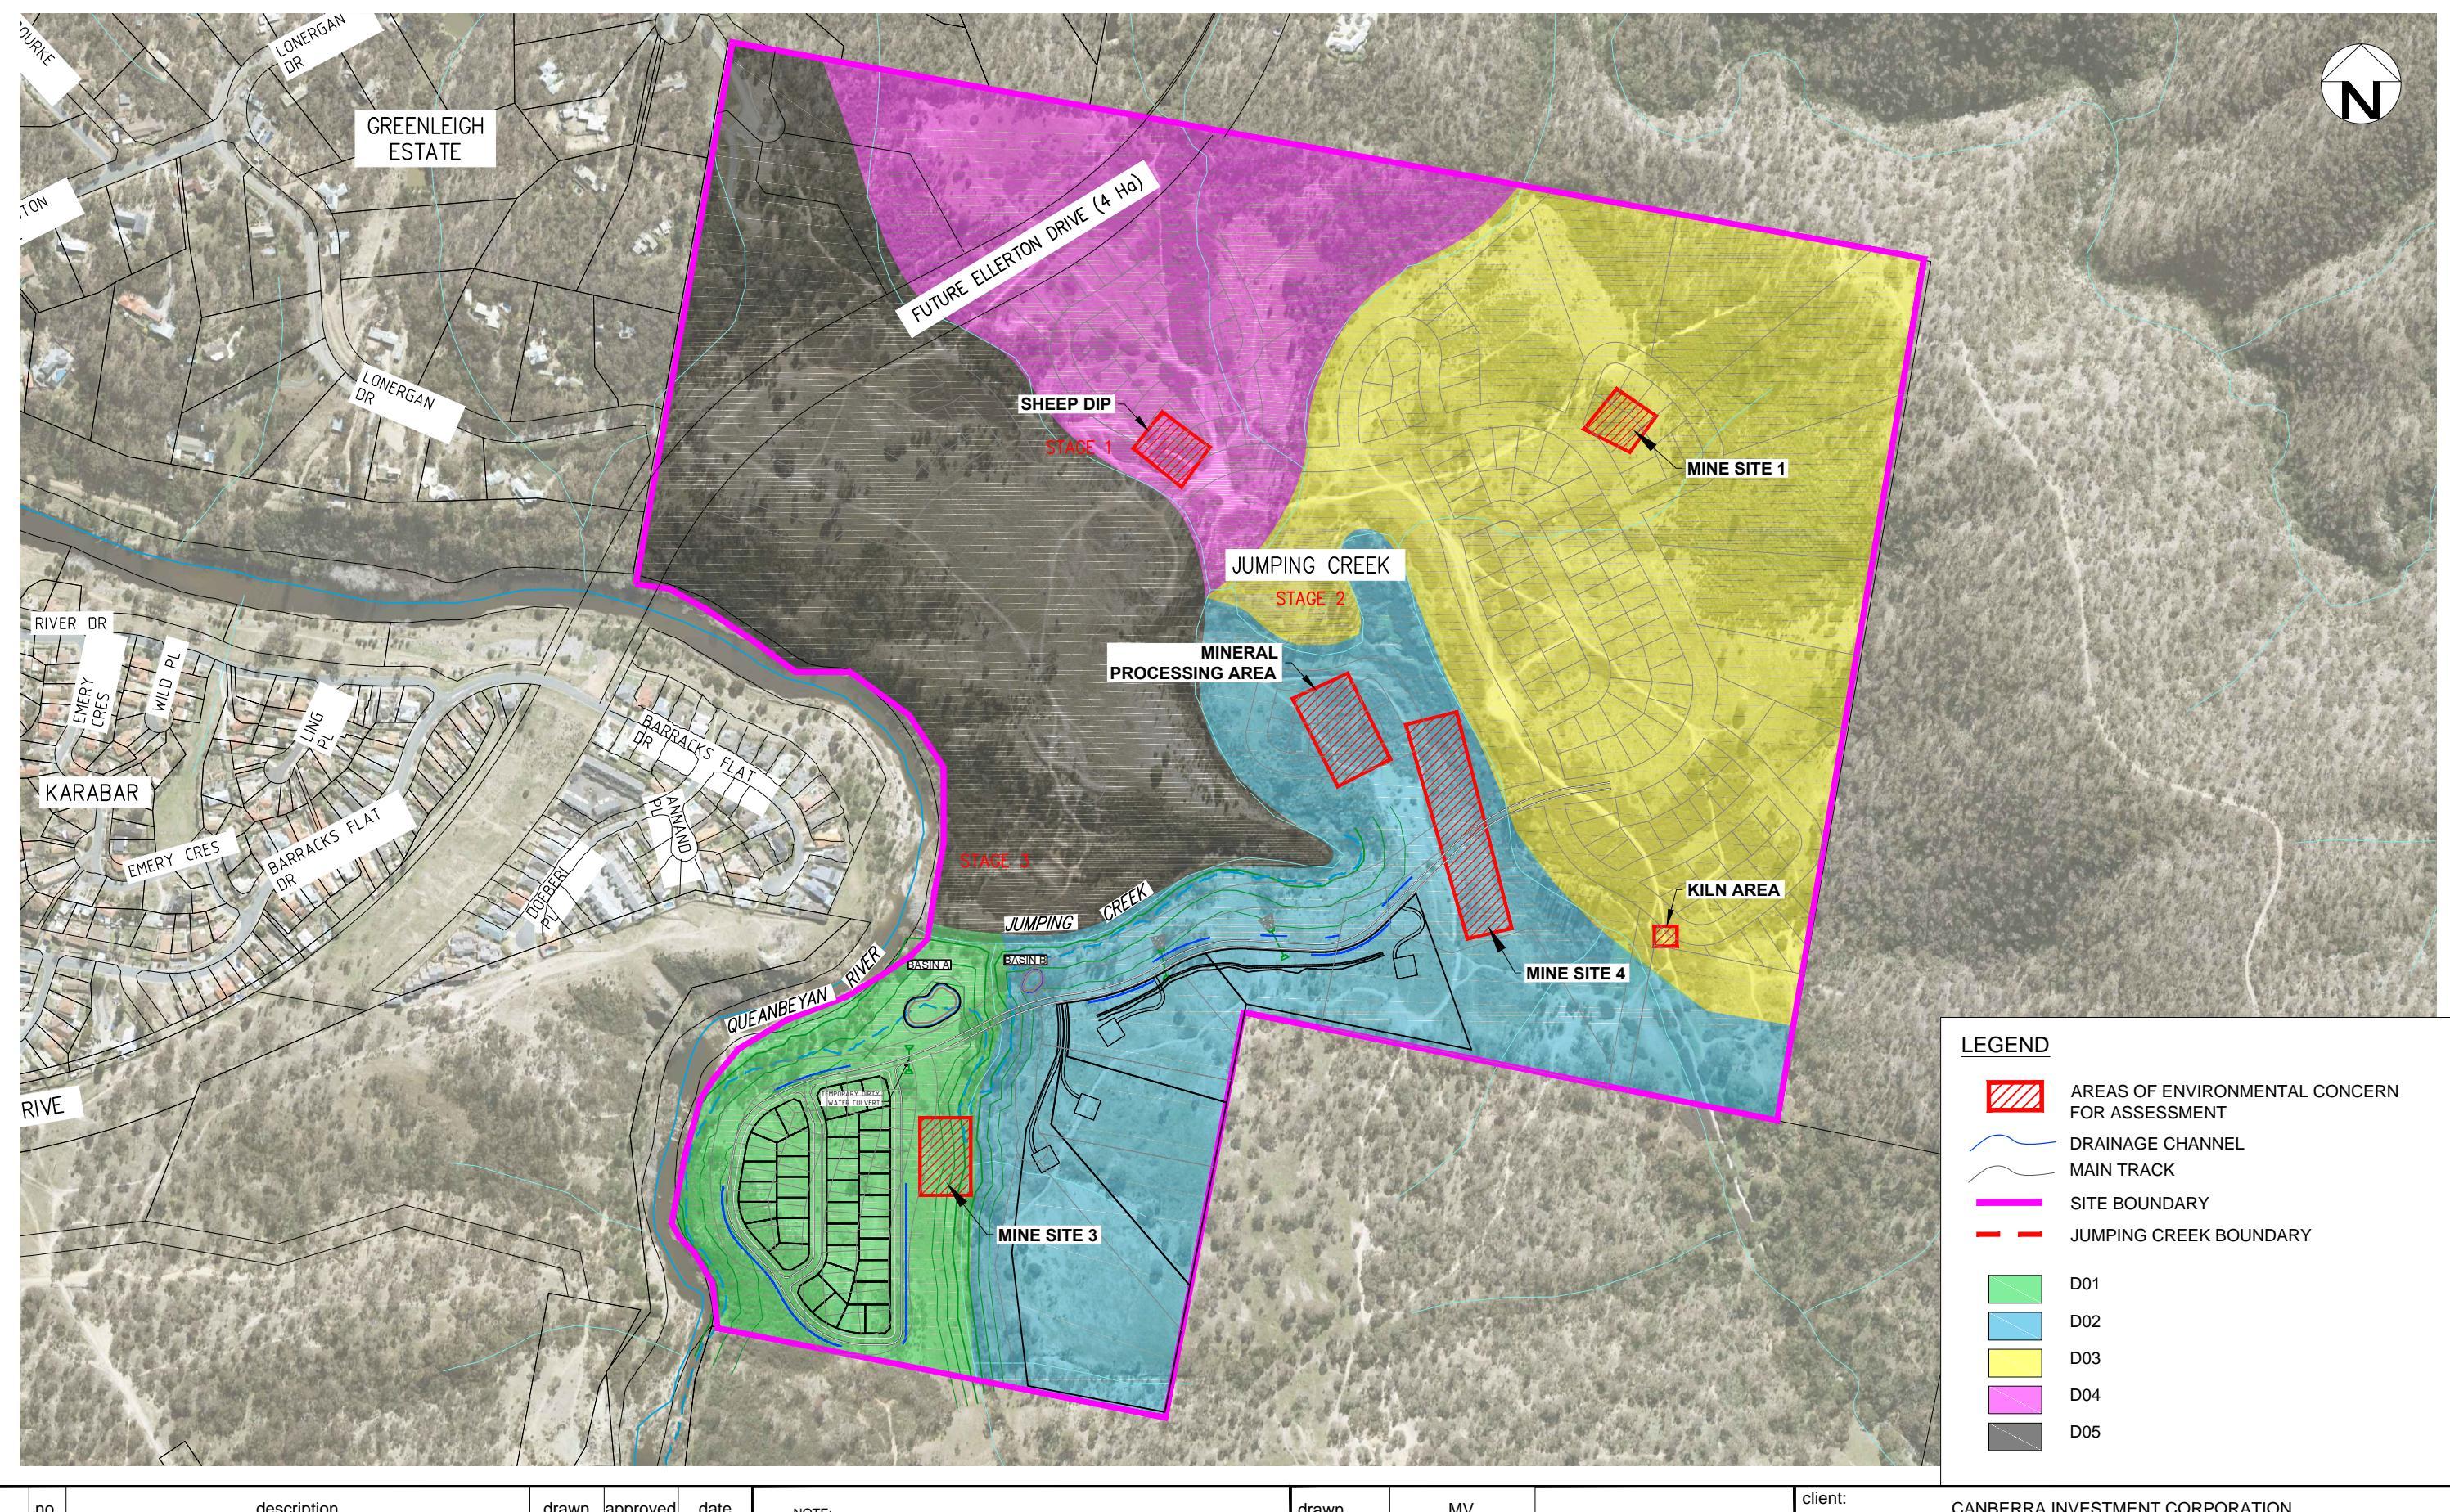
no: ENAURHOD04744AA-R01-D03	figure no:	FIGURE 2	^{rev:} A

MINE SITE EXCLUSION ZONES
