# Aboriginal Heritage Preliminary Impact Assessment – 31 O'Connell Street & 9 Albert Street, North Parramatta

Extent Heritage was commissioned by Peterose Pty Ltd, care of Ceerose to undertake a preliminary Aboriginal heritage impact assessment for proposed development of multistorey, mixed-use buildings, including basement levels and extensive earthworks, at 31 O'Connell Street and 9 Albert Street. Proof of concept plans are included as an appendix to this report (see Appendix D).

The subject land is located at the junction of O'Connell Street and Albert Street (Figure 1). Its real property description is Lot 1 in Deposited Plan 1143431 and Lot 1 in Deposited Plan 998240, and encompasses an area of approximately 8921m<sup>2</sup>. It is situated within the City of Parramatta Local Government Area (LGA), in the Parish of Field of Mars, and the County of Cumberland. The study area is approximately 24km north-west of the Sydney CBD and approximately 1.5km north of Parramatta CBD.

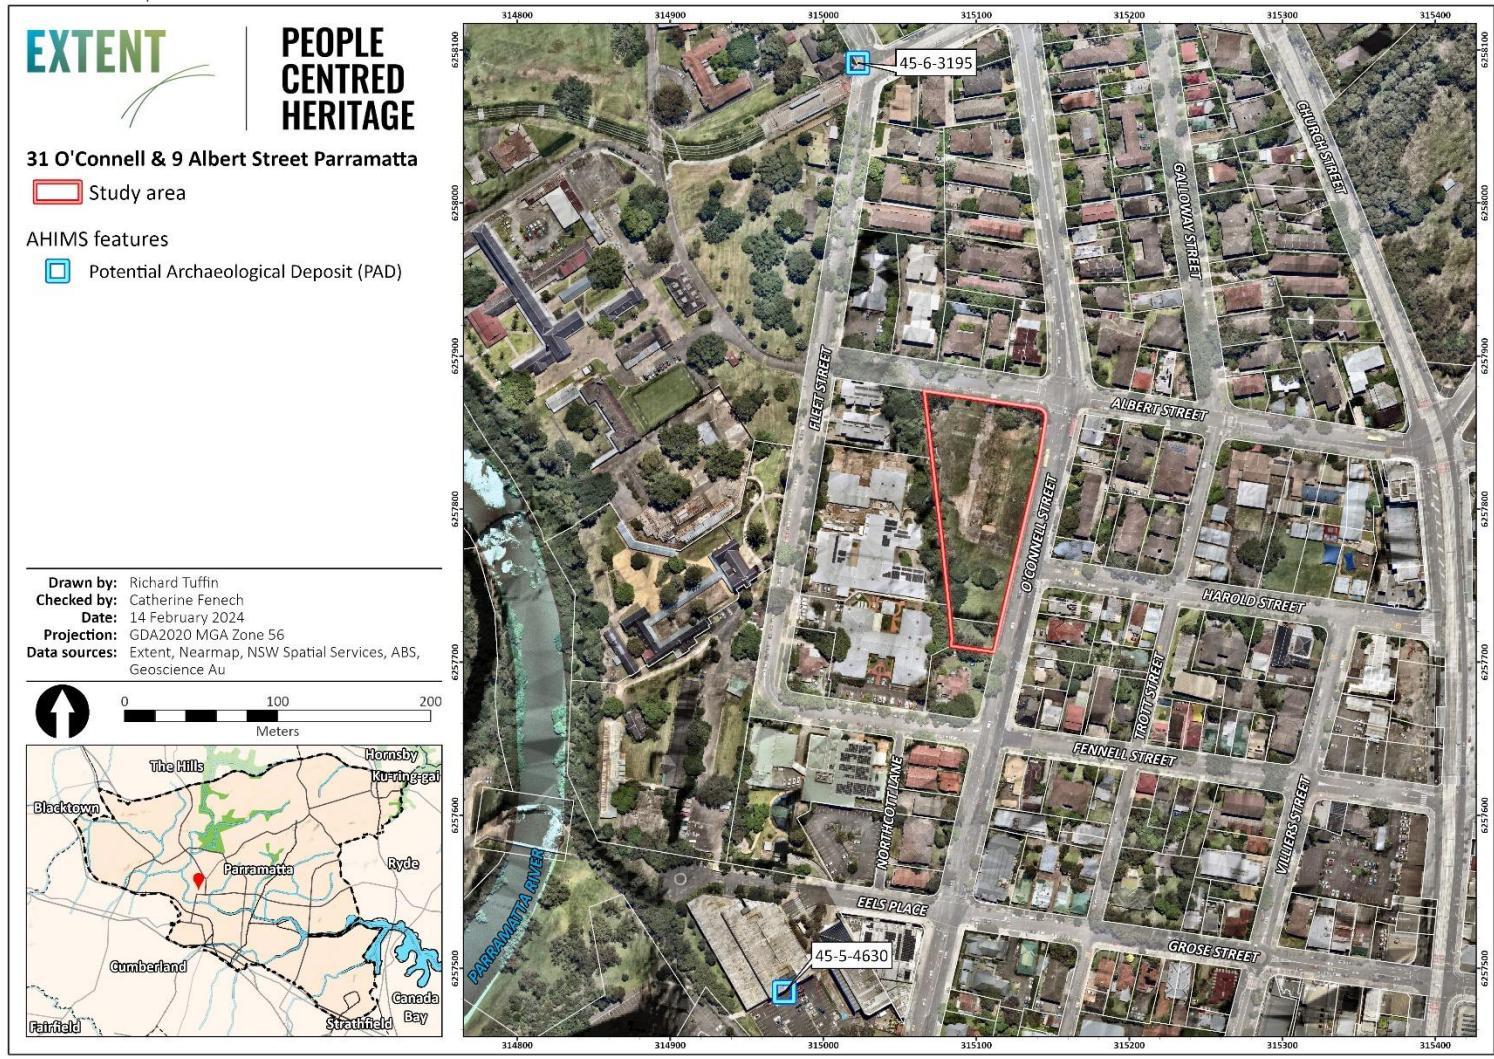
Figure 2. AHIMS sites in proximity to the study area.

There are no registered Aboriginal sites within or intersecting the subject land (Figure 2).

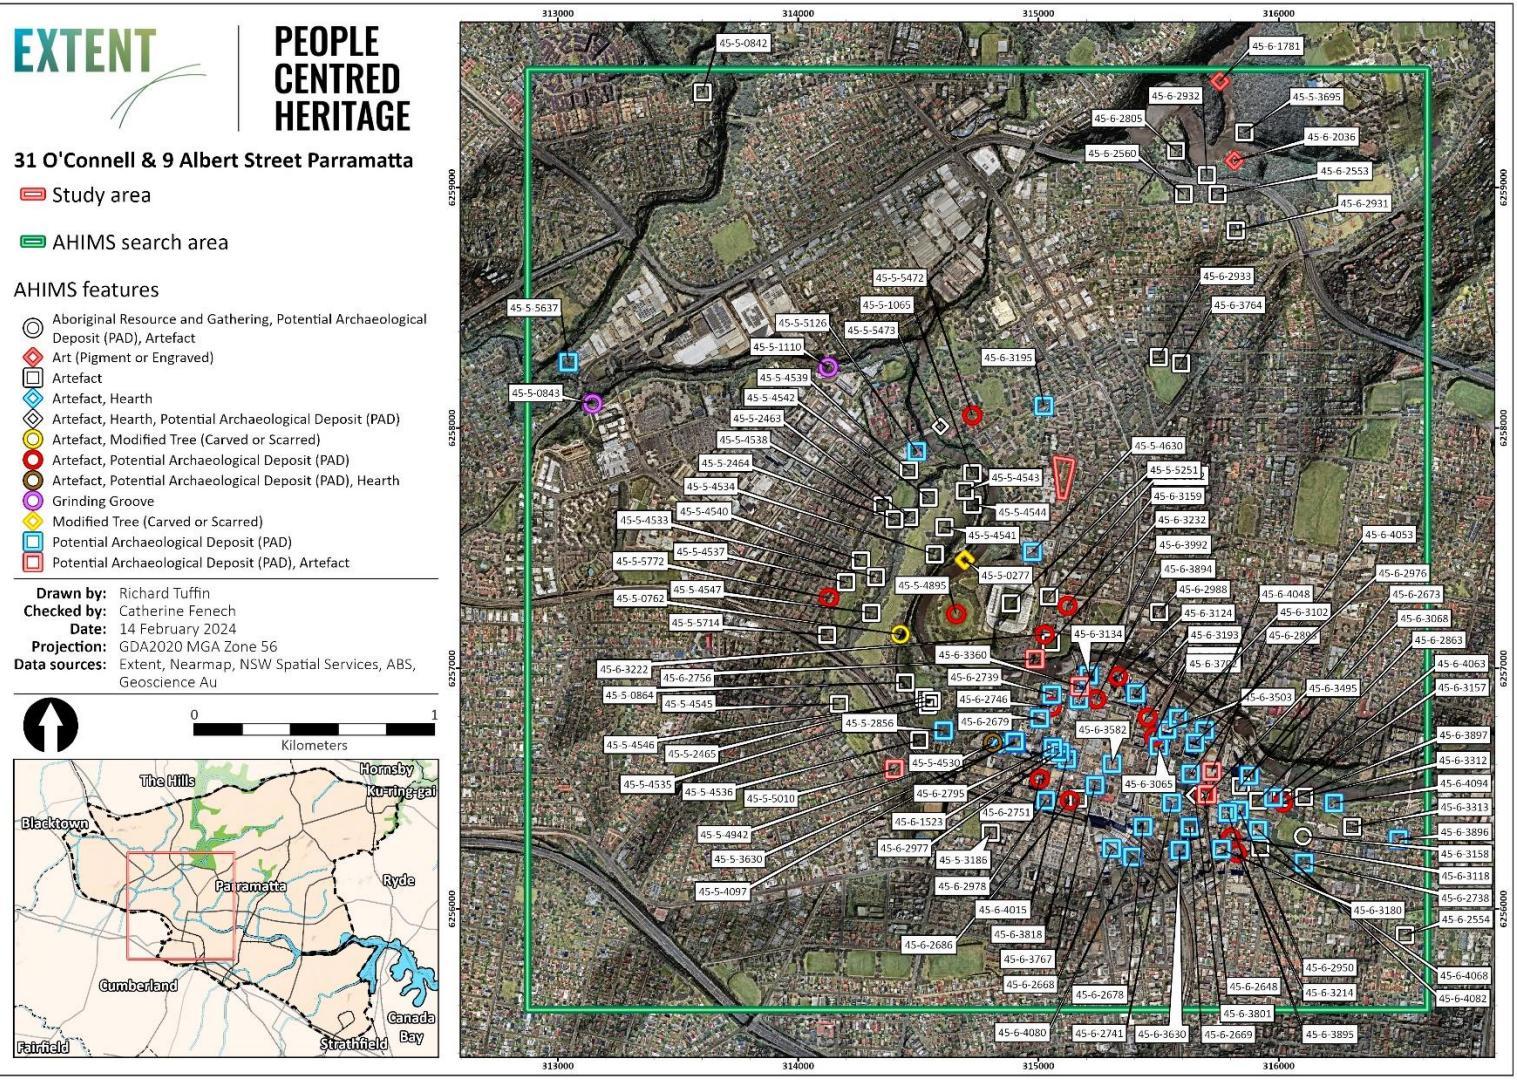
Figure 3. AHIMS search results within 3km radius

There are 115 registered Aboriginal sites within 3km radius of the study area (Figure 3). The most common site features recorded for the 115 sites are artefacts, followed by Artefacts and Potential Artefact Deposits (PADs) as shown in Table 2 below.

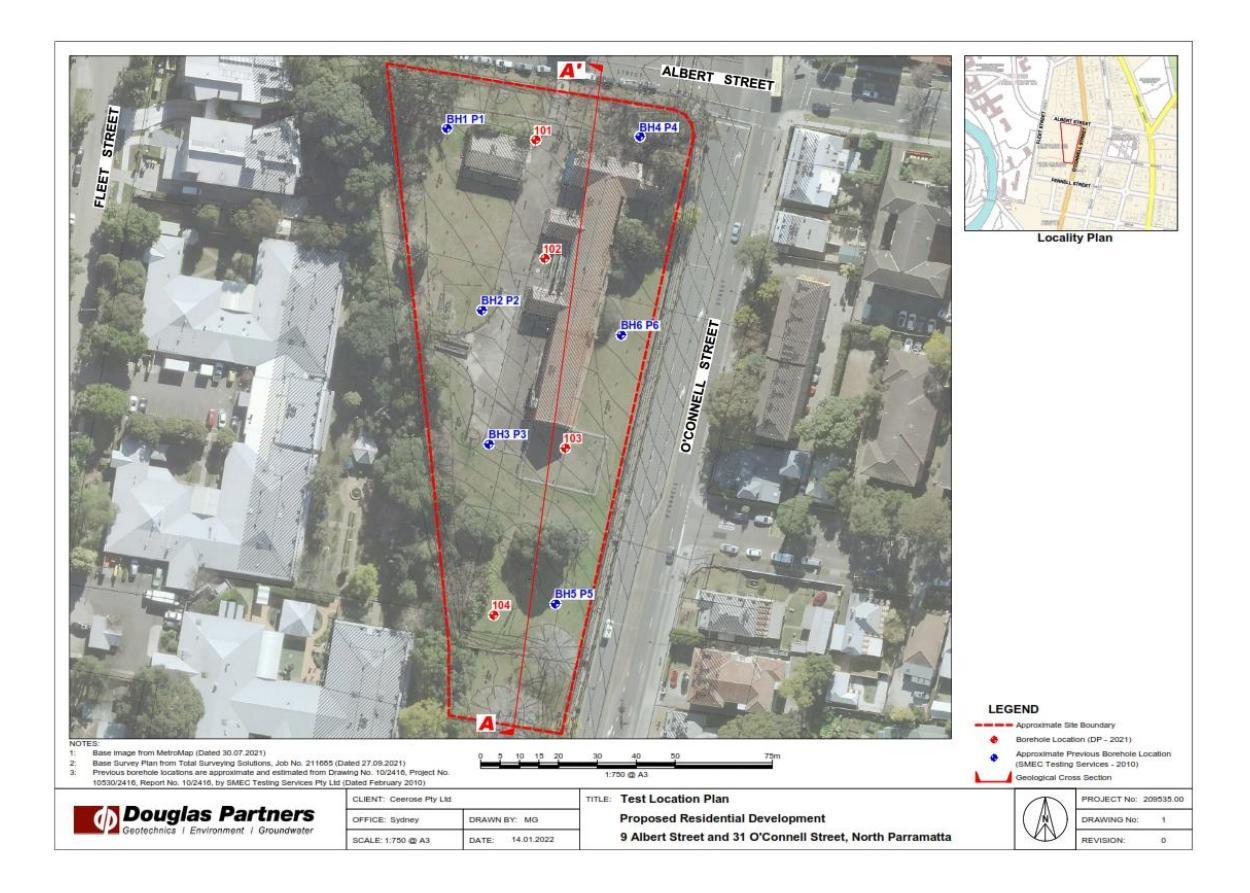
Figure 5. Location of borehole test locations (Douglas Partners 2022)

Several geotechnical investigations have been undertaken within the within the study area. A SMEC Testing Services investigation in 2010 comprised six cored boreholes to 6m depth. This informed a further investigation undertaken by Douglas Partners in March 2022 which comprised a further four boreholes (BH101 to BH104). The general sequence encountered in both investigations comprised asphalts overlying fill and residual firm to stiff sandy clay with sandstone and ironstone gravel to depths of 0.8 m to 1.7 m, overlying Hawkesbury Sandstone of decreasing strength. BH104 in particular comprised a large amount of fill (to 0.6m) overlying a dark brown and red brown clay (to 1.3m). This increased fill may be associated a previous structure on the site in this area.

The geotechnical results suggest that the majority of the study area has been subjected to disturbance and historical filling activities which have truncated topsoils, leaving clay subsoils overlying sandstone geologies.

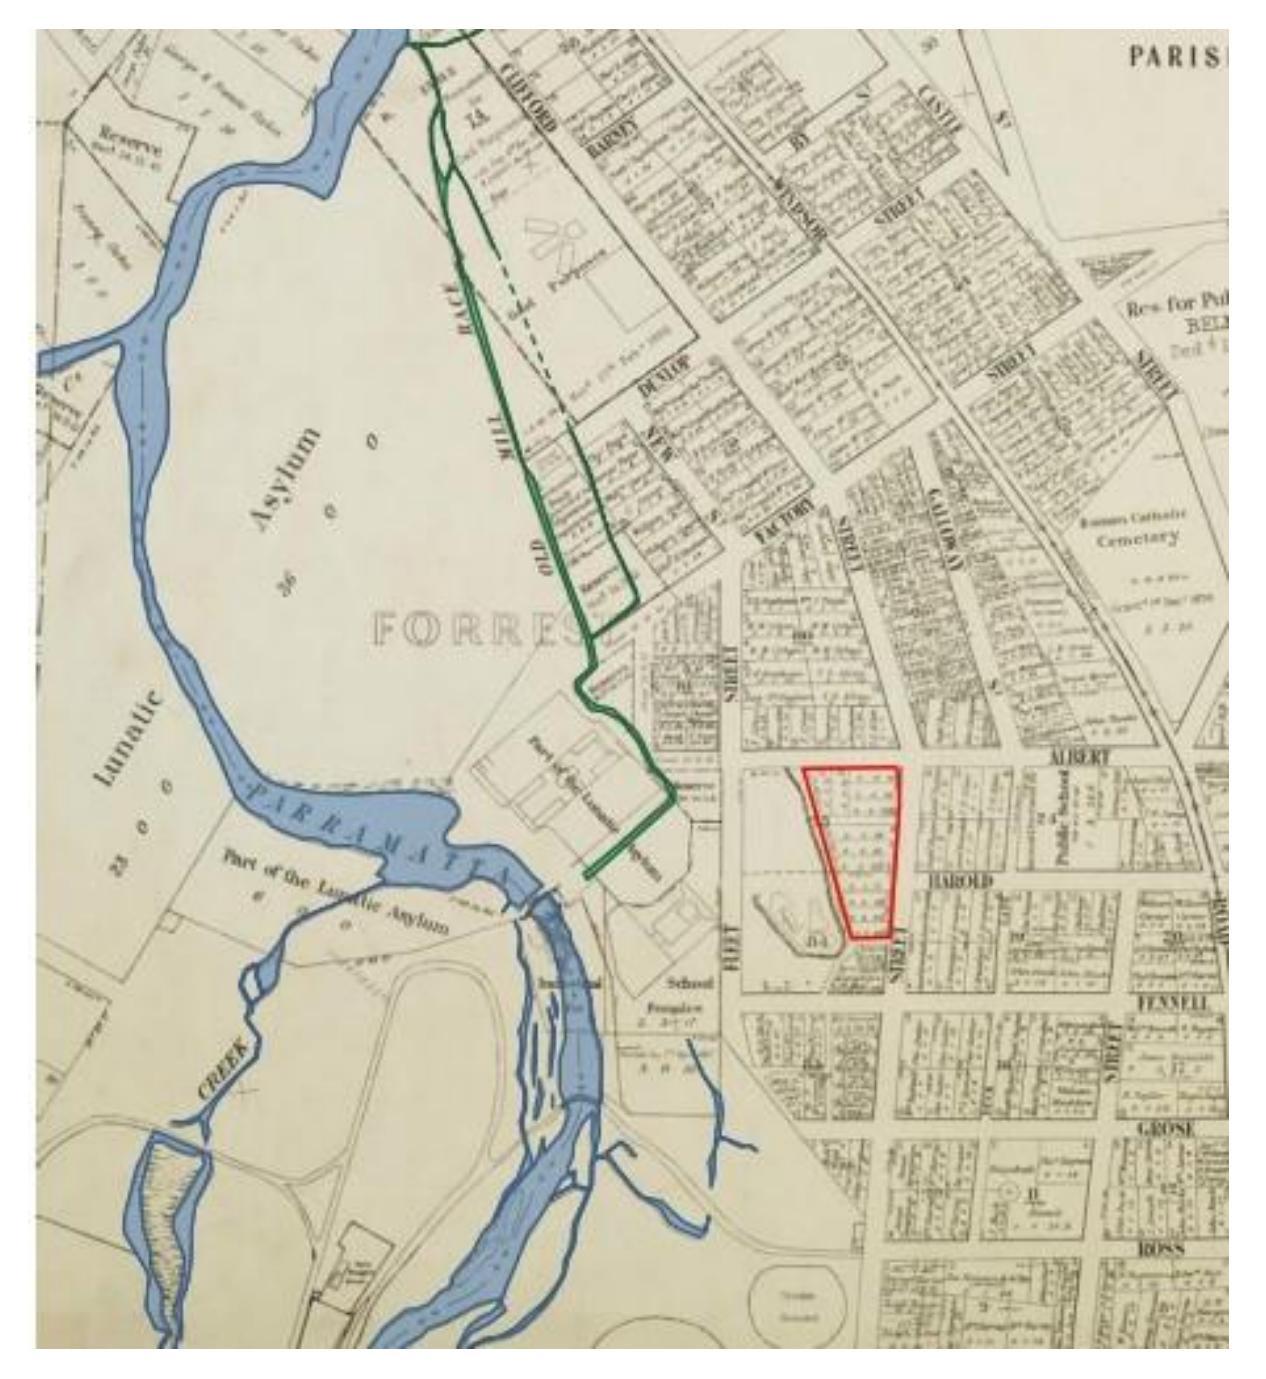
Historical plans of the Parramatta region from the nineteenth century depict what appears to be a series of watercourses in close proximity to the study area. These natural watercourses were significantly altered by the creation of a convict-cut "mill race" channel, to supply water for a series of government mills on the riverbank (Figure 6). According to the notes of Surveyor Edward Ebsworth, the mill race diverted into a natural watercourse much further south (Casey and Lowe 2014, 46). This unnamed, first order watercourse passes within 200 m of the study area.

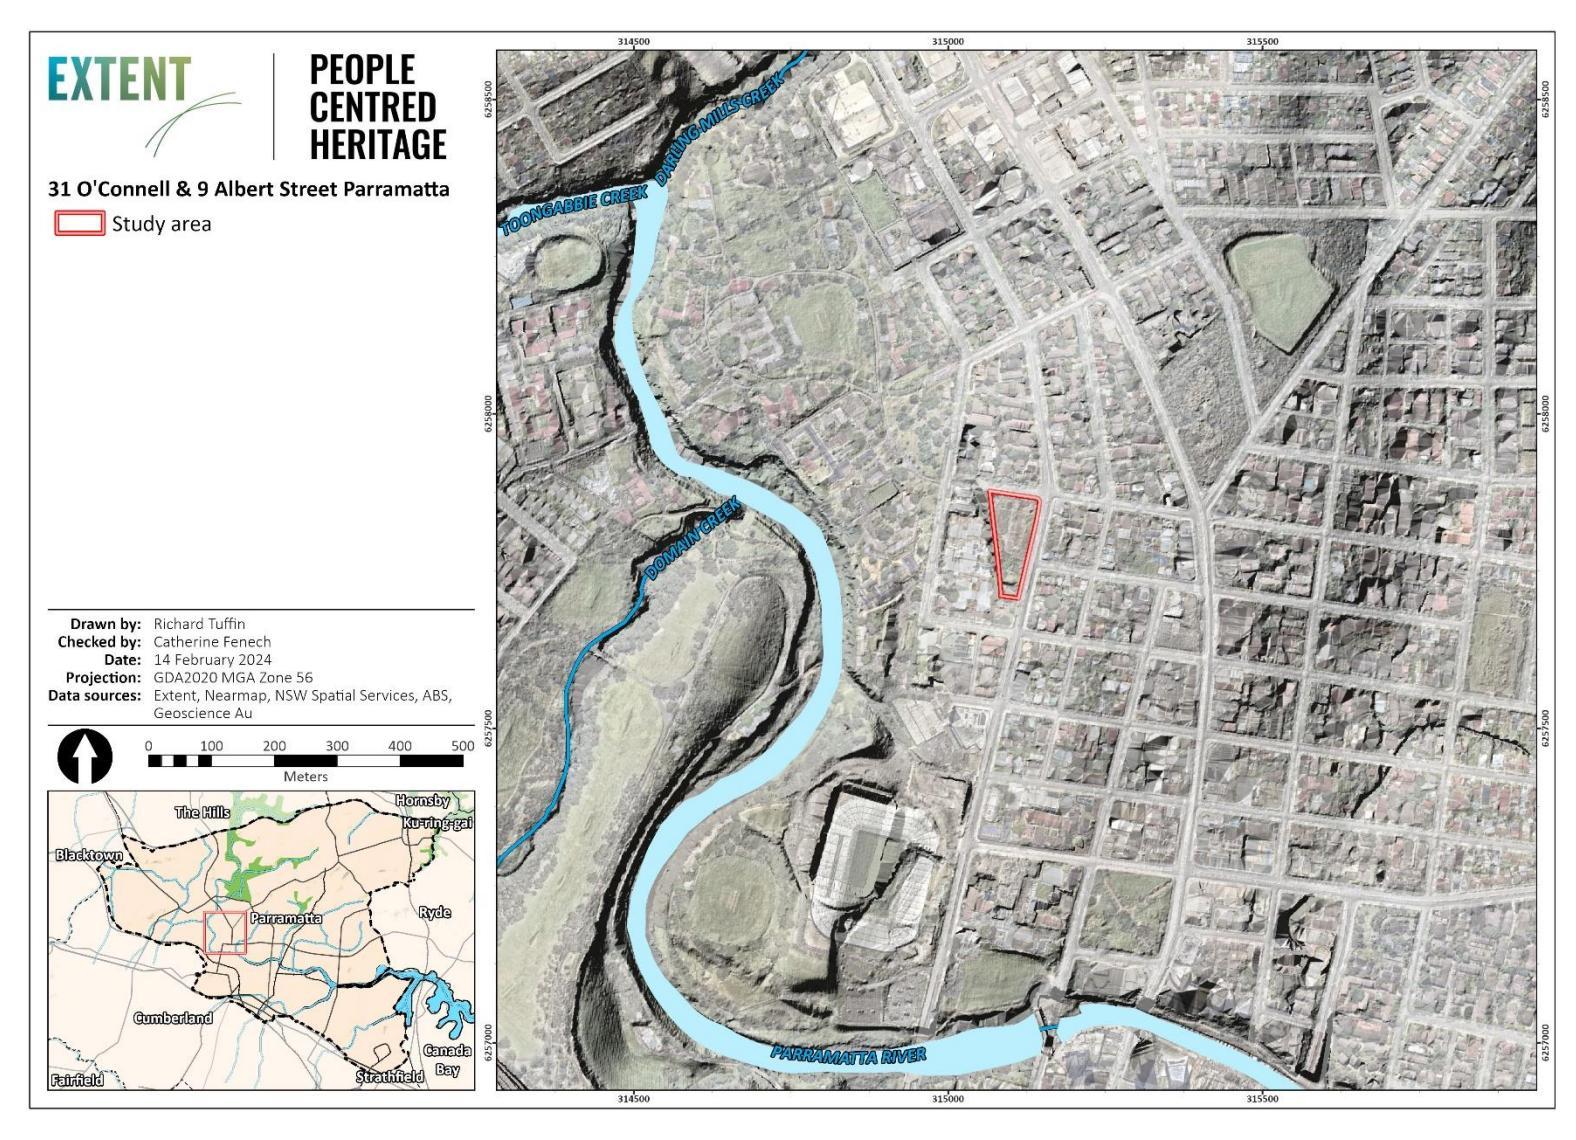
#### Figure 7. Hydrology.

In general, land within 200m of water is identified by DPIE as being likely to contain Aboriginal objects, which encompasses a small part of the south-western corner of the study area.

Based on analysis of topography and aerial photography, the southwestern corner of the subject land is within 200m of an unnamed watercourse. There are no other landforms of note in the vicinity of the study area.

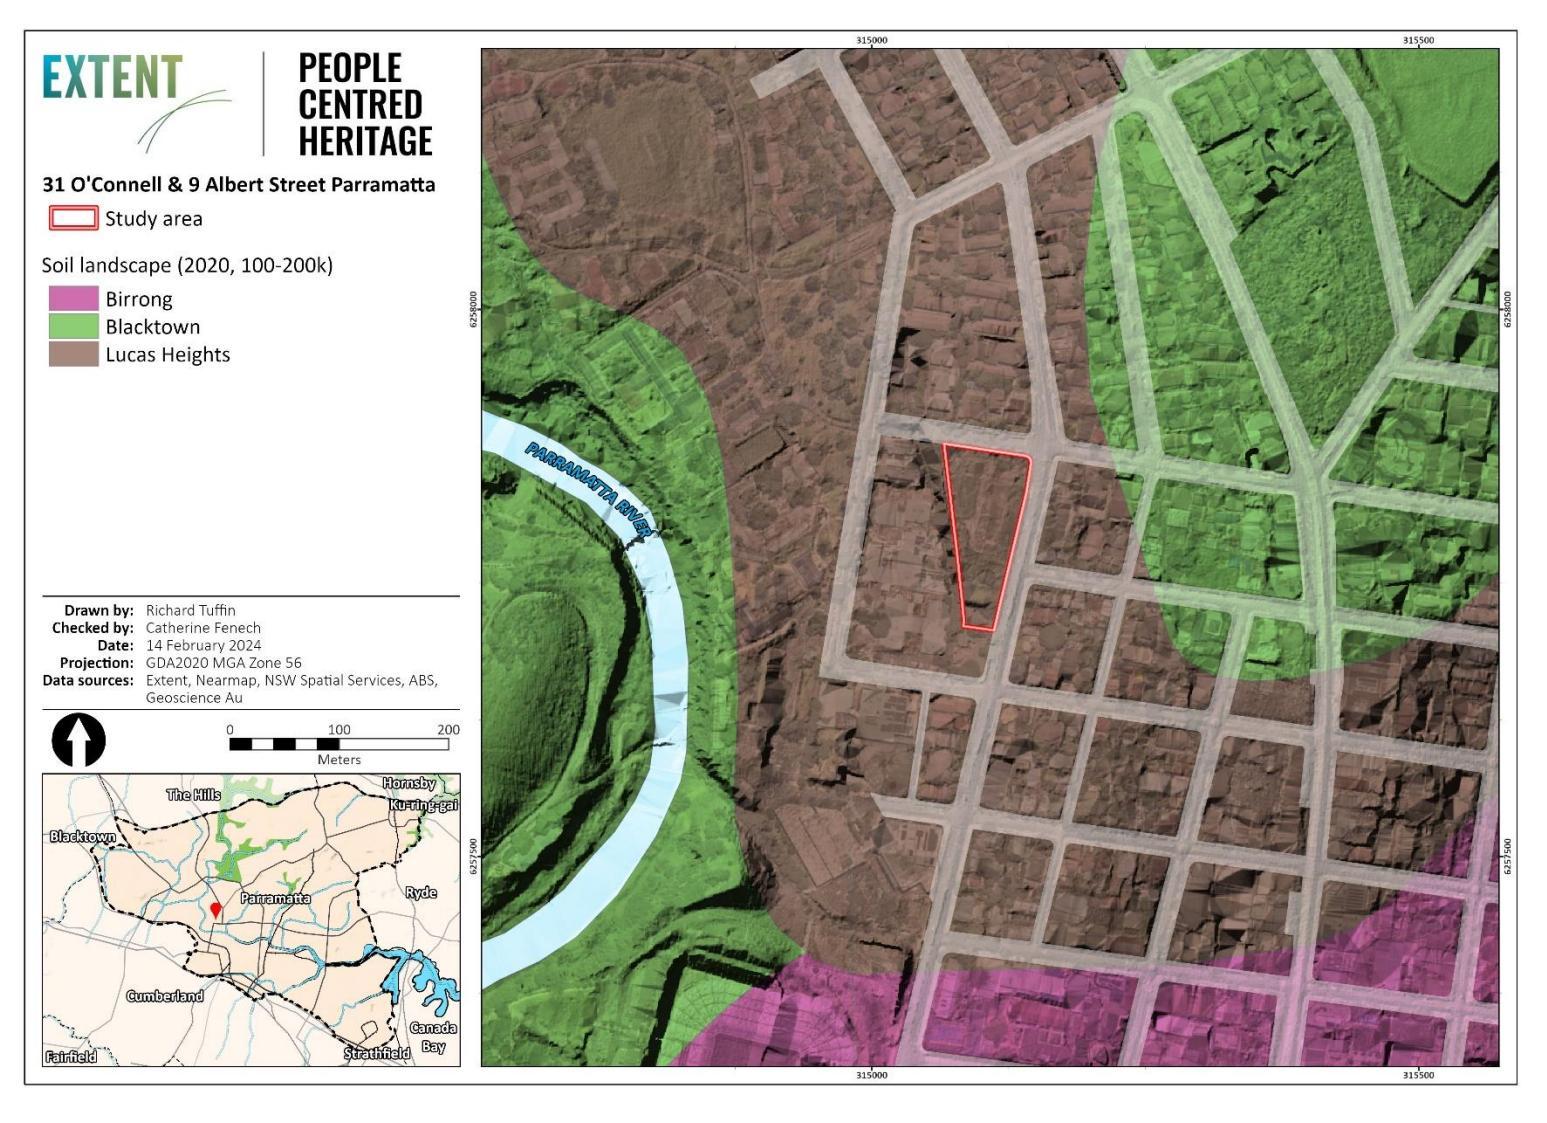
Figure 8. Soil landscapes within and around the study area.

Soil landscape mapping by the NSW Soil Conservation Service suggests that the study area falls within the residual Lucas Heights soil landscape (Figure 8). The Lucas Heights soil landscape is characterised by gently undulating plateaus. Stratigraphically, the formation is

shallow and located between the Ashfield Shale and Hawkesbury Sandstone. Dominant soil materials in the Lucas Heights soil landscape includes loose yellowish-brown sandy loam (<30 cm) and hard-setting bleached clay loam (10–30 cm) with abundant stones (A horizons), overlaying a yellowish-brown pedal clay (B horizon). Roots and charcoal fragments are common inclusions within the A horizon. In addition, the A horizon can sometimes overlie another layer which generally occurs as a subsoil (B horizon) that developed on the coarser Hawkesbury Sandstone along the slopes of the soil landscape (Chapman and Murphy 1989). This layer consists of a yellowish-brown sandy clay loam with apedal massive structure and earthy porous fabric.

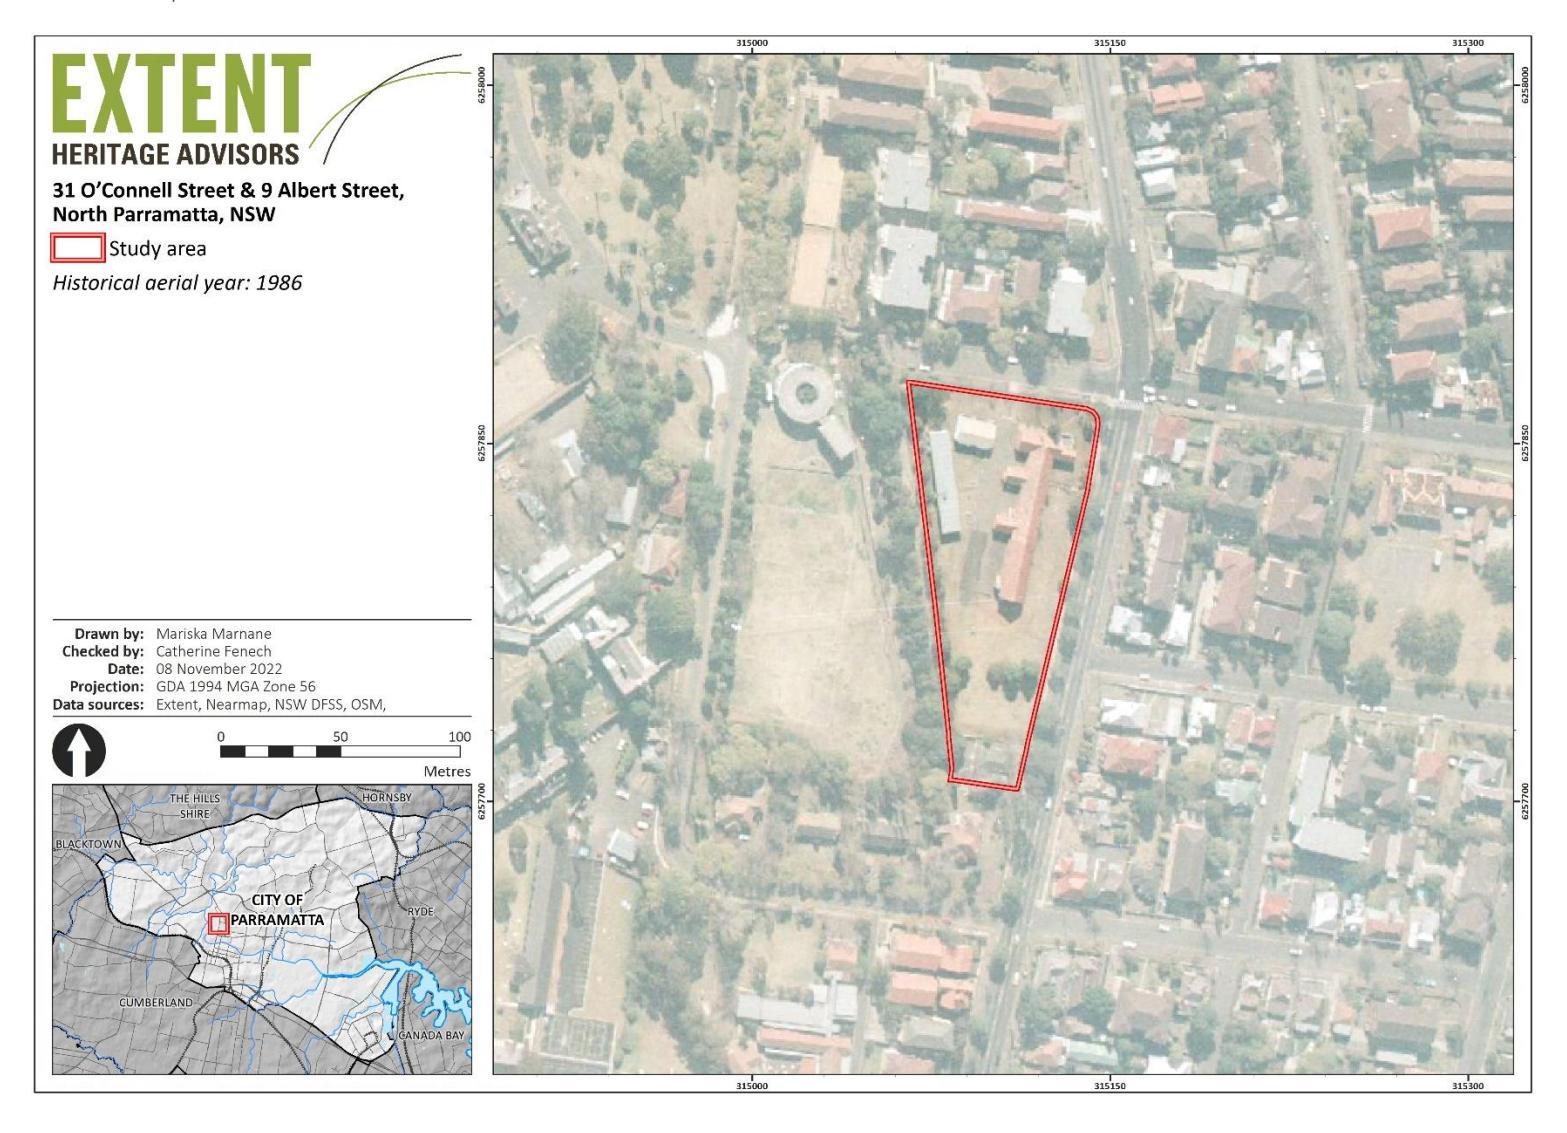
#### Figure 14. 1986 aerial imagery.

- By the 1980s this small shed along the western boundary had been replaced by a larger shed, but this structure was demolished by 2005 (Figure 14 and Figure 15).

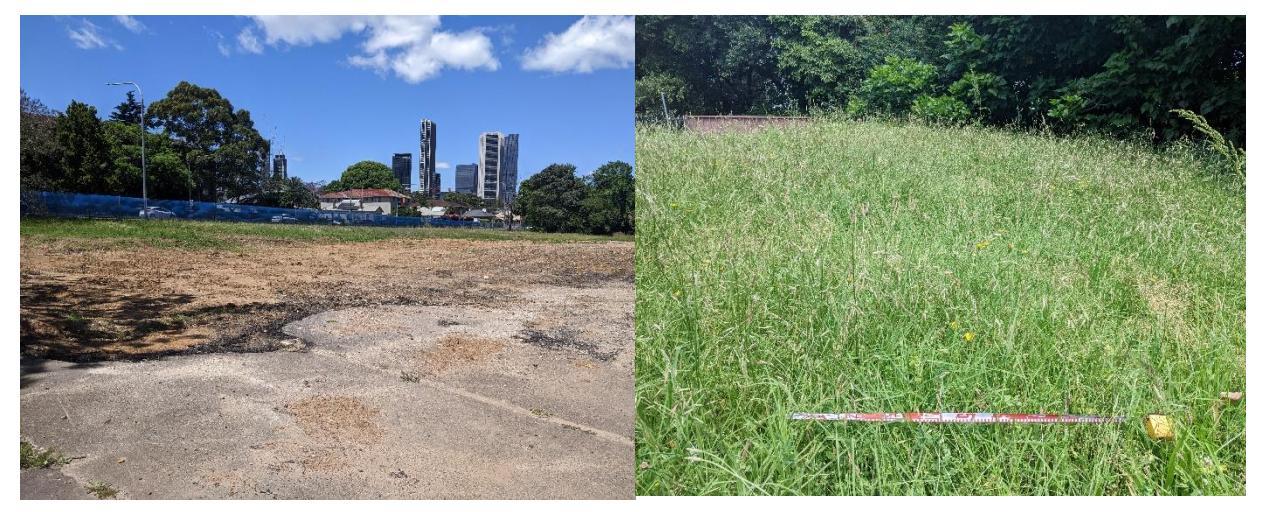
Photograph 1. General view of site and location of Photograph 2. Long grass in southern portion of demolished buildings. Note gentle slope of site. Viewstudy area. towards O'Connell Street.

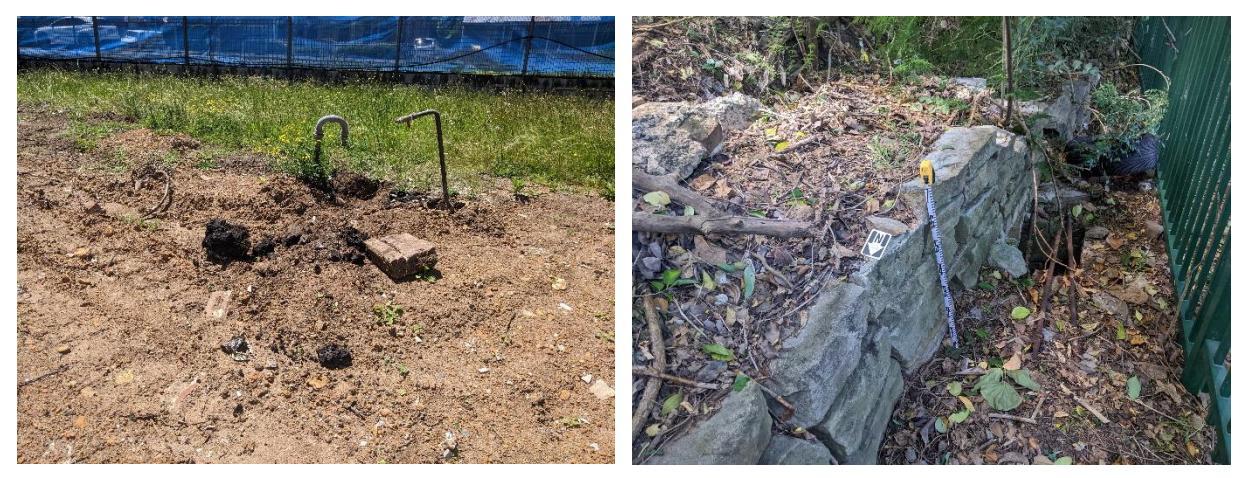
Photograph 3. Utilities and services in area of Photograph 4. Sandstone retaining wall and drain on demolition. western boundary of study area.

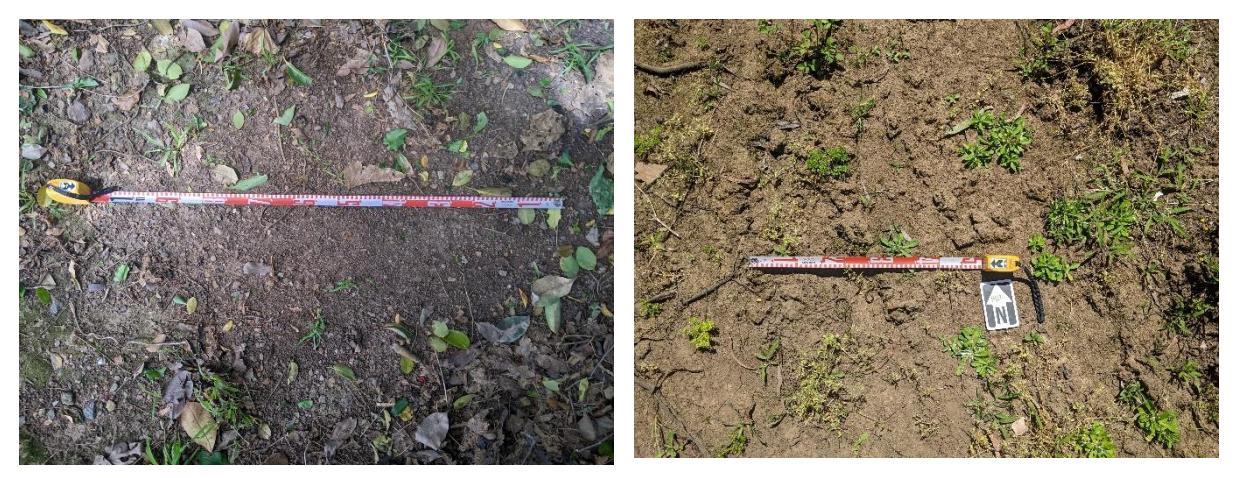
Ground surface exposures across the study area further reinforce the cut back and truncated nature of the study area. In the south-western corner of the study area, ground surface exposures were observed beneath mature trees along the boundary. Soil exposures here revealed a patchy and thin, dark brown sandy clay topsoil with a high organic content, but this unit is considered a recent formation caused by the decomposition of surface leaf litter. In this and other areas across the site, the soil profile comprised a sandy clay to heavy pedal clay with frequent sandstone fragments and ironstone fragments, suggesting that the upper part of the soil profile has been removed. This is particularly evident in a cut observed from the recent demolition activities.

Photograph 5. Area of exposure of silty clay and leaf Photograph 6. Exposure of sandy clay, eastern part litter in south western part of study area.

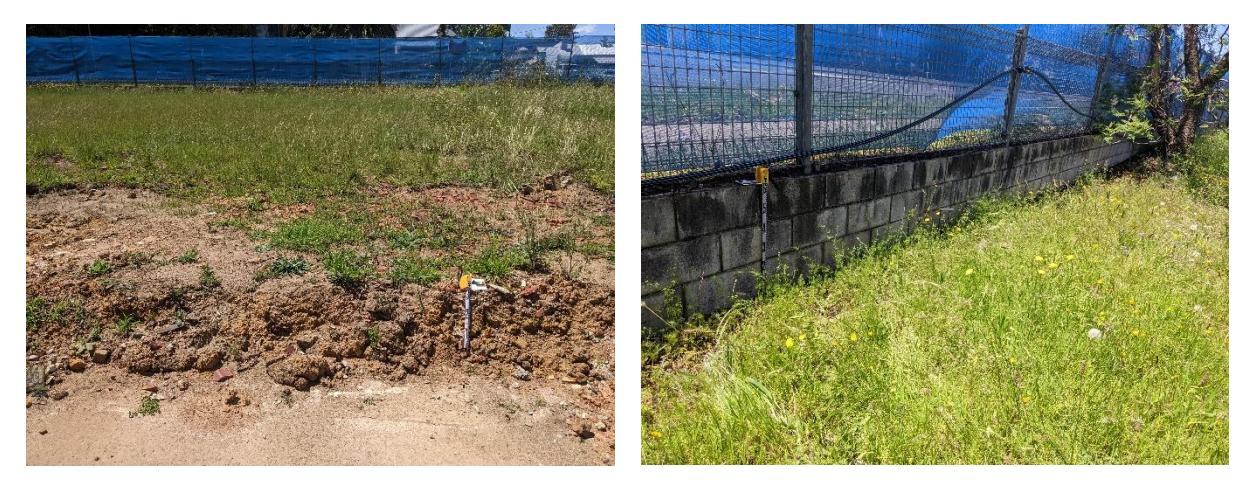
Photograph 7. Exposure in cutting from demolition, Photograph 8. Retaining wall along eastern showing clay soils. boundary of study area.

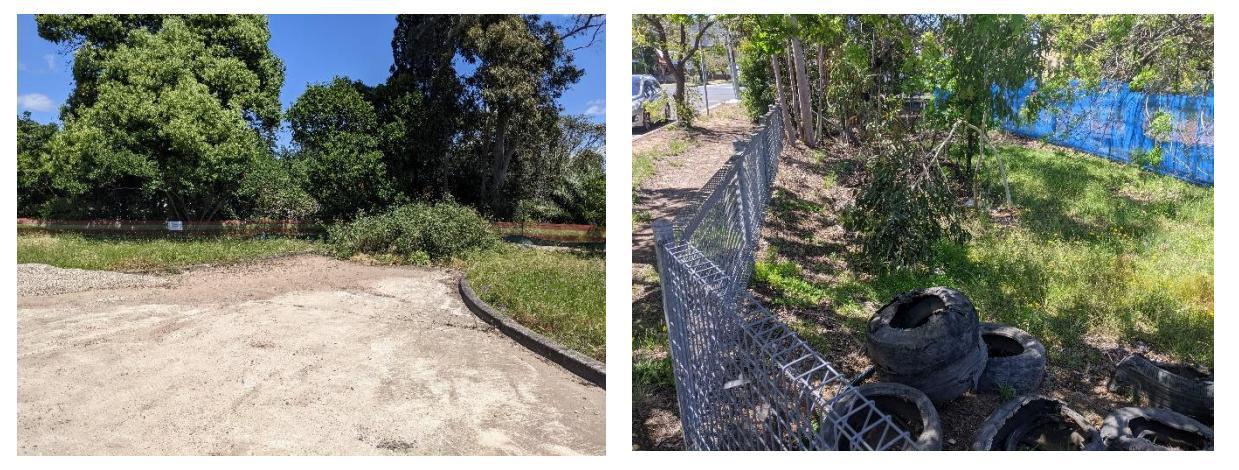
Photograph 9. Former concrete driveway with Photograph 10. Site entrance showing cut slop away kerbing.
