24 October 2023

Ecological Assessment – Existing Advertising Signs, Wentworth Avenue, Eastlake

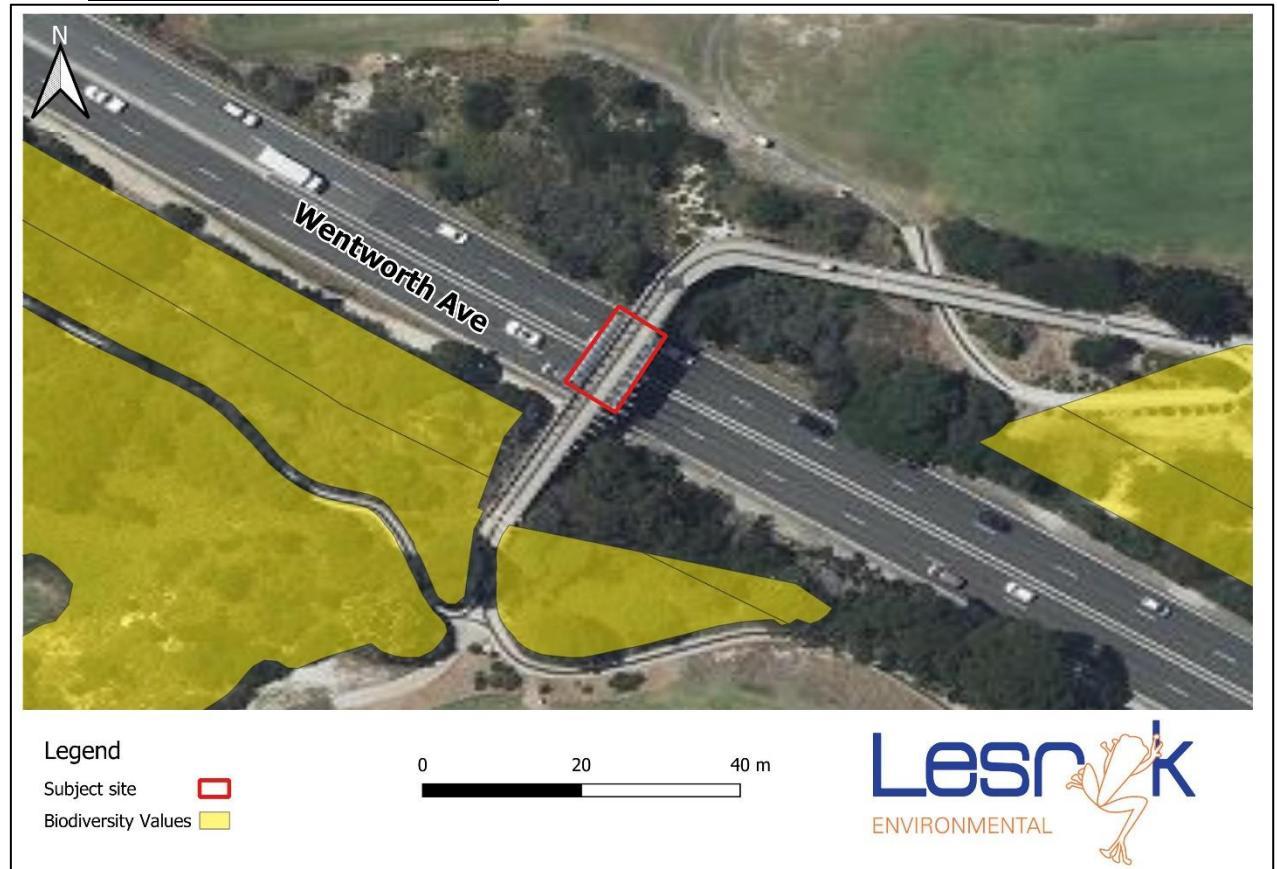
Lesryk Environmental Pty Ltc PO Box 3001 Bundeena NSW 2230 E admin@lesryk.com.au M 0408 258 129 W lesryk.com.au Figure 1. Biodiversity Vales map

The areas of Biodiversity Values that were mapped (Figure 1) in the adjacent land would not be impacted by the ongoing operation and maintenance of the signs. Additionally the installation work for these signs was undertaken within the road corridor of Wentworth

Avenue, therefore not impacting these areas. To permit the initial installation work, and the ongoing operation/maintenance, no vegetation was/is required to be cleared.
