#### PROPOSED RURAL SUBDIVISION 407 CROOKWELL ROAD, KINGSDALE, NSW EFFLUENT DISPOSAL – SITE AND SOIL EVALUATION

At the request of Southern Region Land Engineering, ACT Geotechnical Engineers Pty. Ltd carried out an effluent disposal assessment to AS1547 "On-Site domestic wastewater management", for the proposed rural subdivision at 407 Crookwell Road, in Kingsdale, NSW.

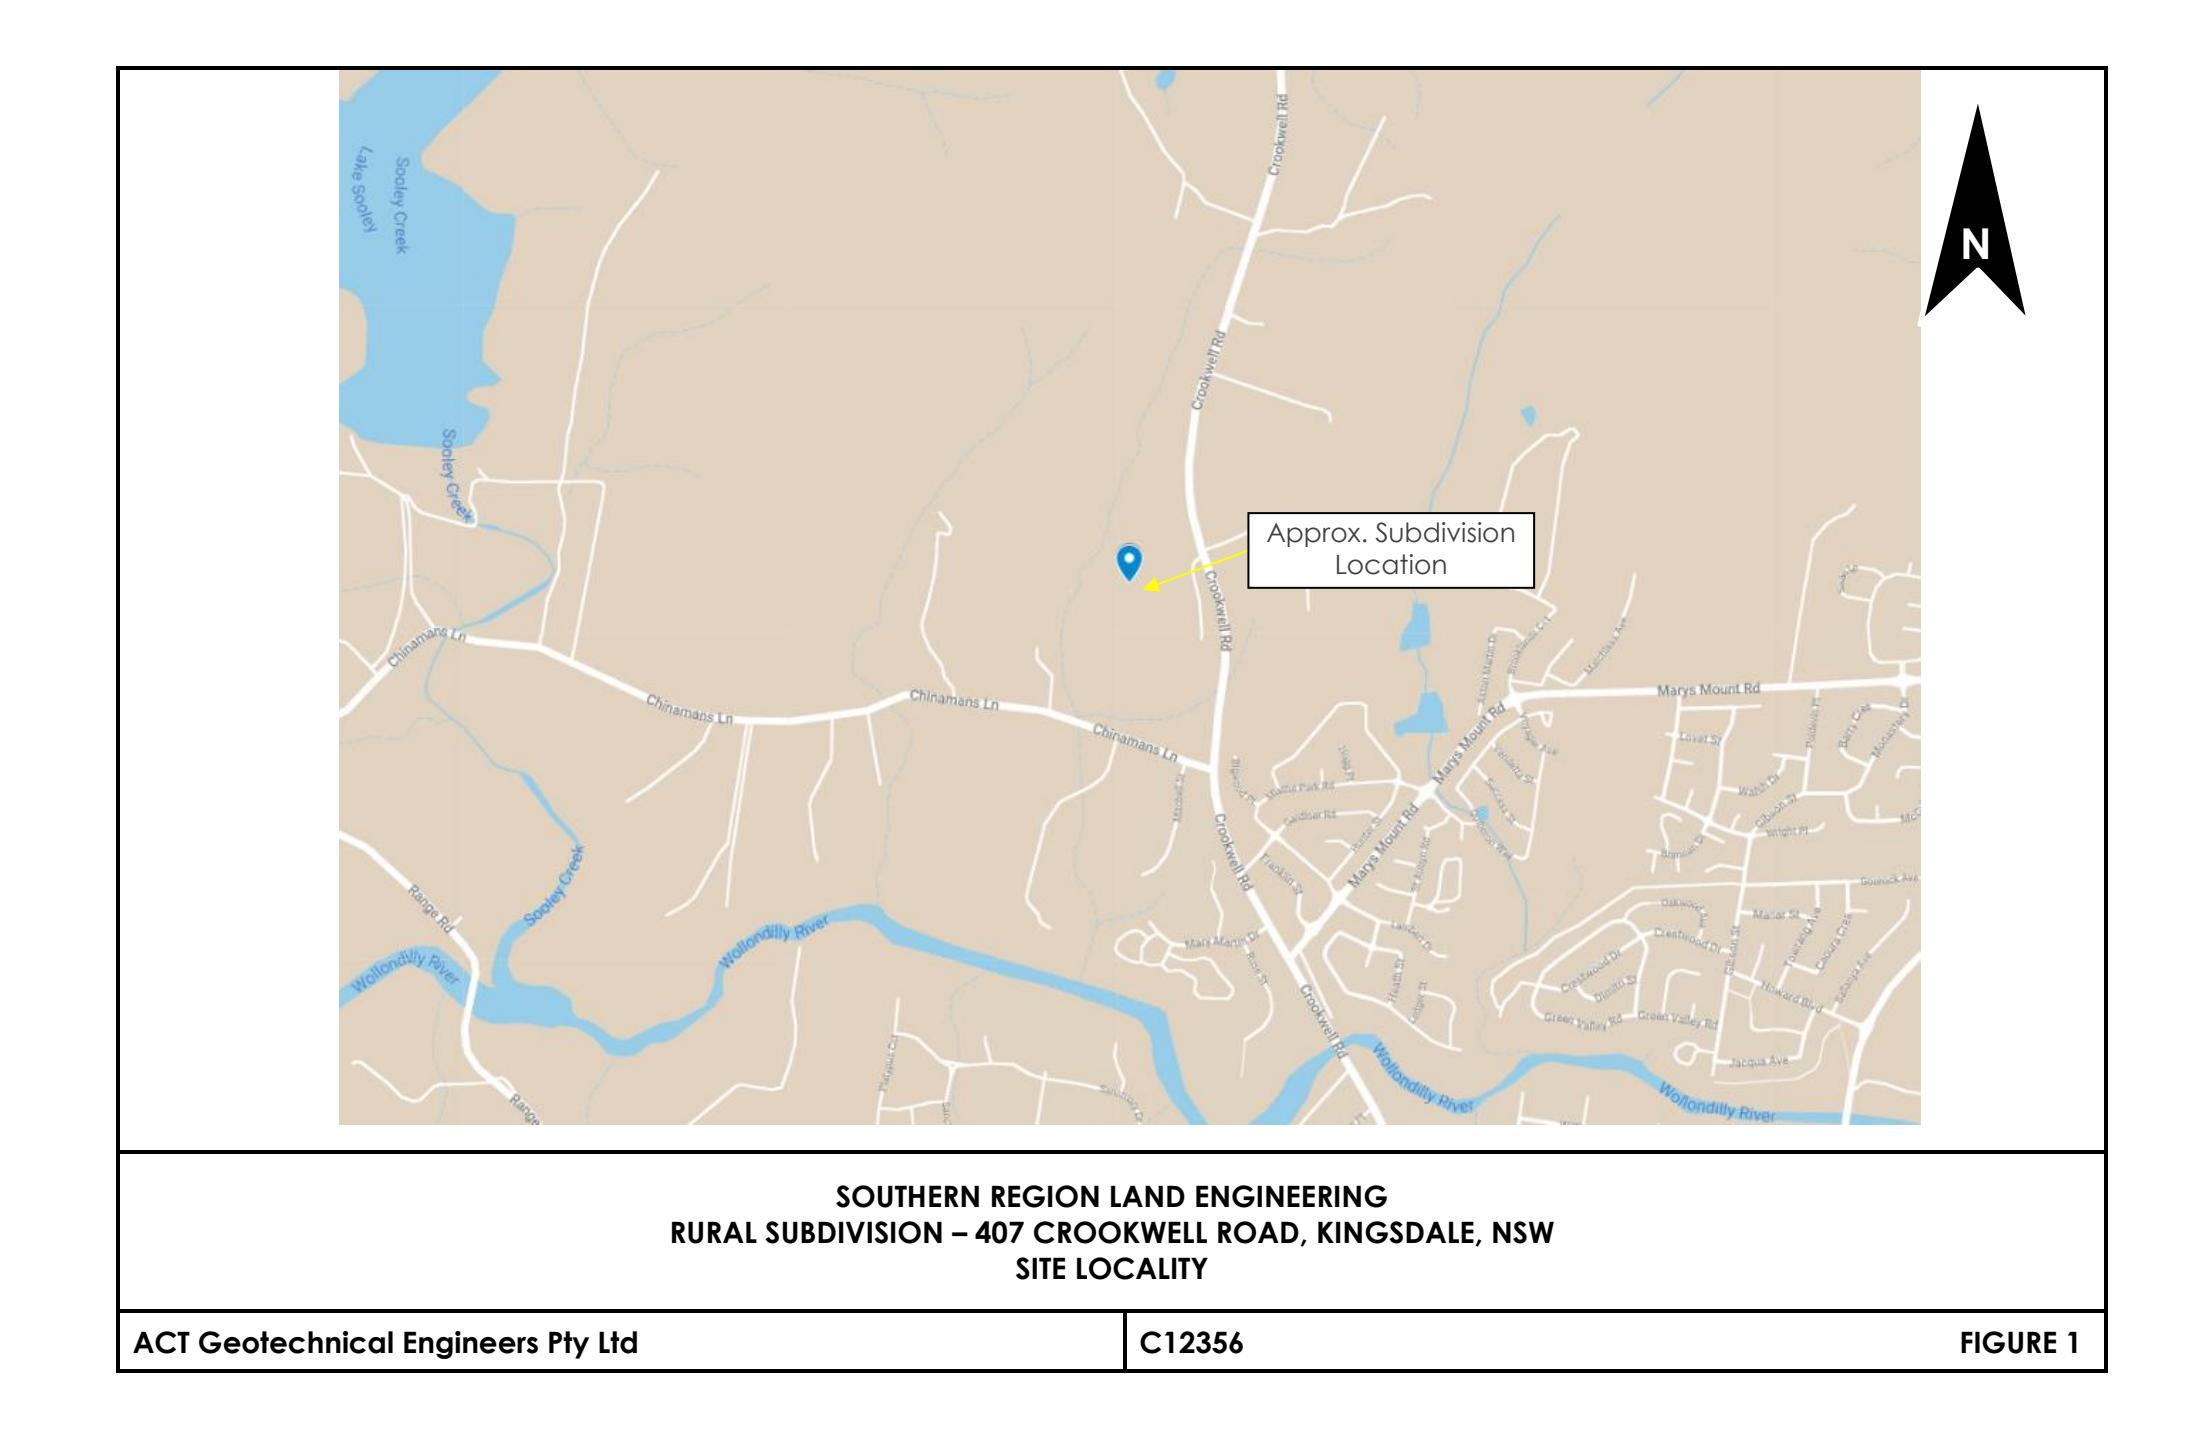
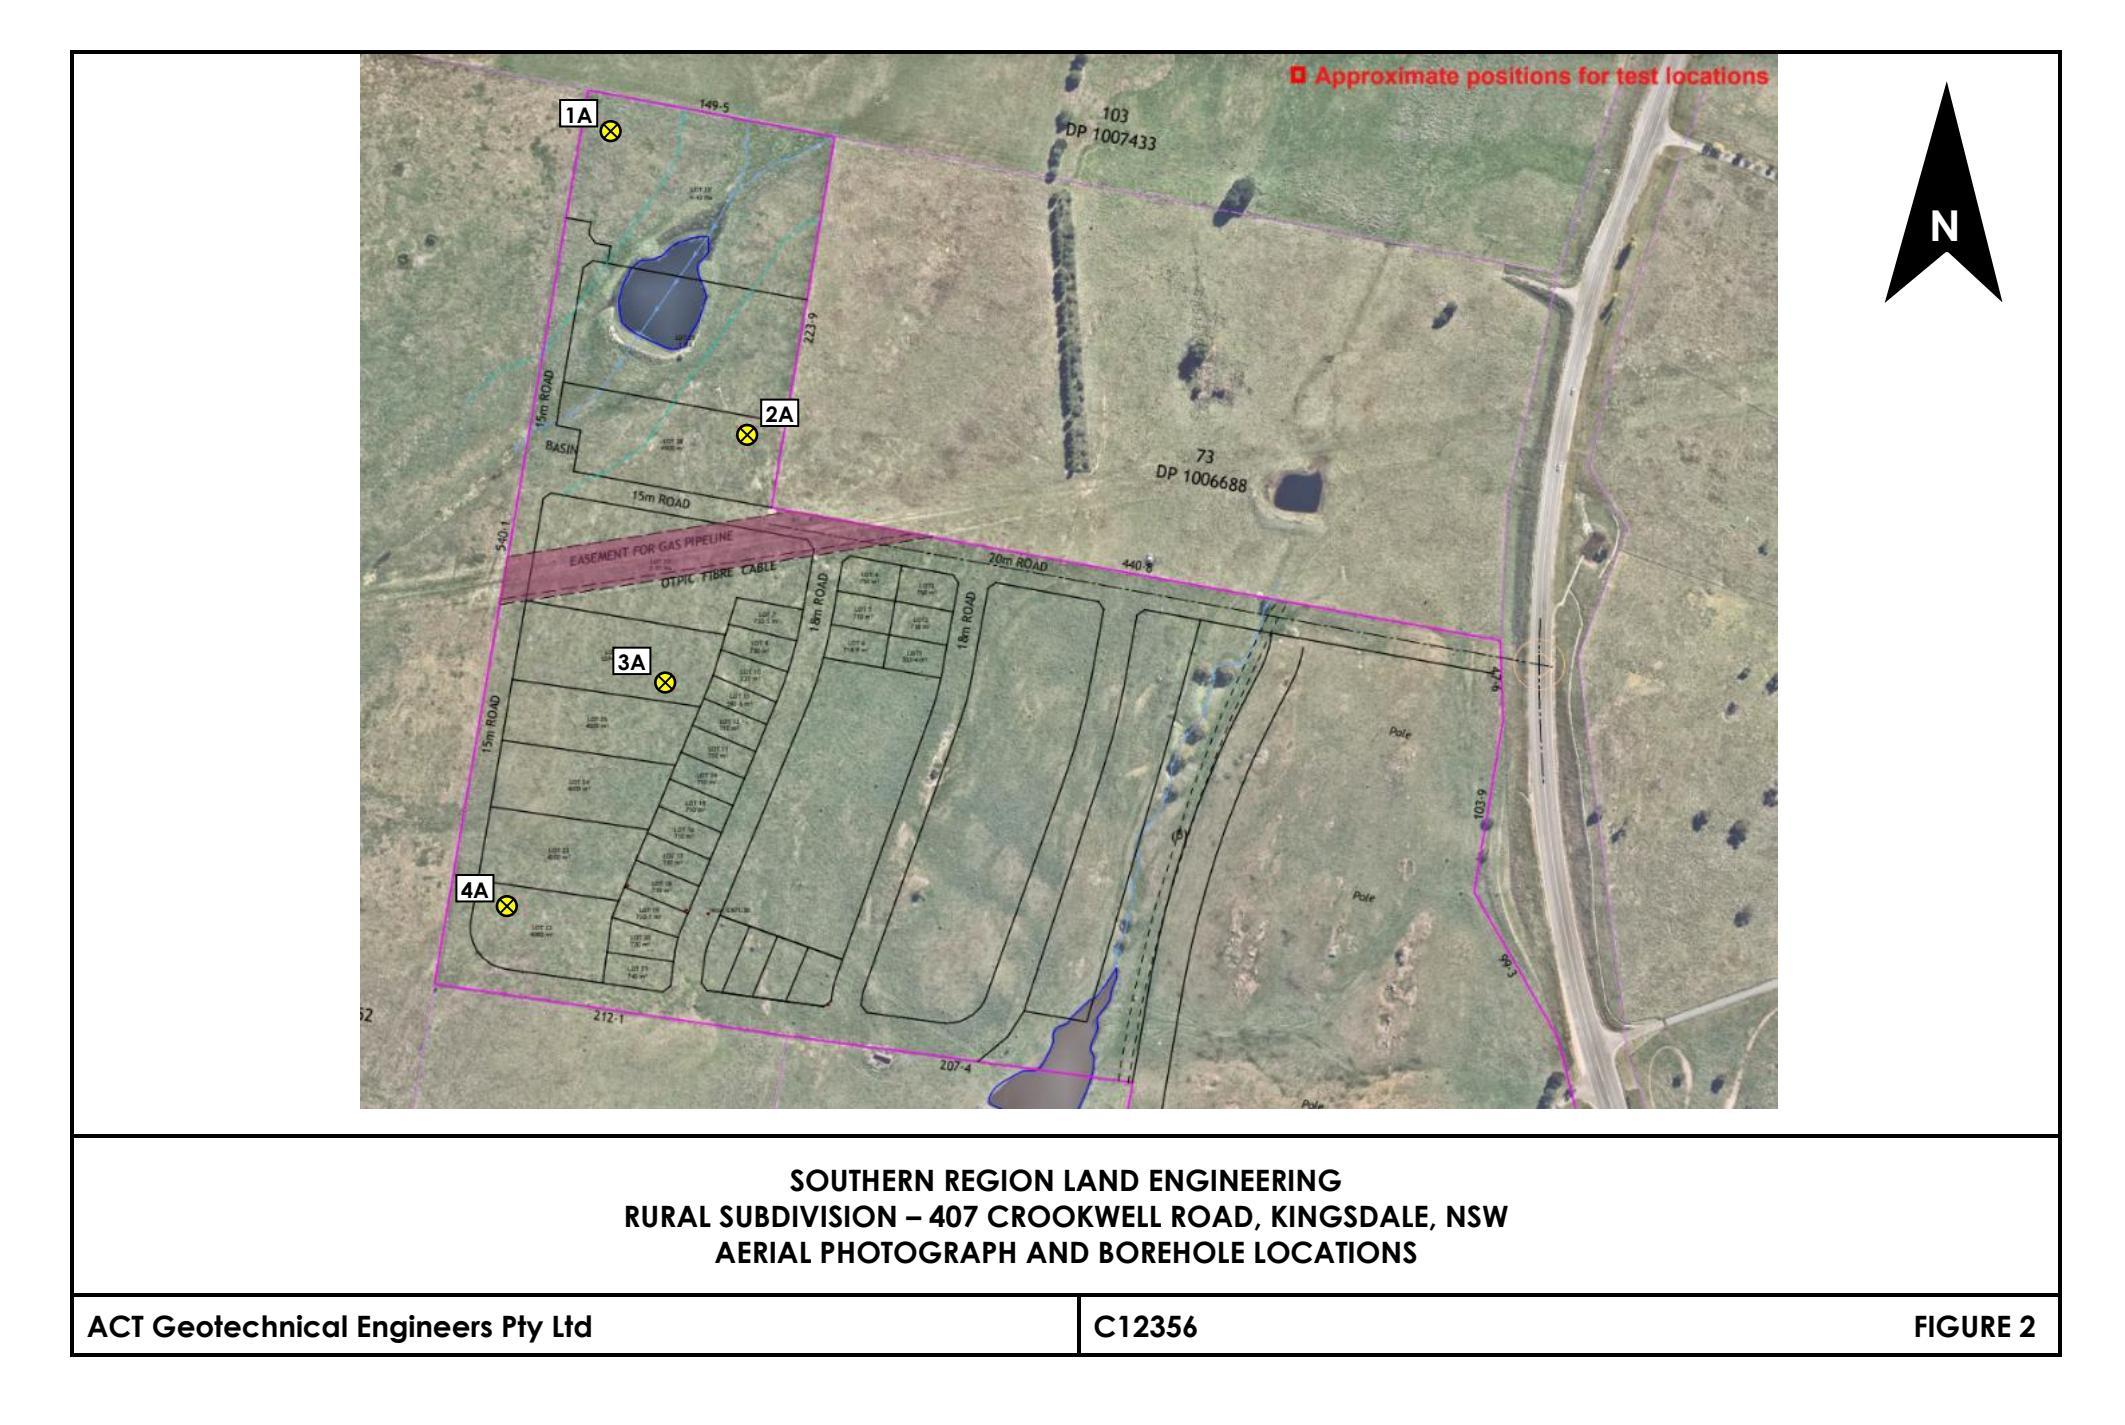
To establish the subsurface conditions, four (4) test holes were drilled at client-provided locations around the proposed subdivision. Figure 1 shows the site locality, while Figures 2 and 3 are aerial photographs showing the location of the investigation boreholes. The subsurface profiles were logged in terms of the Unified Soil Classification System (USCS). The borehole logs can be found in Appendix B.
