Arboricultural Implication Assessment and Arboricultural Method Statement

For proposed apartment development 39-41 Chertsey Avenue, Bankstown, NSW

Prepared 15th August, 2015 by Victor John Molyneaux B.E.;M.Eng.Sc.;M.B.A.; AQF Level 5 Arboriculture

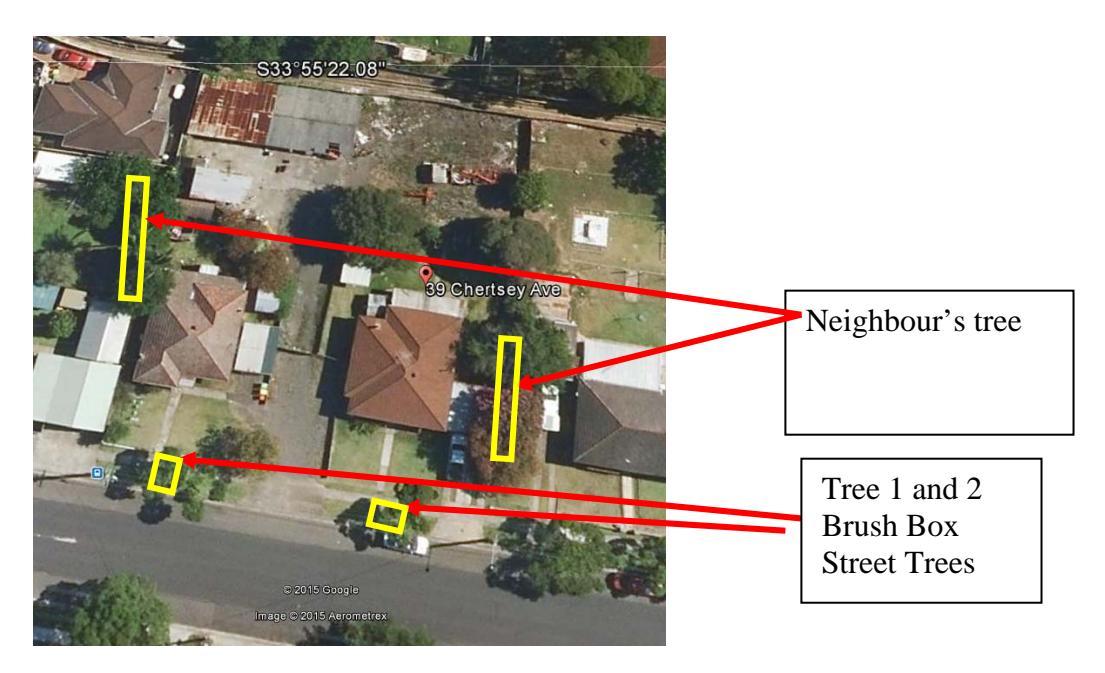
Position of Trees under Protection

Table 3 defines the tree protection zone, areas available and incursions into the tree driplines. According to the generous allowance preferred by Australian Standard 4970 there would be adequate tree protection areas for the retained trees.
