# **SOIL SALINITY REPORT**

230 Sixth Avenue, 80 Edmondson Avenue and 155 Fifth Avenue Austral, NSW 2179

Austral 1 Pty Ltd – October 2016

Report reference: 1601112Rpt01FinalV01\_12Oct16

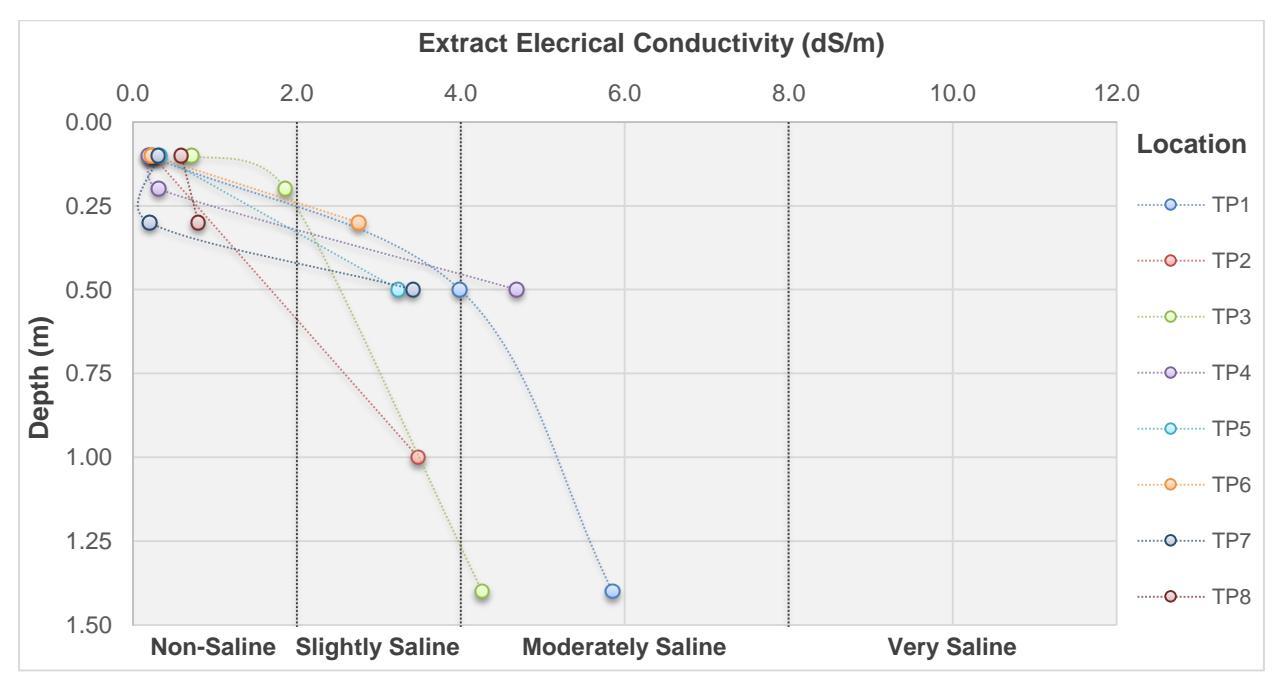
Laboratory results indicate that soil salinity increases with depth across the site; no correlation was observed between salinity and landform features. The  $EC_e$  of soil in each location is plotted against depth in the following chart:

Geo-Logix assessed the salinity class of each soil type based on the range and average of  $EC_e$  values. Topsoil and Fill appear to be generally 'Non-saline', with an  $EC_e$  range of 0.20 to 0.80 dS/m. Underlying low plasticity clays appear to be 'Slightly saline' to 'Moderately saline' with a  $EC_e$  range of 1.86 to 5.85 dS/m.

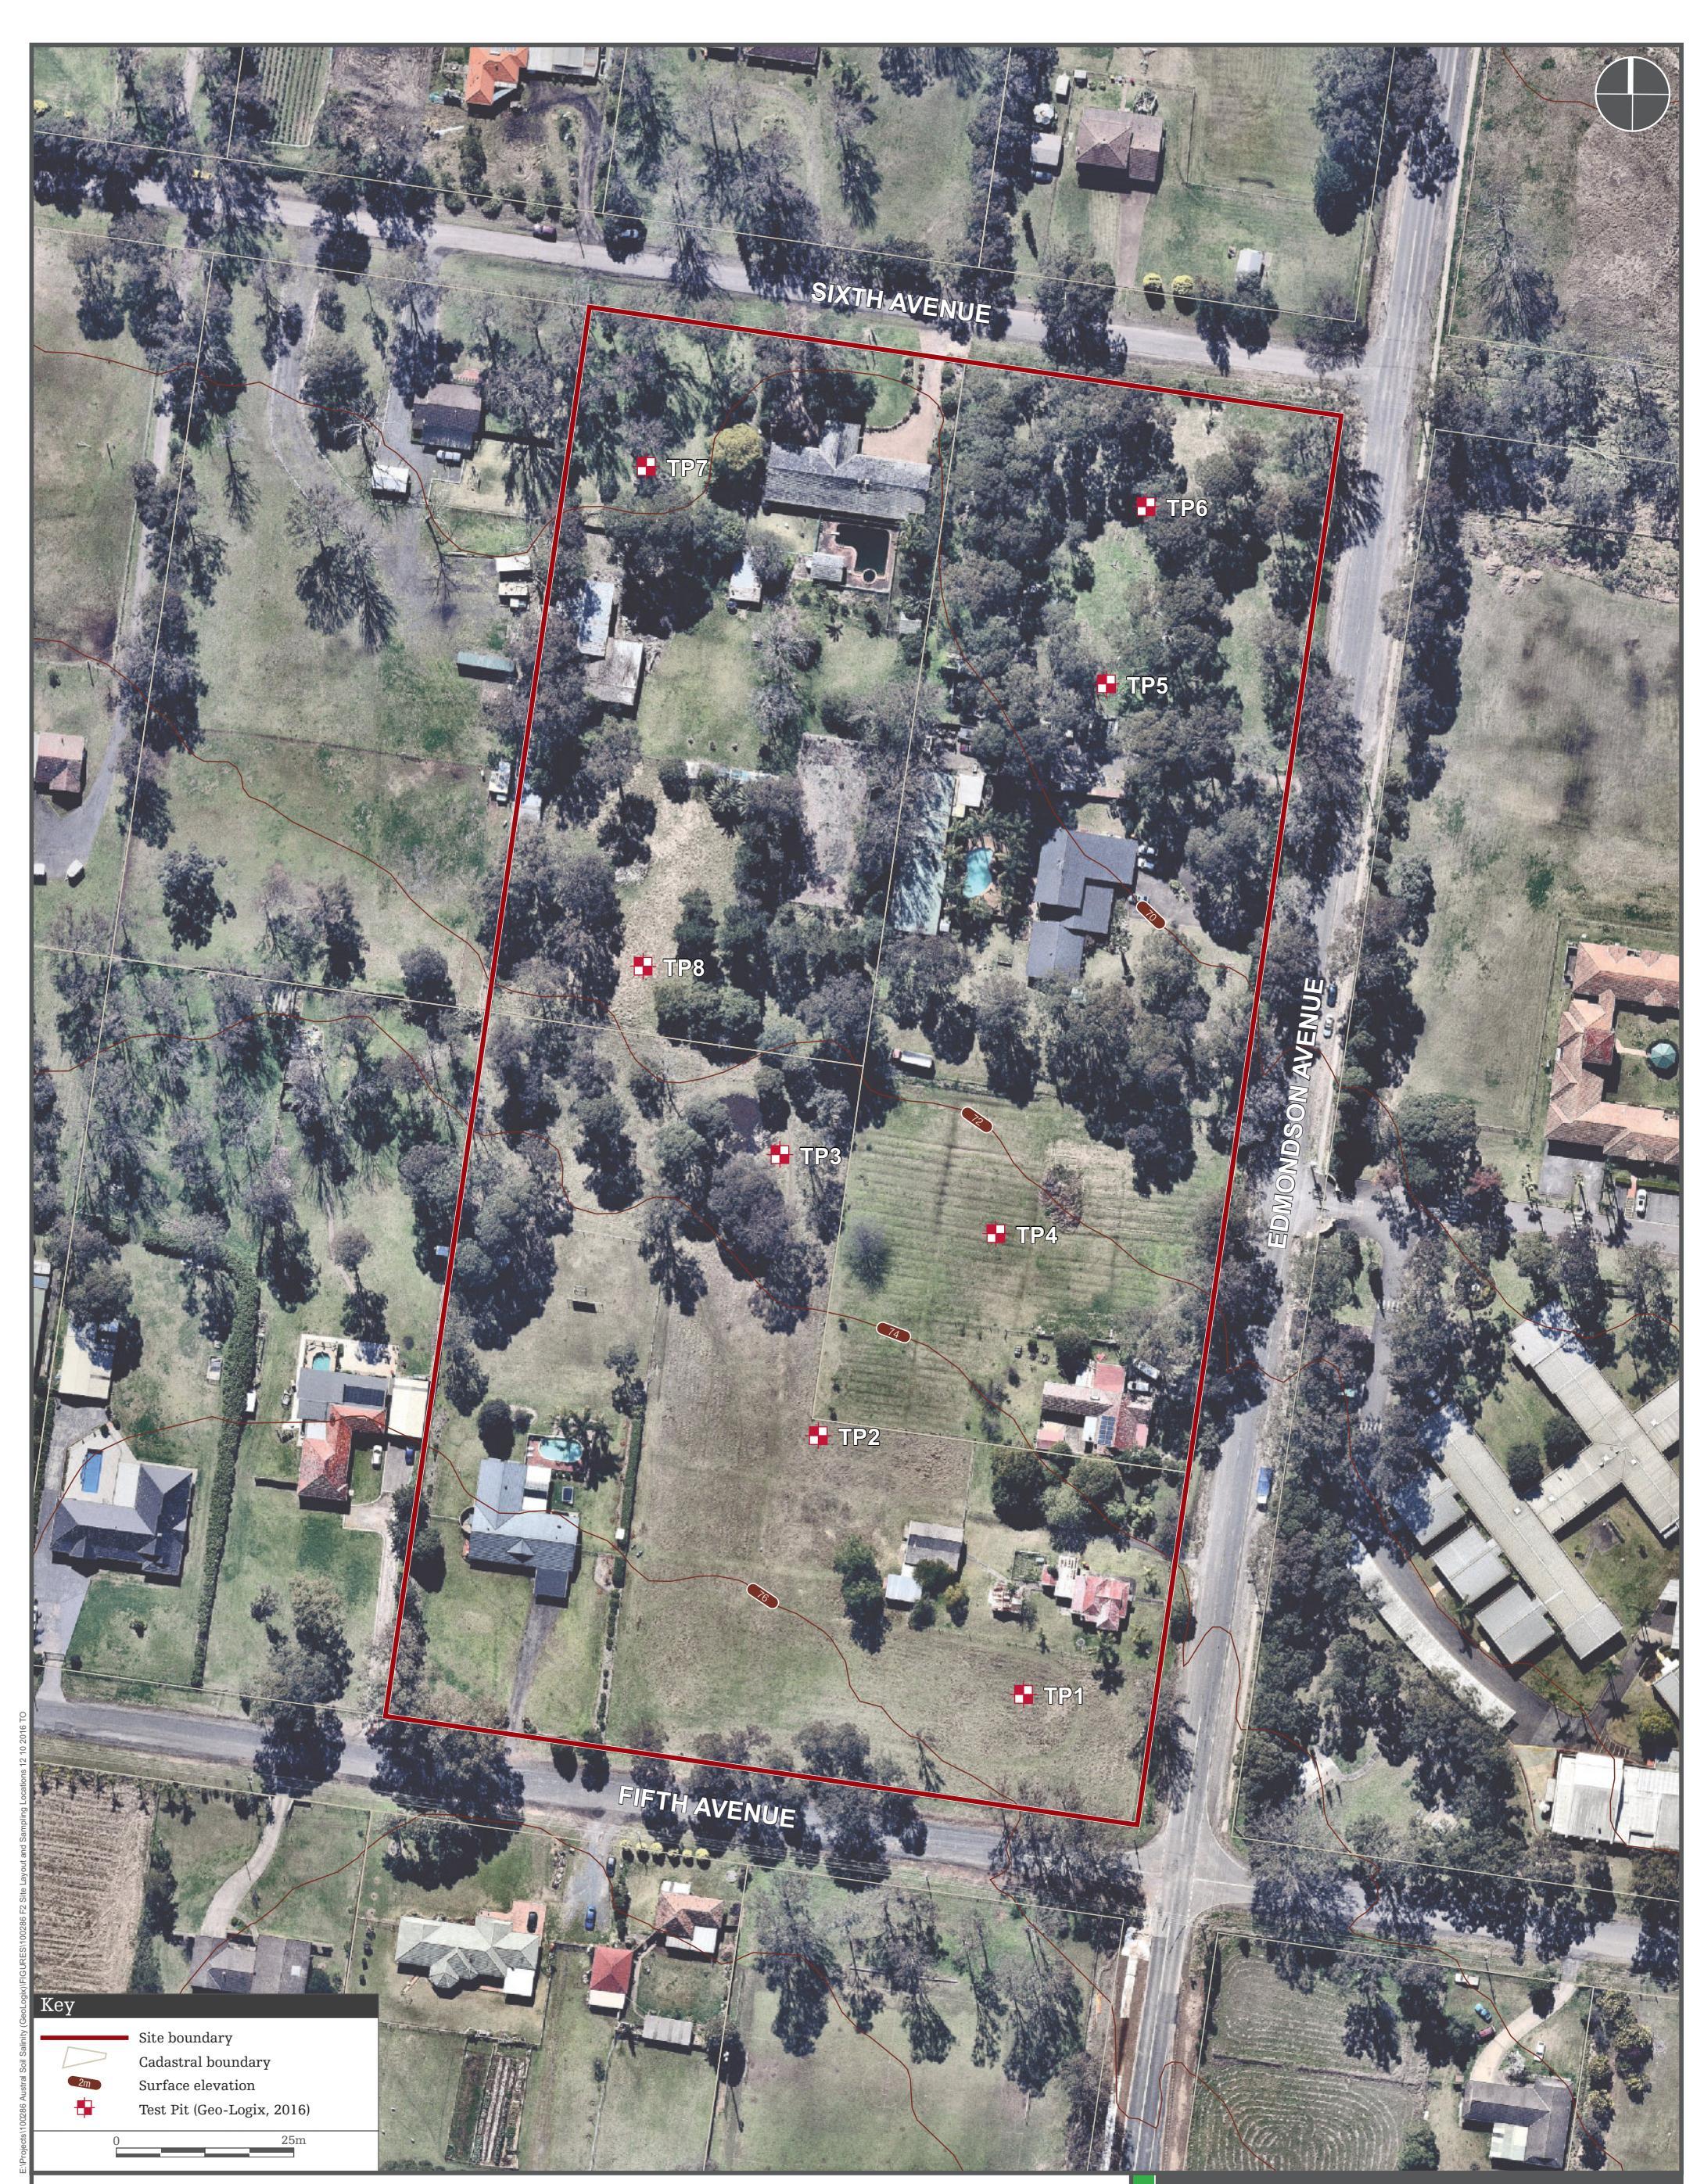
Figure 2

# SITE LAYOUT AND SAMPLING LOCATIONS

Soil Salinity Report 230 Sixth Avenue, 155 Fifth Avenue and 80 Edmondson Avenue Austral, New South Wales

The site is located within a rural/residential area on the western side of Edmondson Avenue, within the western Sydney suburb of Austral, NSW (Figure 2). The site consists of two rectangular-shaped lots and one L-shaped lot, encompassing a total area of 48,539 m<sup>2</sup>. At the time of Geo-Logix investigation, the properties contained five houses, three swimming pools, large grassed paddocks with sheep, a vehicle wreckage area and a tennis court. No salt scalds or distressed vegetation were observed during the investigation.

Test pits were completed to a maximum depth of 1.5 metres below grade (mbg) using an excavator and positioned at locations spread across the site. Test pit locations were selected to provide coverage of each landform type encountered onsite (crest, slope, and channel).
