Re: Site Contamination Assessment and Remediation Annie Street, Wickham, NSW

Remediation Action Plan 49 and 57 Annie Street, Wickham, NSW Investec Australia Finance Pty Limited

Subject: Site Audit of 49 and 57 Annie Street, Wickham, NSW (LBJ 16/09) Interim Audit Advice #1 From Review of Detailed Site Investigation and Remediation Action Plan Geosyntec Project: GSY0072

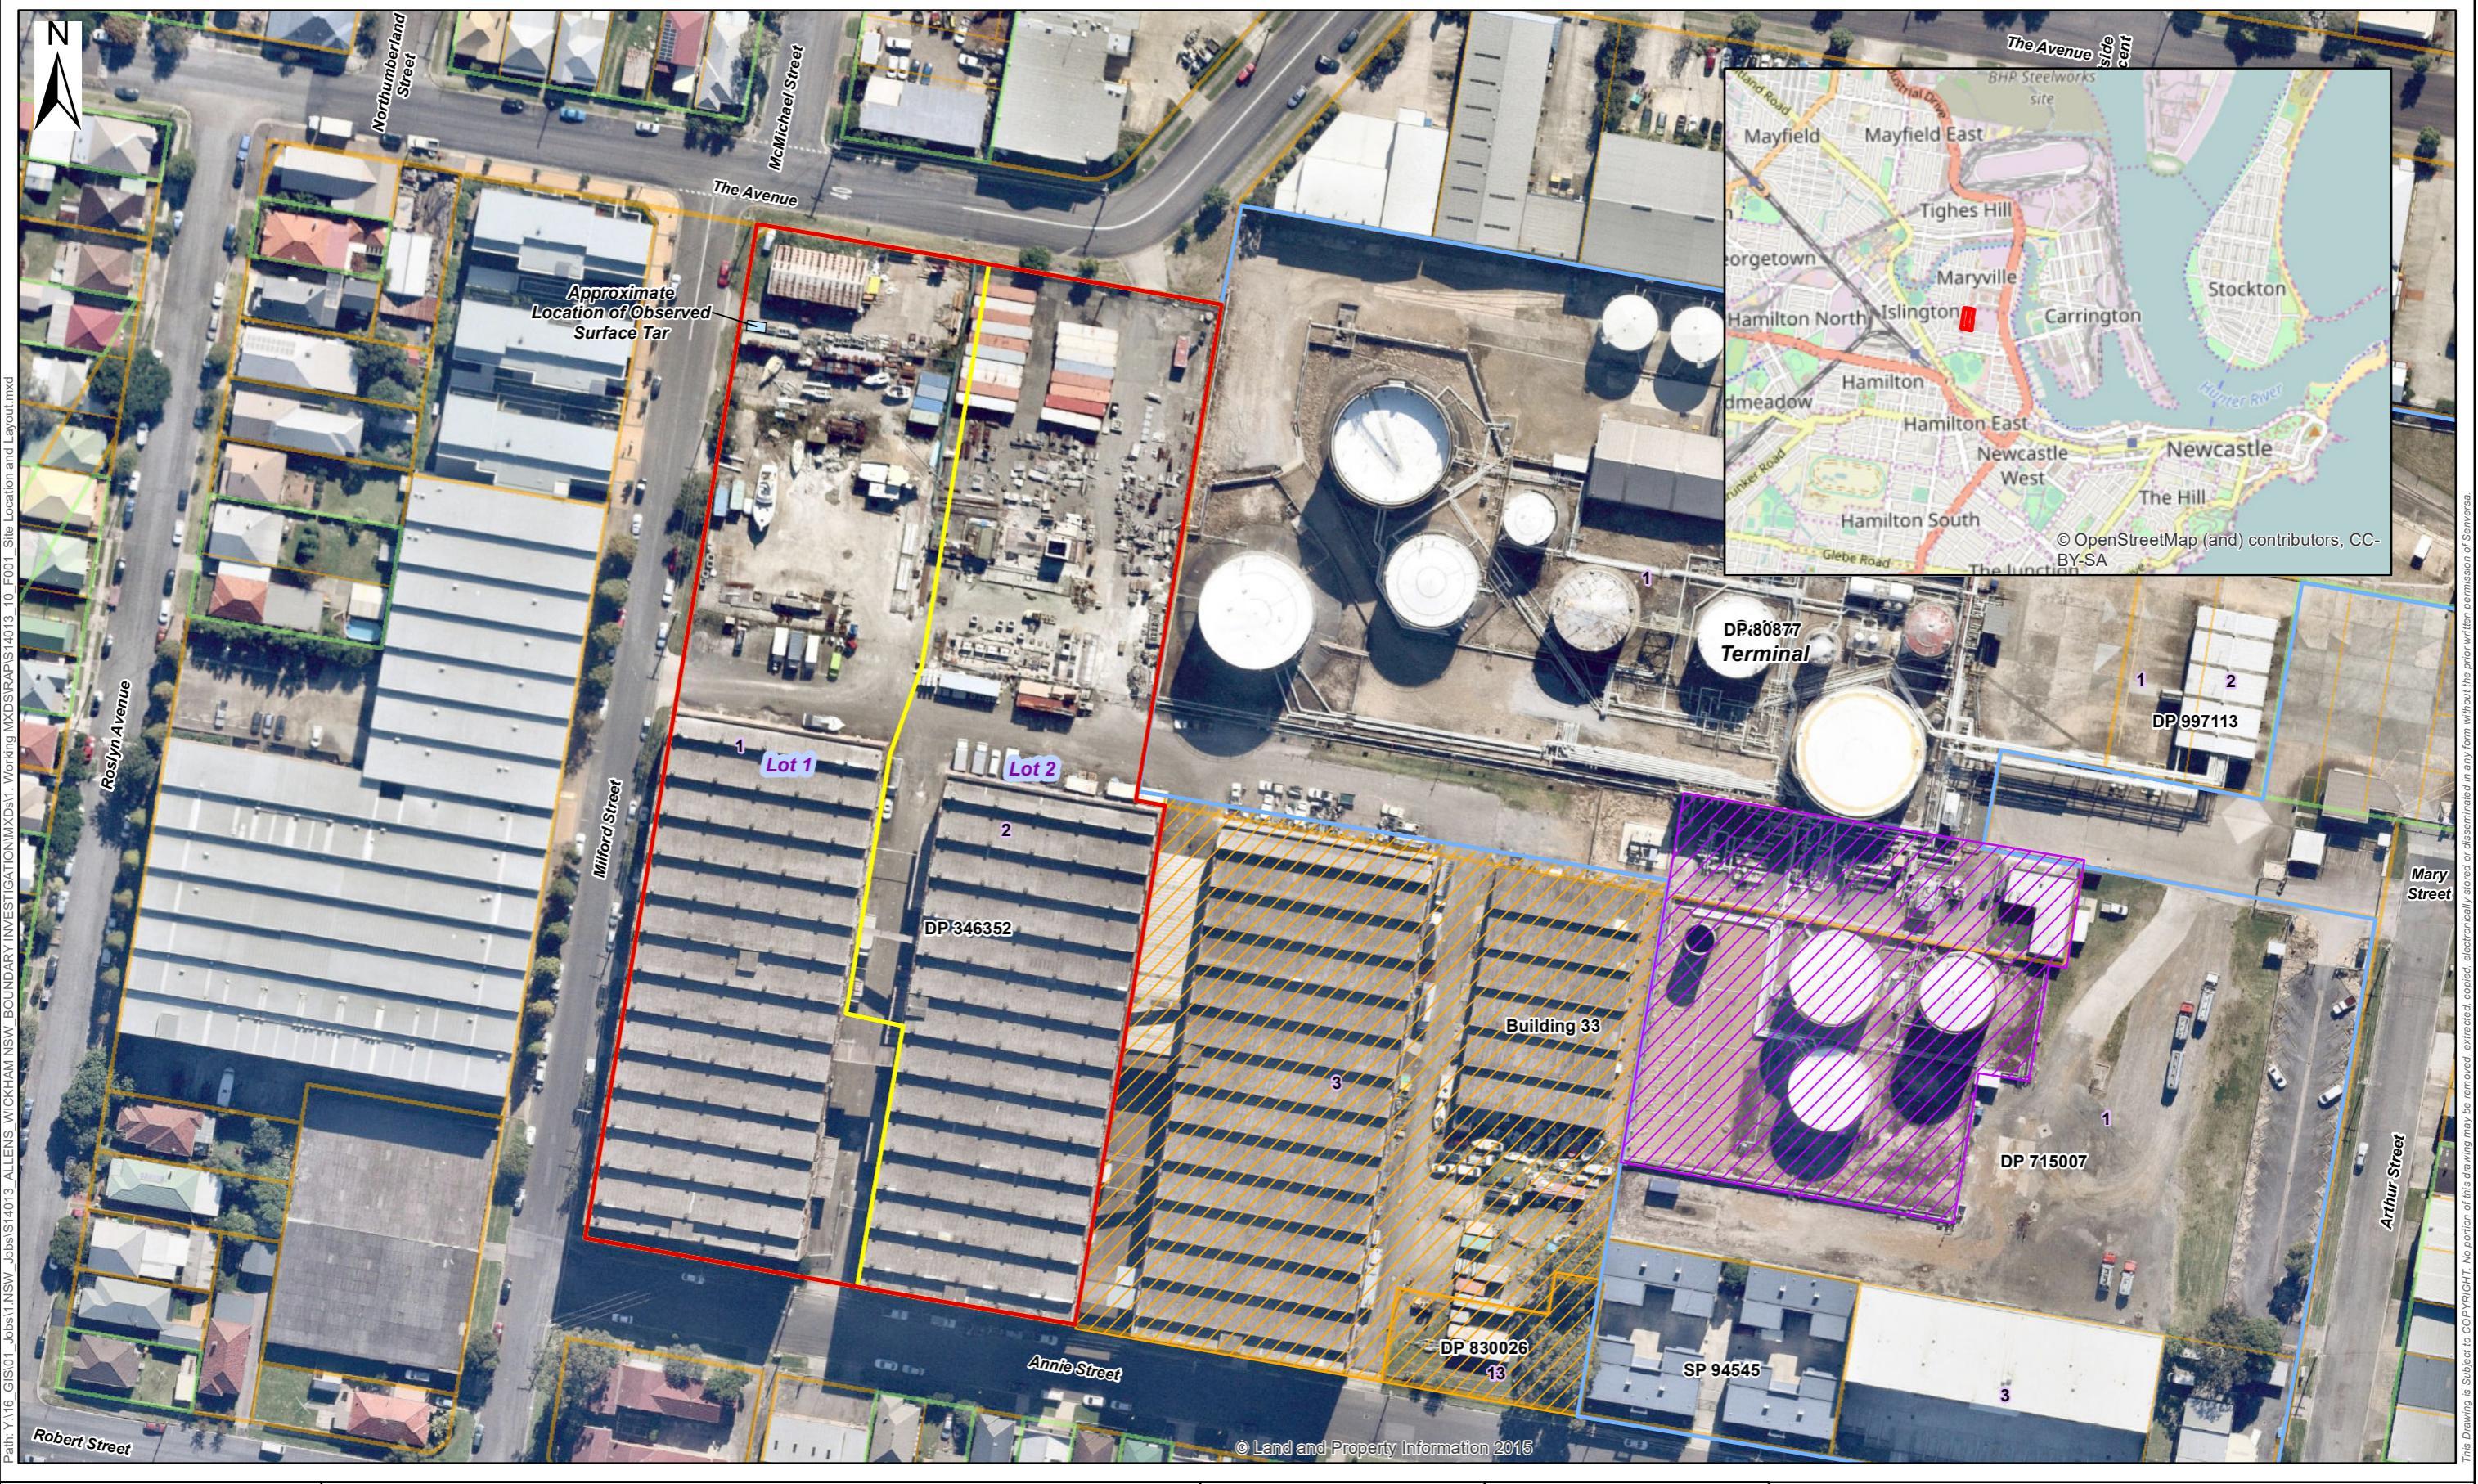
Figure 1: Site Location and Layout

Figure 1 (attached) shows the location and layout of the site, and the distribution of the allotments across the site area. Investec plans to stage the development process, with the first stage being the conversion of the wool store in the southern portion of Lot 1 for residential use, and creation of public open space and stormwater detention in the northern portion of Lot 2
