Report on Site Investigation for Contamination

Proposed Mixed-Use Development 552-568 Oxford Street, Bondi Junction

Prepared for Denscen Pty Ltd

Project 85822.03 December 2017

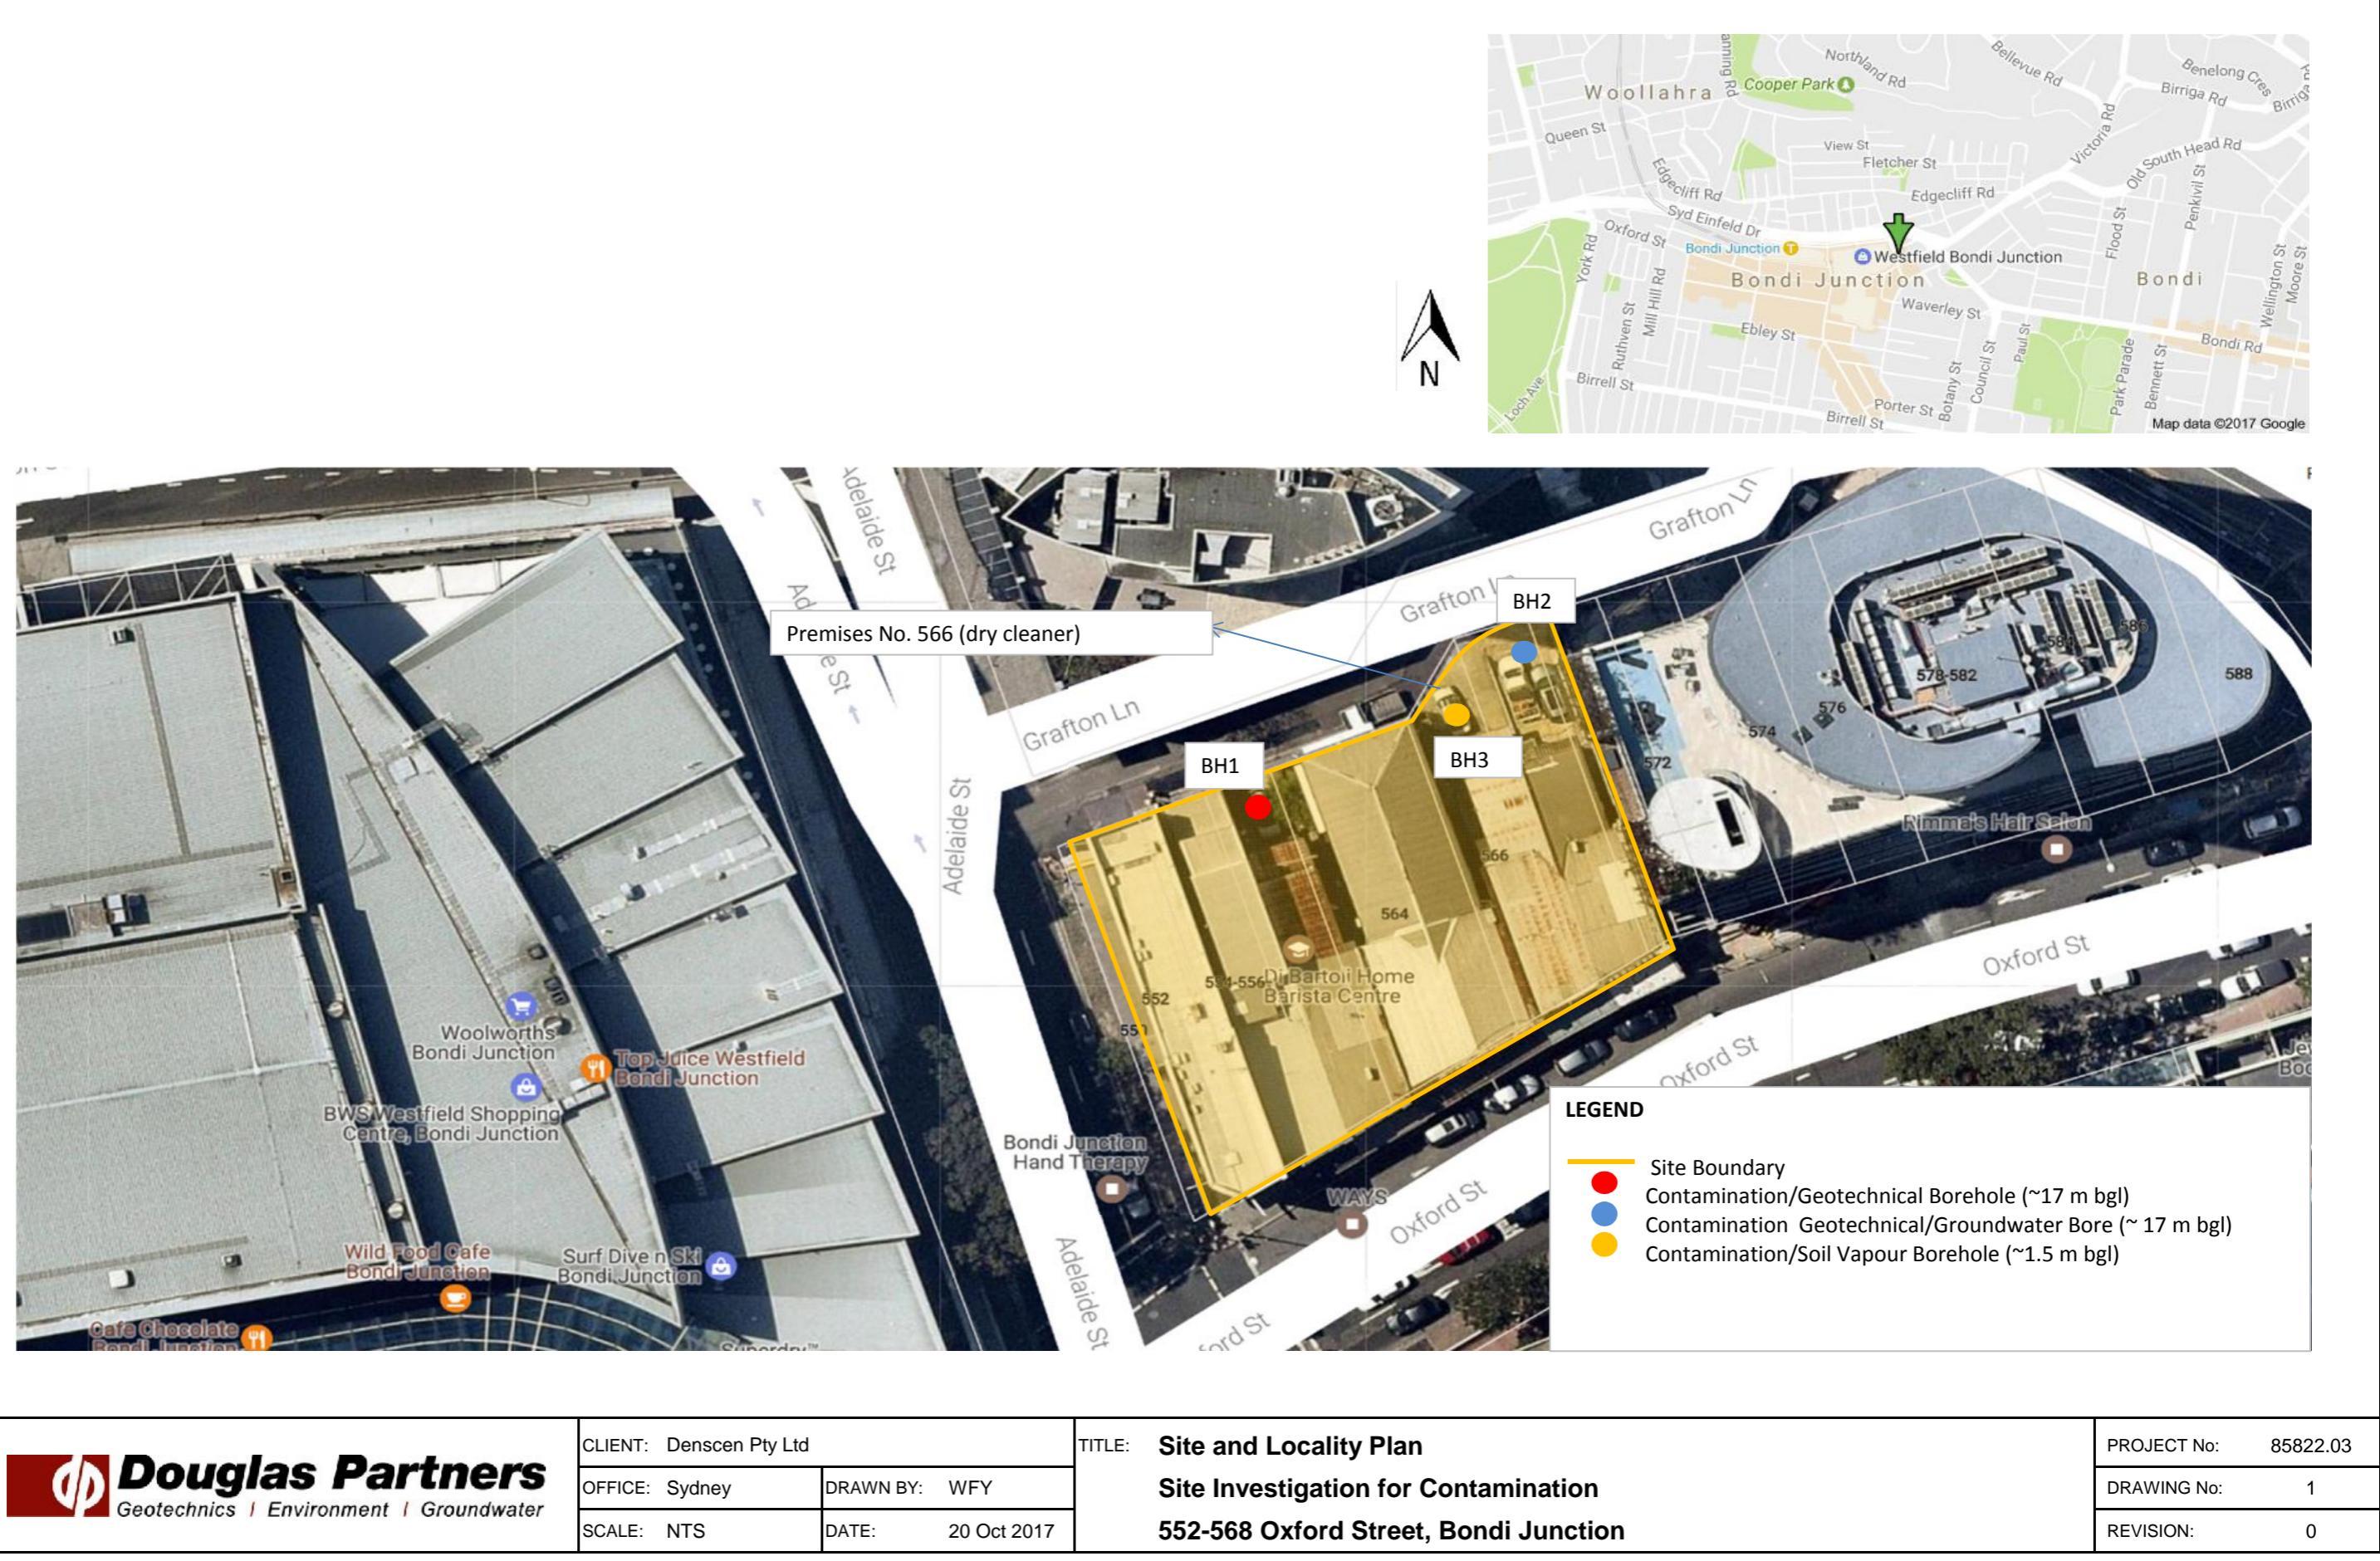
Drawing 1

Devertes Developera	CLIENT: Denscen Pty Ltd				TITLE:	Site and Locality Plan
Douglas Partners Geotechnics Environment Groundwater	OFFICE:	Sydney	DRAWN BY:	WFY		Site Investigation for Contamination
	SCALE:	NTS	DATE:	20 Oct 2017		552-568 Oxford Street, Bondi Junction
