ARBORICULTURAL DEVELOPMENT IMPACT ASSESSMENT REPORT

Greenwich Public School Greenwich Road Campus

REVISION D 4 December 2017

Prepared for GHD

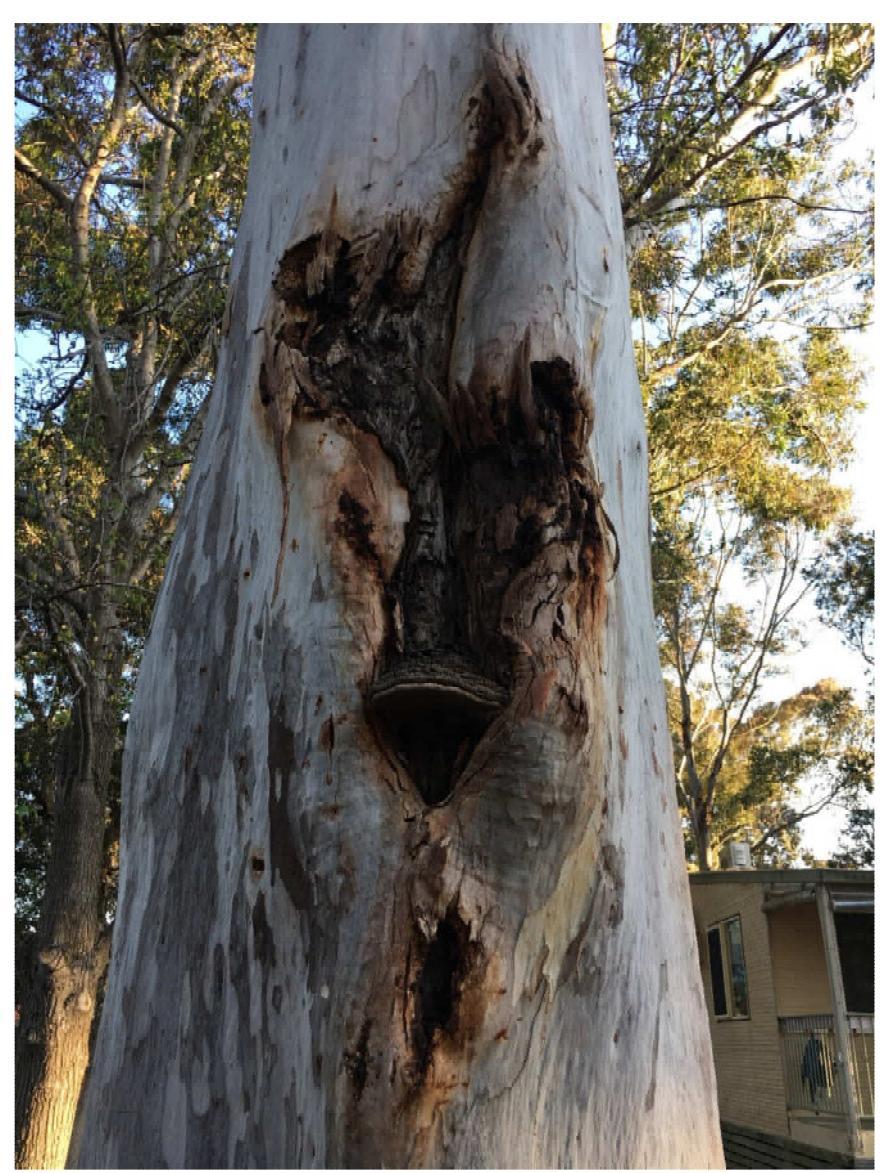
This mature tree is approximately 24m tall with a canopy spread of 14m. It has a single trunk with a DBH of 820mm. This tree has extensive decay evident within the trunk with a fungal fruiting body present indicative of active decay. The decay within this trunk places this tree at increased risk of failure posing a hazard to life and property in a high target area. This tree is recommended for removal in order to remove this hazard.

Figure 1- - Decay with fungal fruiting body in Tree 17

17.	Eucalyptus saligna	Remove	Extensive decay throughout trunk. Fungal fruiting body present				
18.	Grevillea robusta	Remove	Not viable to be retained due to the encroachment of the TPZ by the proposed development.

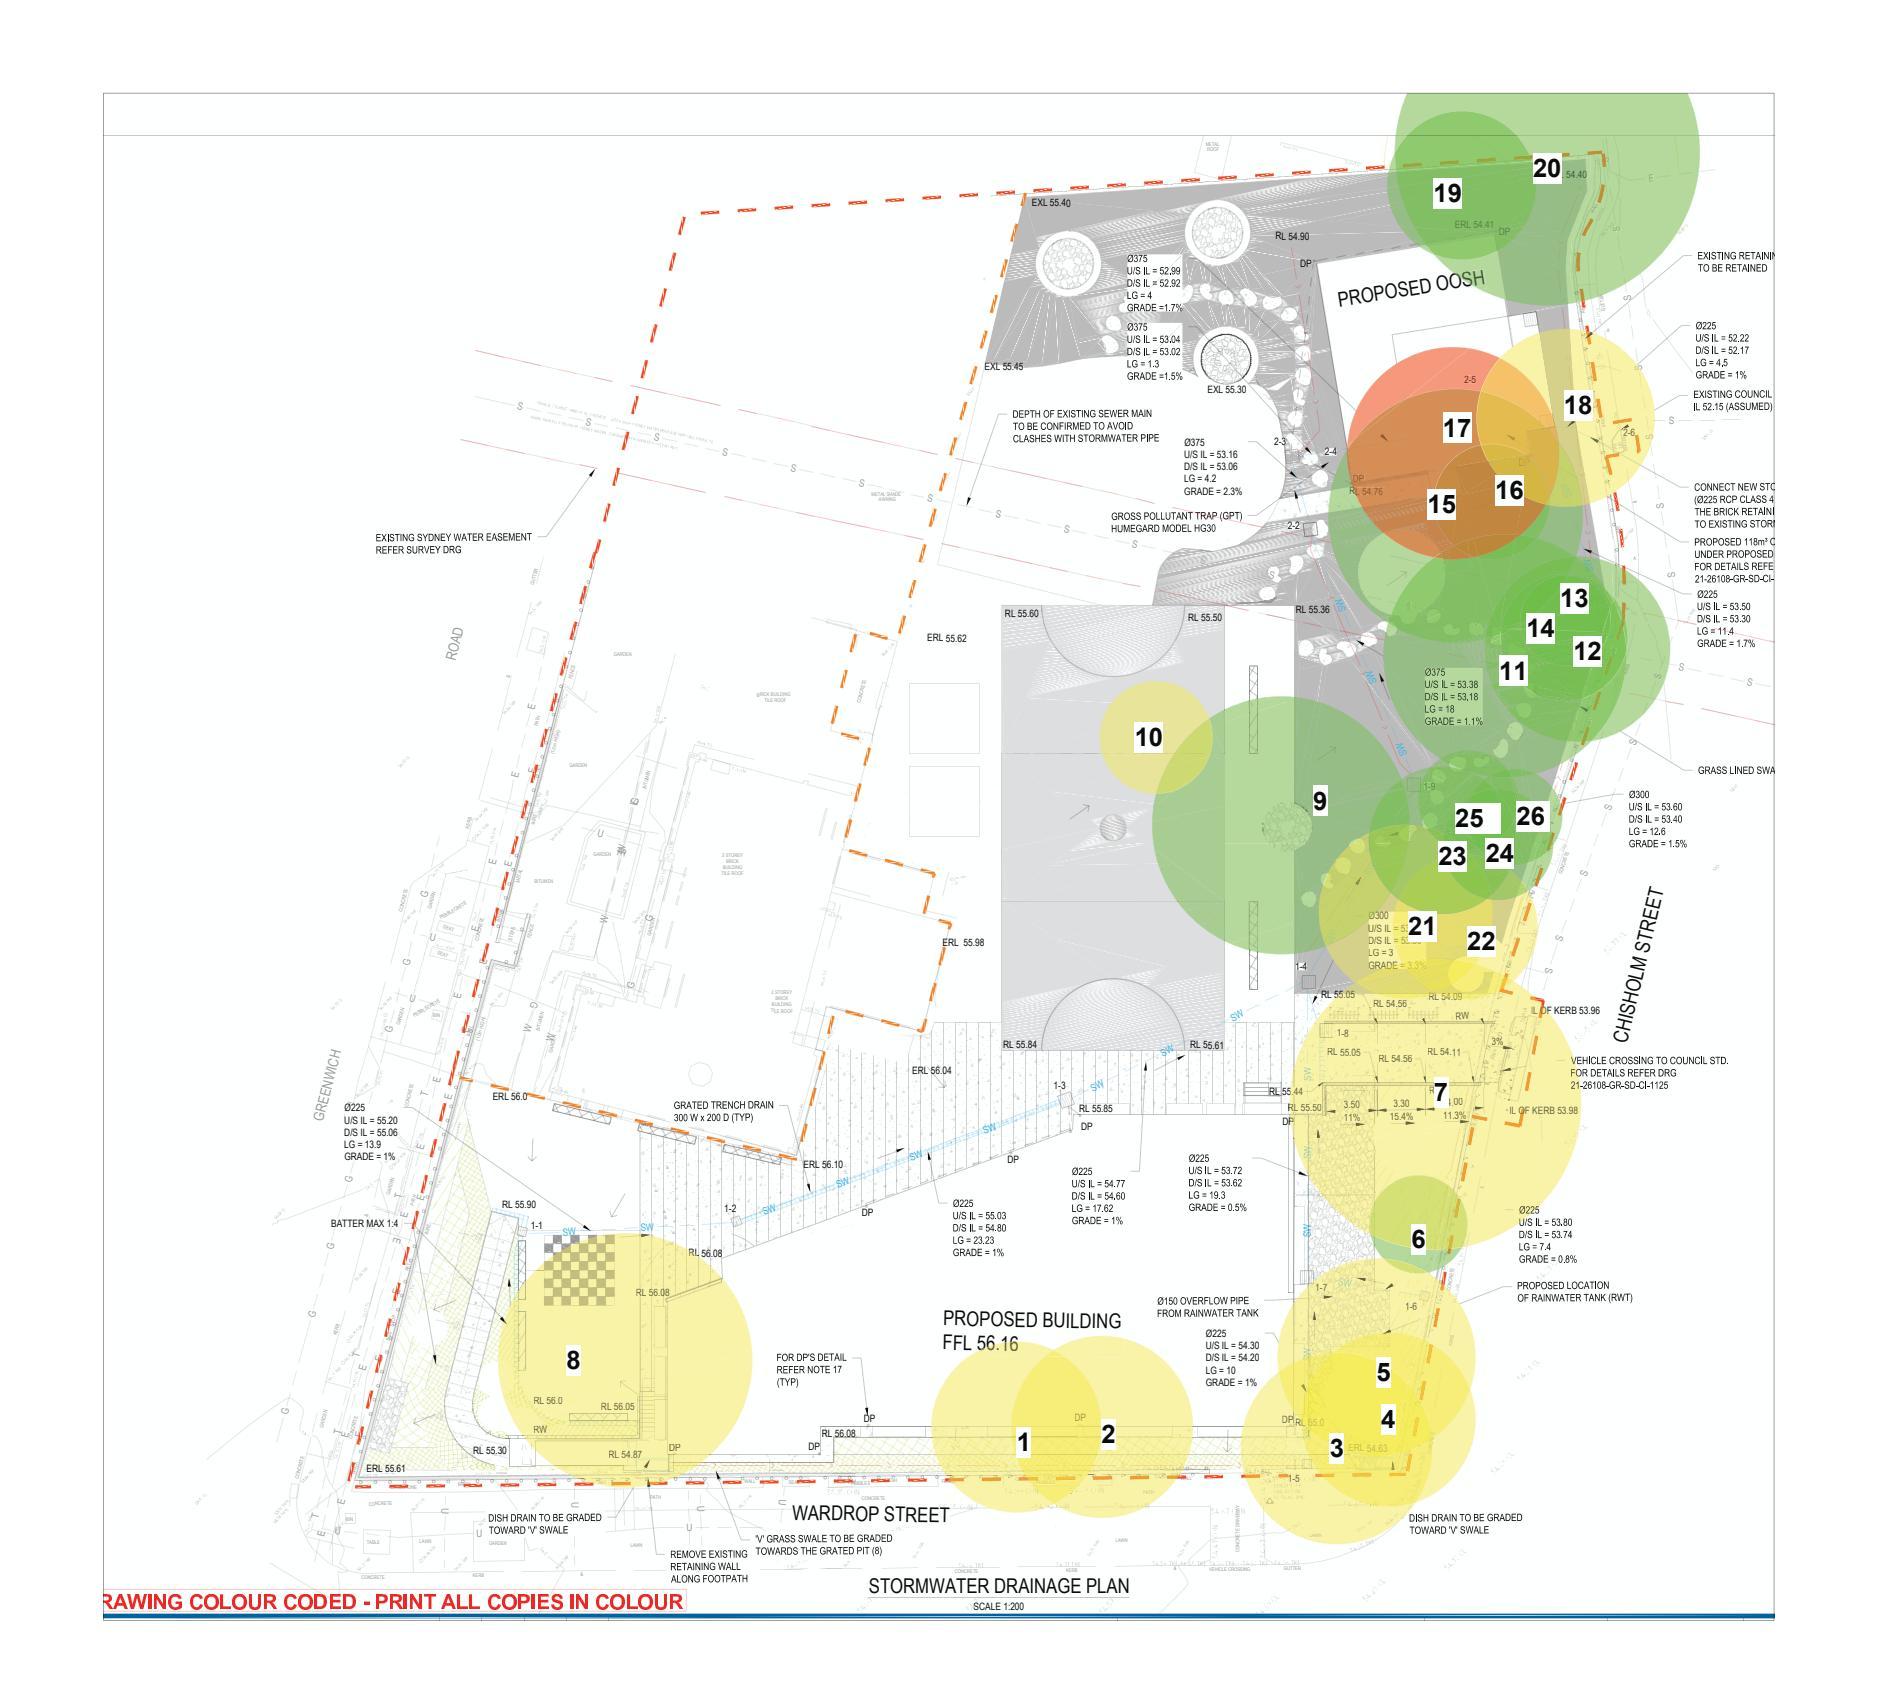
Project: Greenwich Public School K -1 Client: GHD DWG: A01 REV D Plan: Tree Location Plan Date: 4 Dec 2017 Scale : Not to Scale

Trees are as identified in the attached inspection forms in Appendix A and shown in Tree location Plan A01 in Appendix B.
