REMEDIATION ACTION PLAN ASBESTOS CONTAMINATED SOIL 46-50 MEREDITH STREET, BANKSTOWN NSW

Prepared for C & J BOVA Property Investments Pty Ltd

Cary Envder Occupational Hygienist COH, FAIOH Licensed Asbestos Assessor LAA 000160 21 November 2019 Ref: BPI-191112-Meredith St RAP

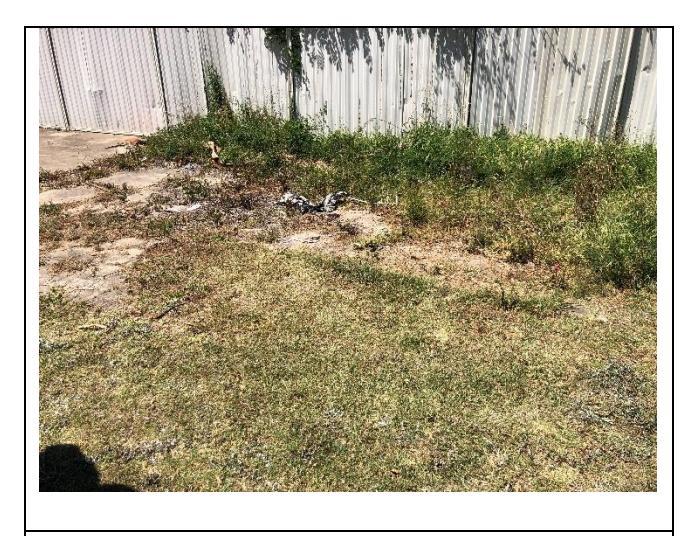
Photo 1 Site of the demolished garage on Lot 48 and site of BH104

A site inspection carried out on 12 November 2019 showed that the site is grassed over and no visible ACM contamination was observed. See Appendix A for the photo of the site.

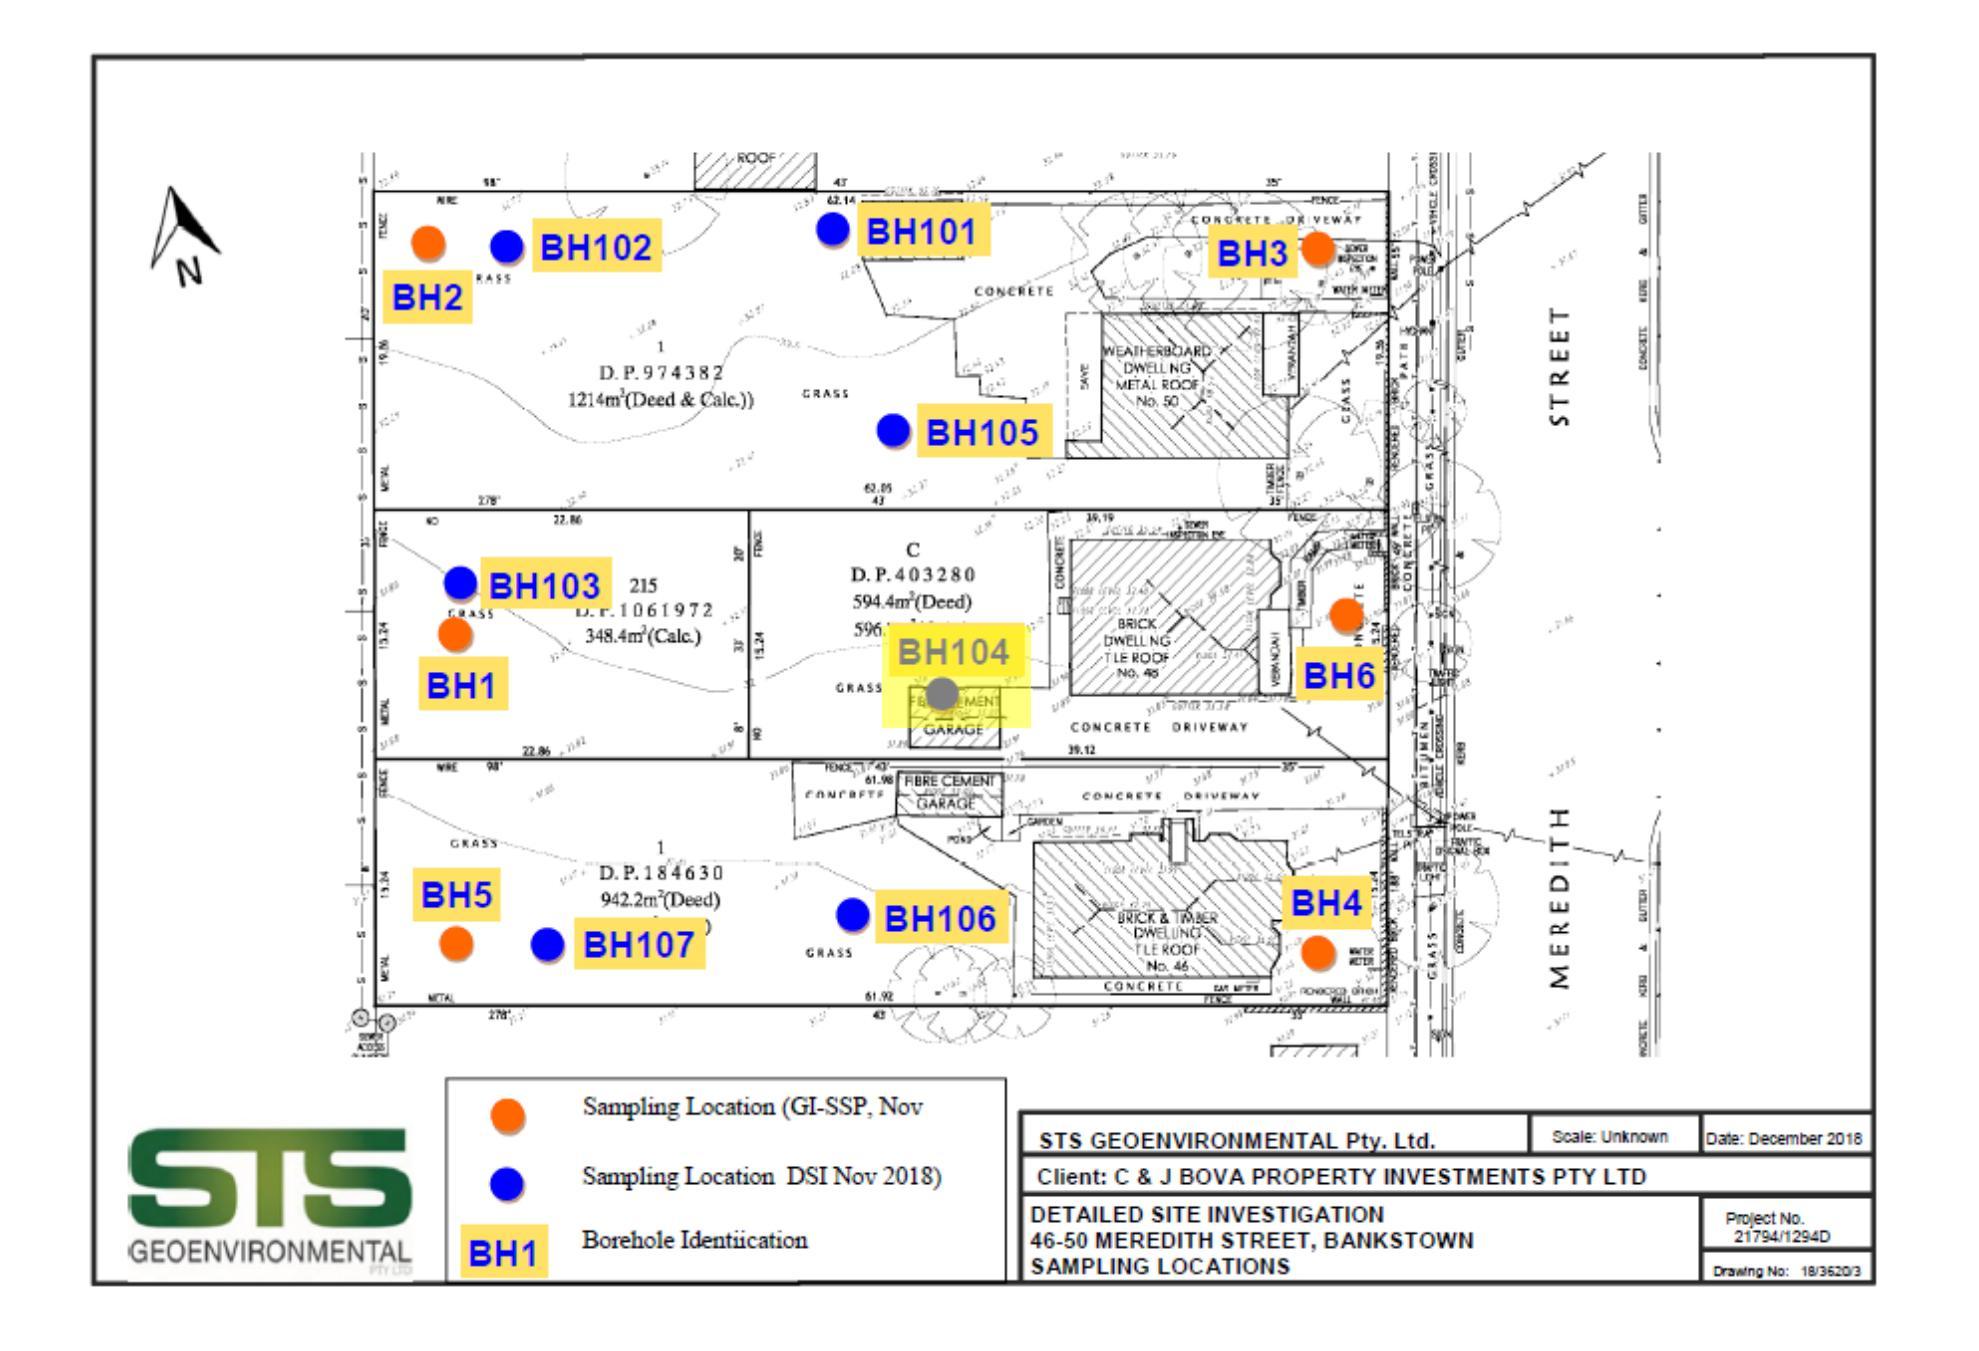
APPENDIX B BORE HOLE LOCATIONS SITE DIAGRAM

STS GeoEnviromental conducted a detailed site investigation of the site. The survey involved digging 20 boreholes on the site. ACM was found on the surface in one (1) borehole (BH104) located adjacent to the demolished garage on Lot 48. Appendix B contains a site diagram with the borehole locations shown with BH104 highlighted. The ACM found was in the >7mm fraction and the <7mm fraction of which 1 was found to contain found that the there was ACM in the top 100mm of the soil. For more information see the STS GeoEnviromental report No 18/3620 dated February 2019.
