Statement of Environmental Effects

Lot 1 DP 117890 Goulburn Aquatic Centre, Goulburn

Prepared for: Goulburn-Mulwaree Council

Revised February 2019

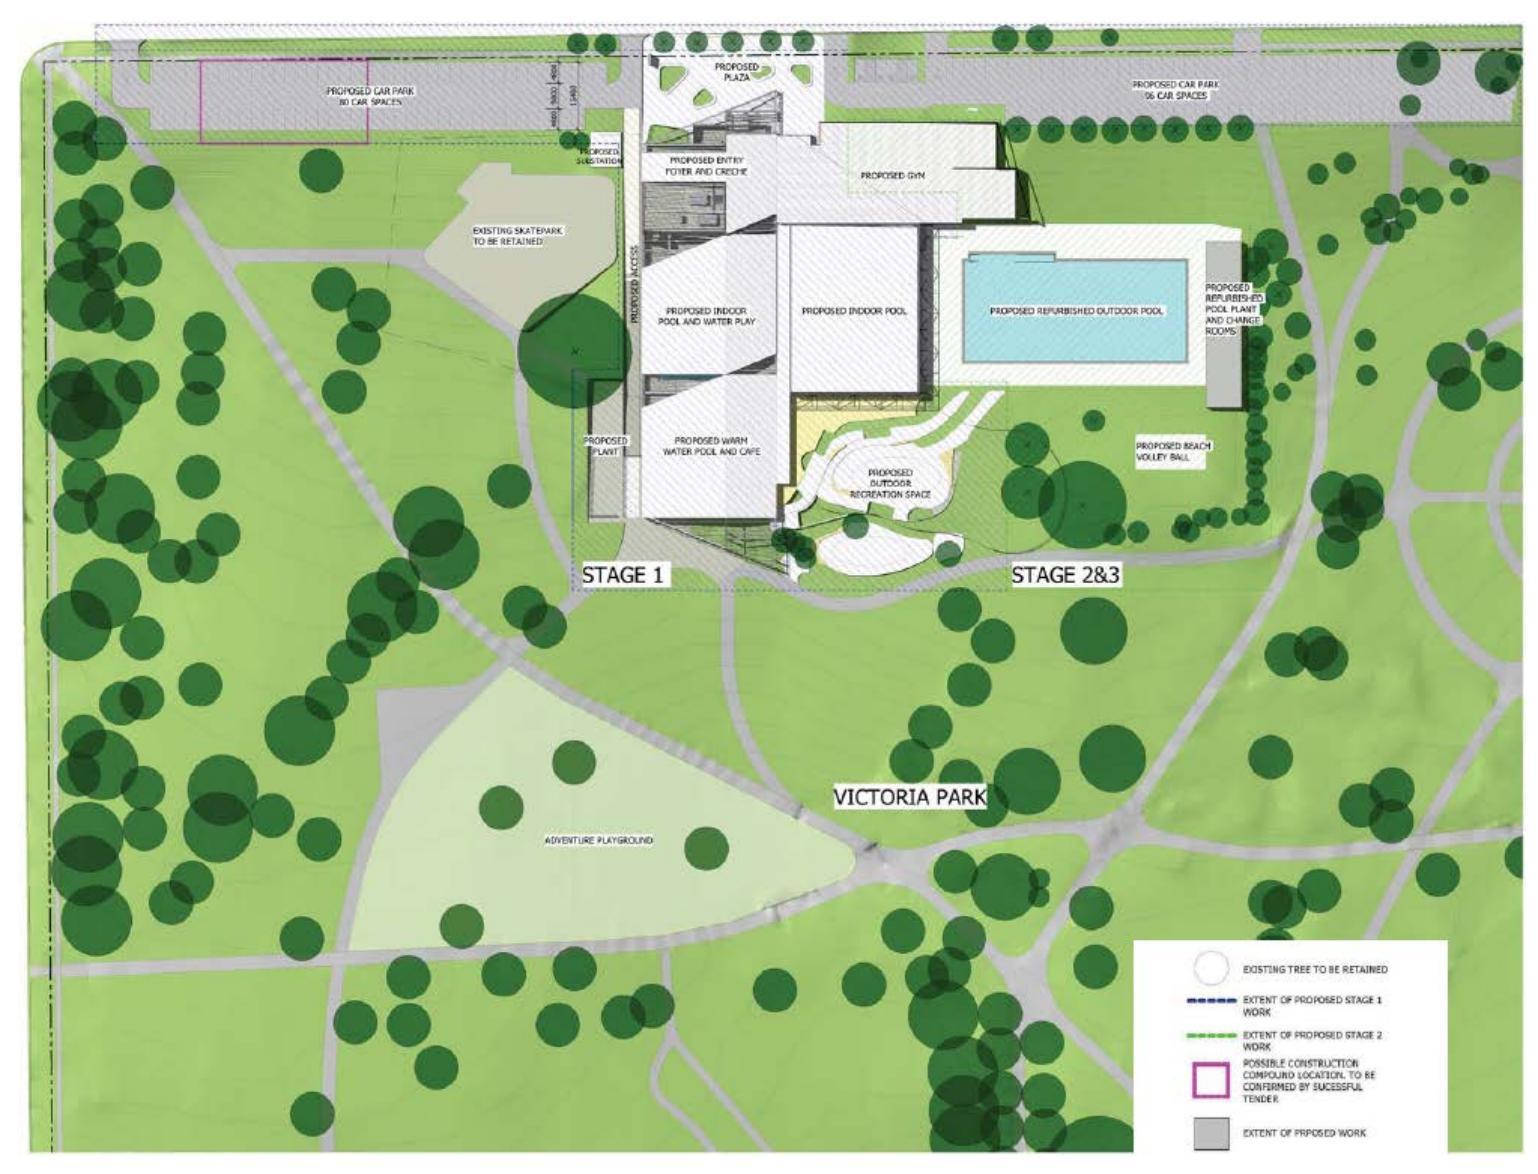
Figure 2. Project staging plan (dwp, 2018)

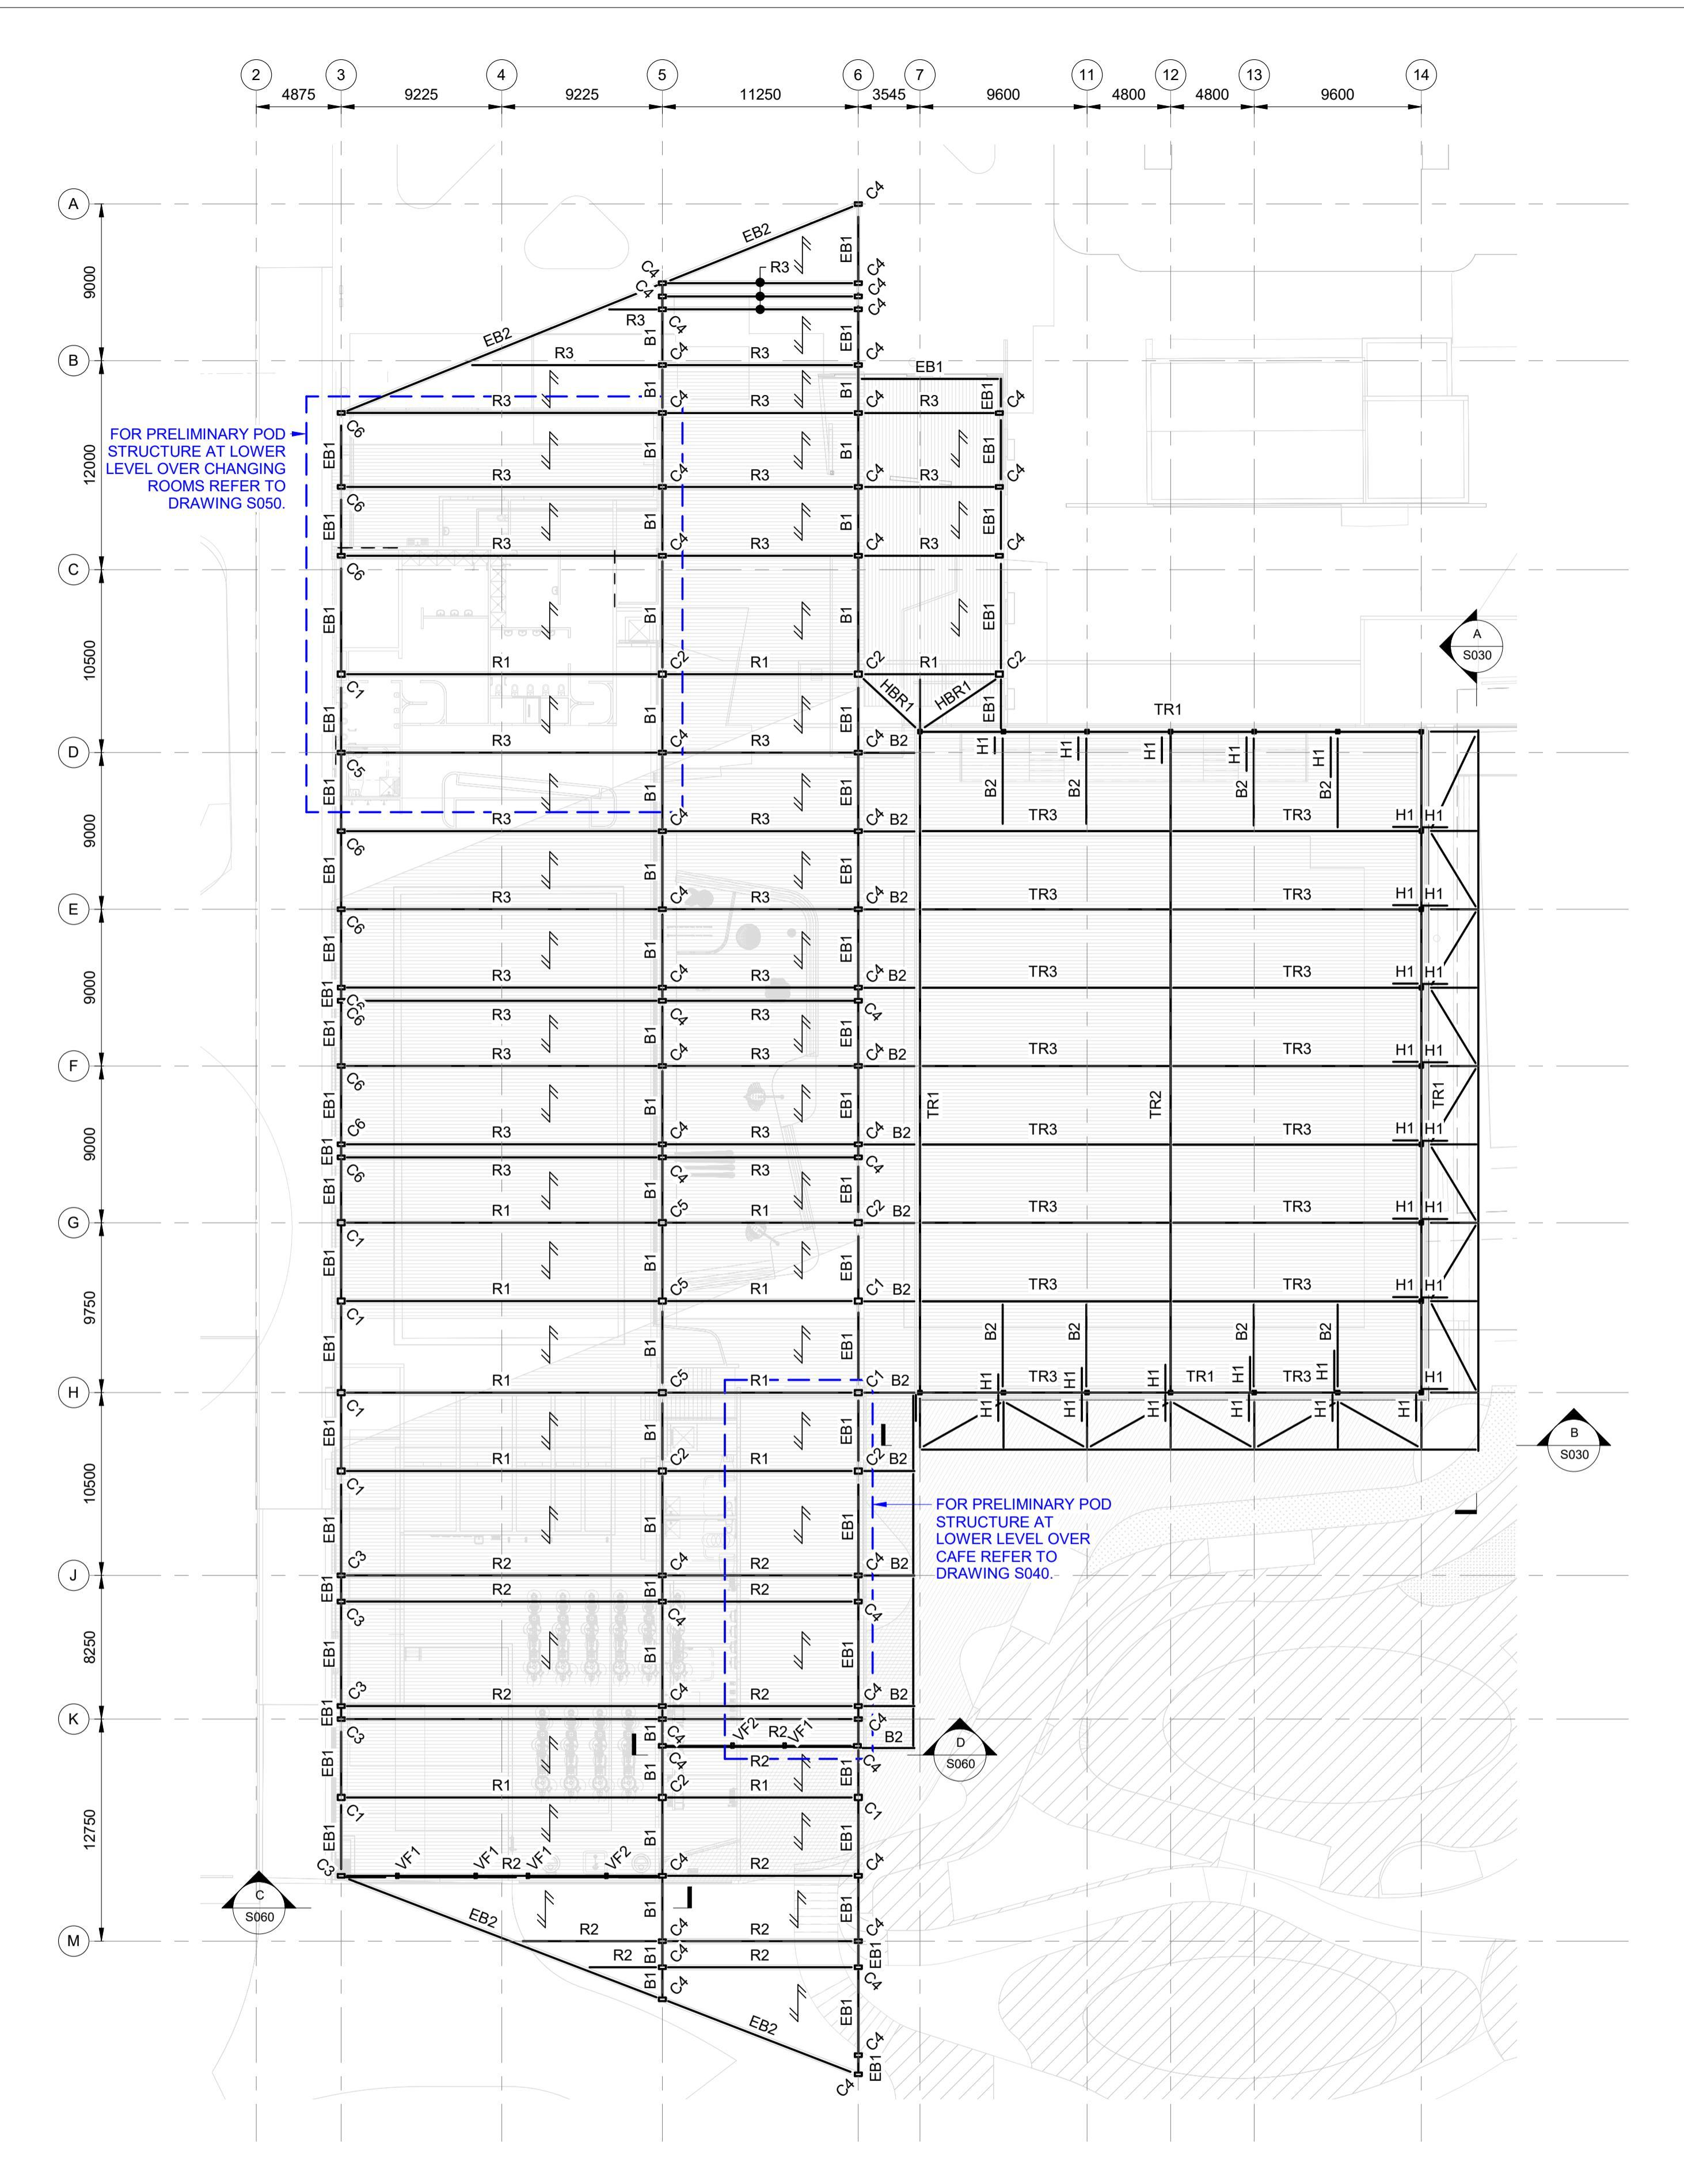
MAIN ROOF STRUCTURAL LAYOUT PLAN 1 : 250

TRUSS MEMBER SCHEDULE								
REF	TRUSS HEIGHT	<u>VERTICAL</u>	DIAGONAL					
TR1	4800mm	250 x 150 x 12.5 RHS	150 SHS	150 SHS				
TR2	2400mm	250 x 150 x 12.5 RHS	150 SHS	150 SHS				
TR3	1200mm	150 x 100 RHS	100 SHS	100 SHS

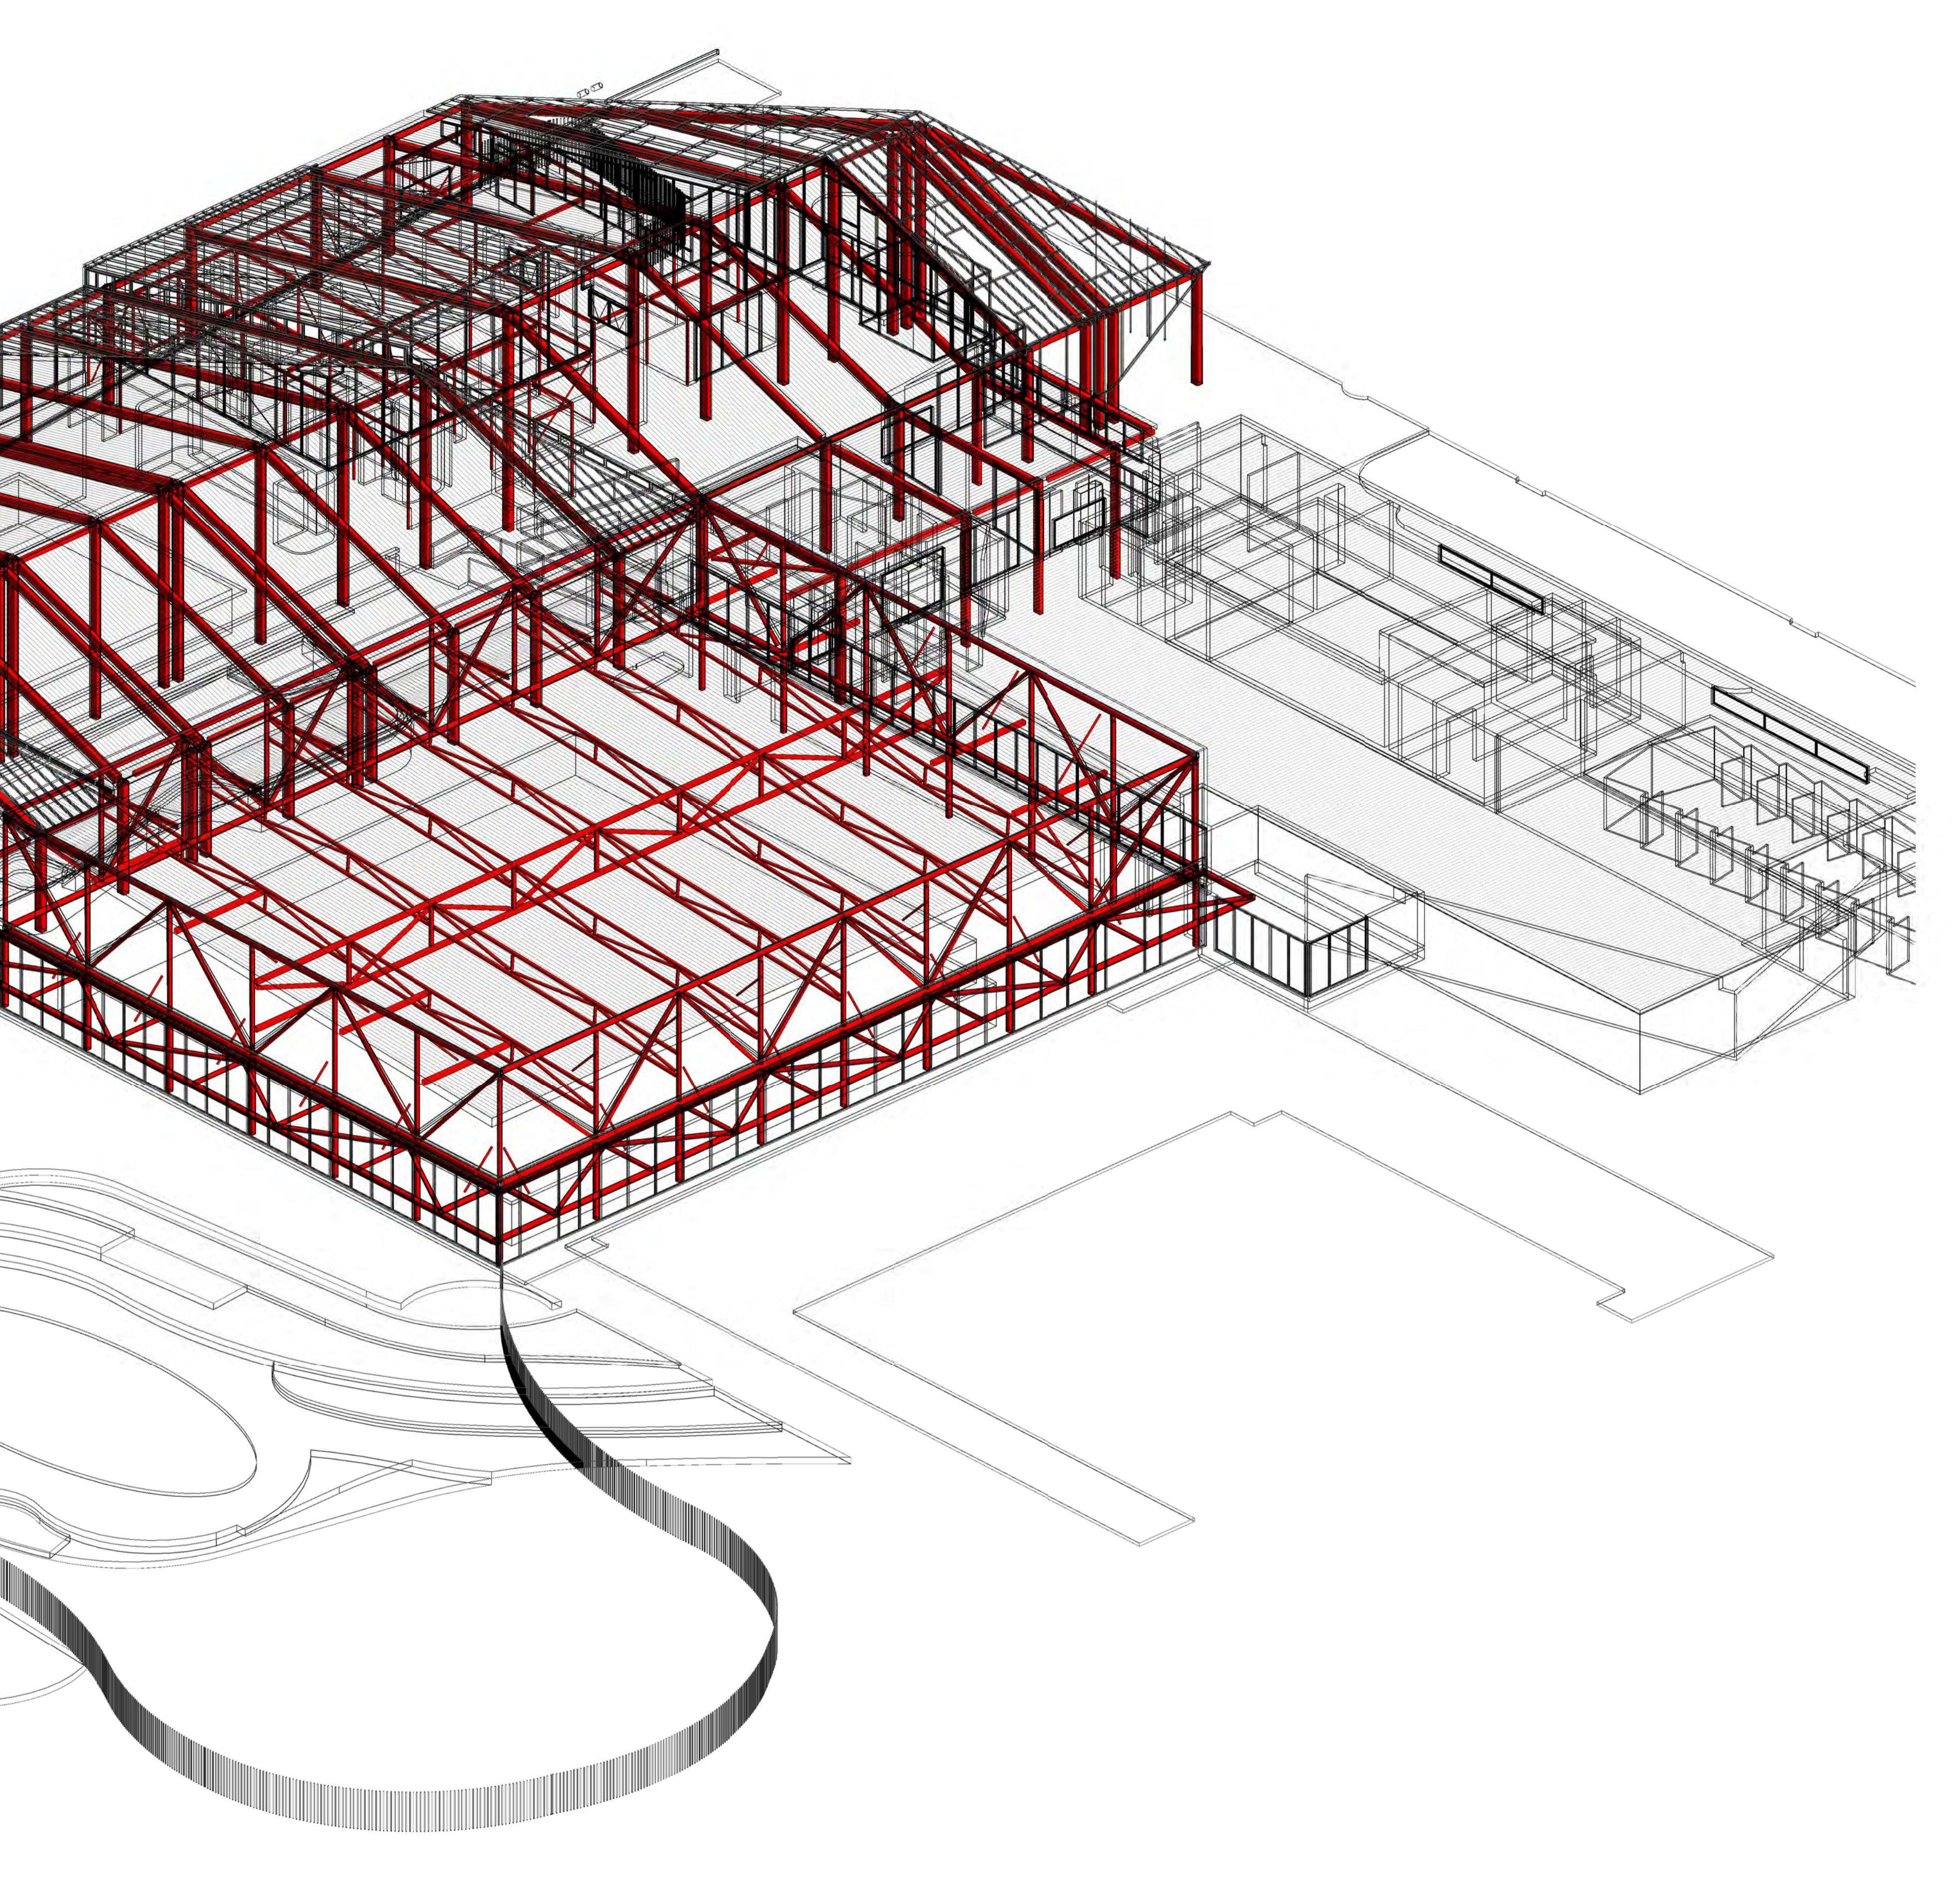
STRUCTURAL ISOMETRIC VIEW

DrawingTitle: CRACKERJACK STRUCTURAL STEEL ISOMETRIC VIEW STAGE 1

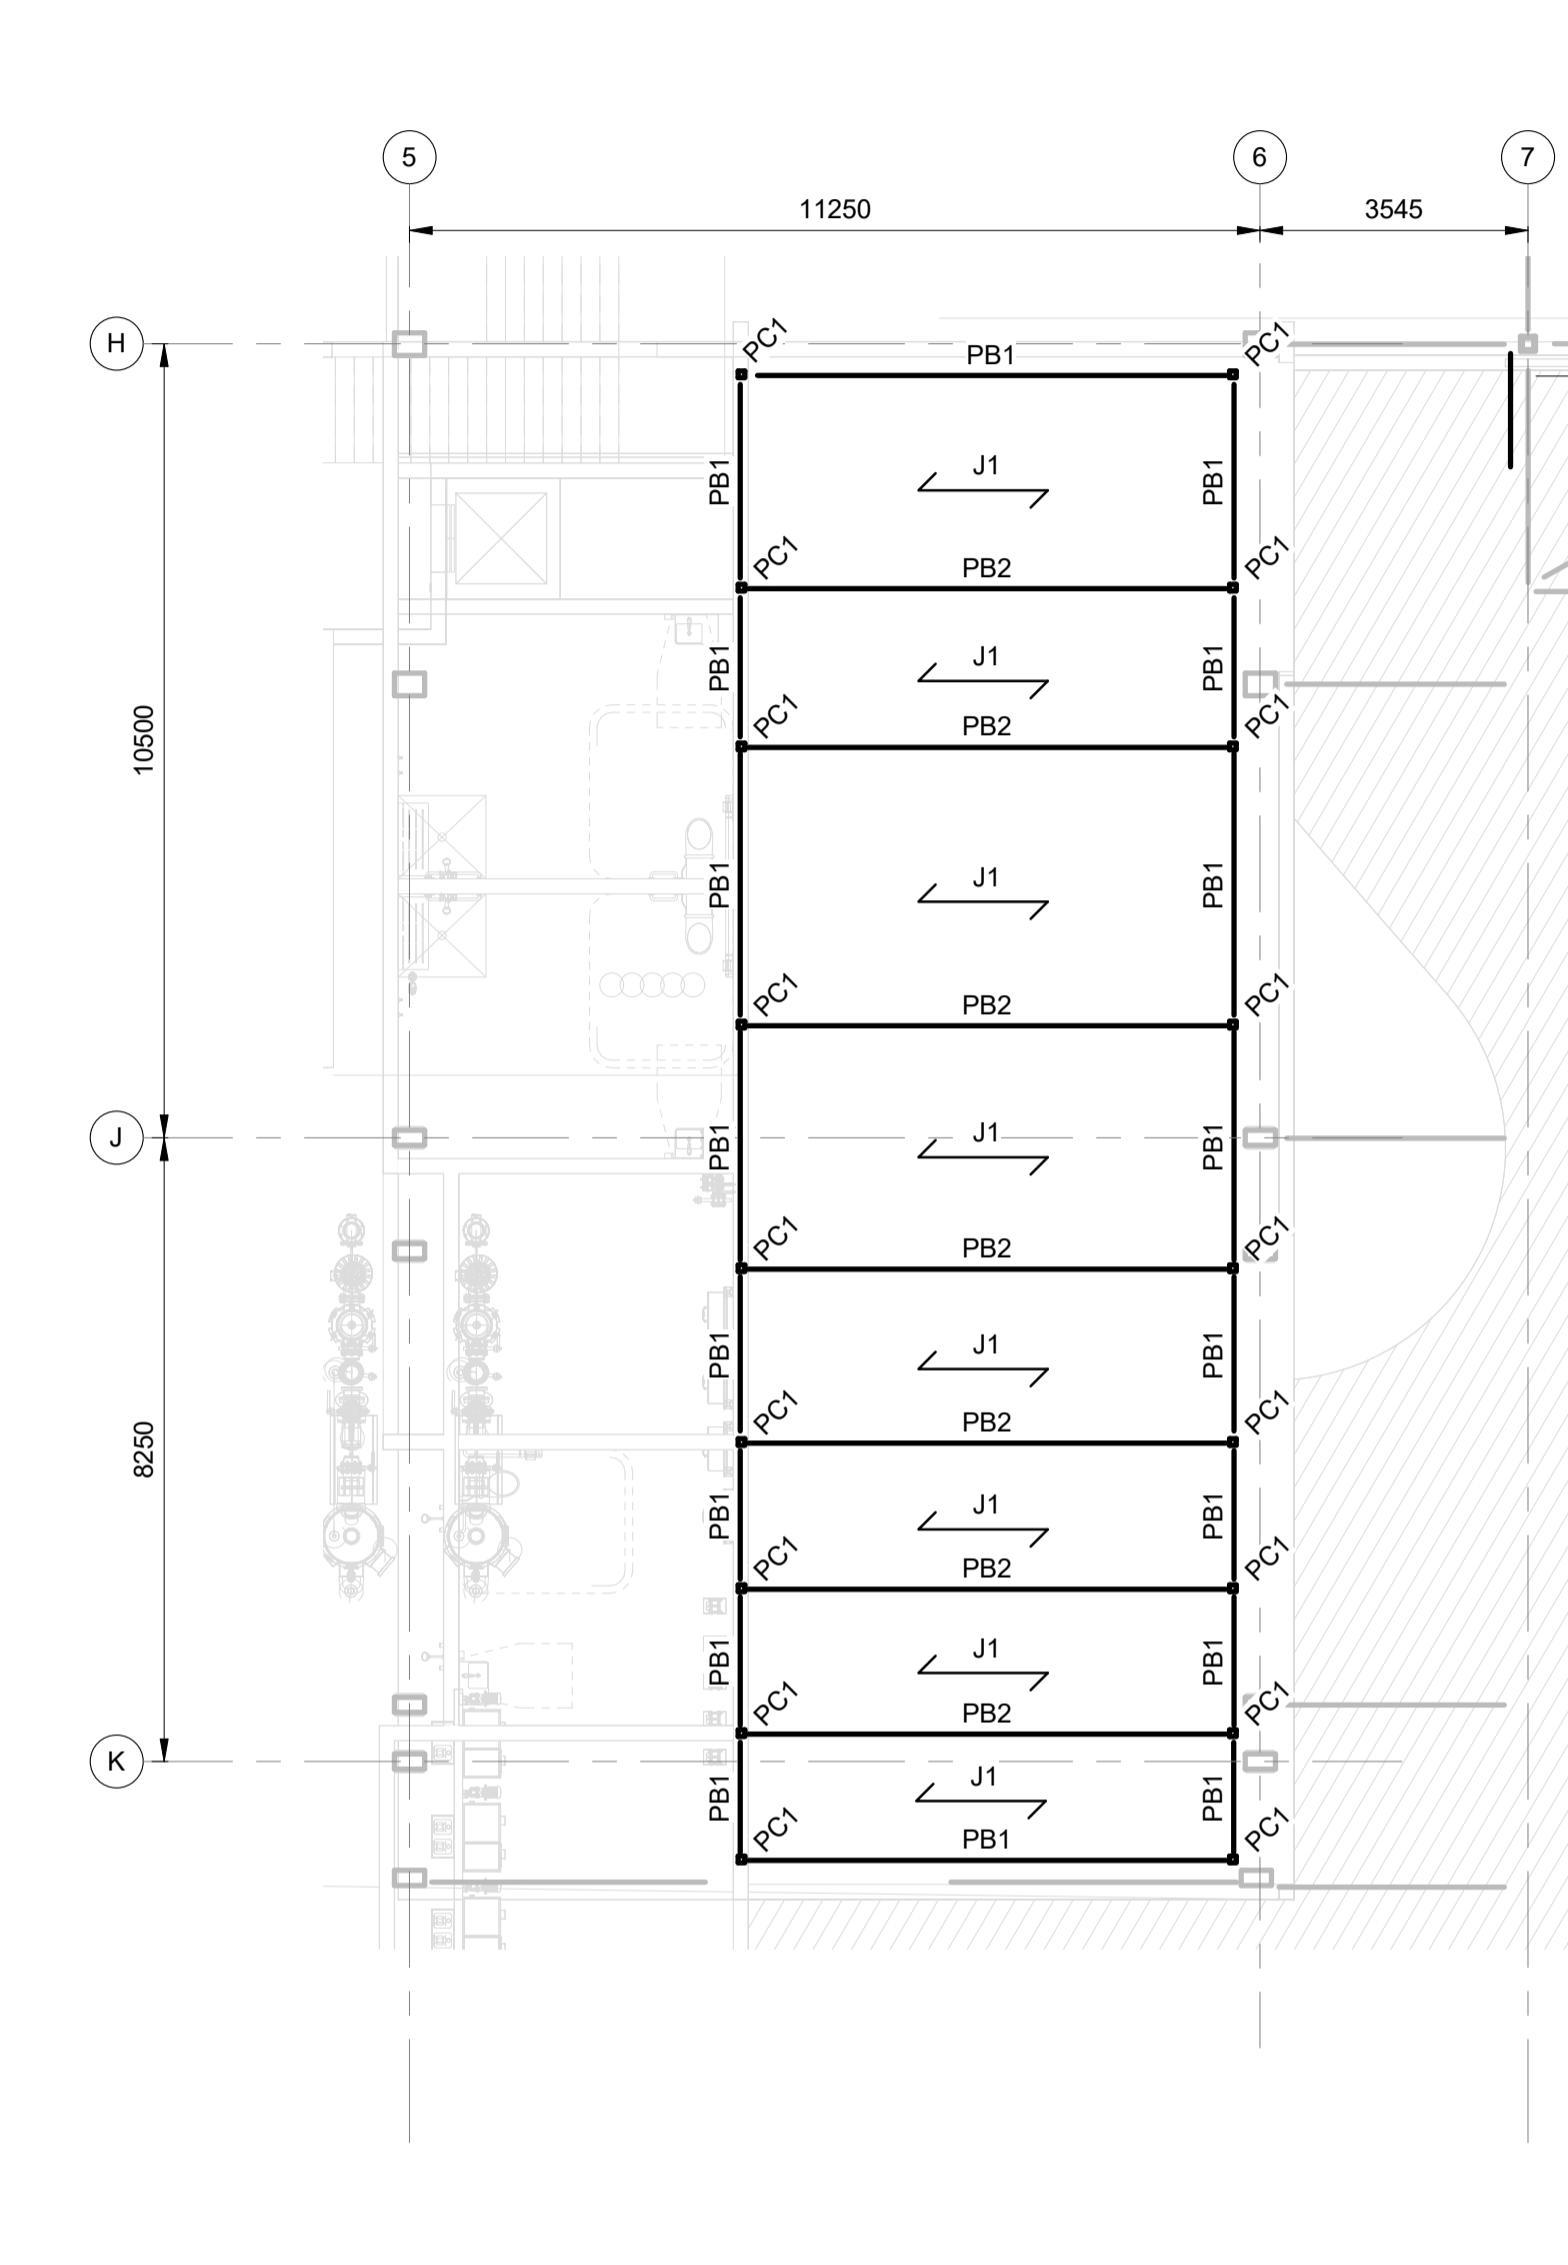
STRUCTURAL POD OVER CAFE LAYOUT PLAN 1 : 100

CAFE POD STRUCTURAL MEMBER SCHEDULE						
SIZE	DESCRIPTION					
150 PFC	BEAM					
150UC 37.2	BEAM					
89SHS 6.0	COLUMN					
C15024	JOIST @ 450 CTS, 1 ROW OF BRIDGING

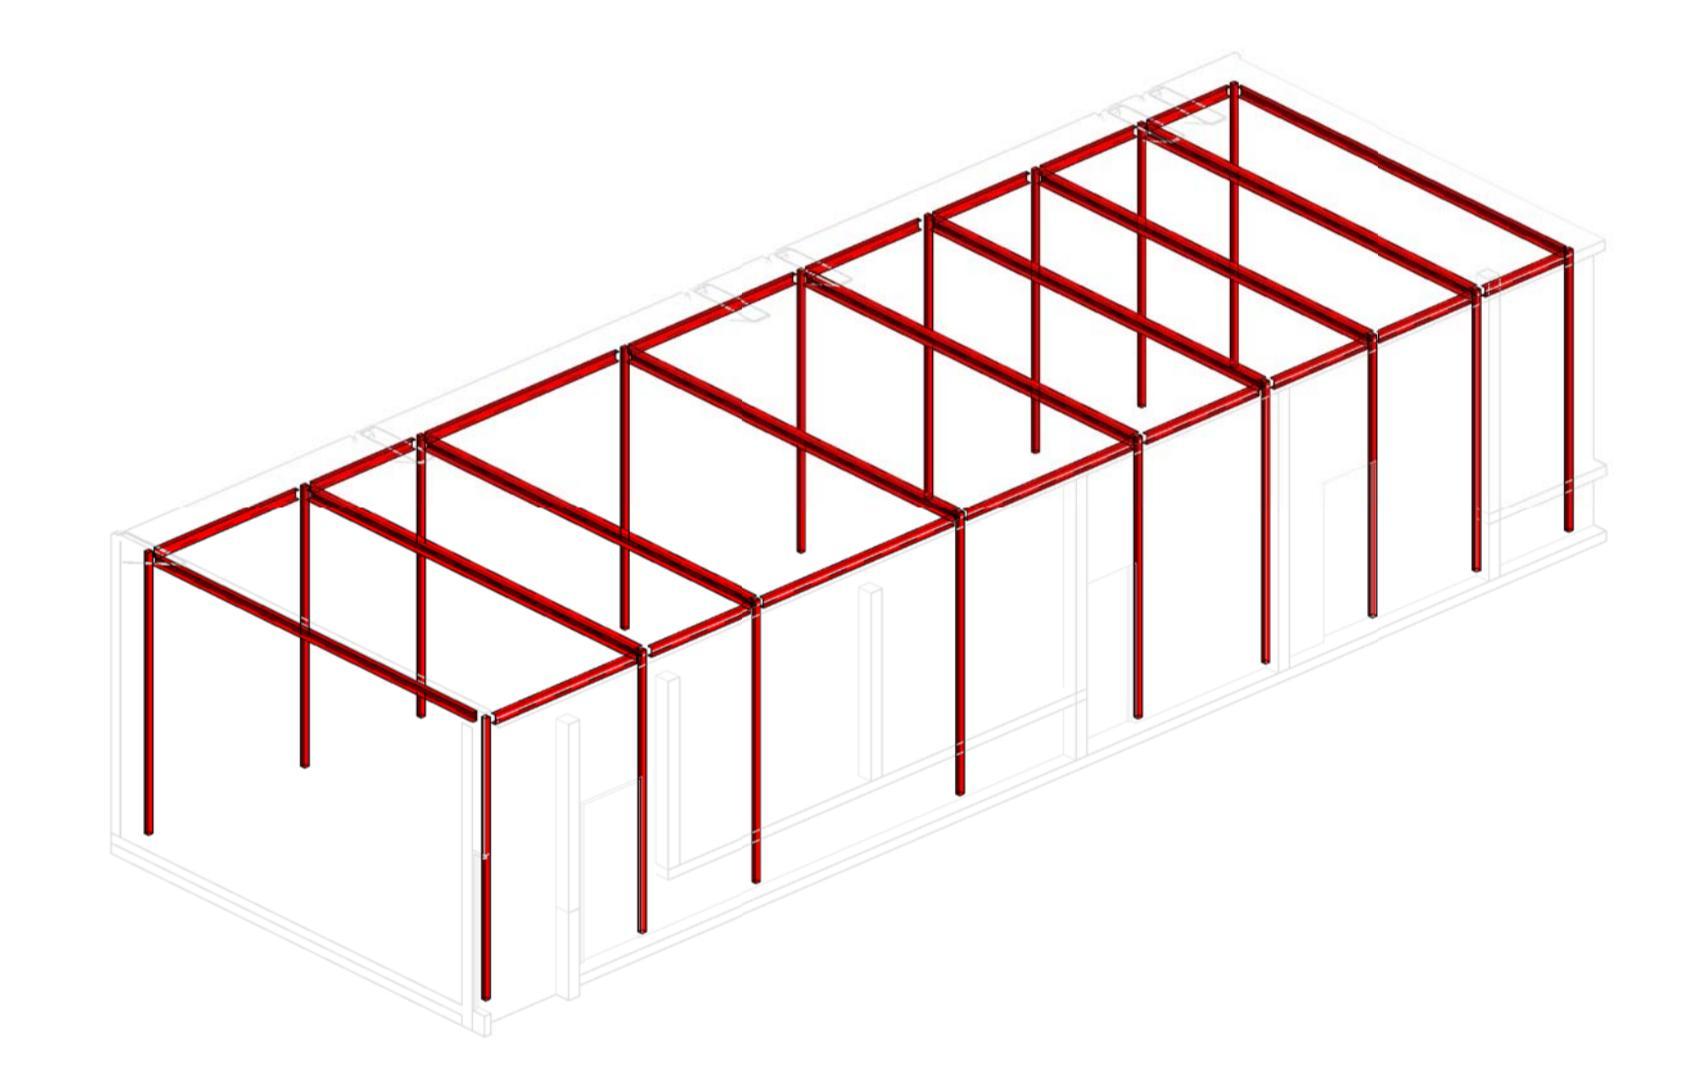
STRUCTURAL POD OVER CAFE ISOMETRIC VIEW

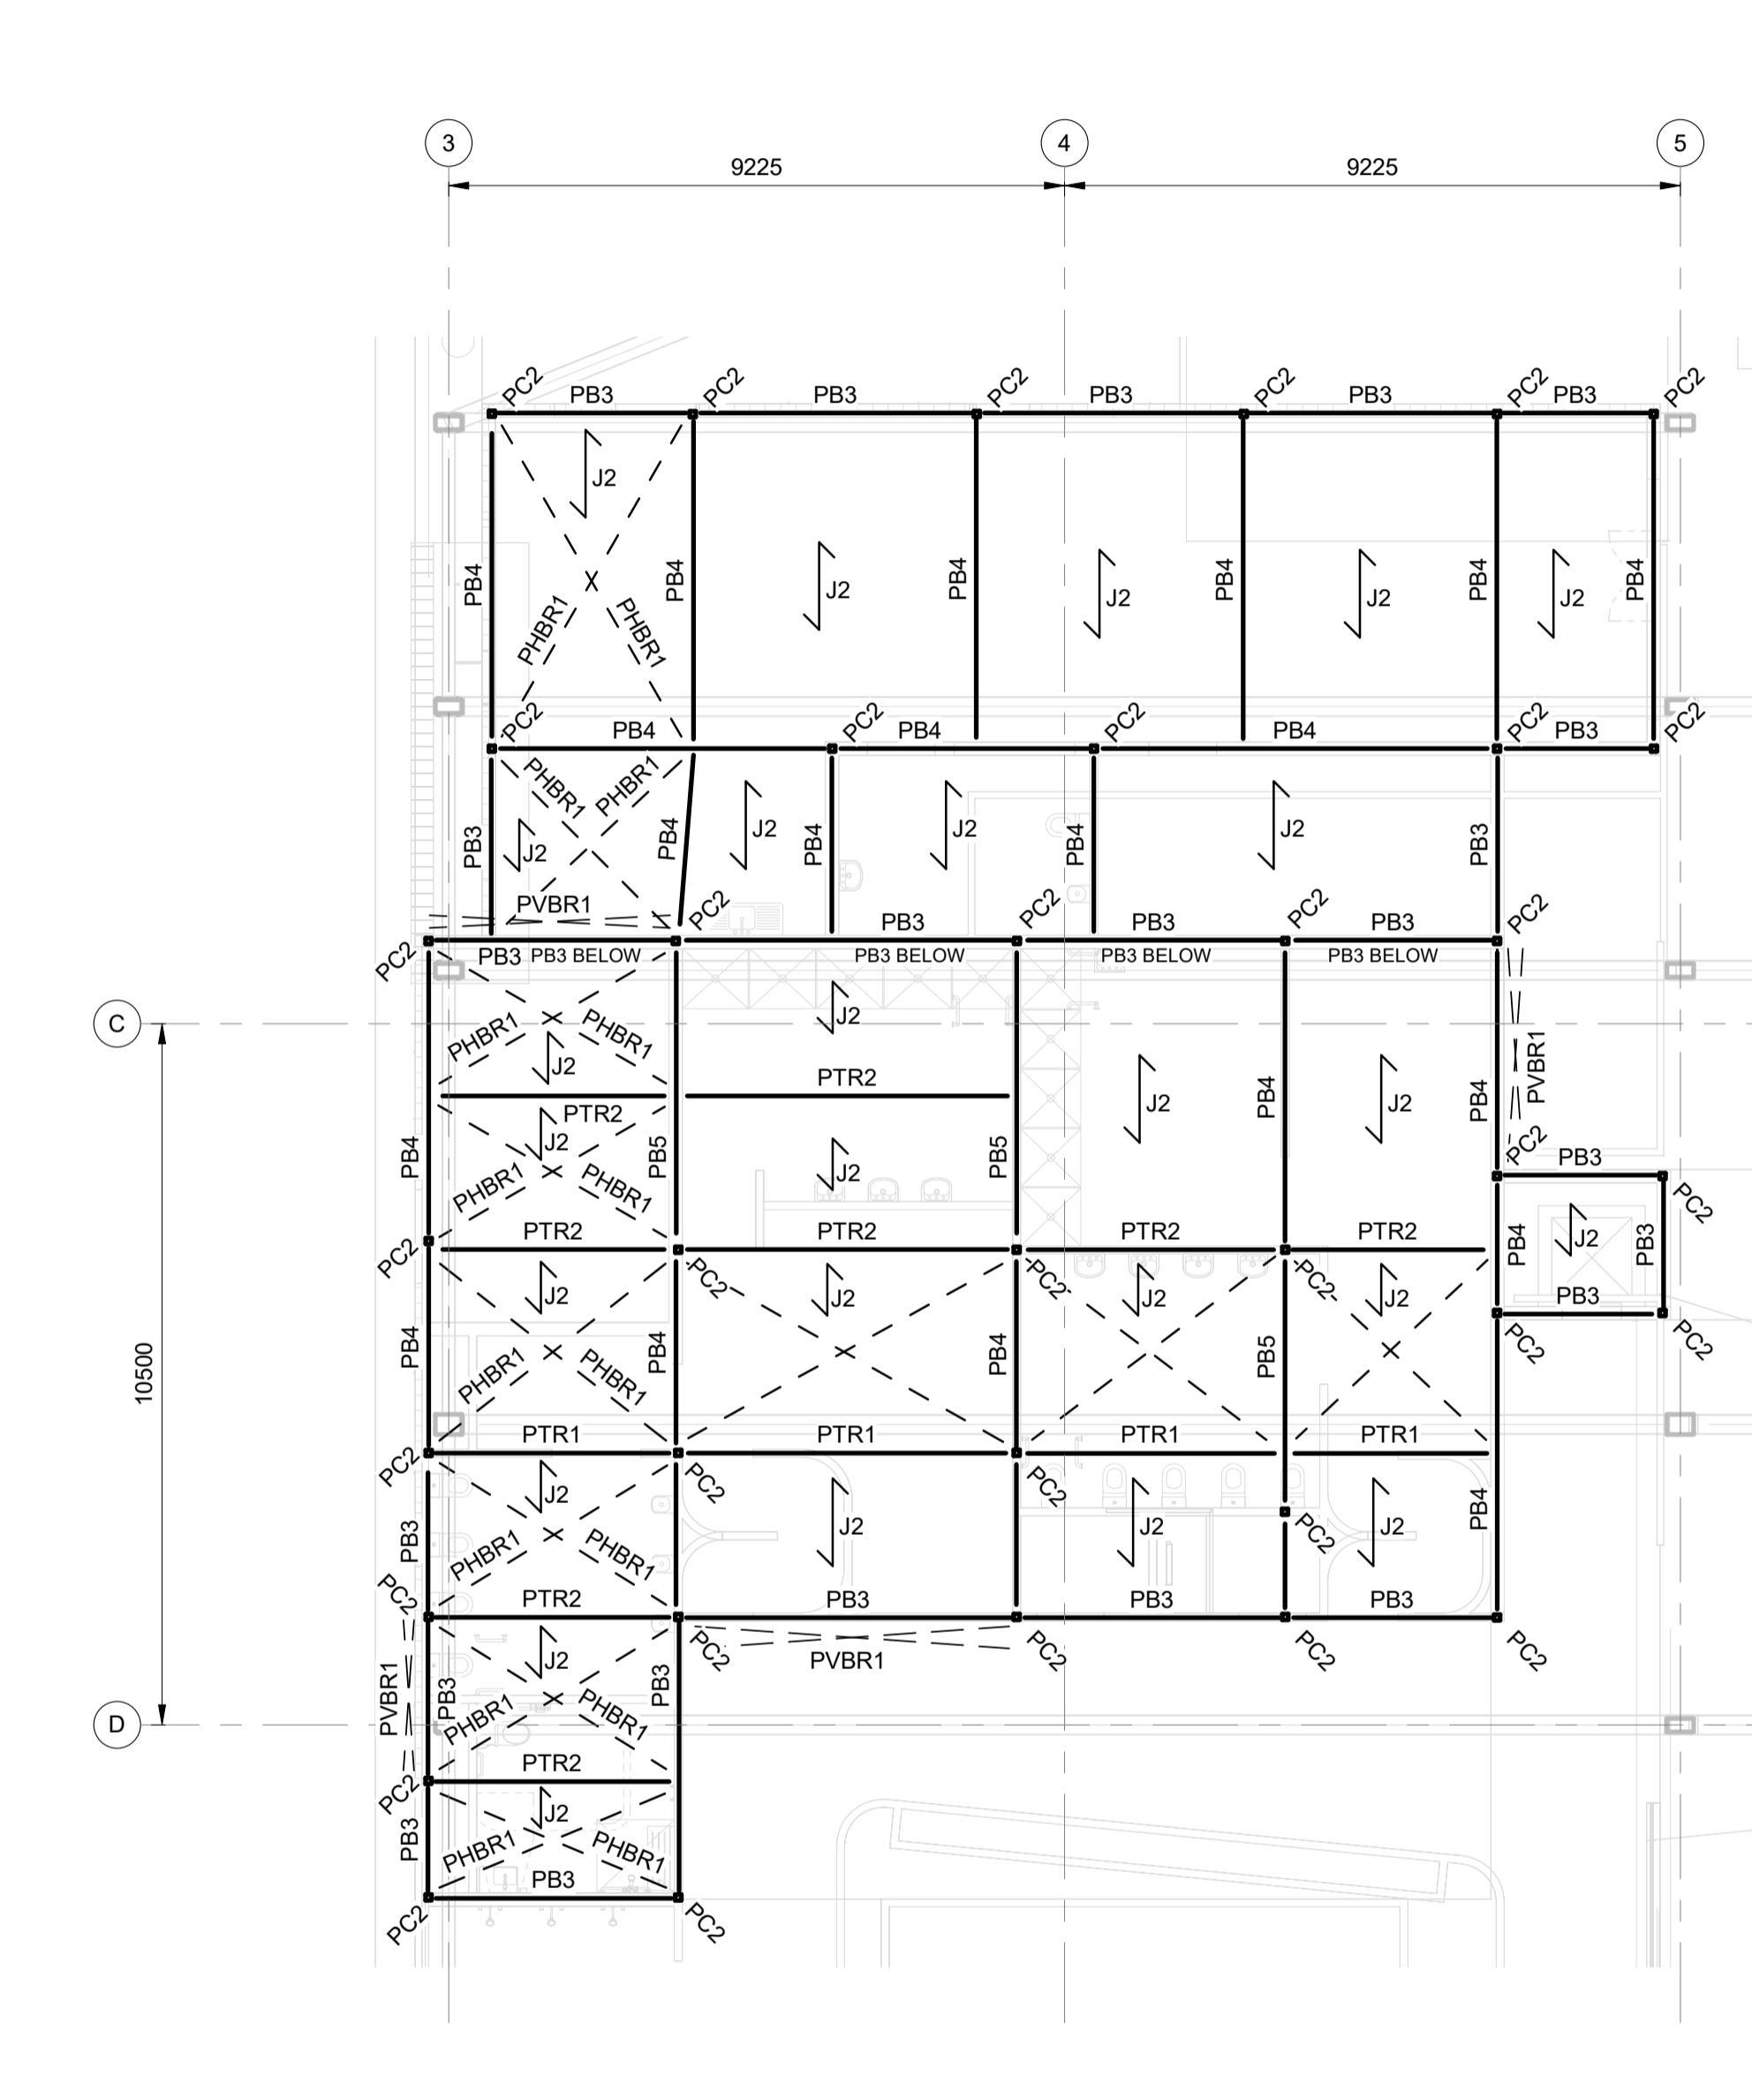
STRUCTURAL POD OVER CHANGING ROOMS LAYOUT PLAN 1:100

CHANGING ROOMS POD STRUCTURAL MEMBER SCHEDULE							
REF	SIZE	DESCRIPTION					
PB3	150 PFC	BEAM					
PB4	150UC 23.4	BEAM					
PB5	150UC 37.2	BEAM					
PC2	89SHS 5.0	COLUMN					
PTR1	150UC 37.2	TRIMMER BEAM					
PTR2	150UC 23.4	TRIMMER BEAM					
PVBR1	50EA 6.0	VERTICAL BRACING					
PHBR1	50EA 6.0	HORIZONTAL BRACING					
J2	C150 12	JOIST @ 450 CTS. 1 ROW OF BRIDGING

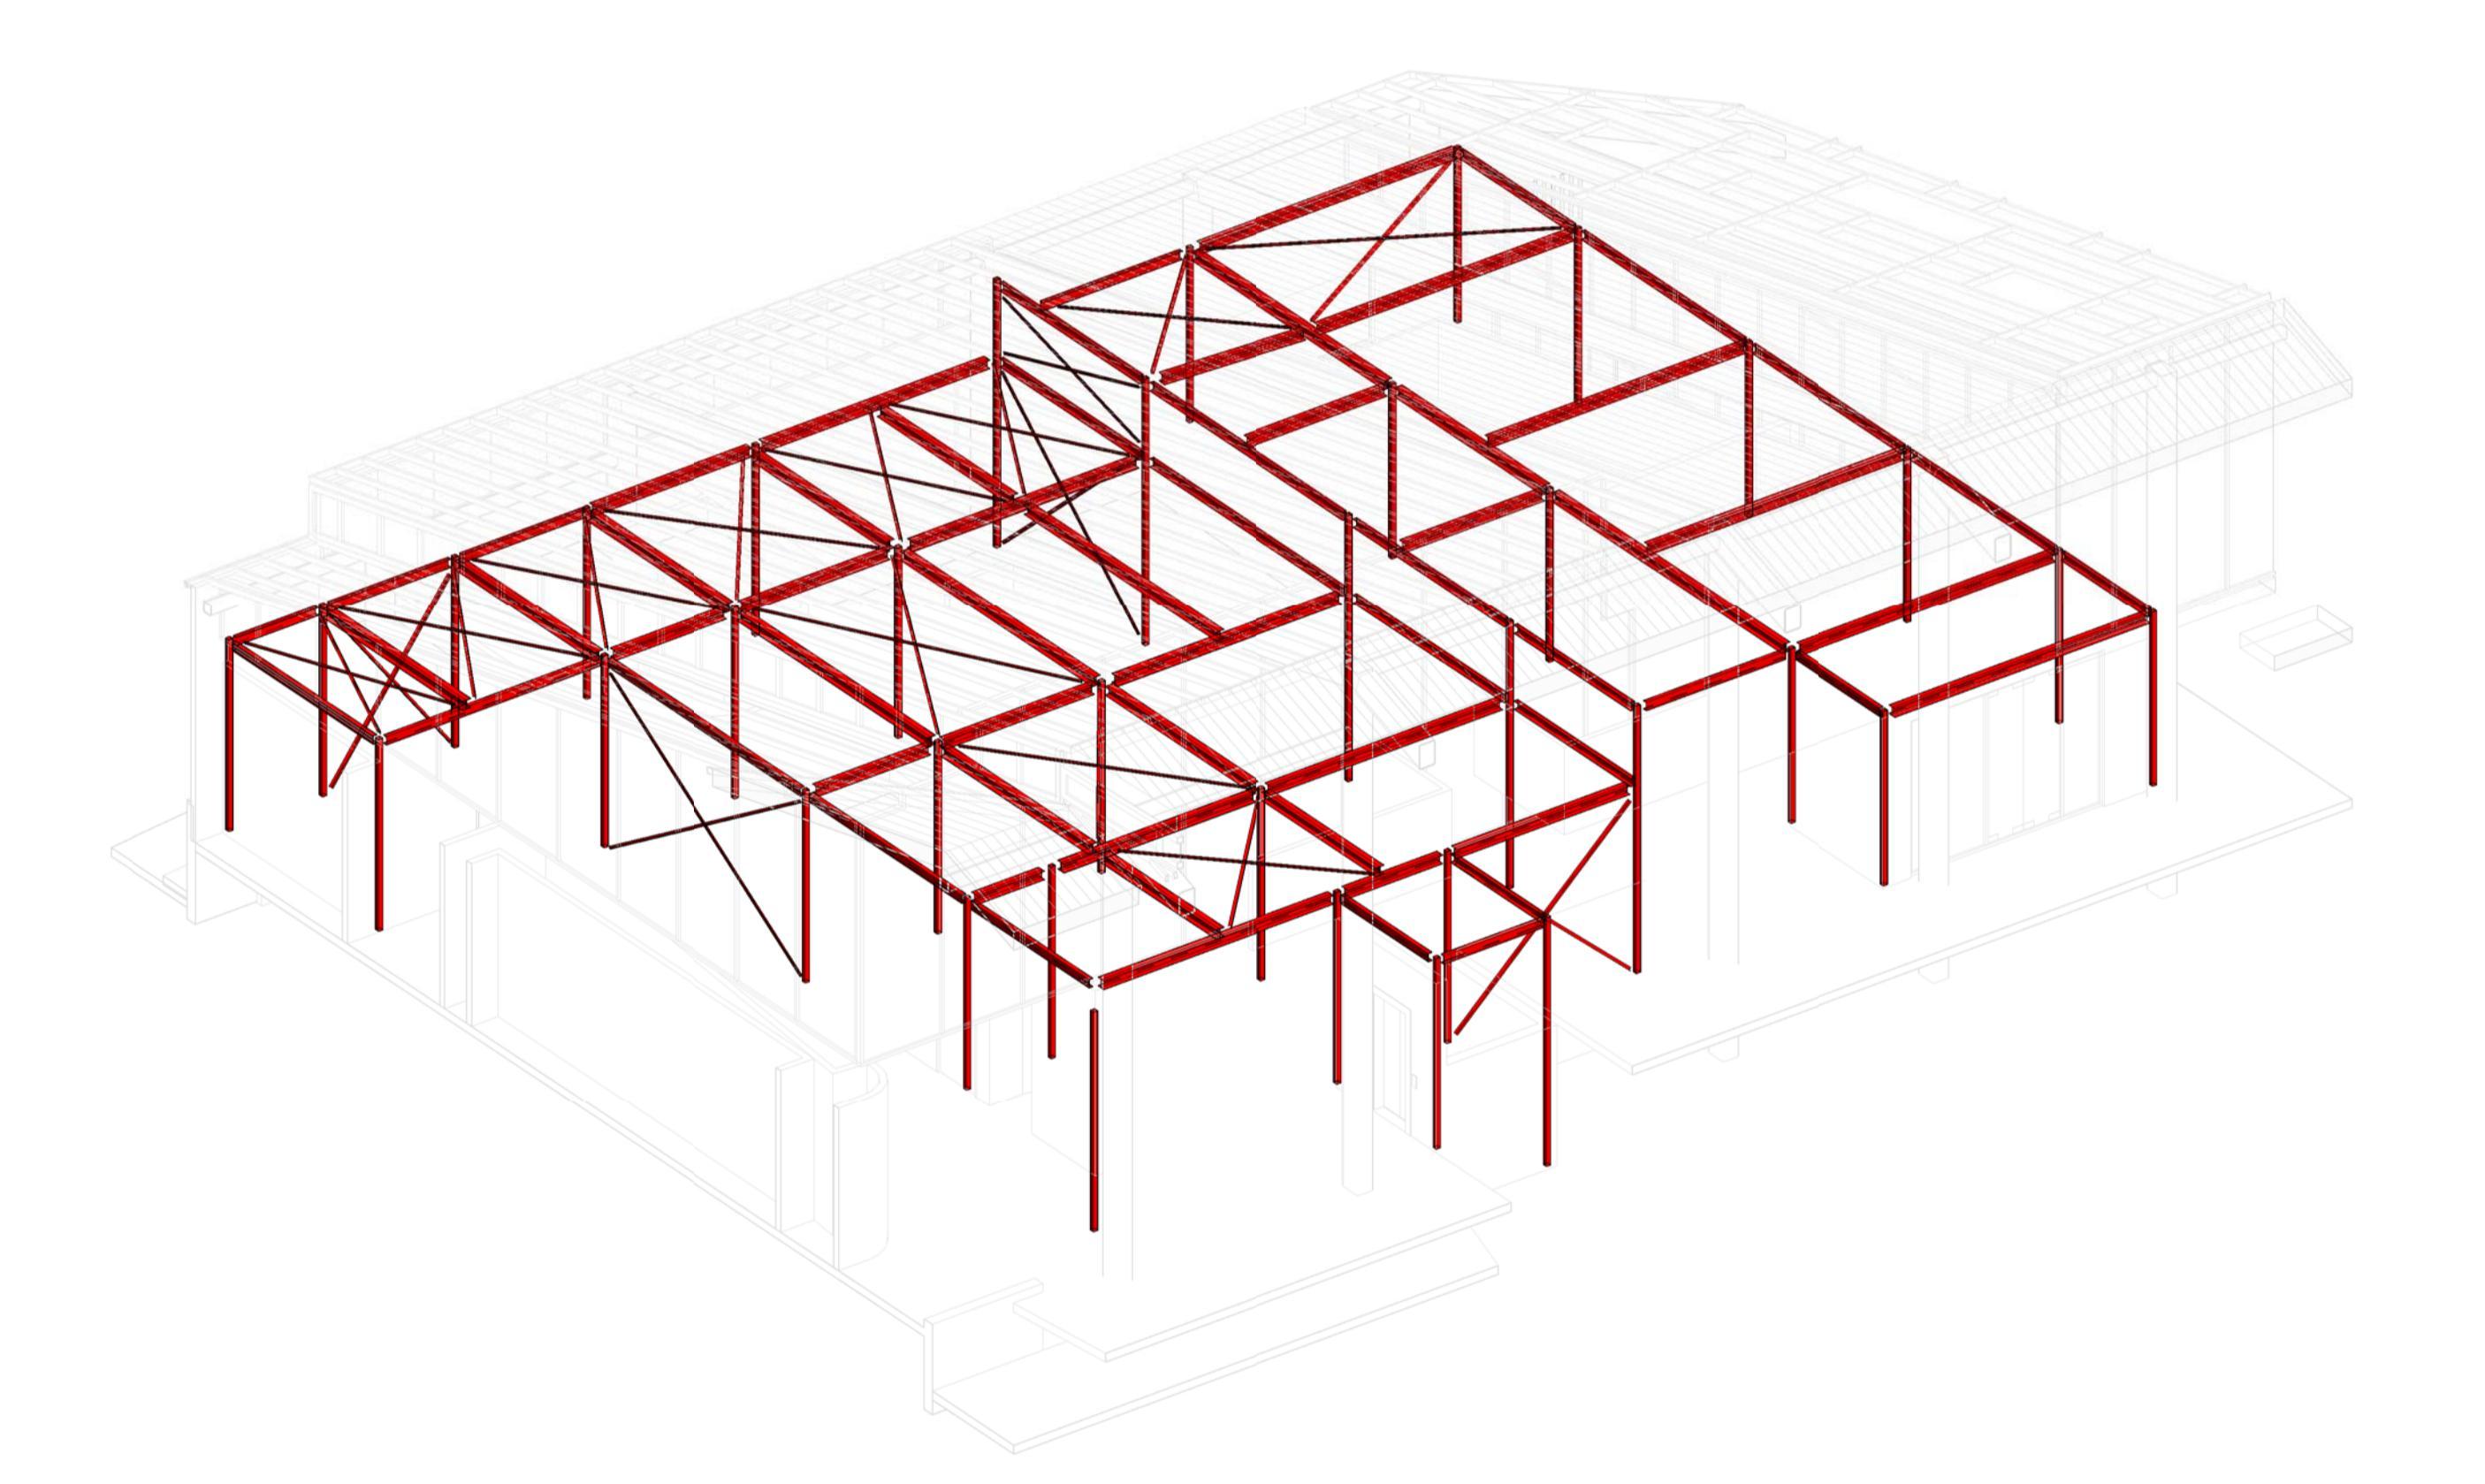
STRUCTURAL POD OVER CHANGING ROOMS ISOMETRIC VIEW

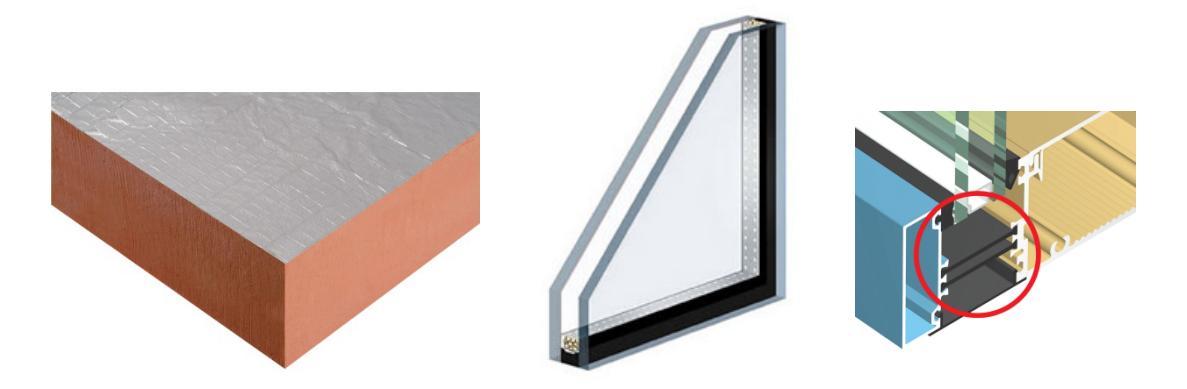
Figure 1 High-performance insulation, glazing & thermally broken frames

The combination of these two issues is that heat loss through building fabric and glazing elements is significantly more prominent in aquatic centres than other building types.

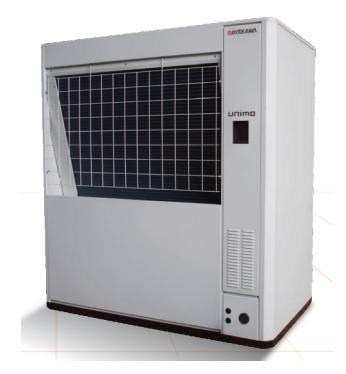
Figure 4 Commercial heat pump systems for hot water generation

Heat-pump technology utilises the direct expansion (DX) vapour-compression cycle to transfer thermal energy from the atmosphere to water. This cycle is exactly the same as a common air conditioner, whereby heat is transferred between the atmosphere and the air on the inside of a building.
