Statement of Environmental Effects

Lot 1 DP 117890 Goulburn Aquatic Centre, Goulburn

Prepared for: Goulburn-Mulwaree Council

Revised February 2019

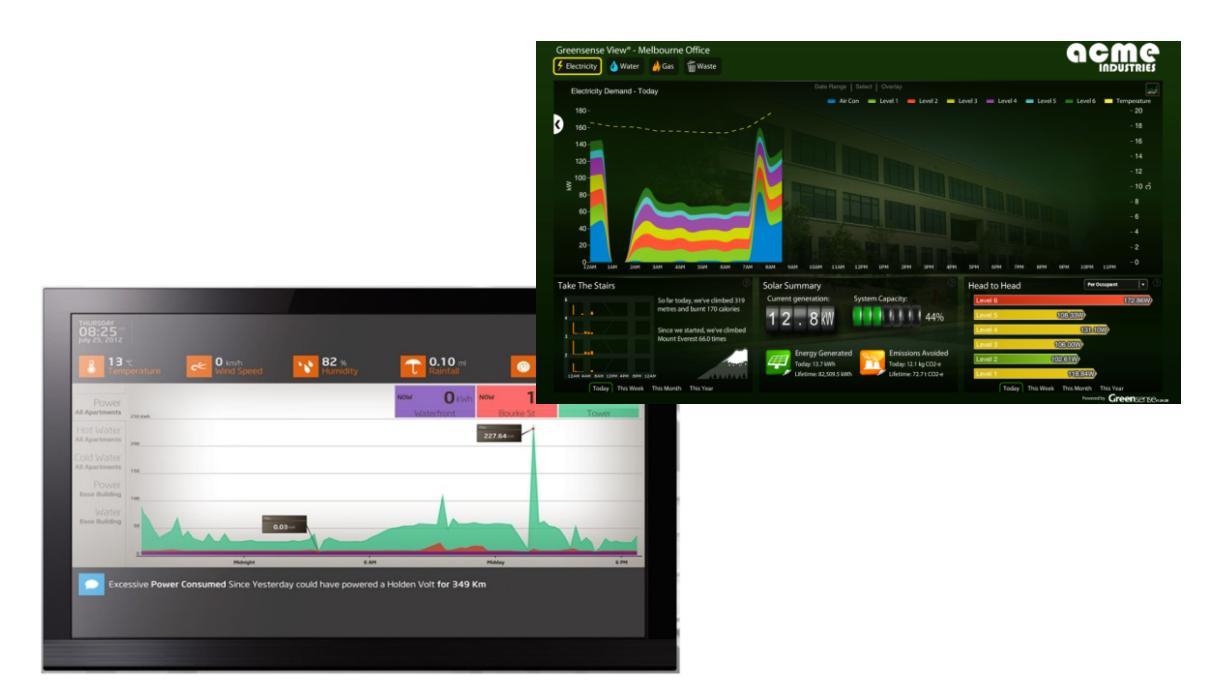
Figure 6 Example of utility "dashboards" available from cloud-based platforms

These proprietary cloud-based energy monitoring and management systems have emerged over the past 3 to 4 years as the industry has recognised a need for tailor made systems that facilitate energy efficiency management. Commonly energy management systems that are an extension to a building's BMS/BAS frequently fail to meet facility manager expectations and are not designed nor well suited to processing, analysing and visualising energy data to produce engaging and powerful displays and reports, critical to an effective energy management system.

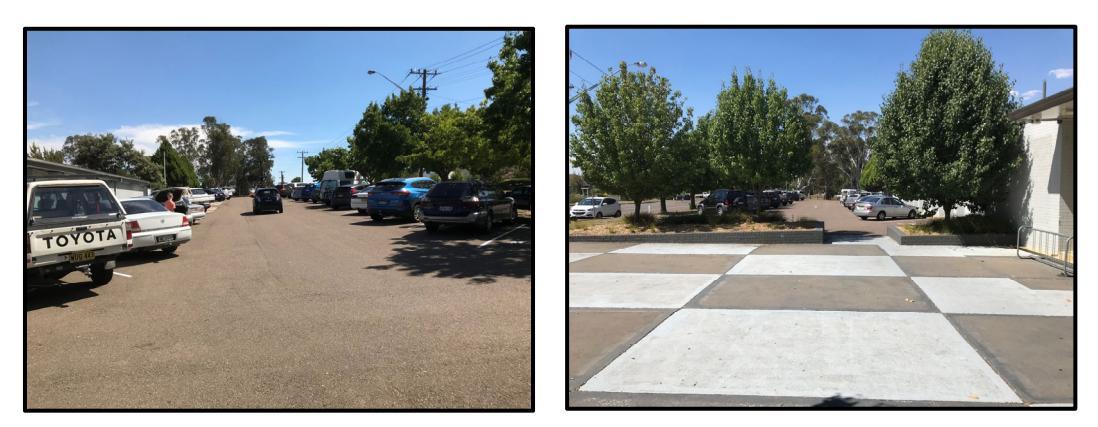
Figure 9 Existing car park facilities and utilisation at 3pm Sunday 21st of January 2018

Figure 8 illustrates that the off-street car park utilisation at 12pm on the Sunday was approximately 20-30% with a further 3-4 vehicles observed parked on street. **Figure 9** illustrates the car park utilisation increased significantly to 60-70% however the on-street car parking was still heavily underutilised with only 2 vehicles observed on street.

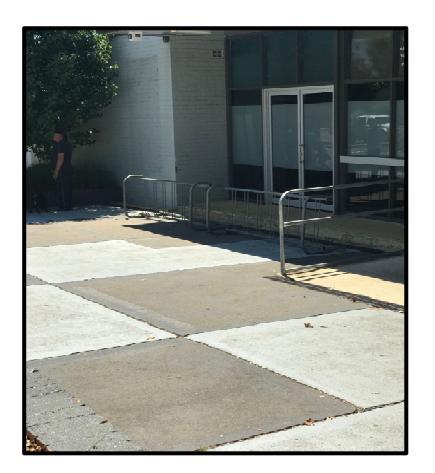
Figure 10 Existing bicycle parking

Existing bicycle parking is available at the entrance to the facility however during the site visit no utilisation of these facilities were observed (see **Figure 10**). Deccan Street has pedestrian paths on both sides of the road corridor which are approximately 1.2m in width. Whilst the pedestrian paths adjacent to the GAC facility have some shade from the existing tree canopy, it would be worth considering further tree plantings to increase shade cover to improve walking conditions during the warmer periods of the year (see **Figure 11**). No on road cycle provisions are provided and due to the on-street parking there is an inherent conflict between vehicular movements and cyclists.

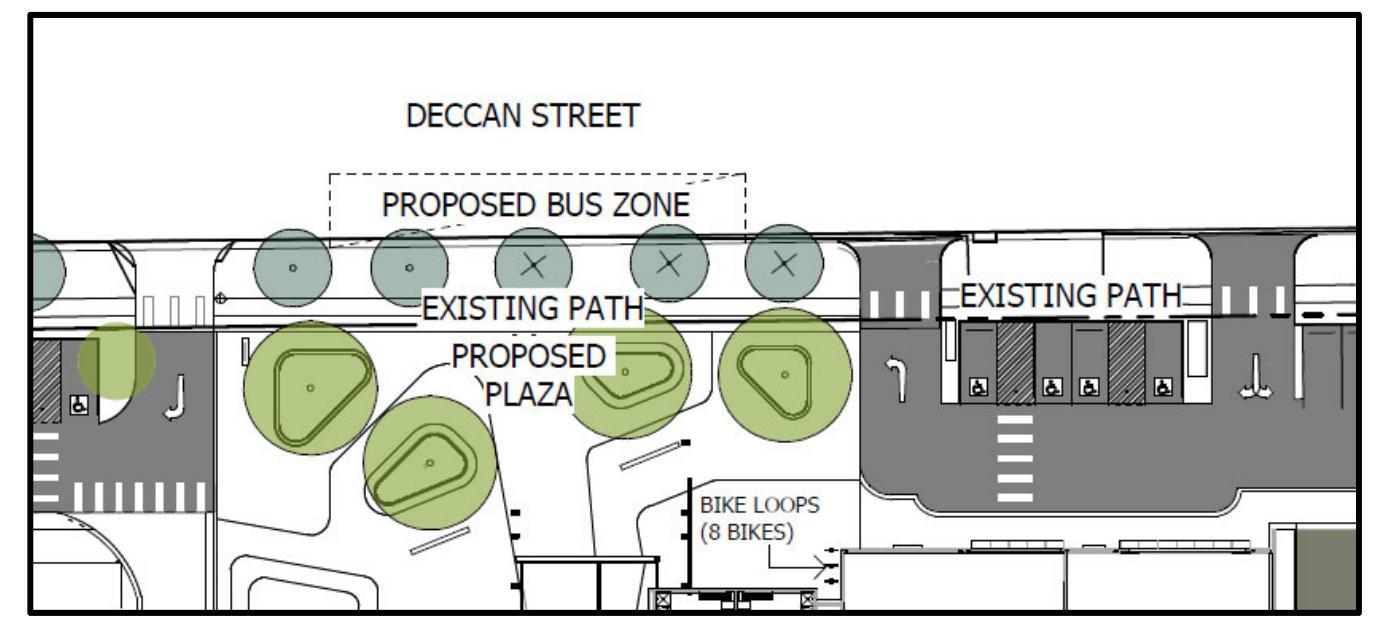
Figure 19 Location of Bus Zone

Following discussions with GMC, a new dedicated bus zone is proposed directly outside the aquatic facility as illustrated in **Figure 19**.
