# REMEDIATION ACTION PLAN FOR ASBESTOS IMPACTED SOIL

84-88 PARKER STREET NEPEAN, NSW 2179

Australian Industry Group (Ai Group) was commissioned by Cornerstone Development Management Pty Ltd to prepare a Remediation Action Plan (RAP) to manage site asbestos contamination issue at 84-88 Parker Street, Nepean, NSW.

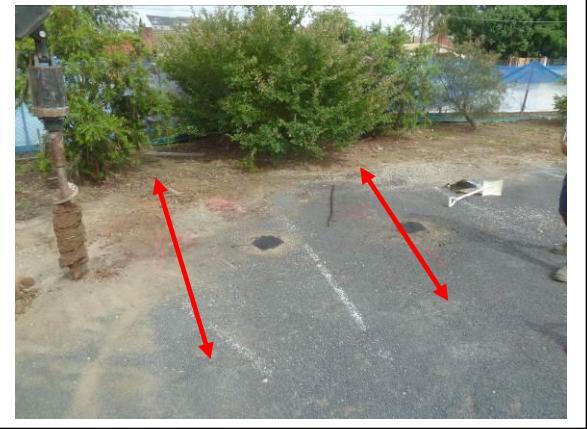
- All asbestos remediation work to be undertaken by Class B asbestos removal contractor.
- Scraping the top 300mm of top soil will be required. As the majority of the bonded asbestos materials are limited to the top soil, the depth of the excavation should be determined by the onsite occupational hygienist. From the soil investigation carried out, it is expected a depth of 0.3m or greater will need to be excavated.
- It is expected excavation will involve layered cutting/scrapping and attempts make to keep the cut/scrapped layer as thin as possible.
- Buried services were encountered approximately 3m north of BH103 and 2m south of BH103 running approximately parallel to the white car parking marking along the east/west direction.

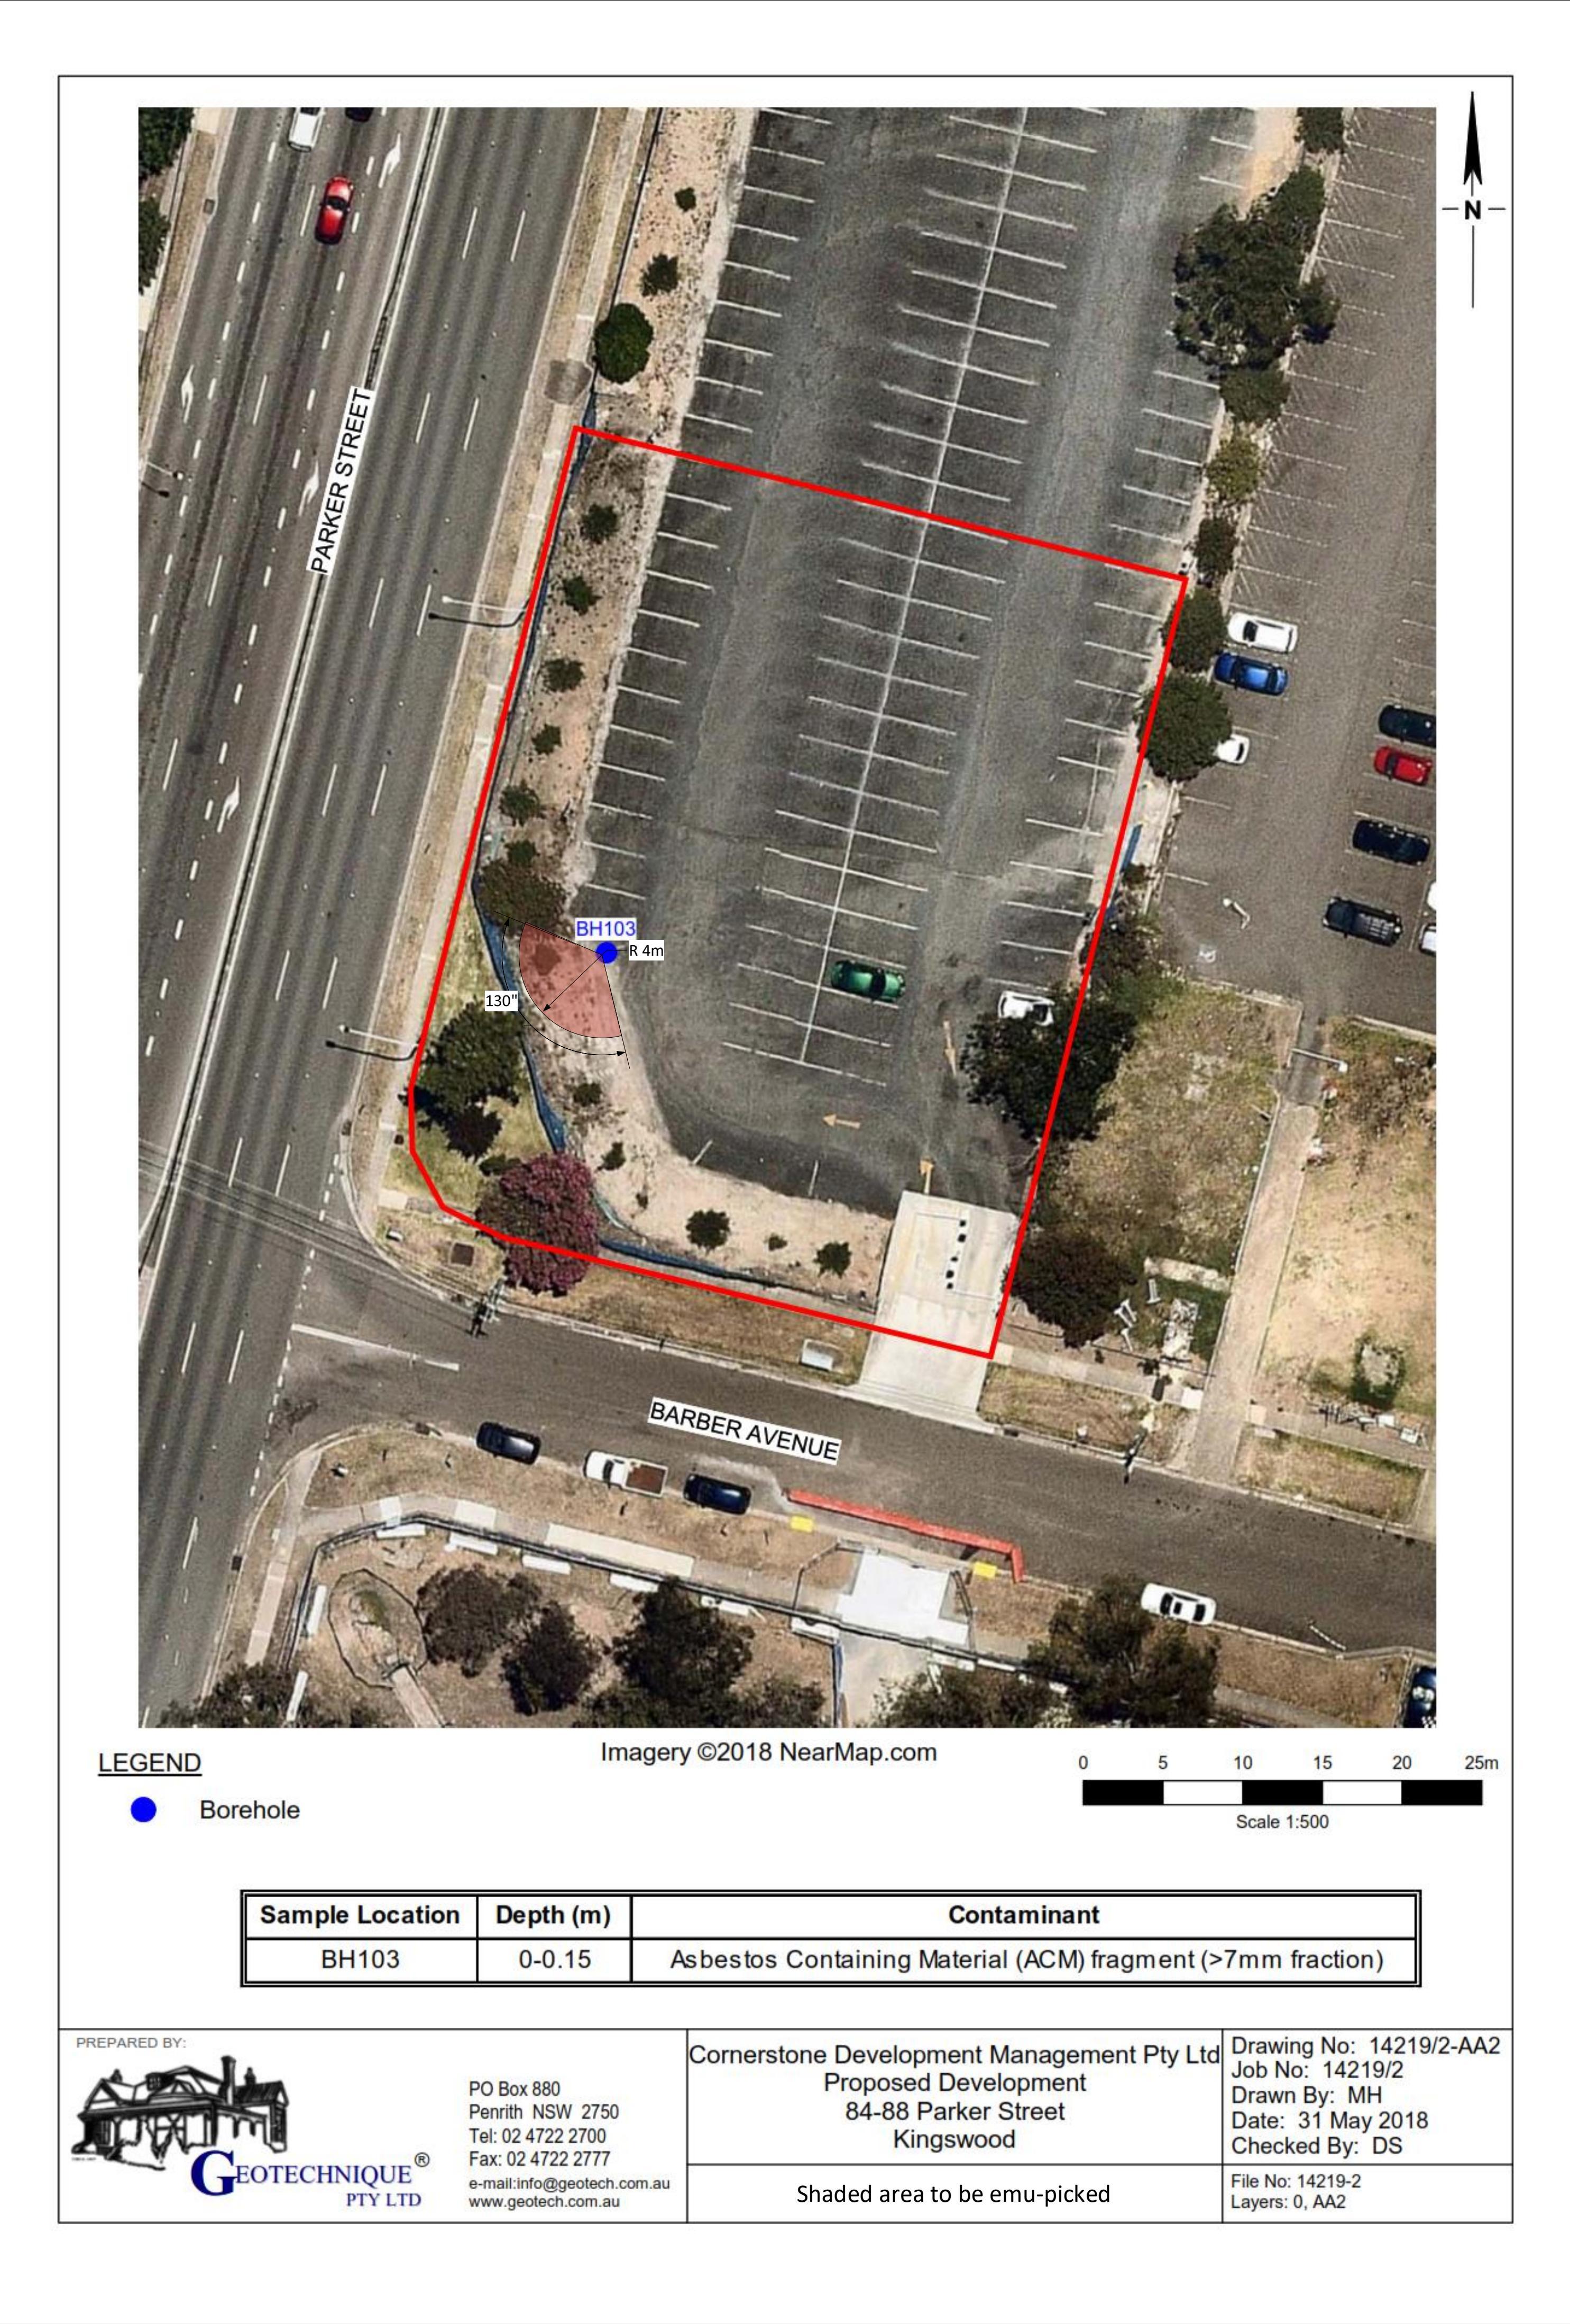
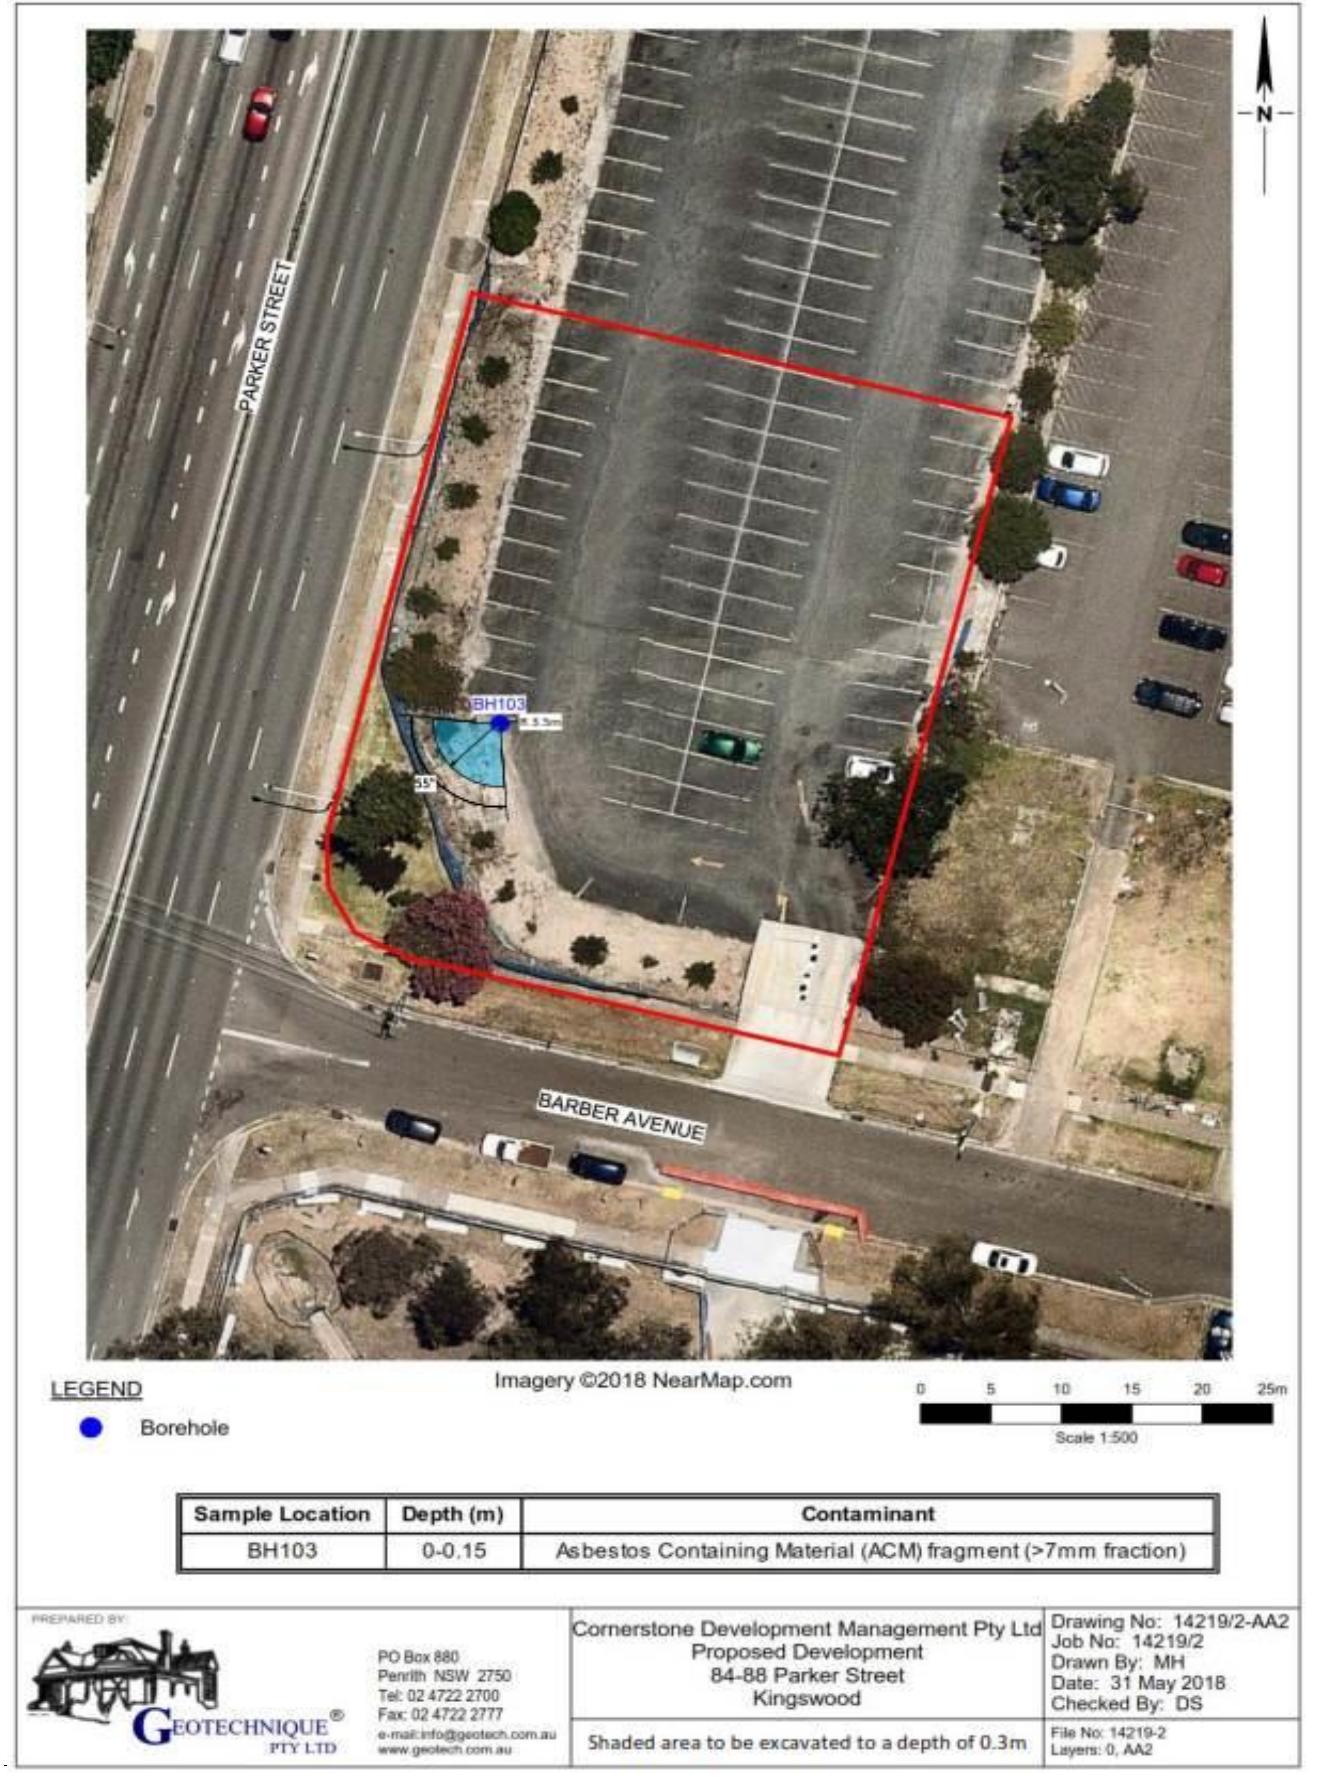
# APPENDIX II (RAP Site Schematic)

Source of Contamination	Location (please refer to Appendix for specific locations of nominated test pit (TP)	Potential Contaminants	Migration Path
Top Soil	<u>BH103 (1/4 circle of 3.5 metre</u> radius of [Bore Hole] BH103 to a depth of 0.3m, light blue shaded area refer to Appendix II)	Asbestos containing material (Asbestos Fines and Fragments) within fill materials	Deterioration and/or disturbance of ACM
Asbestos cement fragments	Asbestos cement fragments (3/8 circle of 4.0 metre radius of BH103 on the surface, light red shaded area refer to Appendix II)	Asbestos containing material (Asbestos Fragments) predominantly on the surface	Deterioration and/or disturbance of ACM

<u>3/8 circle of 4 metre radius of [Bore Hole] BH103 on the surface or light red shaded area</u> of Appendix II

<sup>1</sup>/<sub>4</sub> circle of 3.5 metre radius of [Bore Hole] BH103 to a depth of 0.3m or light blue shaded area of Appendix II

<u>BH103</u> – Further detailed/confirmation sampling within a radius of 5 metres has been carried out. The extend of the contamination is within a radius of 3.5 metre of (Bore Hole) BH103 to a depth of 0.3 m.
