Arboricultural Impact Evaluation Report

Hamlets A and B, Flowers Drive, Catherine Hill Bay

Ref No: 02-0821 Date: 4th November 2022

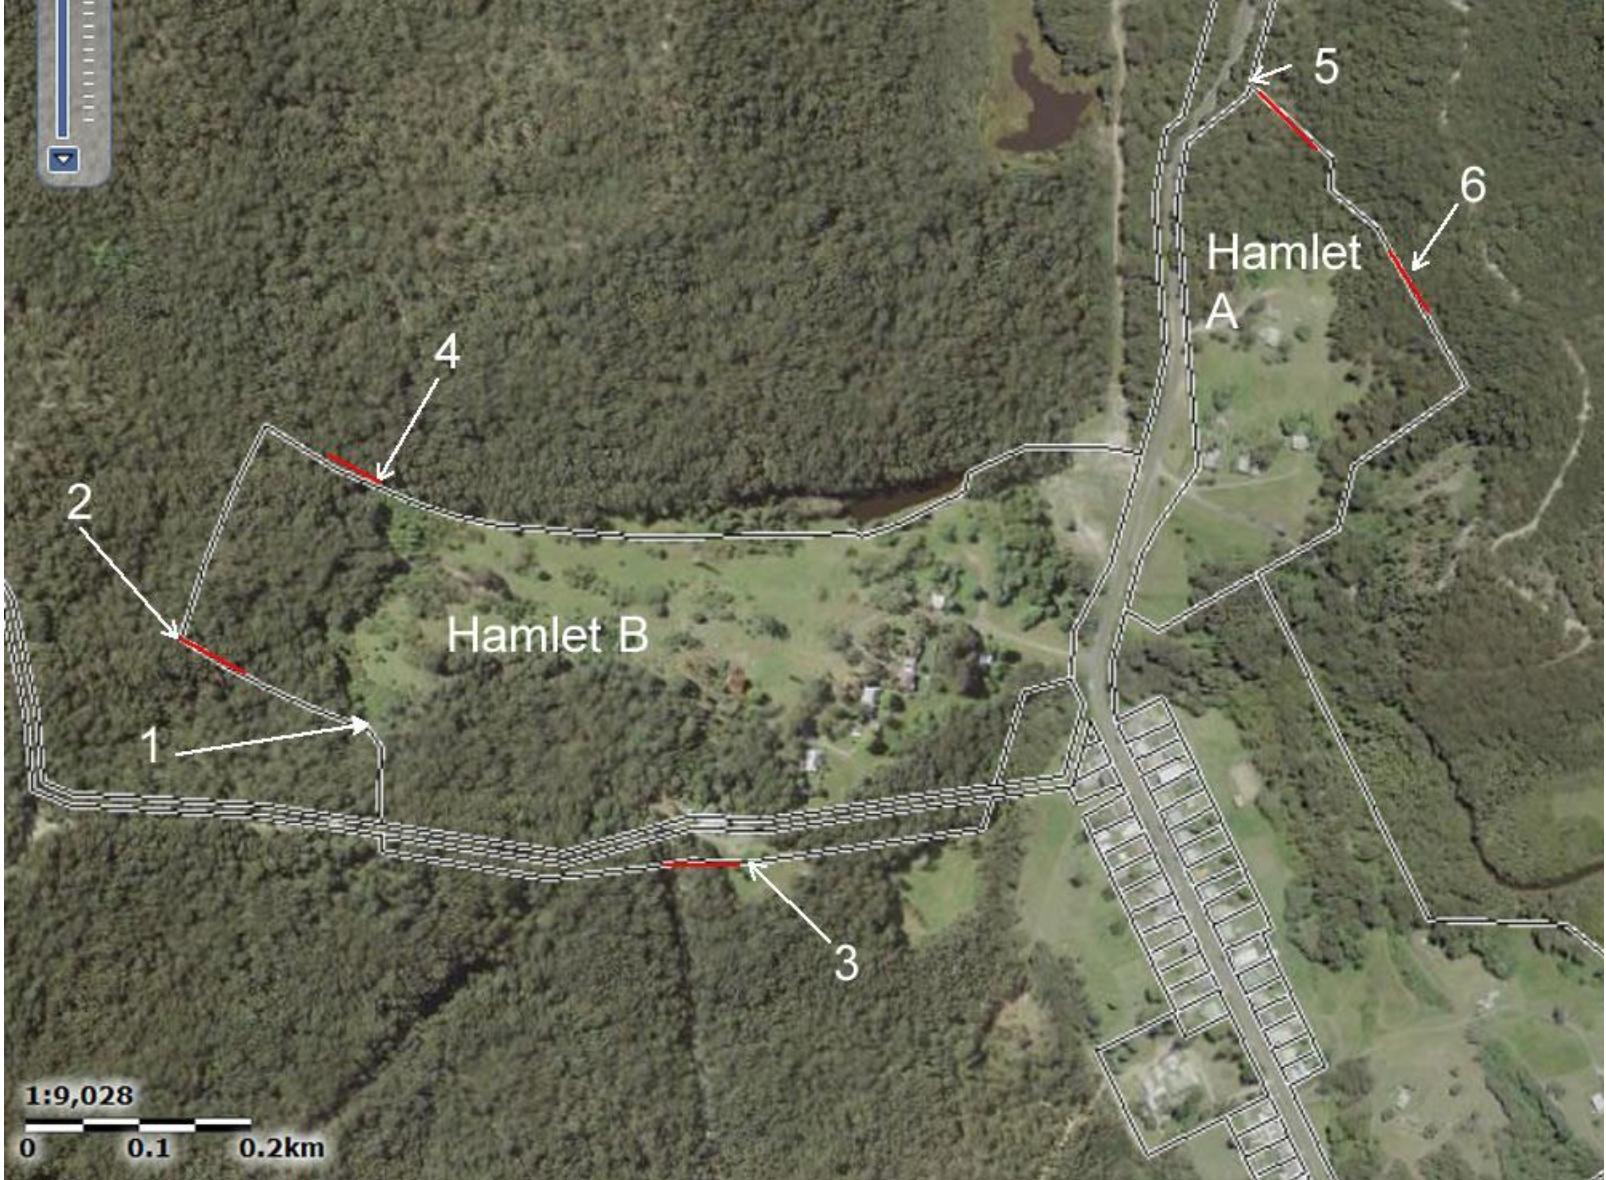
Figure 1 shows the positions of transects 1 - 6 on site. The red lines indicate the direction of each transect along the boundary.

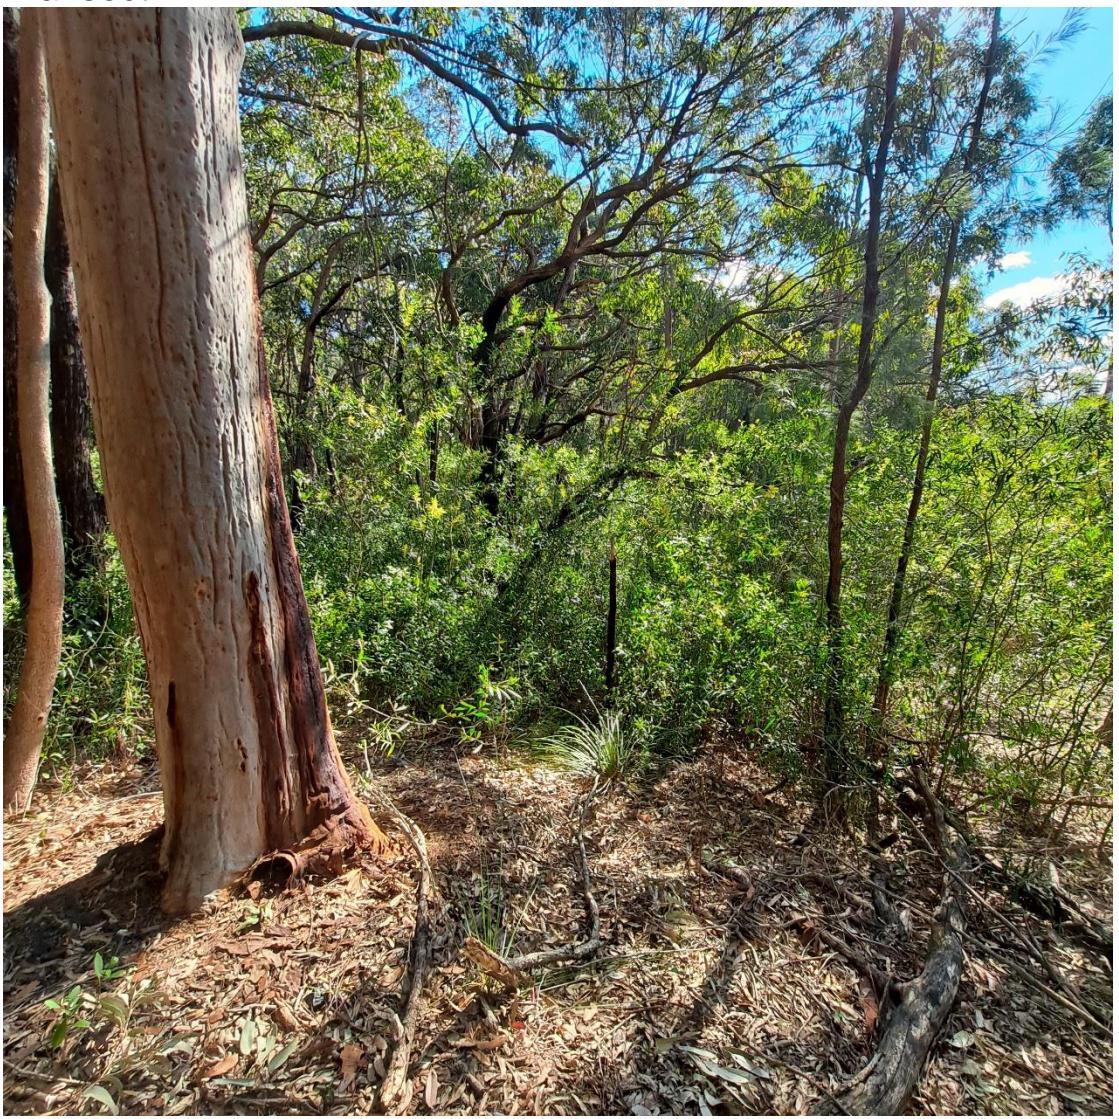
Figure 2 shows the view at Site Transect 1 looking approximately North West along the boundary. The foreground is clear of vegetation as most of this small area was a zone of old coal chitter.

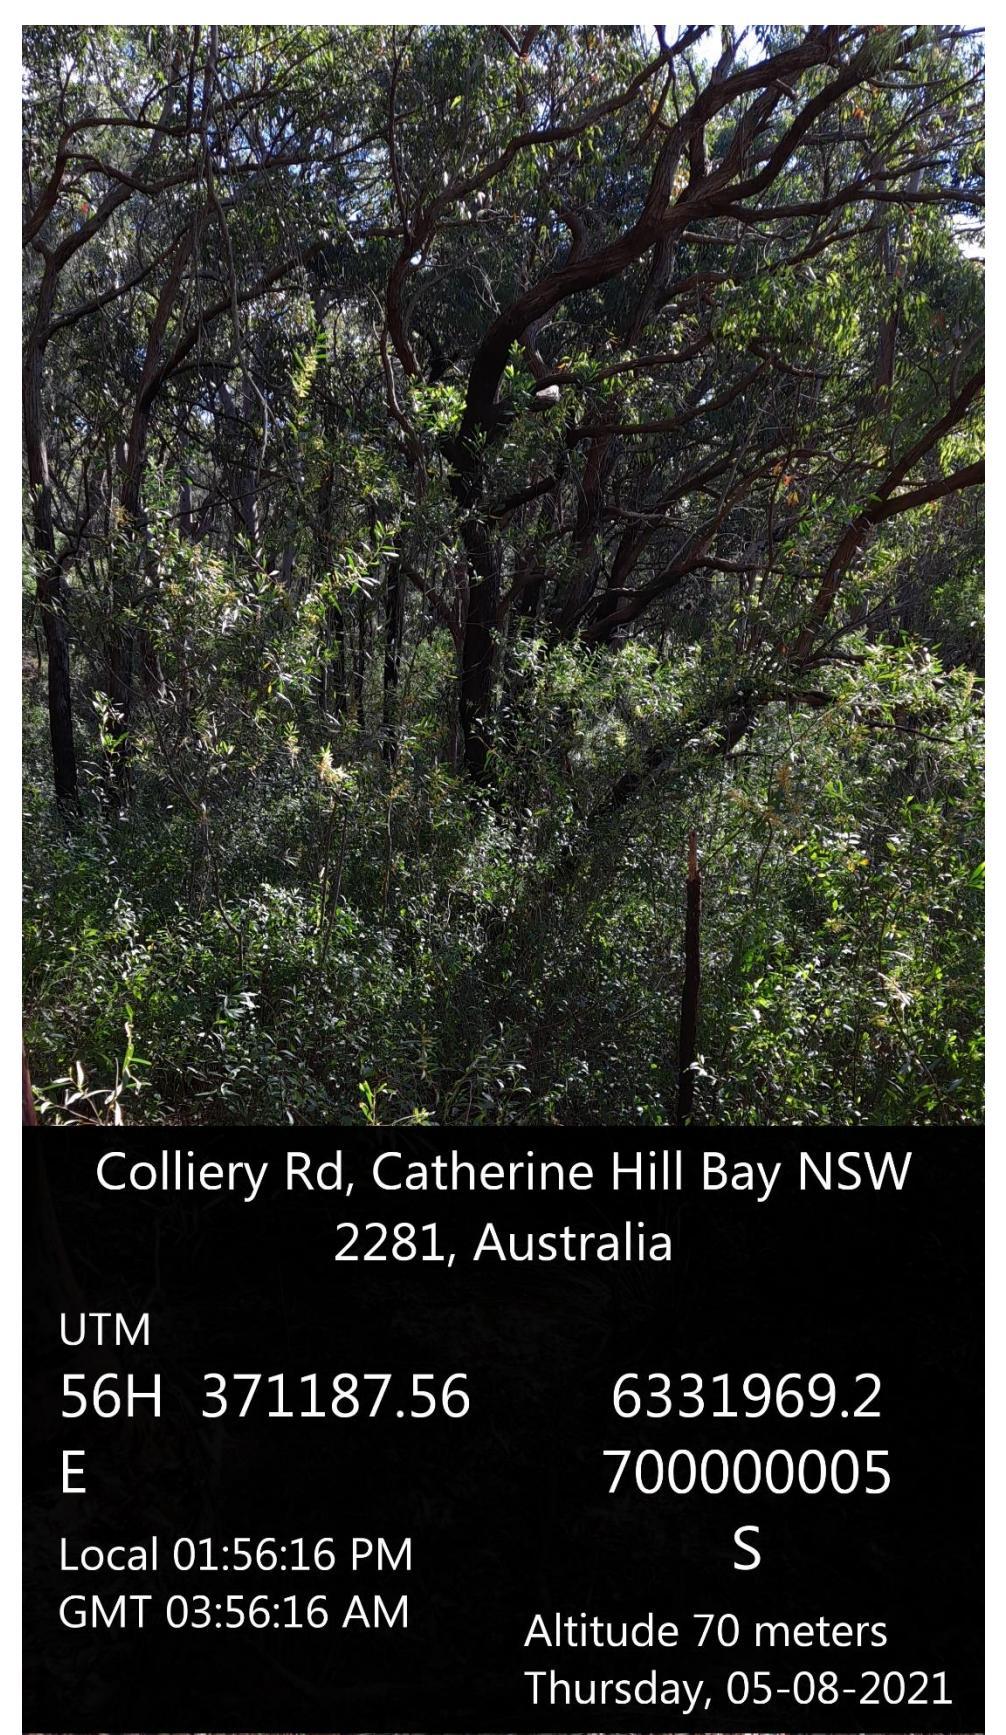
Figure 3 georeferenced image at Transect 1 looking approximately North West.

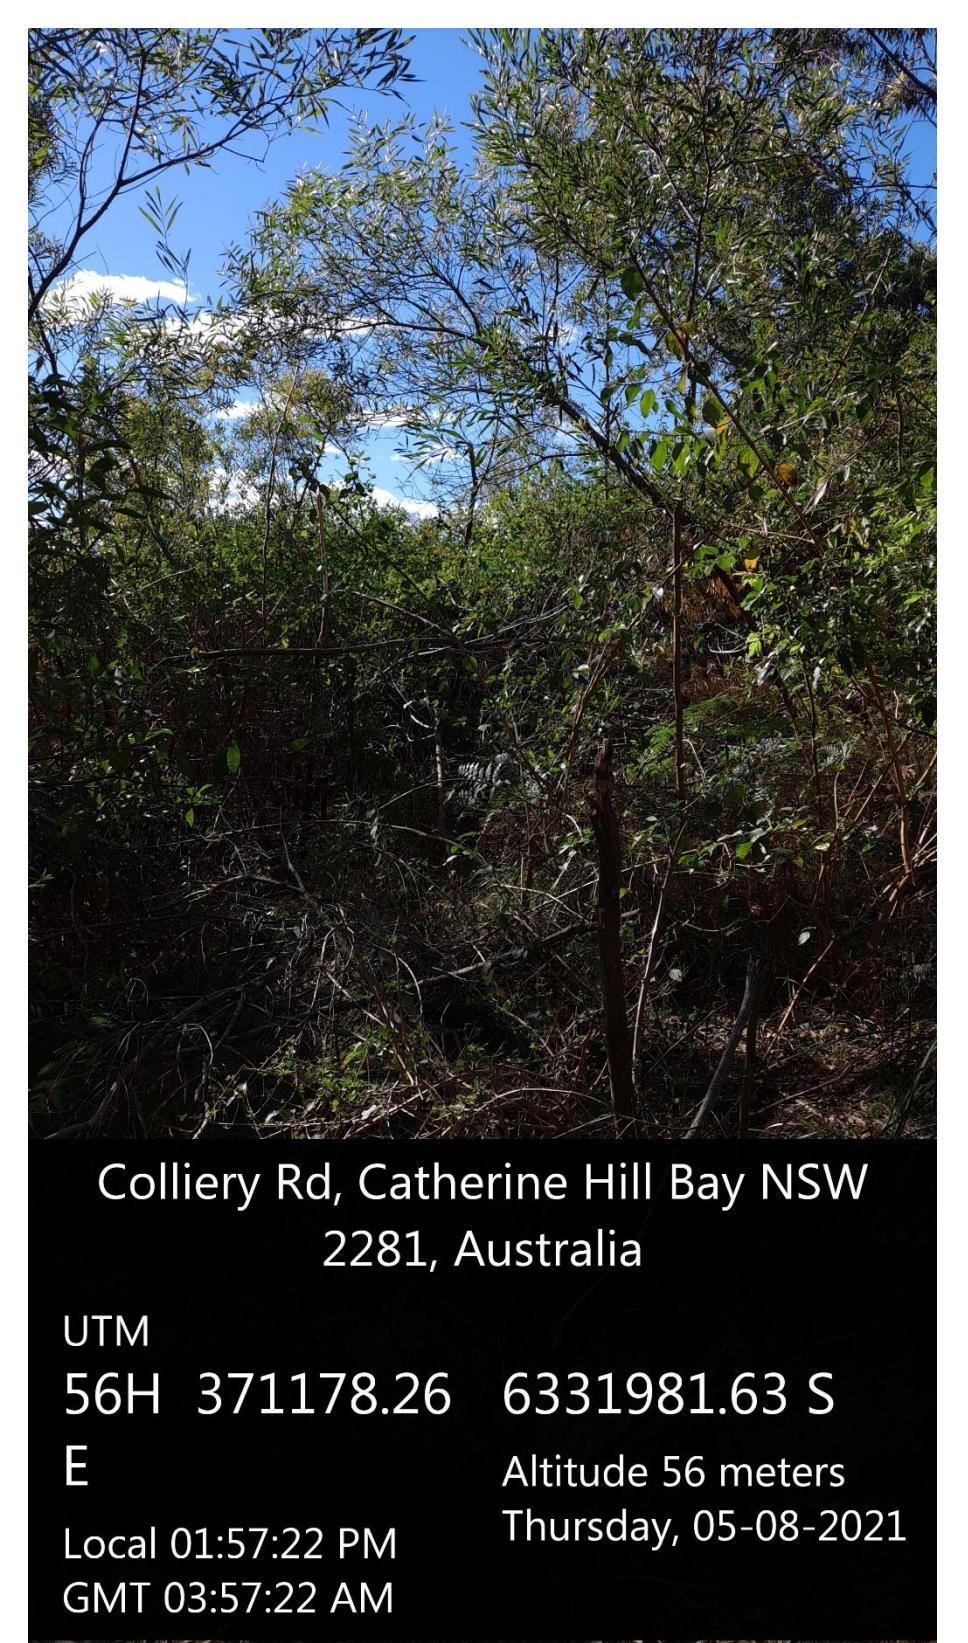
Figure 4 georeferenced image at transect 1 looking North to north east at dense Acacia species.

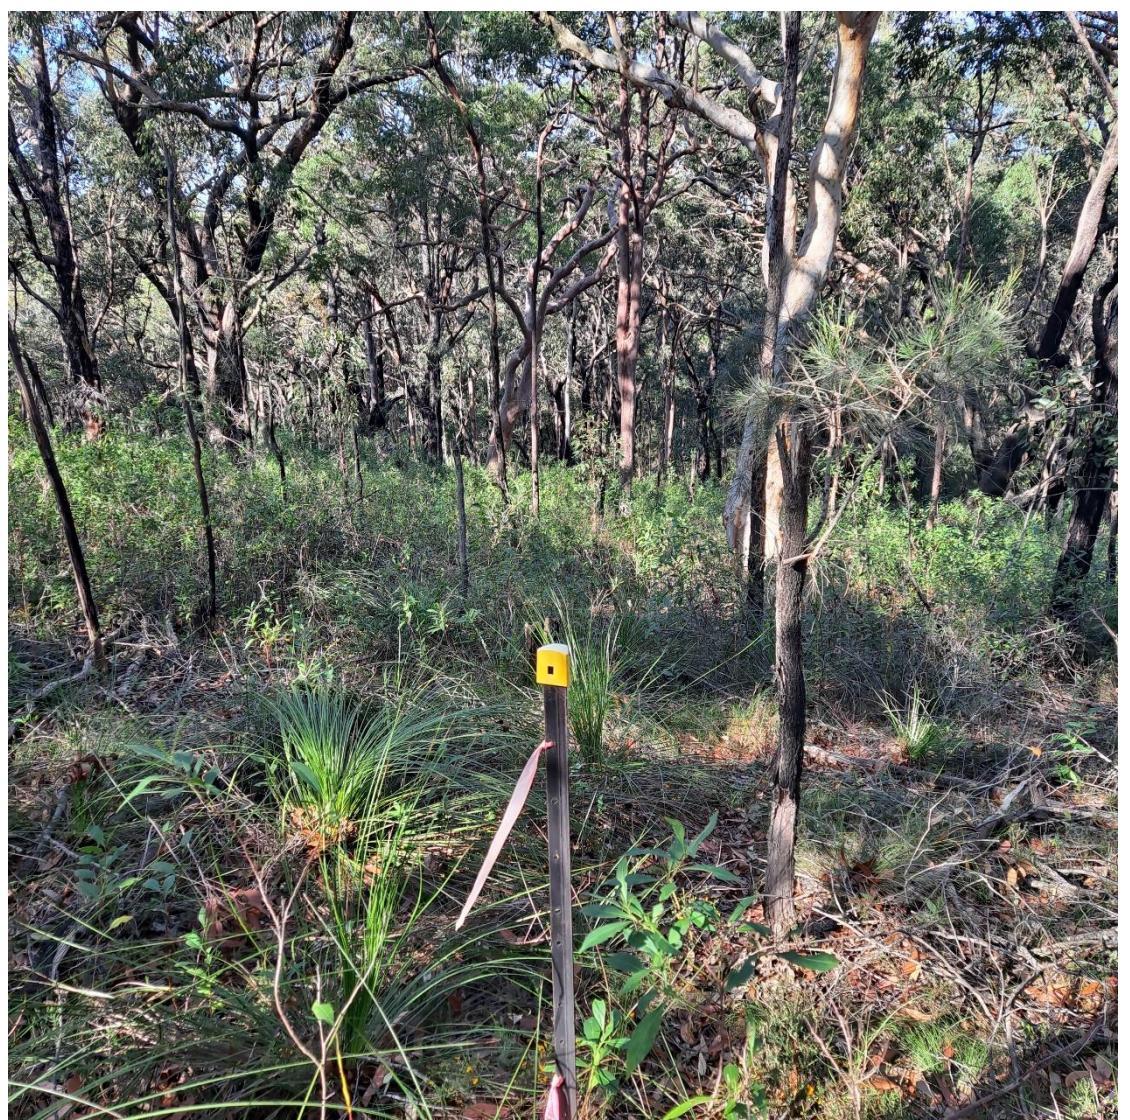
Figure 5 image at transect 2 looking approximately South East. Boundary mark is the yellow capped star picket in the foreground.
