3130 Oxley Highway – Site Remediation and Validation

ASEBSTOS CONTAMINATION AND REMEDIATION WORKS

Gunnedah Shire Council P.O. Box 63, Gunnedah NSW 2380

November 2020

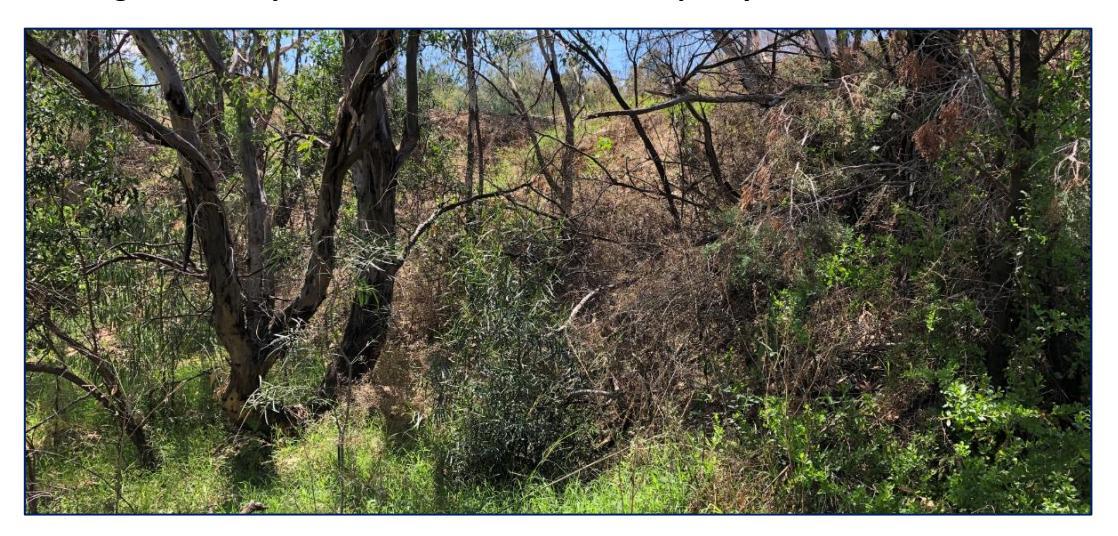
Figure 2: Steep batter on west side of main quarry site formed with fill

The resulting activity on this site has left several internal vehicle tracks through the centre of the property that lead to the northern end of the property. These were originally formed to allow access to the quarry areas. The western side of these internal roads have been levelled with spoil material from the quarry areas or spoil brought to the property. The levelled areas have provided turning areas for trucks. The fill is mainly soil and a mixture of clay and gravel from preparation works for the quarry operations. A steeper bank has been created along the western side of this fill material as per following image. The area supports extensive regrowth which shows the depth of capping over the fill.

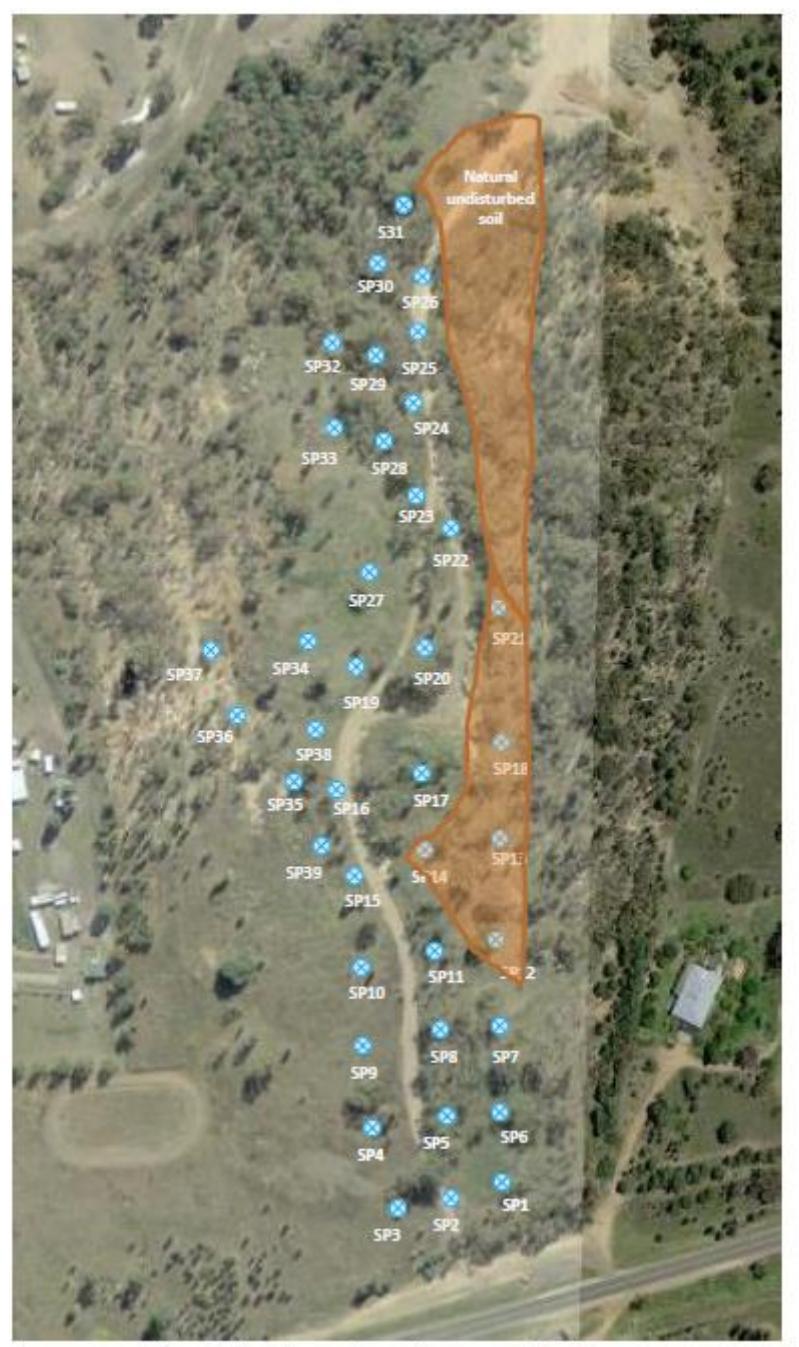
Figure 3: Test hole locations for Contaminated Site Investigation

Figure 2 A mud map of approximate sample locations 🛞

The investigation identified the presence of bitumen/asphalt and asbestos as contaminants of concern. The bitumen/asphalt was deemed to be isolated and required removal from the site. The asbestos appeared to be highly visible, and the report recommended removal of such.

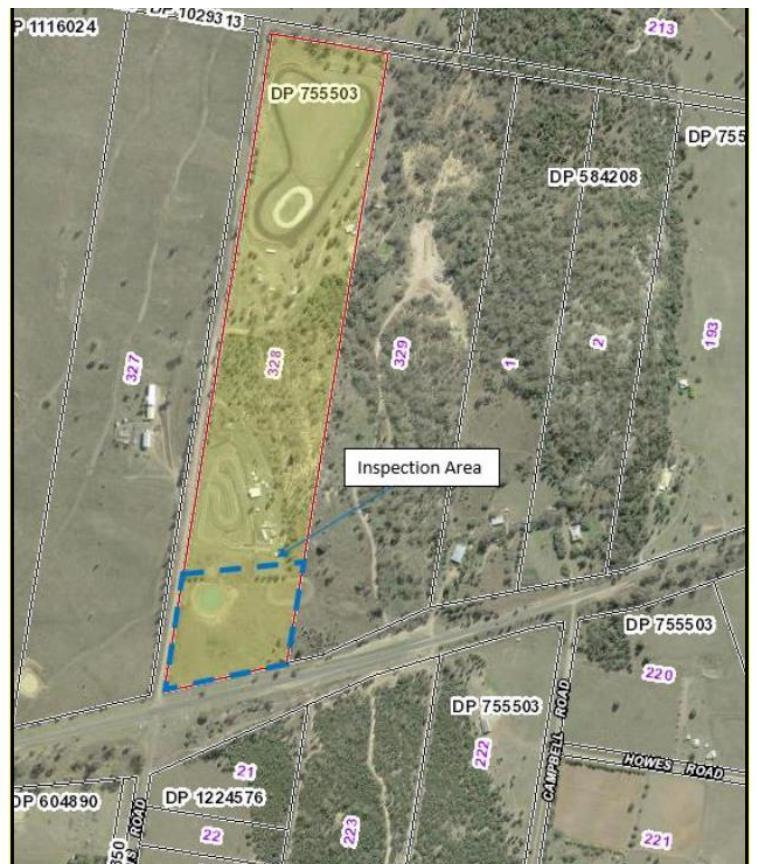
Figure 4: Plan showing inspection area for second site investigation

Site observations during this investigation indicated "the site shows no evidence of imported material on site and did not reveal any potential locations of buried waste." The one site that contained an elevated level of benzo(a)pyrene should be disregarded as the sample was obtained from the boundary fence adjacent to the highway. The sample appeared to have included some bitumen. The outcome from this report included a recommendation that there is little risk of exposure from previous site uses and that works may continue within the area. As noted from the site plan, the area under consideration was isolated to the southern portion of land adjoining the proposed Koala sanctuary that was subject to tree planting.

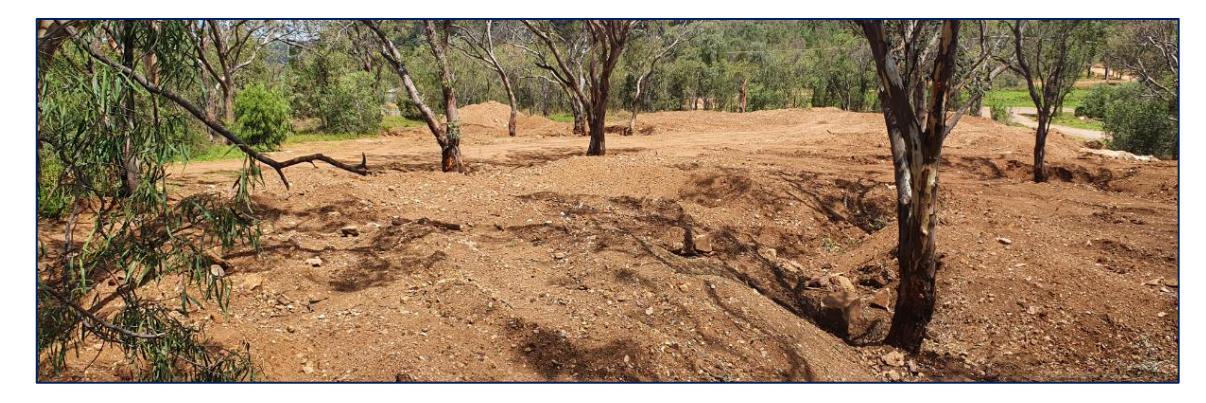
Figure 5: Treated soil from stockpiles

The remediation work involved opening up each stockpile and separating waste from raw soil. Once the soil had been spread and cleared of all visible materials including asbestos, steel, concrete and timber, the soil was then moved to expose the original surface.

The contractor indicated that approximately 3.2 tonnes of asbestos material was removed from the site during the work associated with sieving of the stockpiles. This was bagged and disposed of at the Gunnedah landfill. An additional 20 kg or more of smaller pieces of asbestos were hand-picked from the treated stock pile once this material was spread out over previously cleaned areas. The treated soil is shown in the above image.

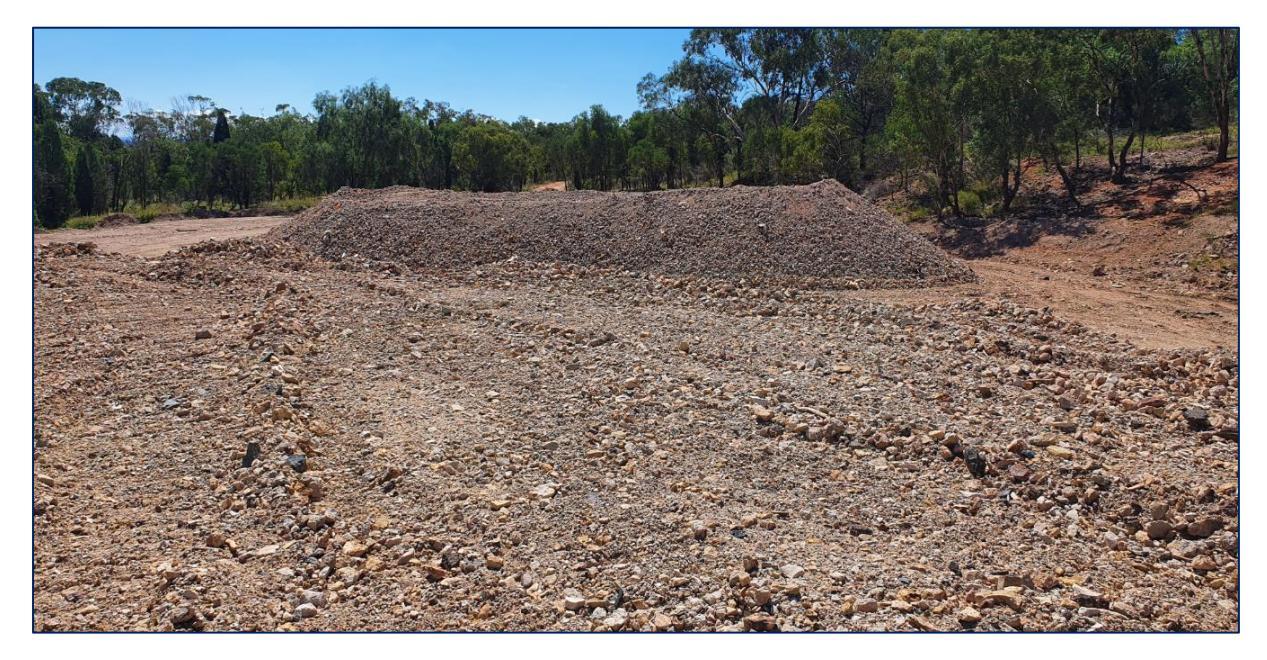
Figure 6: Northern stockpile from top of Southern stockpile

Crushing continued for a one-week period. Consistent rainfall wet the concrete pile, reducing dust emissions. Two stockpiles of crushed concrete are now piled in the quarry area (**Error! Reference source not found.**). An estimated 425 m³ of material is present in the piles.

During the remedial validation site visit, SMK completed an inspection and remedial sampling of the two piles.

The crushed concrete stockpiles were also inspected during the final site validation walkover. The stockpiles were found to contain sand, concrete, gravel and mixed household plastics. No suspected asbestos containing material was identified during the visual inspection. Asbestos fibres were not detected in air monitoring samples taken during the first day of crushing. Similarly, no asbestos fines or fibres were detected in the 8 composite samples taken across the stockpiles. The risk for the gravel stockpiles to contain friable, crushed asbestos materials does exist; however, the likelihood of it existing in levels greater than adopted guidelines is very low. All concrete was sieved, separated and washed prior to crushing. The material has been deemed suitable to spread as required across site a road base and building foundation material.

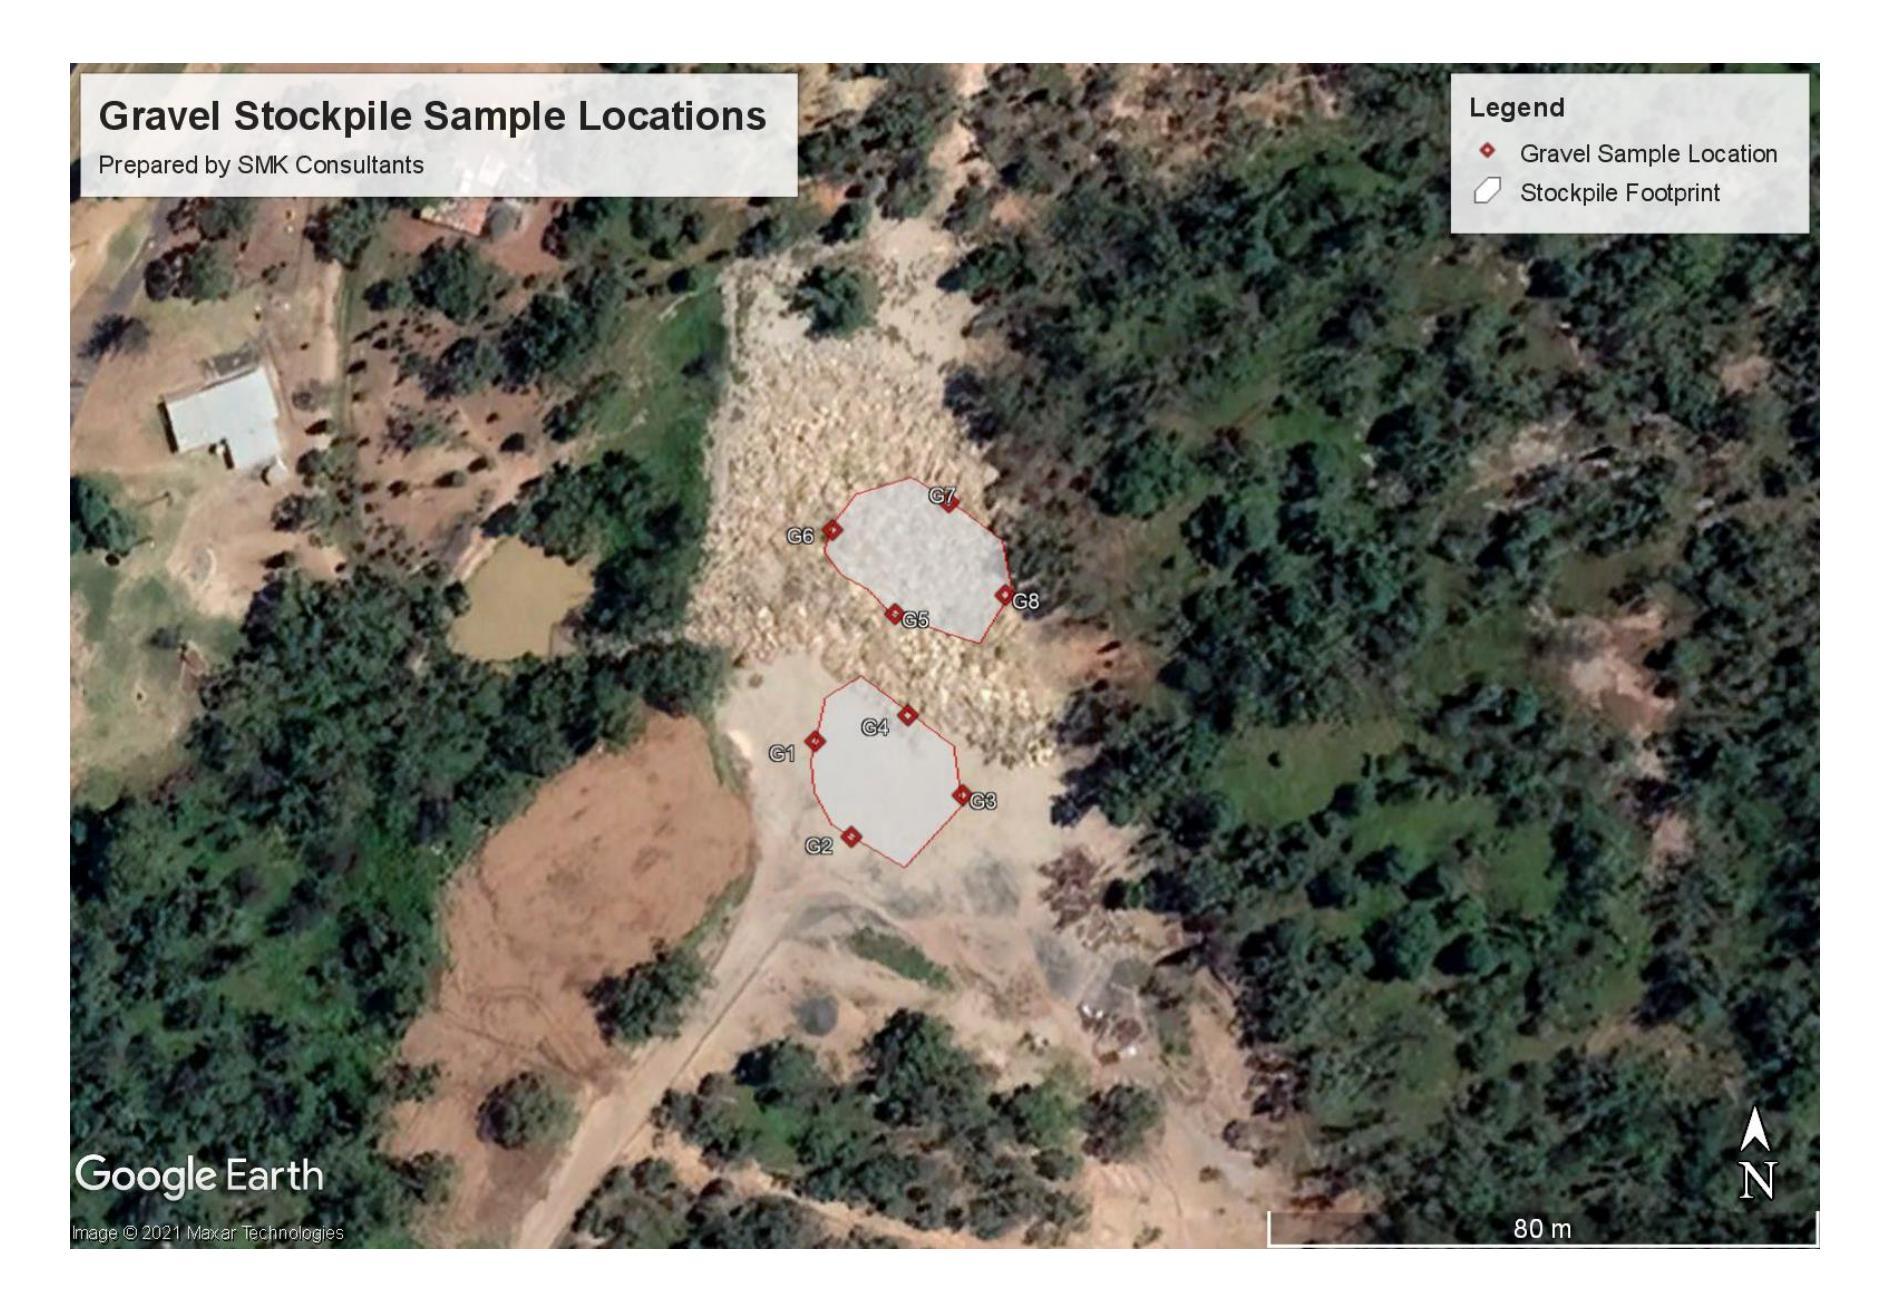
The following depicts the outline of crushed concrete materials as well as sample locations. A handheld GPS was used to create a string around the base of each stockpile and note the location of each sample.

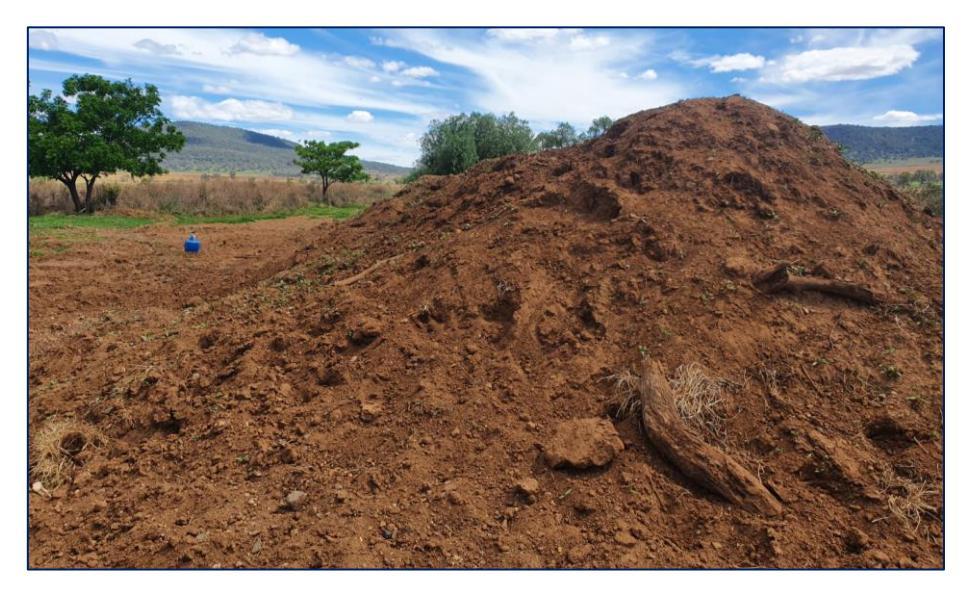
Figure 1: Stockpiled material looking South - Turners Gully, Gunnedah

Therefore, the material in the stockpile is classed as ENM. However, this must be chemically validated to ensure it meets the required criteria for reuse on another site.
