# Arboricultural Development Assessment Report

Shellharbour Anglican College 1 Piper Drive Dunmore NSW 2529 Lot 2 DP 1144885 AUGUST 2022 *FINAL*

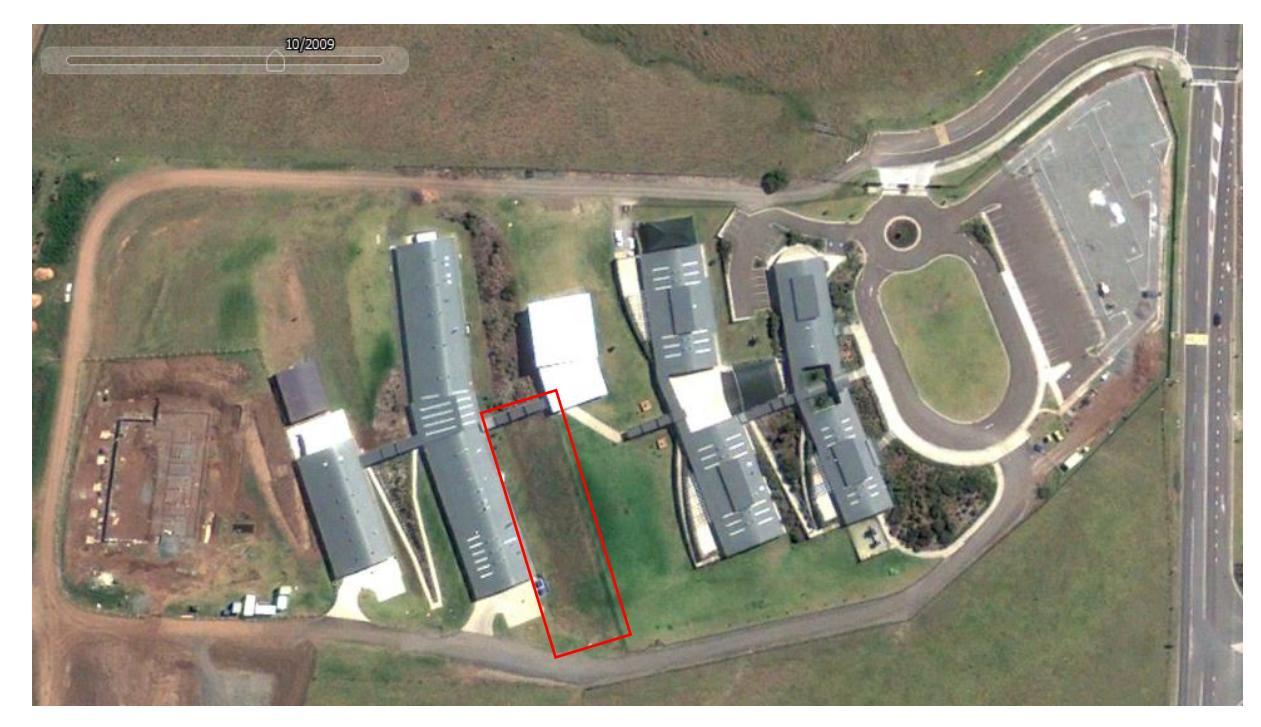
Plate 4: Aerial image from 2009 showing the study area clear of any vegetation. P. Vezgoff.

I have assessed most of the trees as being rated as 5b;*Young trees less than 15 years old but over 5m in height* (See Plate 4). These trees could be replaced and appropriately spaced to allow trees that will grow for more than fifty (50) years as long term specimens.

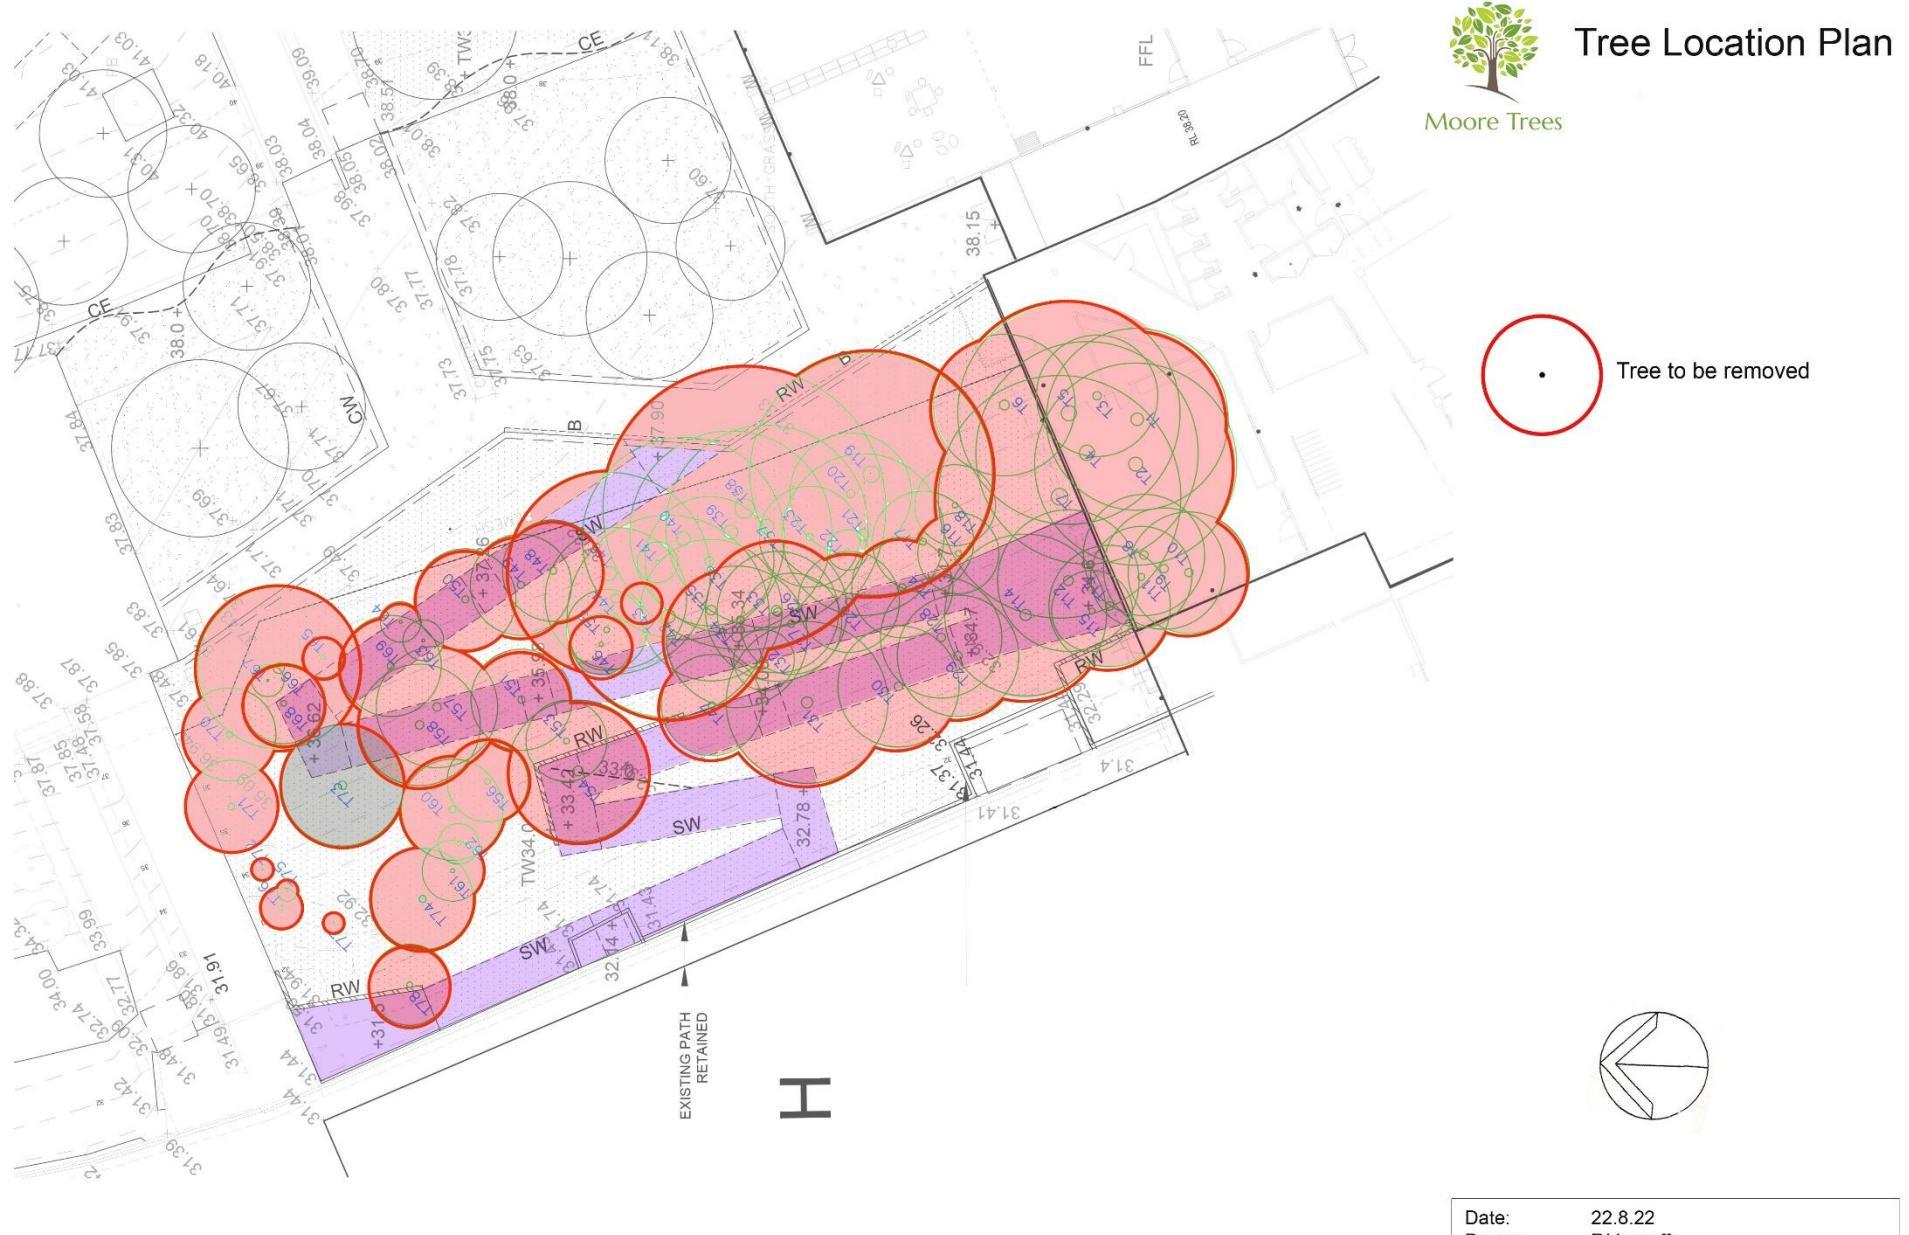
## **Tree Location Plan**

- **3.4** The Site Trees: The site was inspected on 5<sup>th</sup> August 2022. Each tree has been given a unique number for this site and can be viewed on the Tree Location Plan (Appendix 1).
- **3.5** In total seventy eight (78) individual trees have been assessed for this report. Most have been planted too close together and as such are unlikely to reach their full potential in terms of their natural shape and size (Plate 1). All trees have been identified as native Illawarra species.
- **3.6** The tree species in this group consist of Blackbutt (*Eucalyptus pilularis*) and Forest red gum (*Eucalyptus tereticornis*), Coastal banksia (*Banksia integrifolia*), Acacia melanoxylon, Acacia maidenii, Melaleuca bracteata, Melaleuca decora, Melaleuca styphelioides.

- **3.8 Impacts:** Based on the construction requirements Trees 1-78 will be removed. Compensatory planting will be addressed within the landscape plan and School Master Plan.
- **3.9** Ultimately due to poor soil conditioning and overplanting in a small area, with species that are forest trees, the specimens within the study area will never reach their full potential and as such new plantings are recommended.

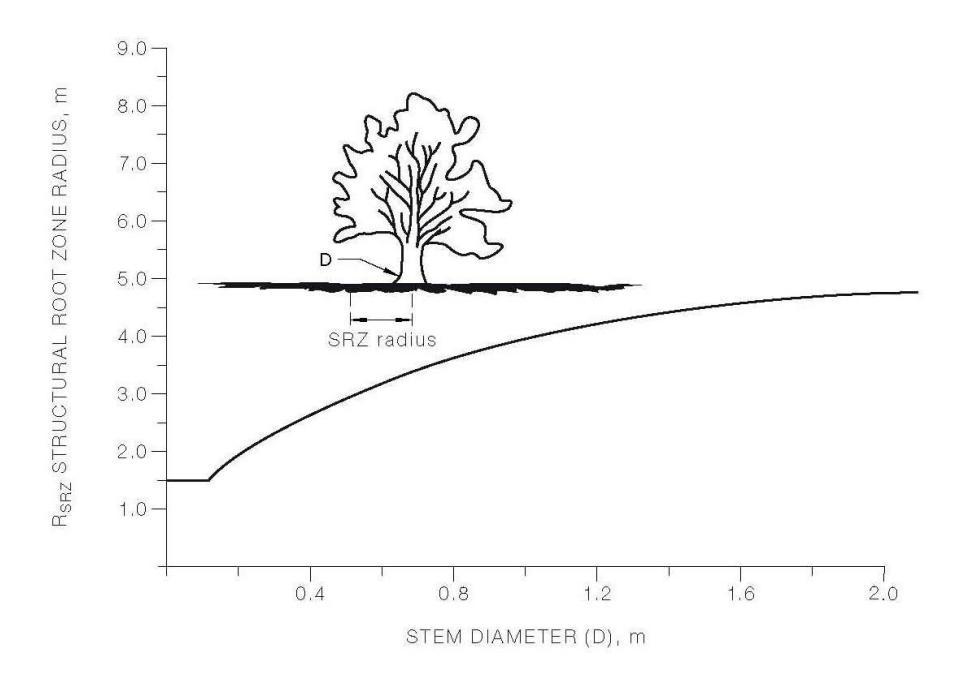
#### FIGURE 1 - STRUCTURAL ROOT ZONE

NOTE: The SRZ for trees with trunk diameters less than 0.15m will be 1.5m (see Figure 1).

The curve can be expressed by the following formula:  $R_{SRZ}$  = (D  $\times$  50)  $^{0.42}$   $\times$  0.64

- 1  $R_{SRZ}$  is the structural root zone radius.
- 2 D is the stem diameter measured immediately above root buttress.
- 3 The SRZ for trees less than 0.15 metres diameter is 1.5 metres.
- 4 The SRZ formula and graph do not apply to palms, other monocots, cycads and tree ferns.
- 5 This does not apply to trees with an asymmetrical root plate.
