Remediation Action Plan for Wallacia Memorial Park, Wallacia, NSW

Prepared for Catholic Metropolitan Cemeteries Trust

Report No: P1706171JR09V02

2 March 2021

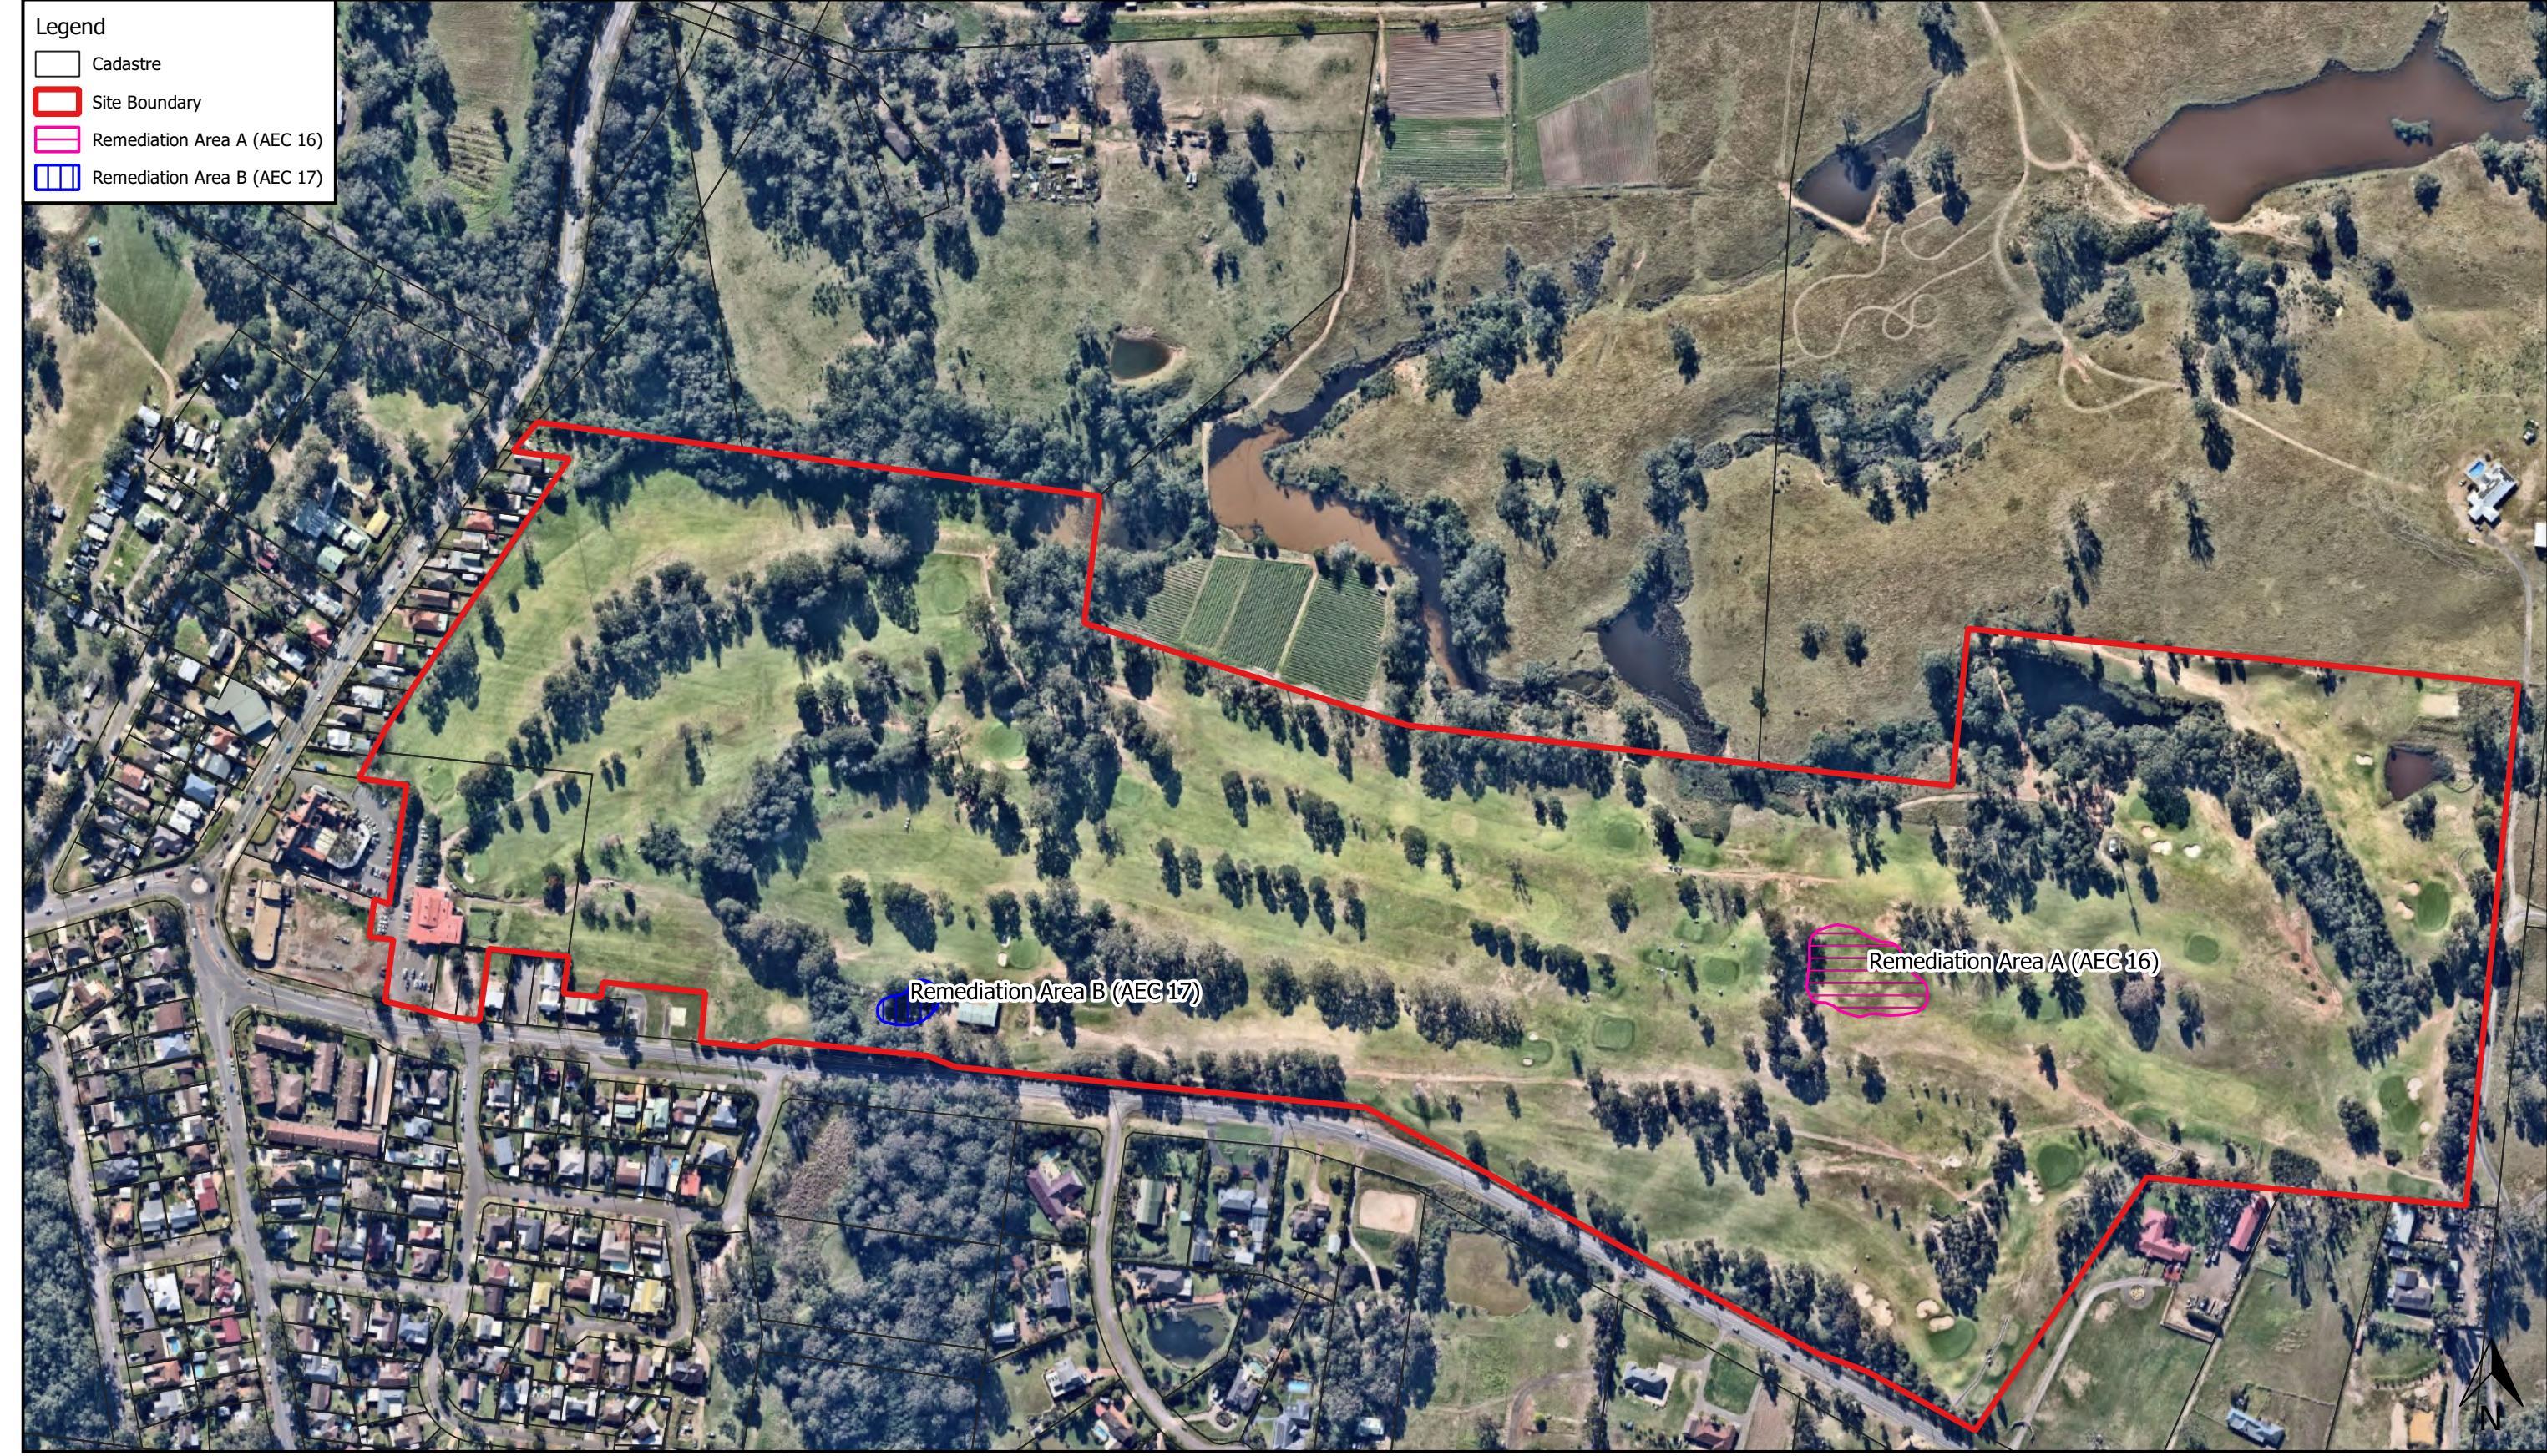
Map 02 Wallacia, NSW Amendment to Wallacia Memorial Park Remedial Action Plan CMCT 01/03/2021

The location of remediation areas (AEC 16 and AEC 17) is provided in Attachment A.

- <u>Remediation Area A (AEC 16)</u> Fill material was observed in several test pit locations in AEC 16, with depths ranging between 0.0 mbgl and > 1.8 mbgl. The area of AEC has been estimated as approximately 3,200 m². The MA (2020) DSI indicated that fill material within AEC 16 contains bonded ACM fragments. Based on an approximate average depth of fill (1.0 m), the volume of ACM impacted fill requiring remediation is approximately 3,200 m³.
- <u>Remediation Area B (AEC 17)</u> A stockpile of approximately 100 m³ of soil fill material was located in AEC 17. The MA (2020) DSI indicated that fill material within this stockpile contains bonded ACM fragments.

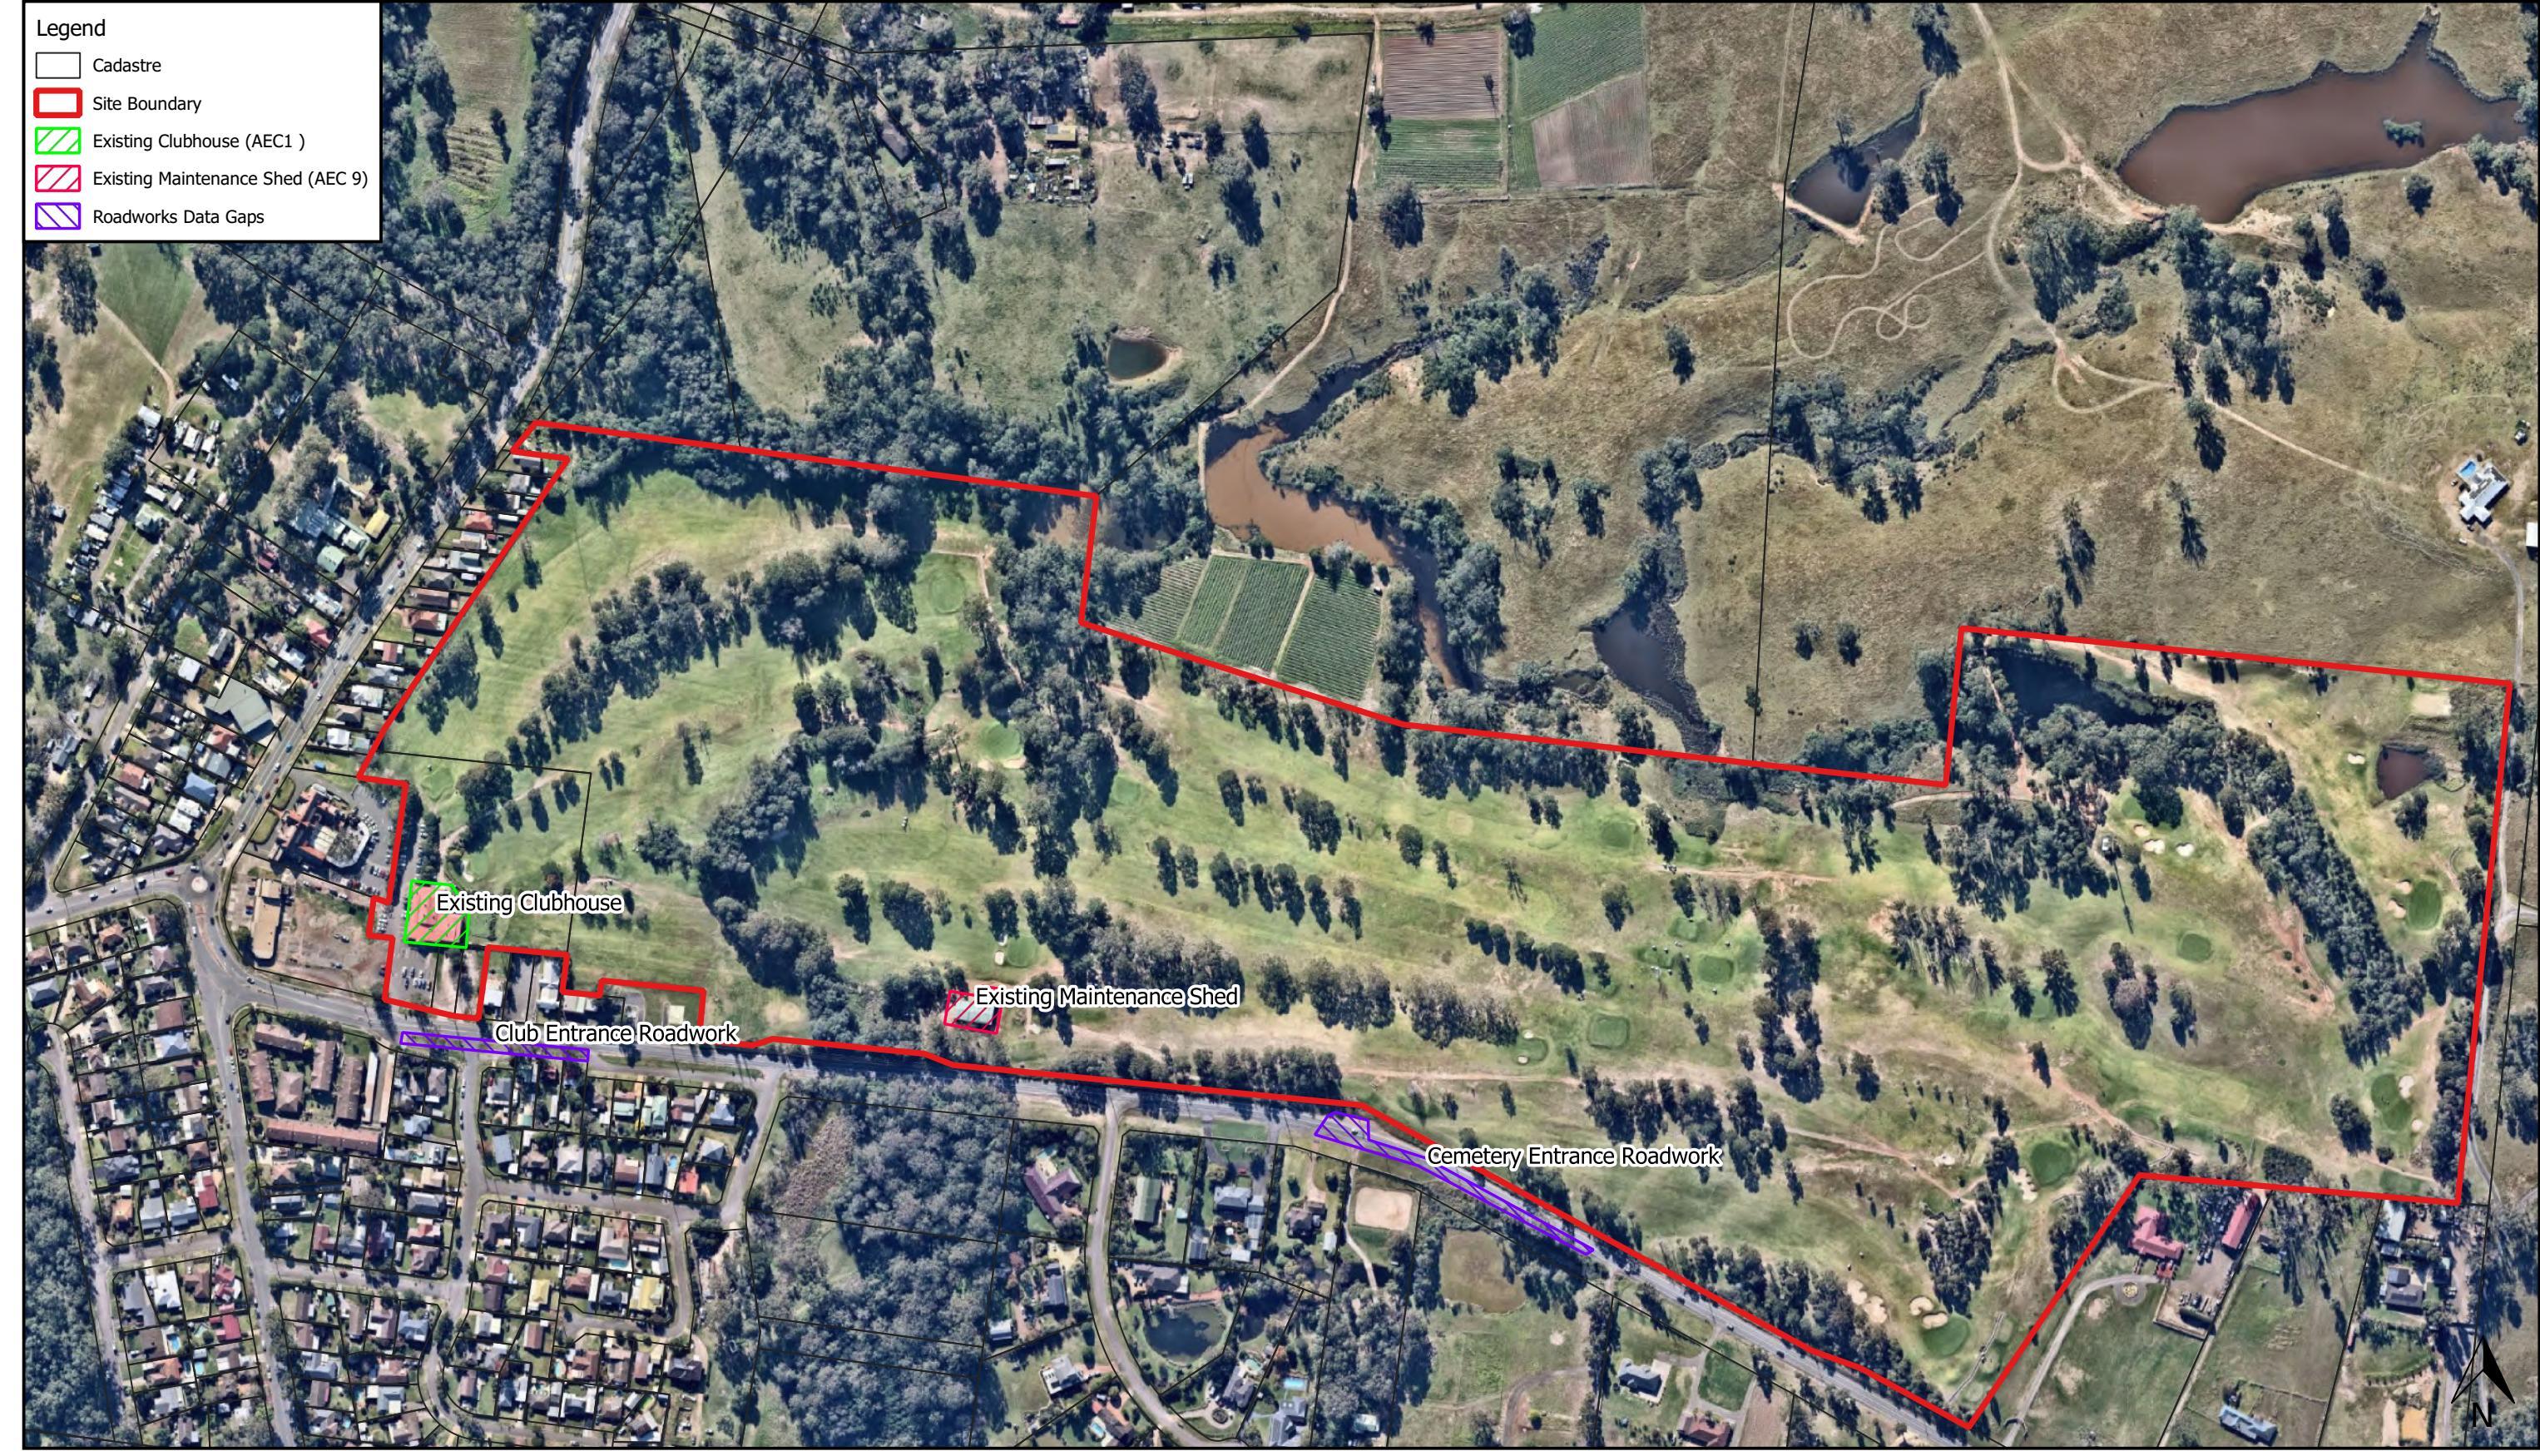
Data gap locations are shown in the site plan in Attachment A.

The following data gaps identified in the DSI (MA, 2020) as requiring additional assessment that still remain as data gaps are:

- 1. AEC 1: Footprint of existing clubhouse.
- 2. AEC 9: Footprint of existing maintenance shed.

A further minor data gap has been identified as part of the RAP, that being material contained within Council's road corridor which will be subject to road works on Park Road as part road widening work and an upgrade to the current site driveway and entry.
