RE: INTERIM AUDIT ADVICE LETTER NO. 1 - REMEDIATION ACTION PLAN, PROPOSED LOT 5, PRECINCT 3 EDMONDSON PARK

Audit Number: RS 162

Attachment 1 - Precinct 3 Development Area Locality Plan

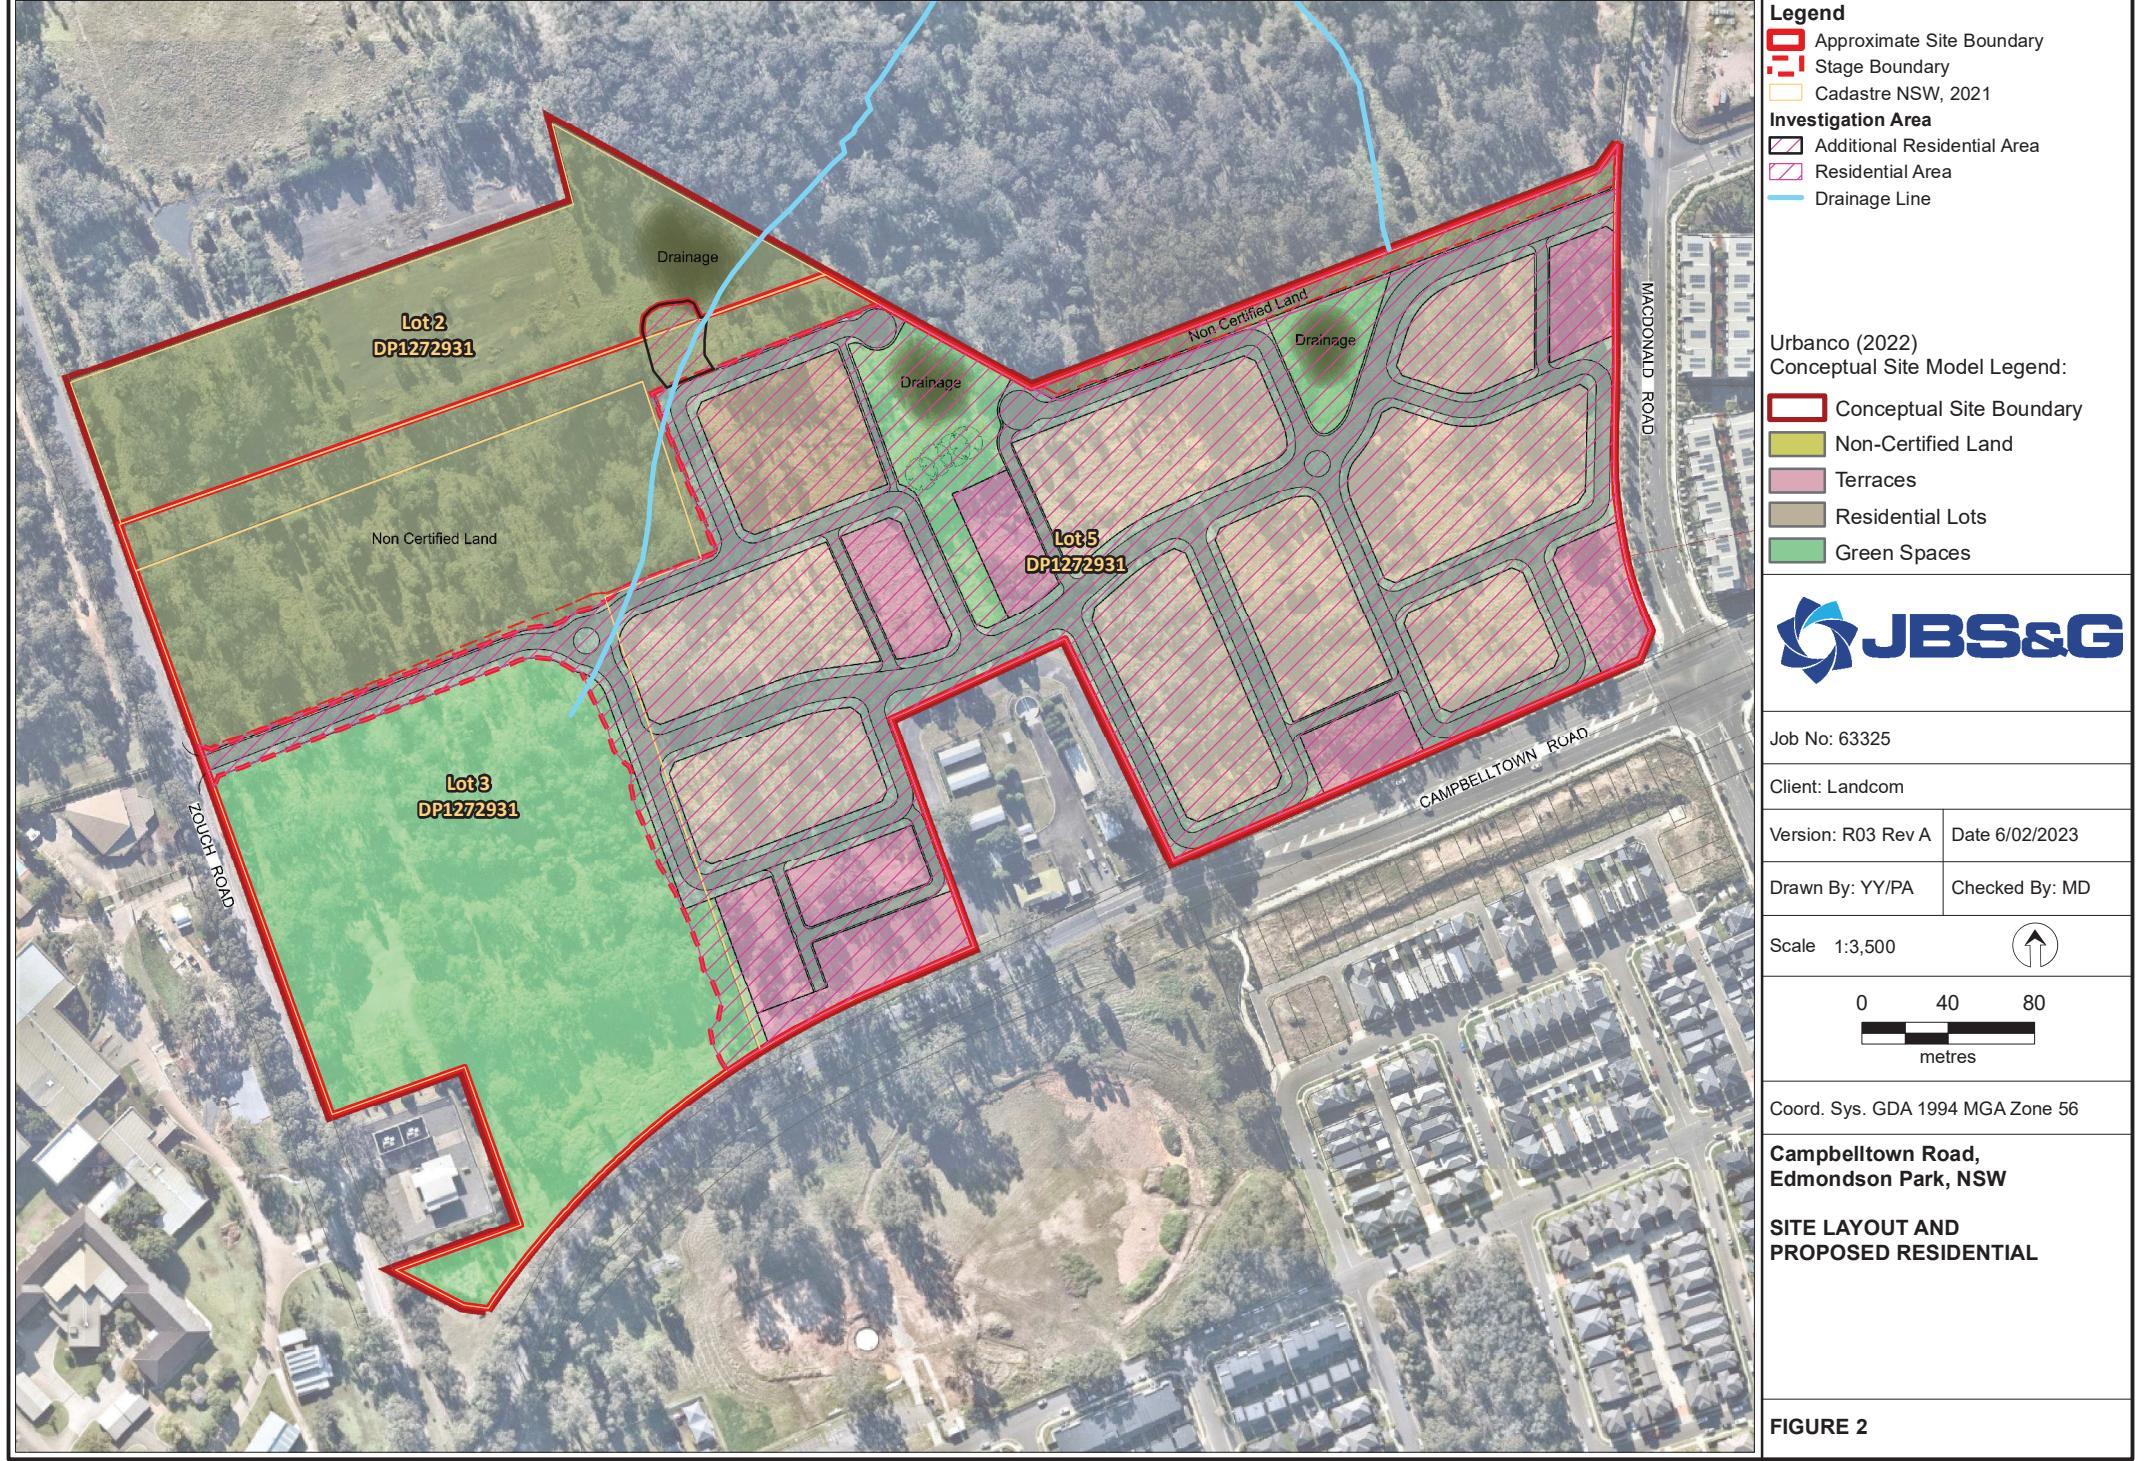
Attachment 2 shows the location of Precinct 3 (shown as "Conceptual Site Boundary" in the key), the Development Site (shown as "Approximate Site Boundary") in the key and the site (shown as "Residential Area" in the key).

The cadastral lot boundaries are also shown on Attachment 2.

5HUW a Ybh&! 6ci bXUf]Yg UbX DfcdcgYX 8Yj Y cda Ybh@Unci h(the site is the pink hatched "Residential Area")

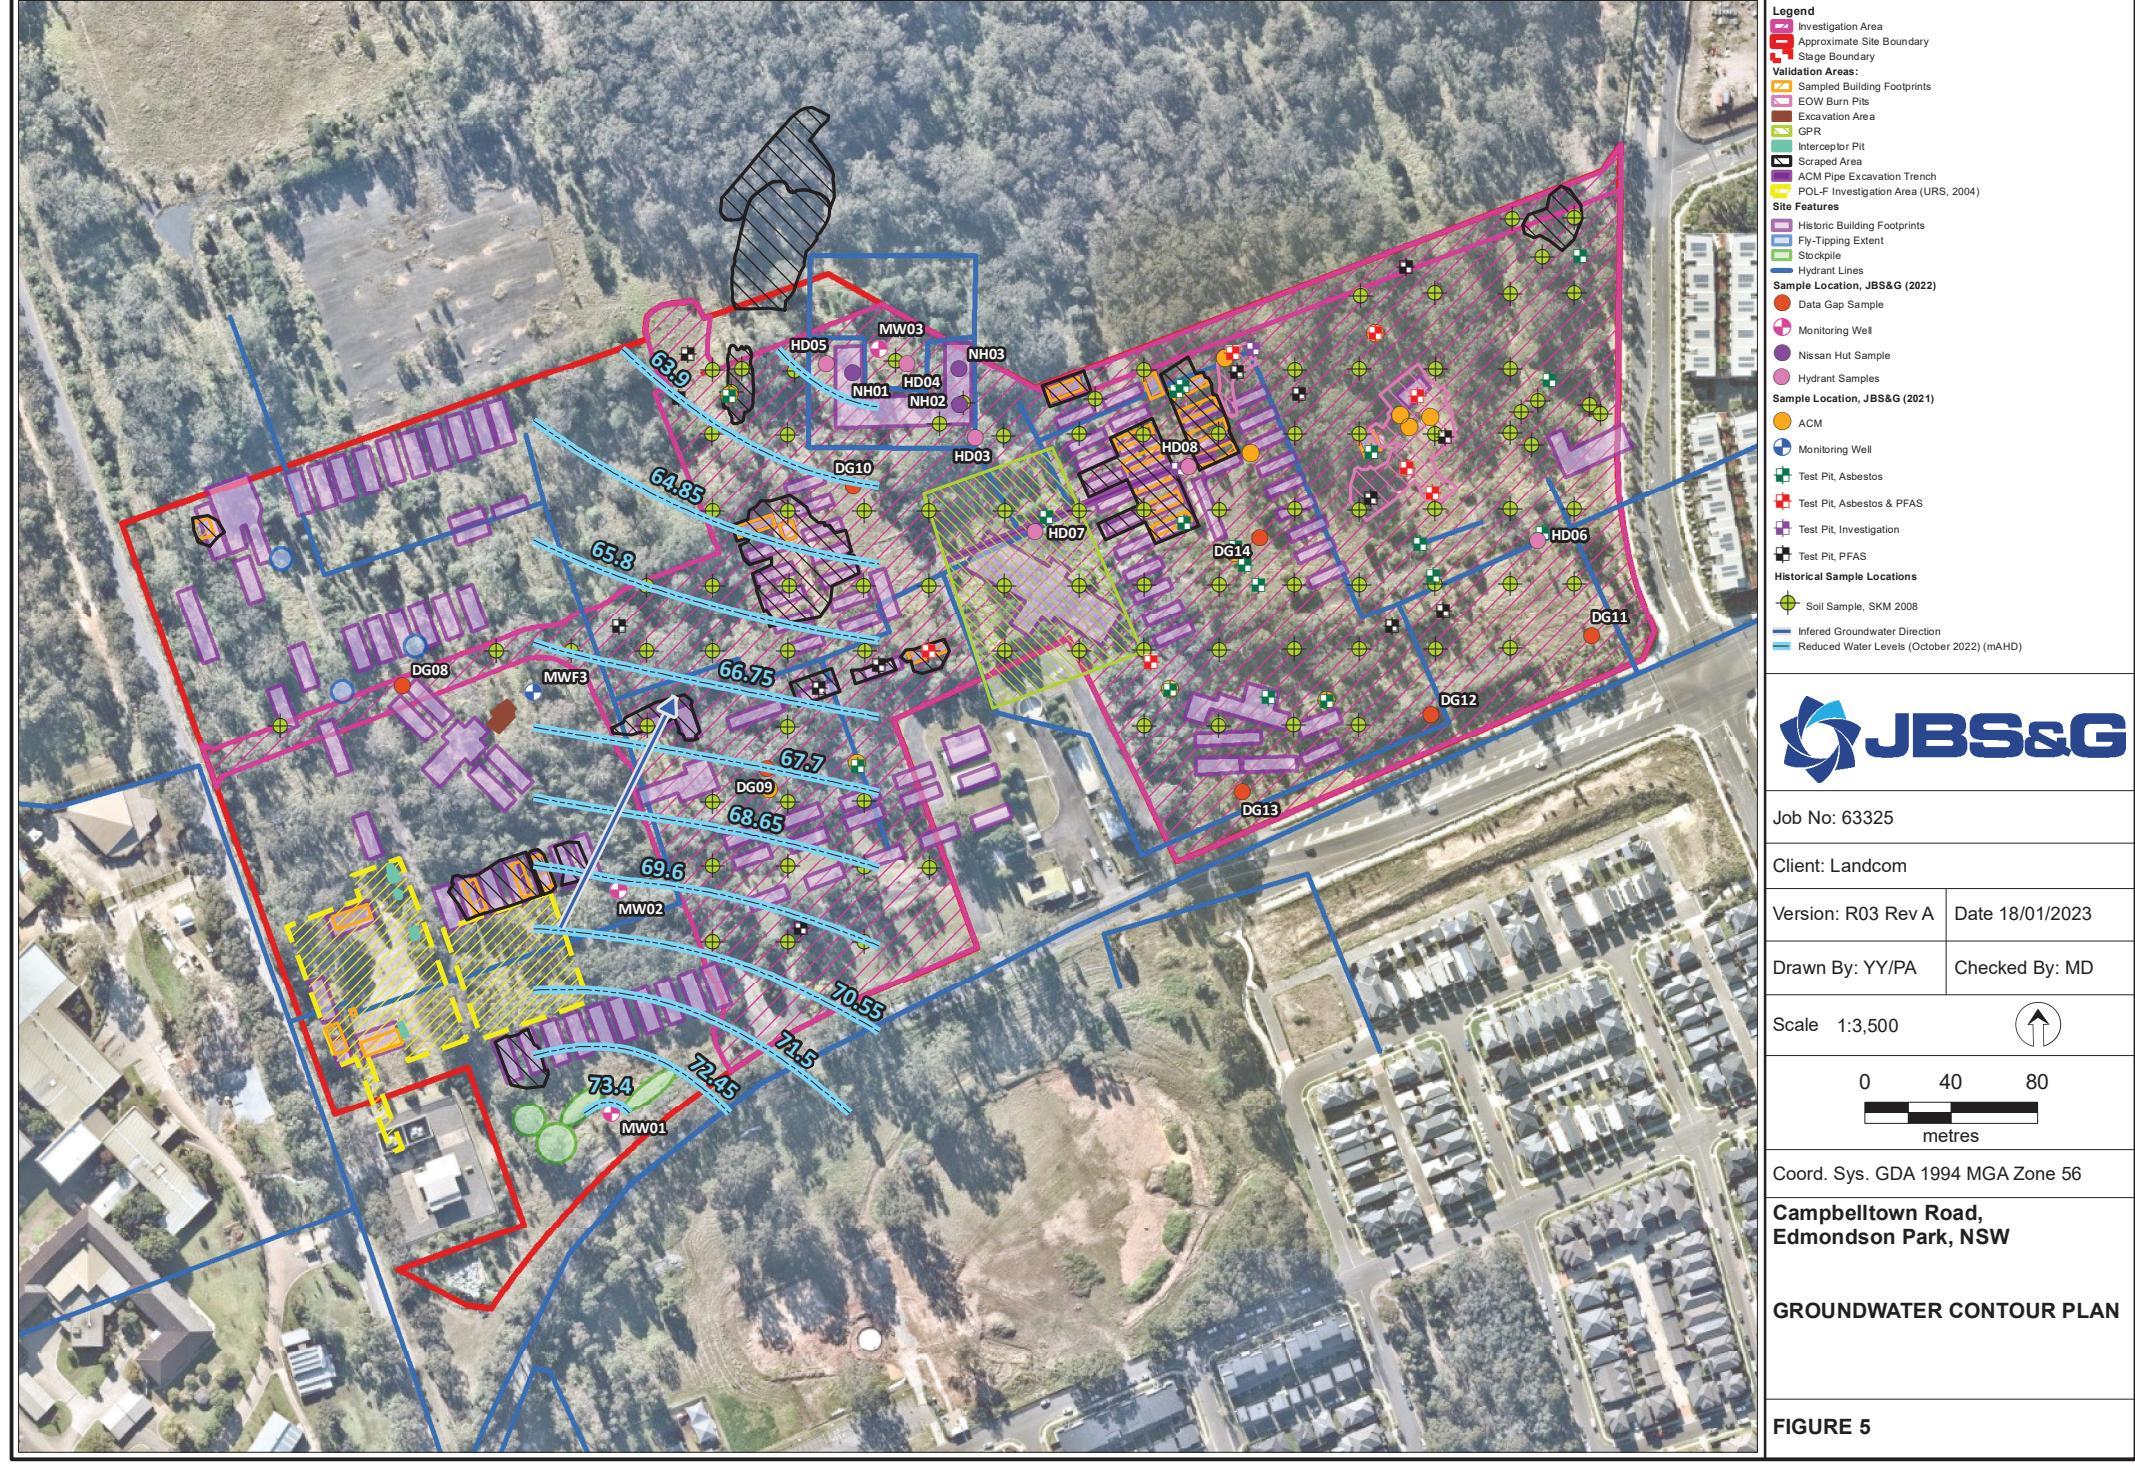
Attachment 3 - Groundwater Contours and Well Locations

Groundwater sampling was conducted on 28 October 2022 for the Lot 5 DSI. The measured depth to groundwater at the time of gauging was between 6.796 m and 7.823 m below top of casing (mbTOC), which was more elevated than the water strike zones observed within the weathered shale rock during the drilling program, identified to be at depths of 10-12 m below ground level (mbgl). This indicates that groundwater at Precinct 3 is likely to be present within a confined/semi-confined system.

Interpolated groundwater contours are shown on **Attachment 3** and the direction of groundwater flow is inferred to be generally toward the northeast, with the local topography influencing groundwater flow.

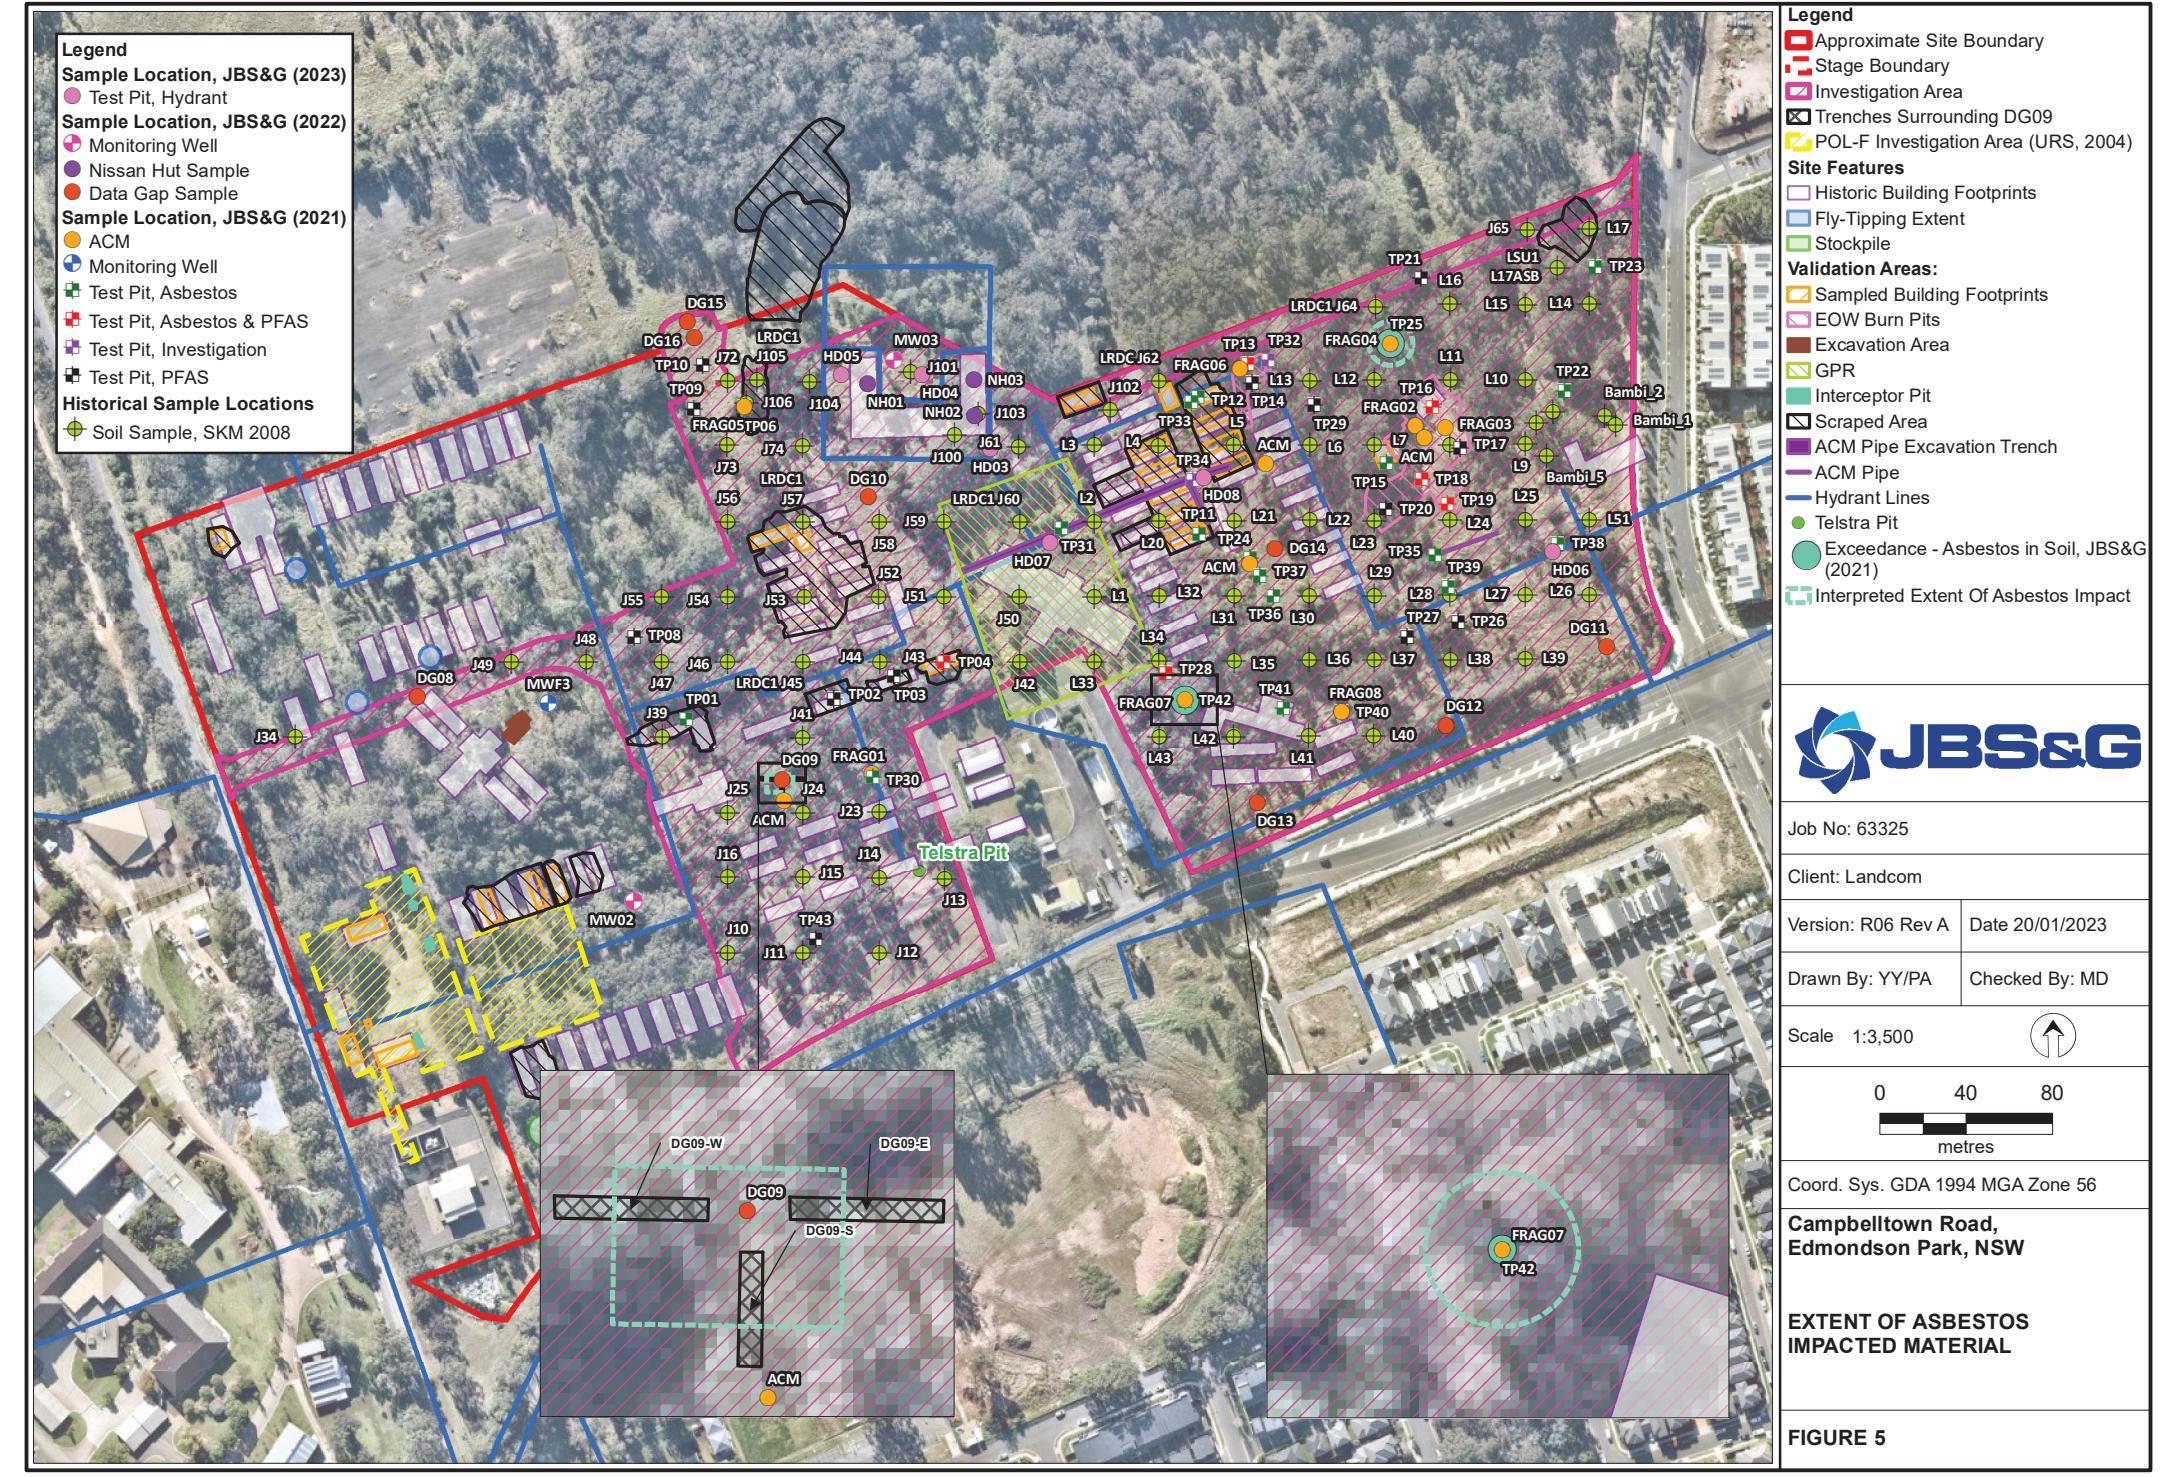
Attachment 4 - Consolidated Sample Plan and Remediation Areas

- Bonded ACM observed on the ground surface has been identified during site inspection/assessment activities at scattered locations across the site, including at FRAG01 (TP30), FRAG02, FRAG06 (TP13) and FRAG08 (TP40), TP24/TP36 and TP37 as shown in Attachment 4.

- Given the extent of vegetation cover (and low sampling density), additional areas of surface ACM fragments are expected to occur in addition to the above noted areas. Limited anthropogenic material, including bricks, were also observed on the surface and within the fill, which indicates the potential for associated further asbestos impacts as a result of demolition activities.

Bonded ACM observed on the ground surface has been identified during site inspection/assessment activities at scattered locations across the site, including at FRAG01 (TP30), FRAG02, FRAG06 (TP13) and FRAG08 (TP40), TP24/TP36 and TP37 as shown in Attachment 4 . The known areas of bonded ACM fragment impacts will be identified by the Environmental Consultant for the completion of asbestos removal from the top 100 mm of soils with rakes and removing all visible ACM fragments. Inspection of material and collection of ACM fragments will be undertaken on a grid basis and at least two passes across the site made with a 90° direction change between each pass.	
Given the extent of vegetation cover, additional areas of surface ACM fragments are expected to occur in addition to the above noted areas. Limited anthropogenic material, including bricks, were also observed on the surface and within the fill, which indicates the potential for associated further asbestos impacts as a result of demolition activities.

- Similar to the potential for ground surface ACM fragments, there is the potential that further ACM-containing infrastructure will be identified following demolition and site vegetation clearance works at the site. As such, in addition to allowances for removal of the ACM infrastructure noted above, a contingency for removal of additional infrastructure should also be planned.
