Report on Preliminary Geotechnical Land Capability Assessment

> Proposed Appin (Part 2) Precinct Appin NSW

> > Prepared for Walker Corporation Pty Ltd

> > > Project 76589.18 October 2024

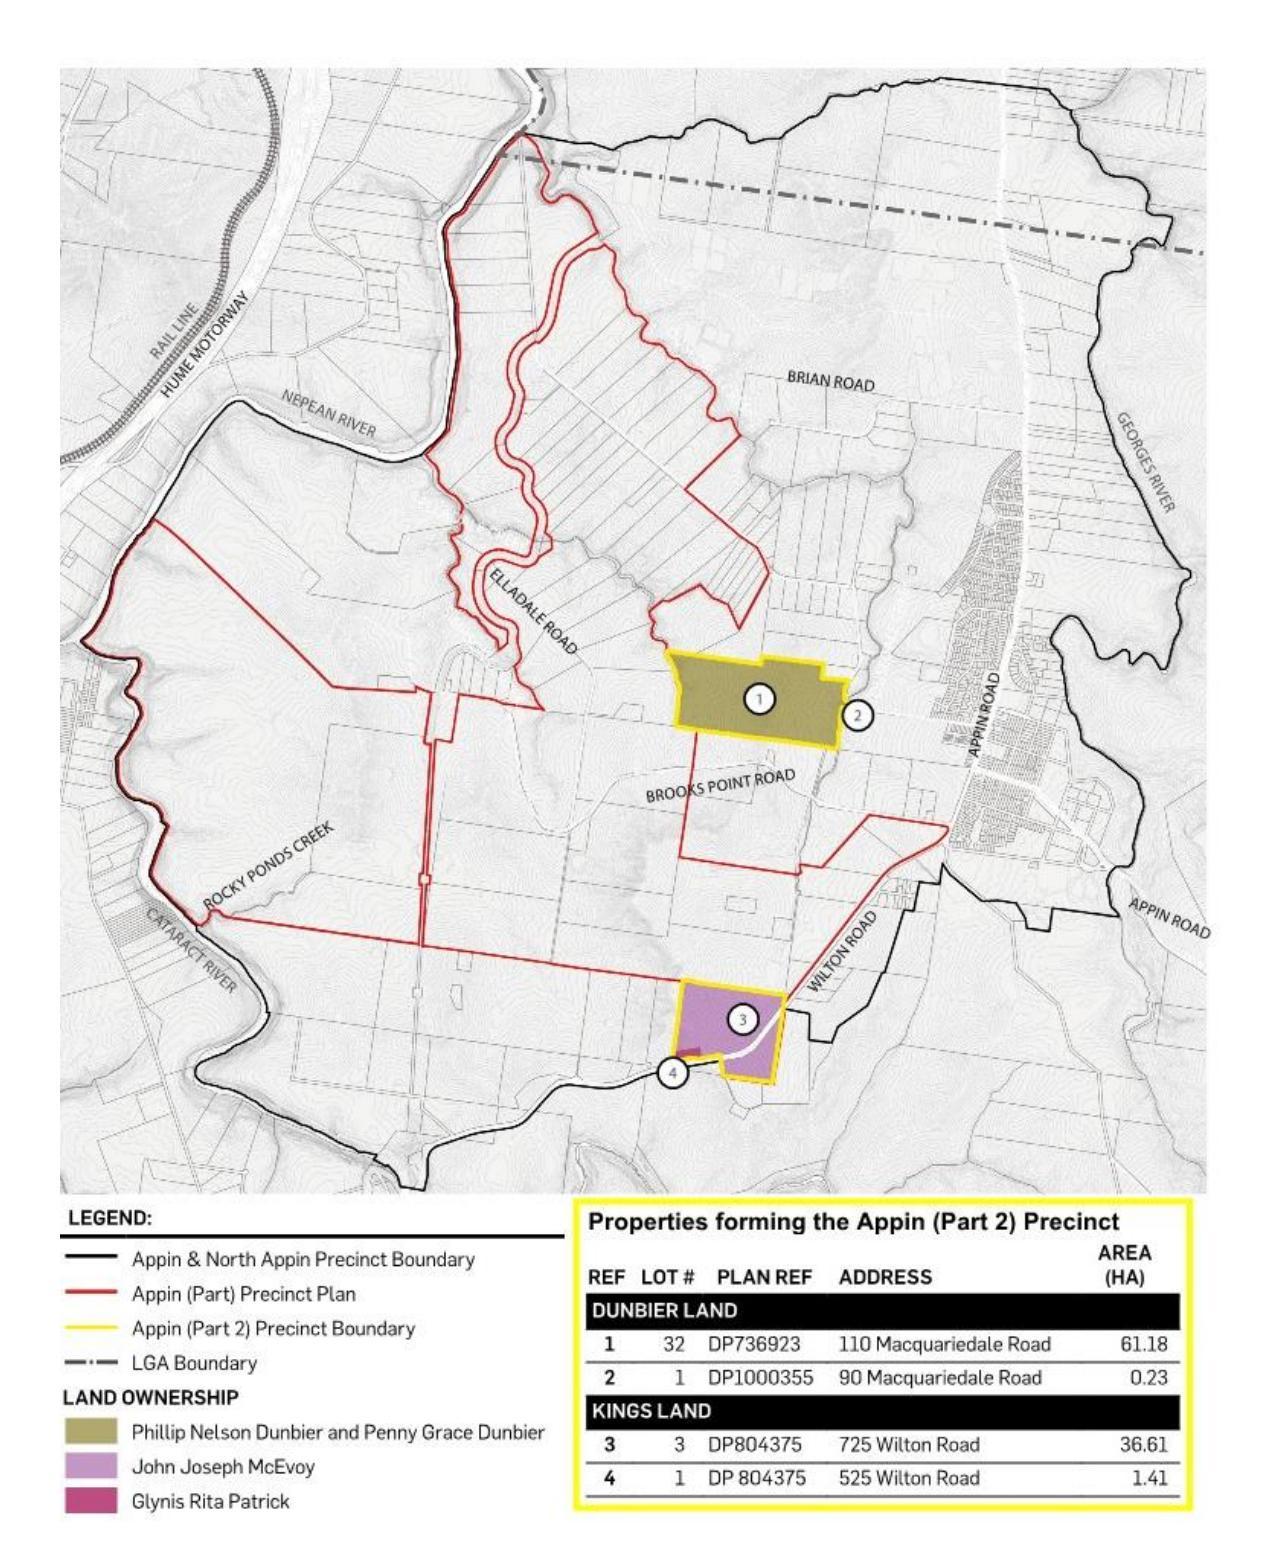
The precinct and structure plan boundaries are Wilton Road to the east, the Nepean River to the west and Ousedale Creek to the north. Refer to Figure 1 and Table 3 for key attributes of the precinct plan and structure plan area.

The purpose of this investigation is to provide a preliminary evaluation of the geotechnical features of the site and its suitability, from a geotechnical standpoint, for future urban redevelopment. The boundary of the investigation is shown on Figure 1.

The site, which has a total area of approximately 100.10 ha, is located in the local government area of Wollondilly Shire Council ('Council'). Table 3 below and Figure 1 shows the formally registered lots located in the site.

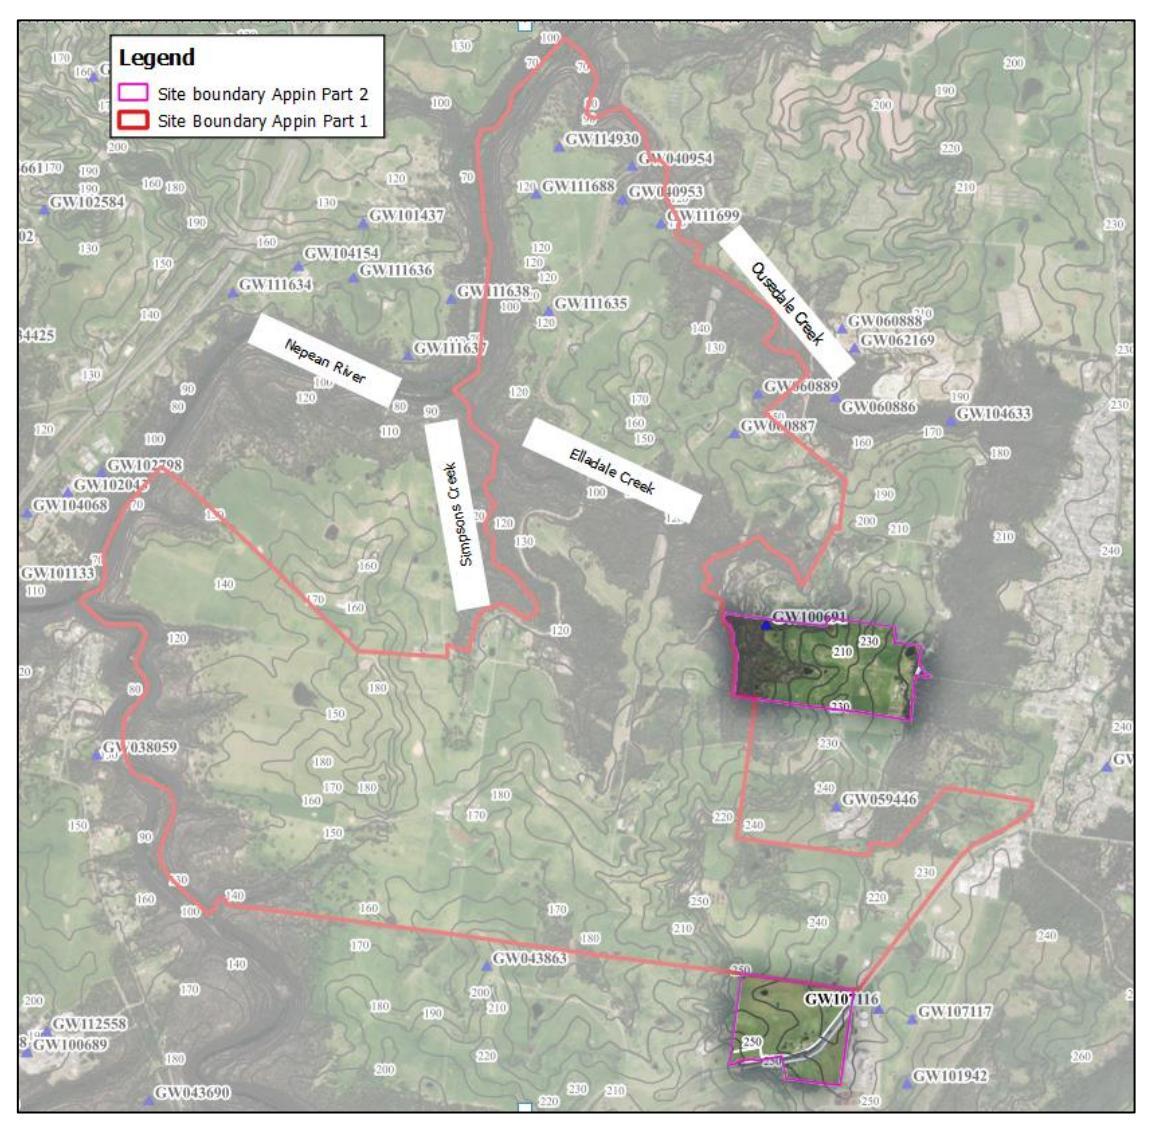
Figure 2: Site Topography (dark grey lines are 10 m intervals), Surface Water Features and Registered Groundwater Bores (blue triangles)

The site topography is undulating with two valleys ranging from 226 m Australian Height Datum (AHD) to approximately 250 m AHD in the south portion of the site (lots 1 and 3 DP804375) and between approximately 150 m AHD to 230 m AHD in the north portion of the site (lot 32 DP736923 and lot 1 1000355).

The slope gradient generally ranges from approximately 5-10% in low lying generally flat areas of the site. Slopes increase to approximately 20 - 30% in the vicinity of incised creek lines.

Figure 2 below presents regional topography mapping (10 m Australian Height Datum (AHD) intervals between contours) as obtained from NSW Spatial Services, key surface water features and registered groundwater bores as recorded by the NSW Department of Primary Industries (Water) and the Bureau of Meteorology Groundwater Explorer.

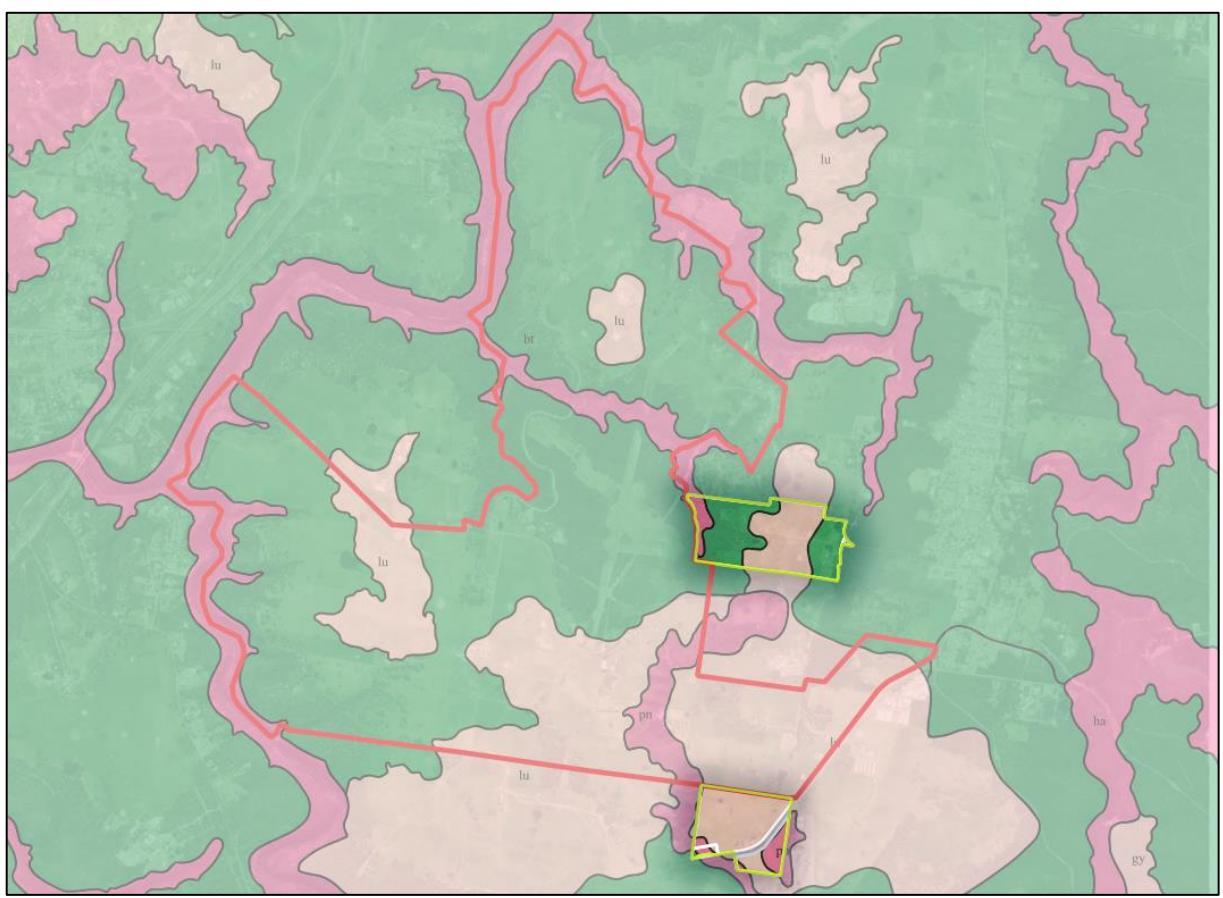
Figure 3: Regional soils mapping for the site (yellow boundary)

Regional soils mapping for the site as obtained from Soil Conservation Service of NSW, *Soil Landscapes of the Penrith 1:100 000 Sheet* is presented in Figure 3, below.

Regional soils mapping as presented and referenced above indicates that the majority of the site is mapped as Luddenham soils (light pink) in the southern portion of the site (lots 1 and 3 DP804375), and centre portion of the site (lot 32 DP736923 and lot 1 1000355), comprising shallow dark podzolic or massive earthy clays on crests being erosional soils. Luddenham soils are associated with undulating to rolling low hills of the Wianamatta Group shales and lower slopes and drainage lines. Also mapped as present at the site are the following:

- Blacktown soils (dark green) which are associated with the gently undulating rises on Wianamatta Group shales and Hawkesbury Sandstone. Blacktown soils comprise shallow to moderately deep red and brown podzolic soils on crests, upper slopes and well drained areas and deep yellow podzolic soils and soloths on lower slopes and in areas of poor drainage. Such soils are generally moderately reactive highly plastic subsoil, of low soil fertility with poor soil drainage; and
- Hawkesbury soils (dark pink) which are colluvial lithosols/siliceous sands comprising podzolic soils, siliceous sands and secondary yellow earths associated with drainage lines dissecting Hawkesbury Sandstones, along the Nepean River and tributaries.

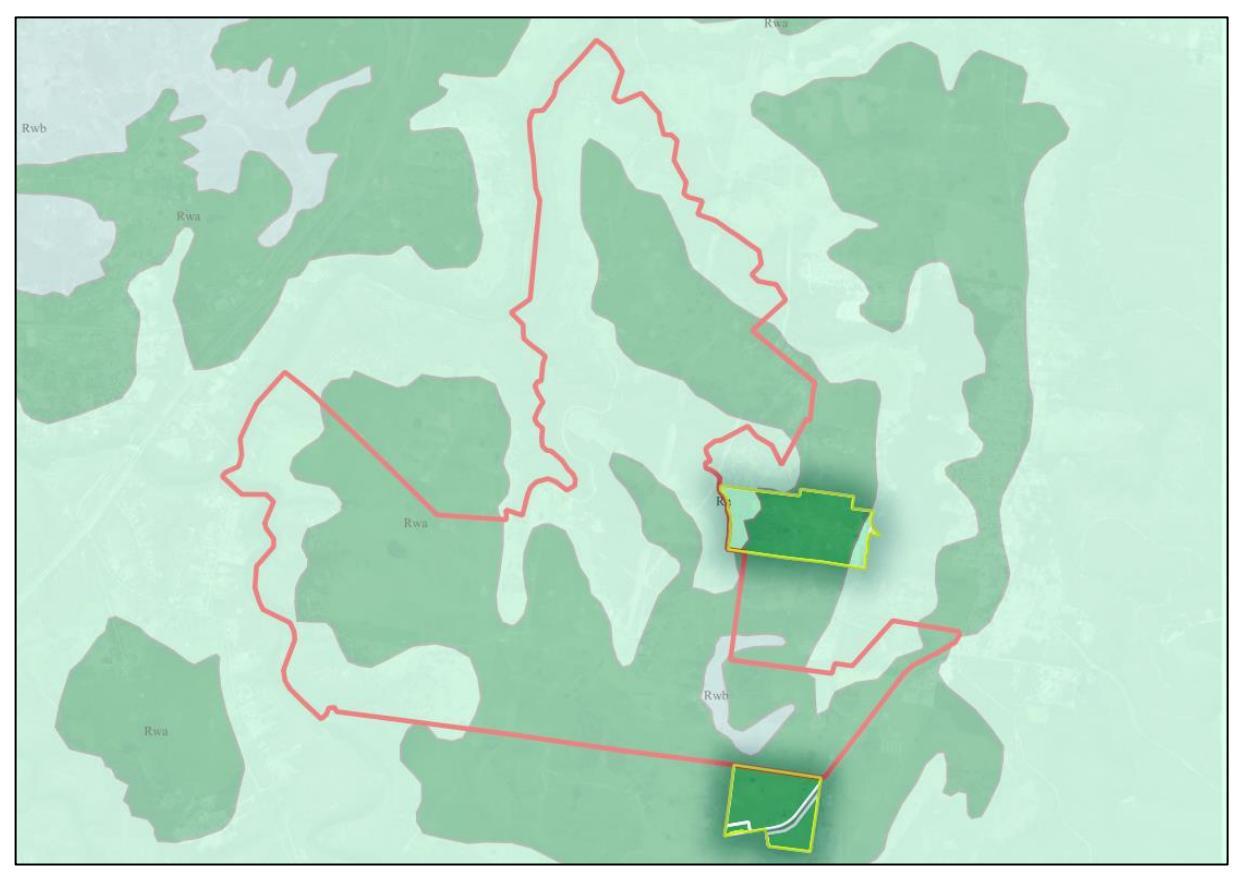
Figure 4: Regional geology mapping for the site (yellow boundary)

Regional geology mapping for the site as obtained from Geological Survey of New South Wales *Wollongong – Port Hacking 1:100 000 scale Geological Series Sheet 9029 - 9129*, 1st Edition 1985 is presented in Figure 4 below.

Regional geology mapping as presented and referenced above indicates that the majority of the site is underlain by Ashfield Shale of the Wianamatta Group (dark green) comprising laminite and dark grey siltstone. Also mapped as present at the site Hawkesbury Sandstone (light green) comprising medium to coarse-grained quartz sandstone with very minor shale and laminite lenses.

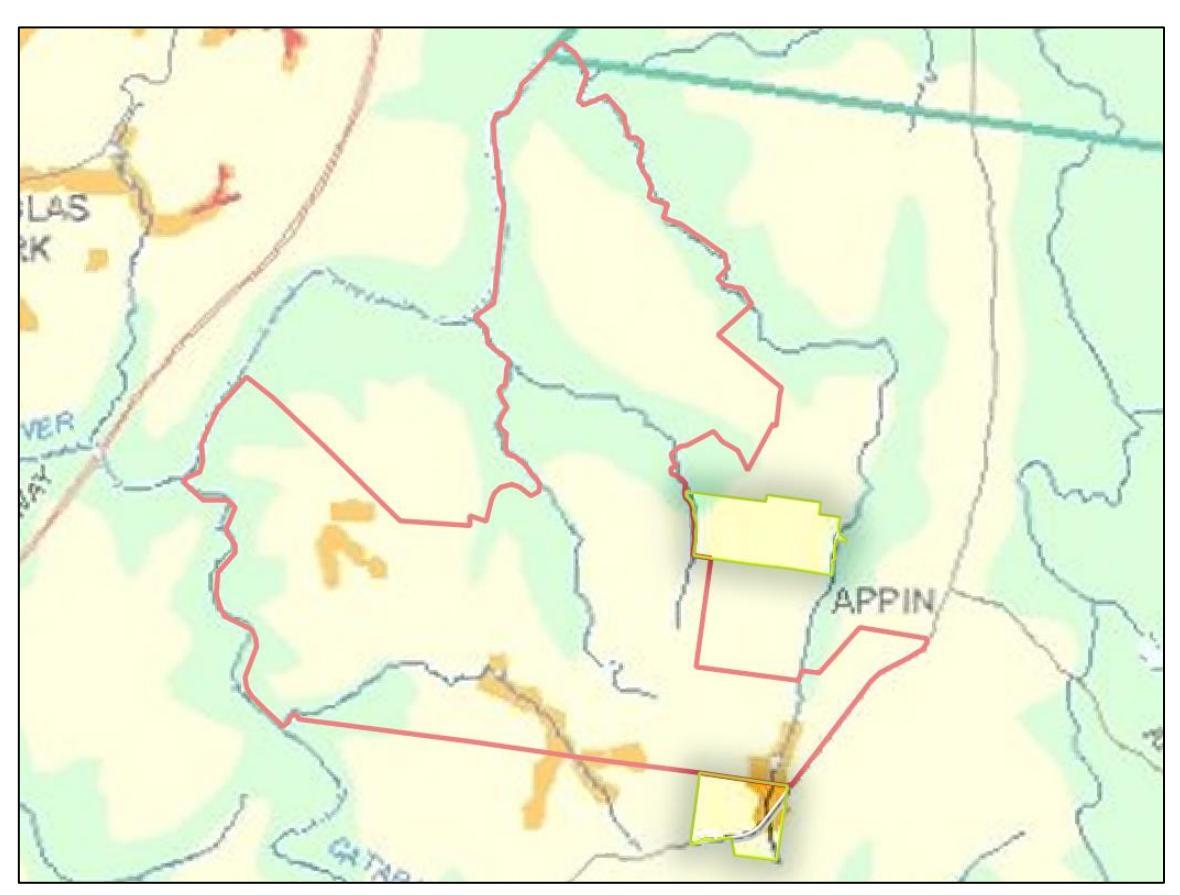
Figure 5: Regional Salinity Mapping

Figure 5 below presents regional salinity mapping for the site as obtained from the Department of Infrastructure, Planning and Natural Resources *Salinity Potential in Western Sydney* (2002).

Regional salinity mapping as presented and referenced above indicates that the site is located in an area mapped as follows:

- Very low salinity potential (green) along the Nepean River and tributaries;
- Moderate salinity potential (pale yellow) across the majority (approximately 90%) of the site; and
- High salinity potential (orange) along the southernmost portion of an unnamed creek in the southern portion of the site.
