Tree Impact Assessment

The Arbour – Stage 6 10 Victoria Street Berry

11 April 2019

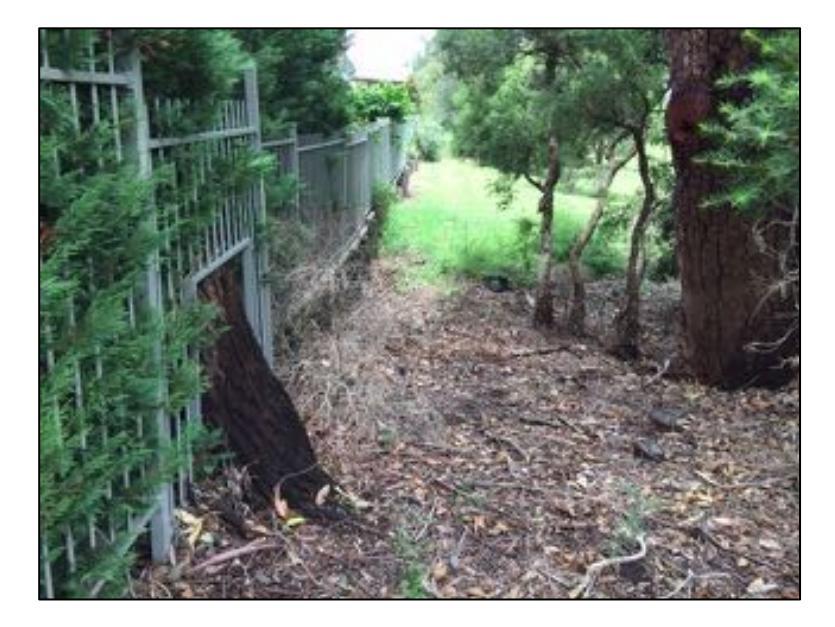
Photo A: The steel fence on the eastern boundary juts out around the trunk of Tree 35. It would appear the survey does not accurately depict fence alignment.

It has been advised that alignment of the metal fence and the Leyland hedge is not on the property boundary. The Detail & Level Plan does not accurately depict observations made on site.

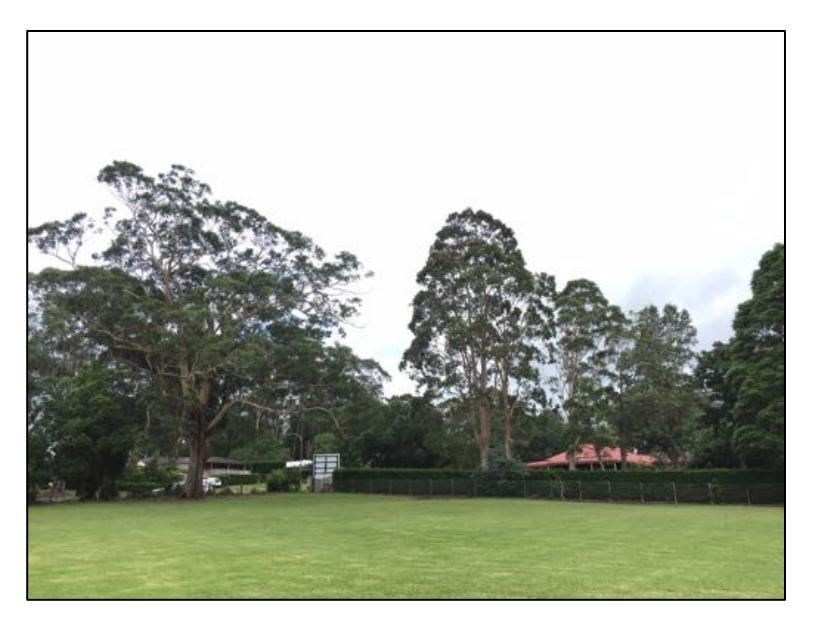
Trees 22, 24, 25 & 29 contributed to the surrounding amenity given their size and prominence in the landscape.

Photo B: Looking northeast across the vacant site at Trees 22 to 29.

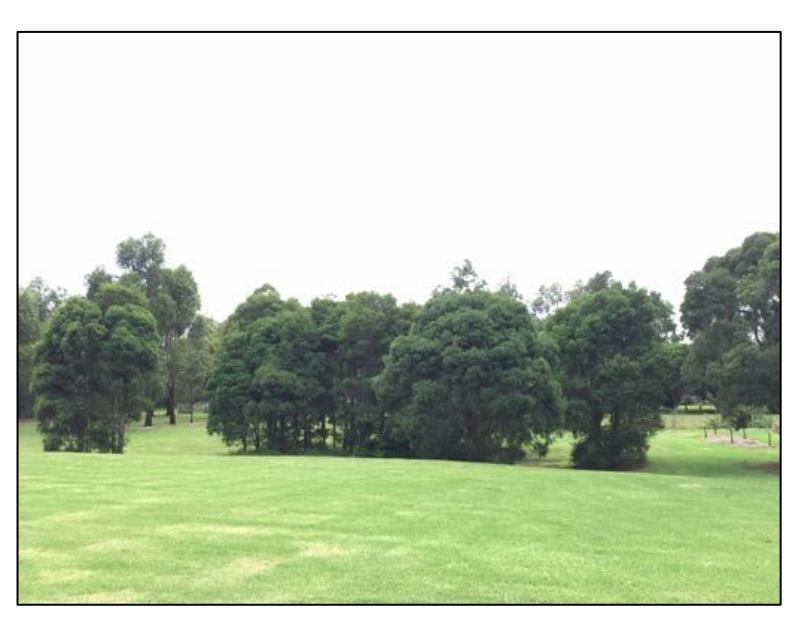
Single stands of Narrow-leaved Paperbarks (*Melaleuca linariifolia*) growing in close proximity to each other were grouped together as Trees 41, 42, 43, 45, 50, 51 & 52. Recent changes had occurred to ground level beneath the canopies of Trees 38 & 39.

Photo C: Looking south at a single stand of Narrow-leaved Paperbarks grouped together as Tree 41. Trees 40 & 43 were located either side of the group.

Amendment to the draft Floor Plan has removed the proposed footprint of Street C to outside the indicative TPZs of Trees 41, 43, 44 & 47 to 52. Installation of adequate site fencing at alignment of the work area will ensure the retention and protection of these groups of Narrow-leaved Paperbarks. Furthermore, existing soil levels will need to remain unaltered around these trees and all underground services excluded within their TPZs.
