# BUSH FIRE ASSESSMENT REPORT

Lot 105 in DP 260058

247 Mungo Brush Road  
HAWKS NEST

**PREPARED BY  
TATTERSALL LANDER  
PTY LTD  
DEVELOPMENT CONSULTANTS  
October 2024  
Version 3**

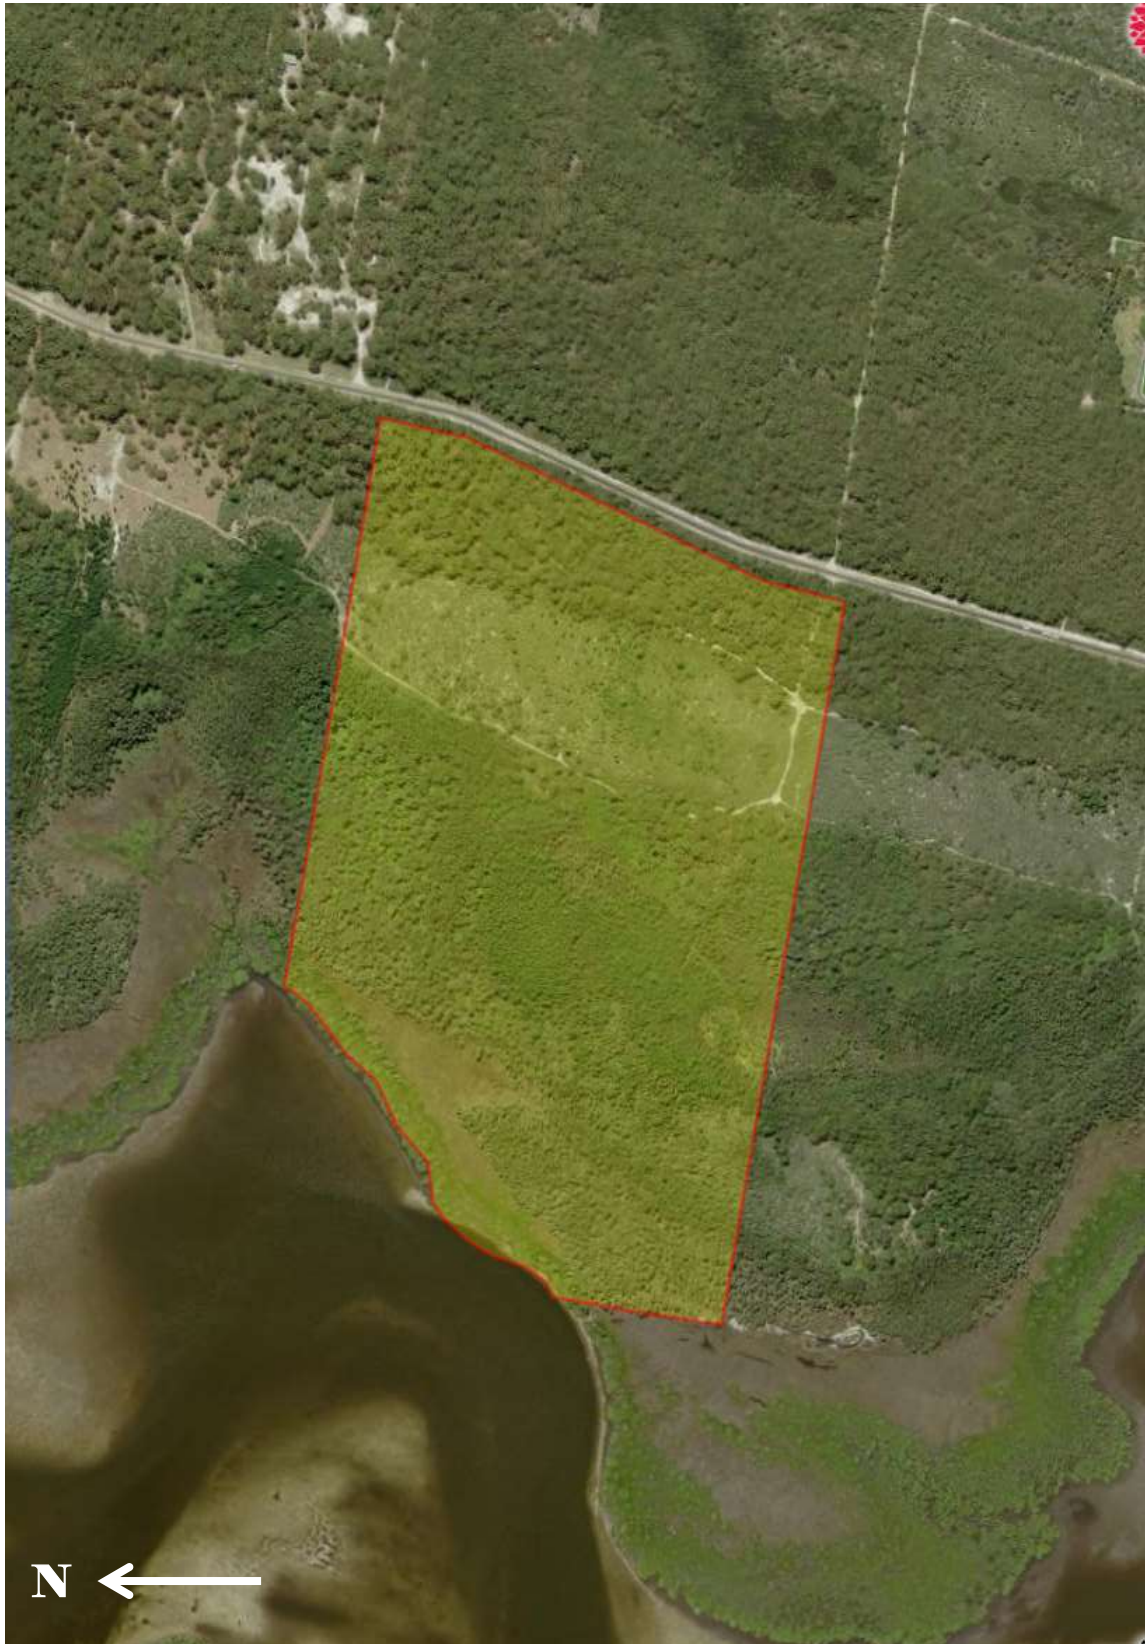
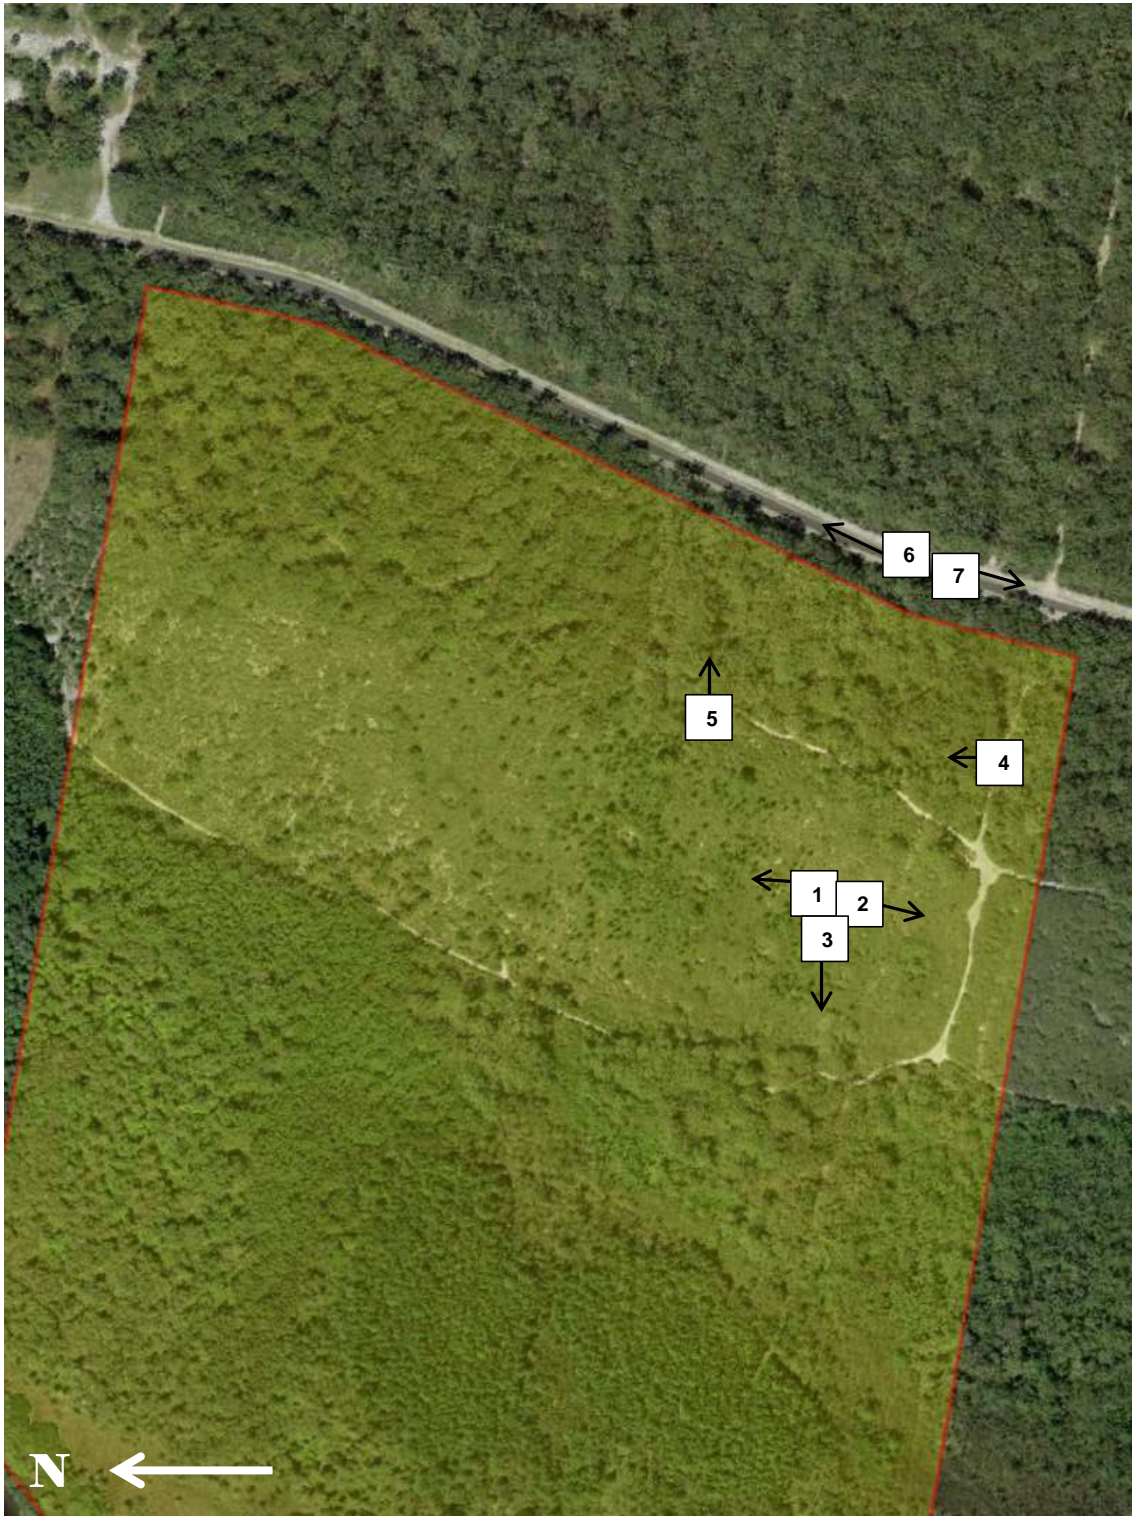
## Appendix A: Aerial Photographs

Aerial photographs of the site and surrounds are provided in Appendix A. Appendix B includes photographs of the site and surrounds and the approximate location and direction of these photographs is depicted on the aerial photographs.

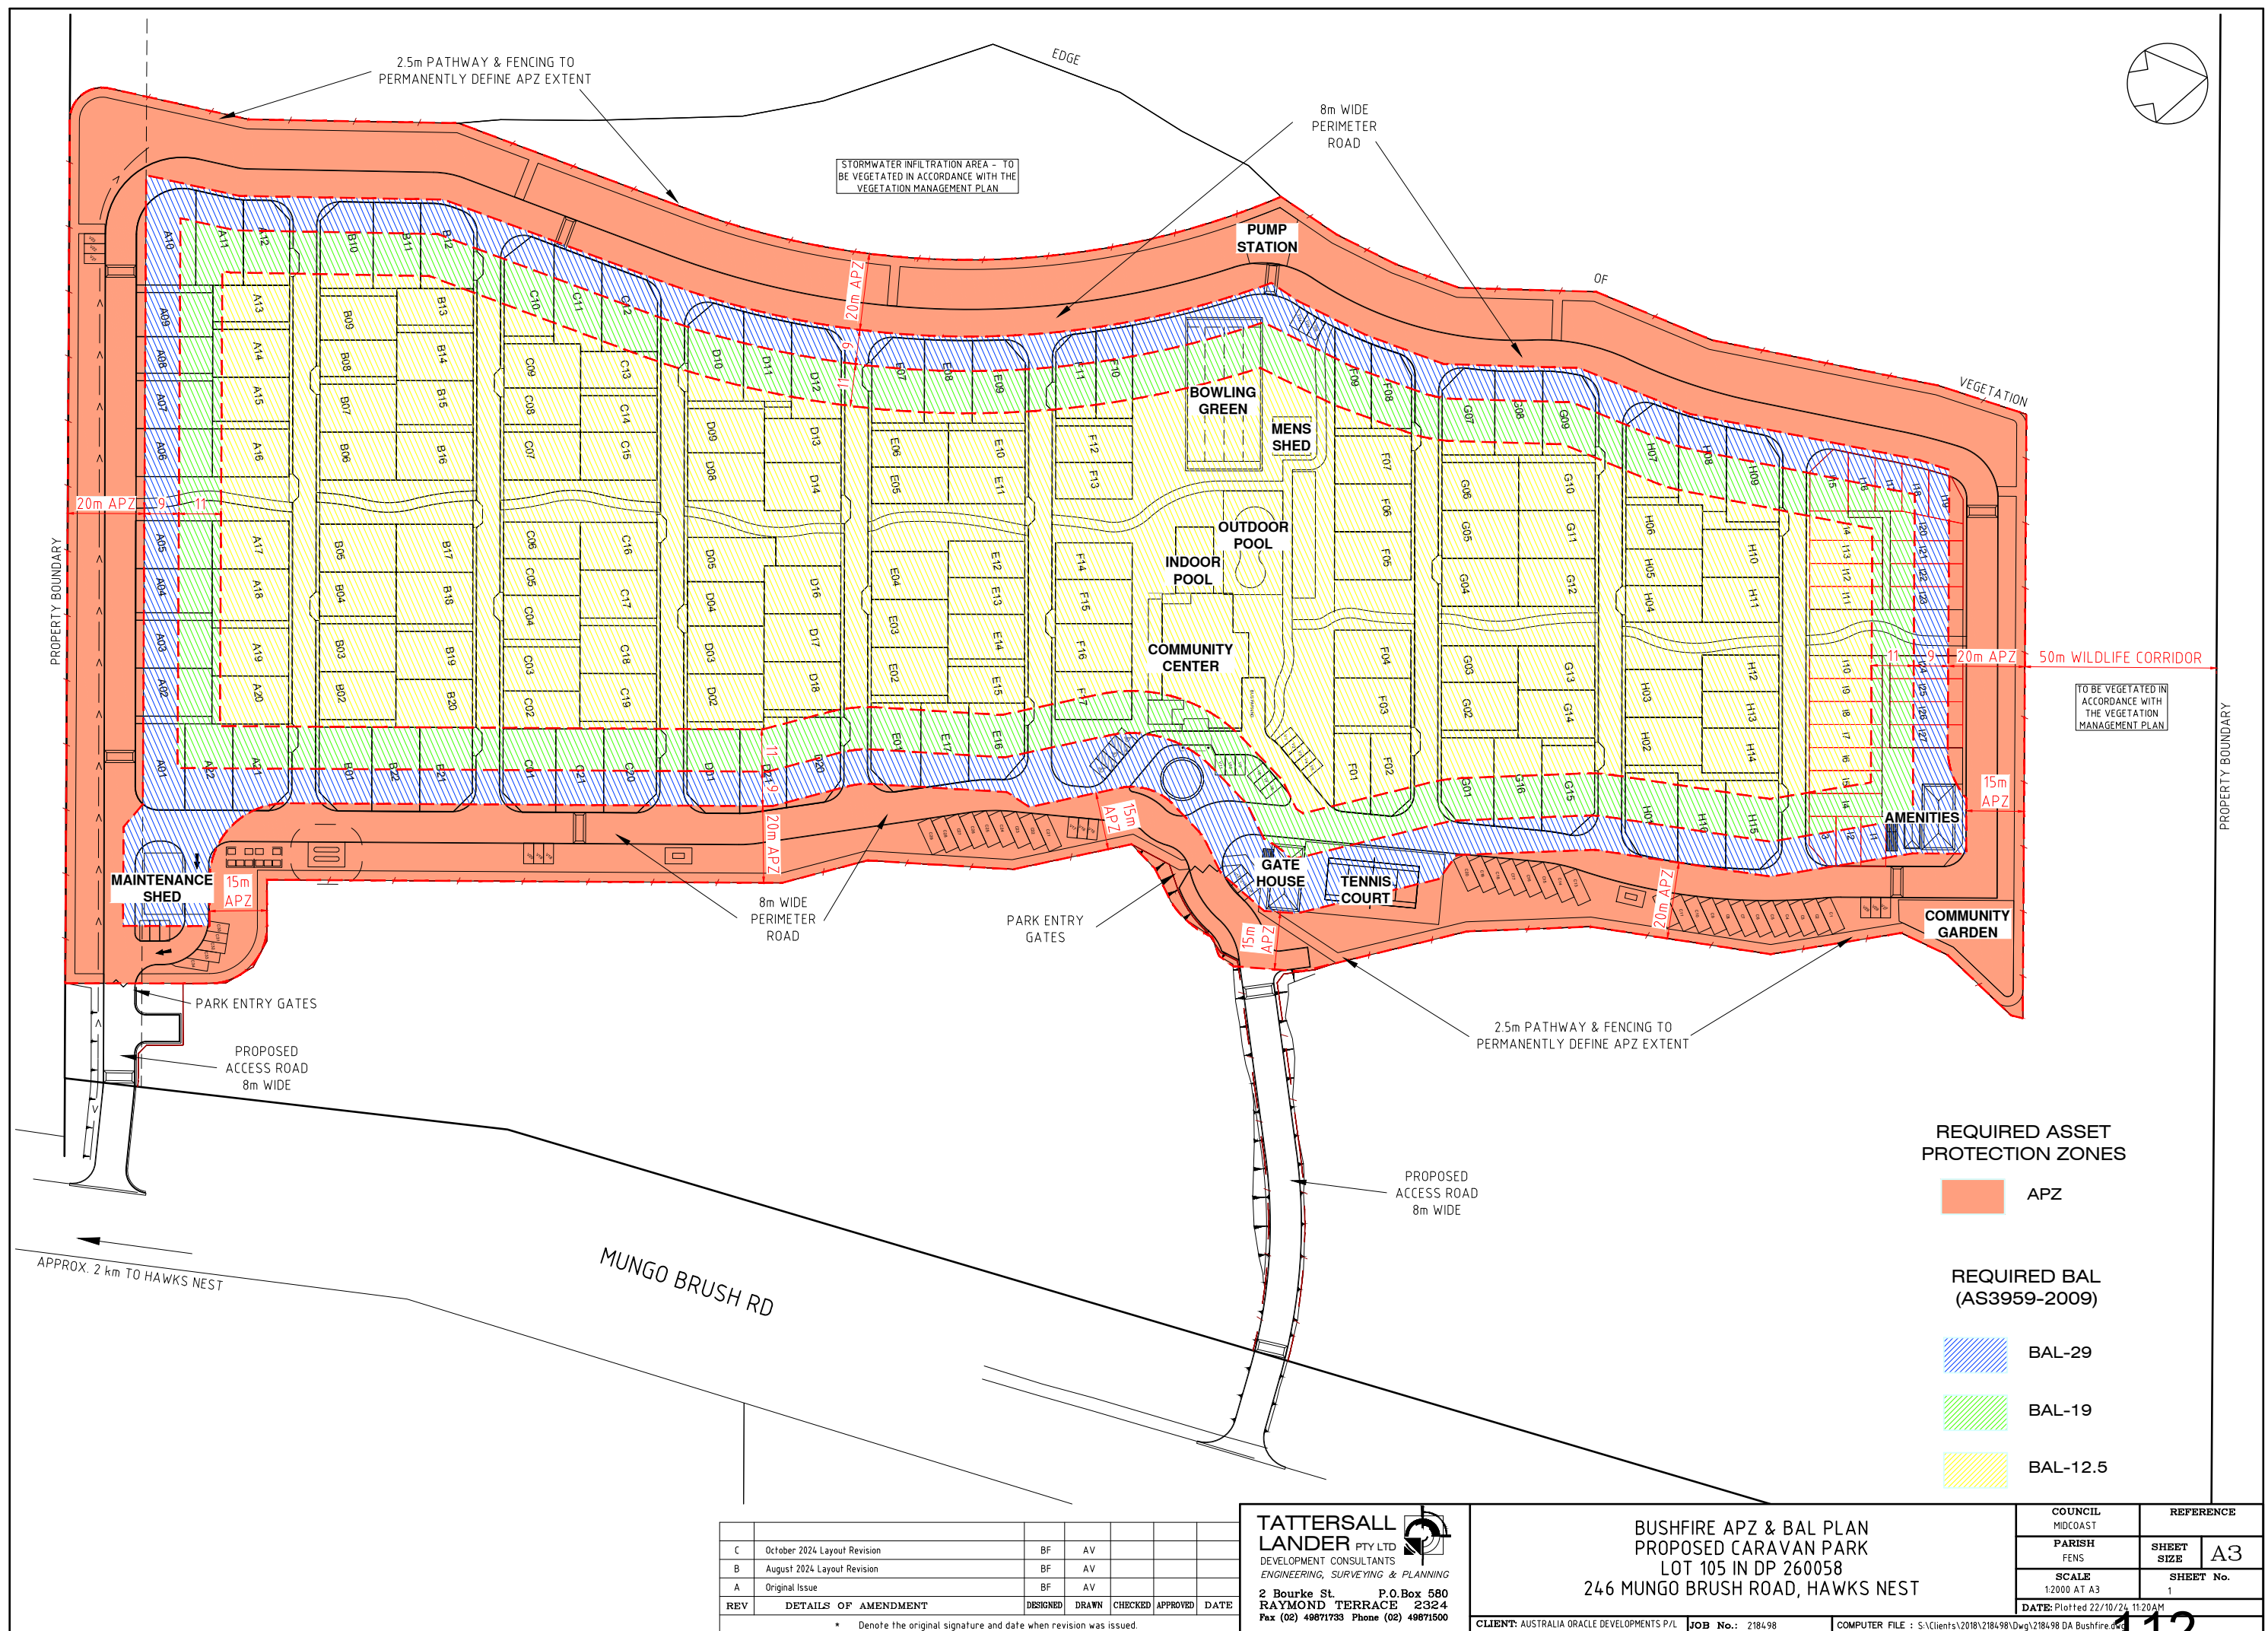
### Site/BAL Plan

The proposal will require a minimum 20 metre APZ for all the dwellings and this has been achieved in the design. All other potentially combustible structures (such as the amenities buildings and maintenance shed) require a minimum 15 metre APZ as this will result in them being located outside of the flame zone and they do not require construction to any BAL – such structures are to be located at least 6 metres from any dwelling unless they are also located such that they have a 20 metres APZ and in this instance they are to be treated the same as a dwelling. The proposal is completely compliant in this regard. A site plan which also includes the relevant BAL zones is included in Appendix C.

The proposal layout includes an 8m wide perimeter road and two entrance ways, one of which shall be located towards the south of the site and the other is to be located approximately centrally. Both shall access the park from Mungo Brush Road which abuts the site to the east. The internal road network (i.e. those roads excluding the perimeter road) proposes roads will run in a general east west direction, linking at each end with the perimeter road. These internal roads have a straight, flat alignment that offers clear visibility from one end to the other. No cul-de-sacs or other such no-through roads are included in this proposal. A copy of the proposed site layout is included in Appendix C.
