# **Statement of Environmental Effects**

## **Ricochet Mountain Bike Trail Realignment**

Thredbo Alpine Resort  
Kosciuszko National Park, NSW

Project: 23004MO

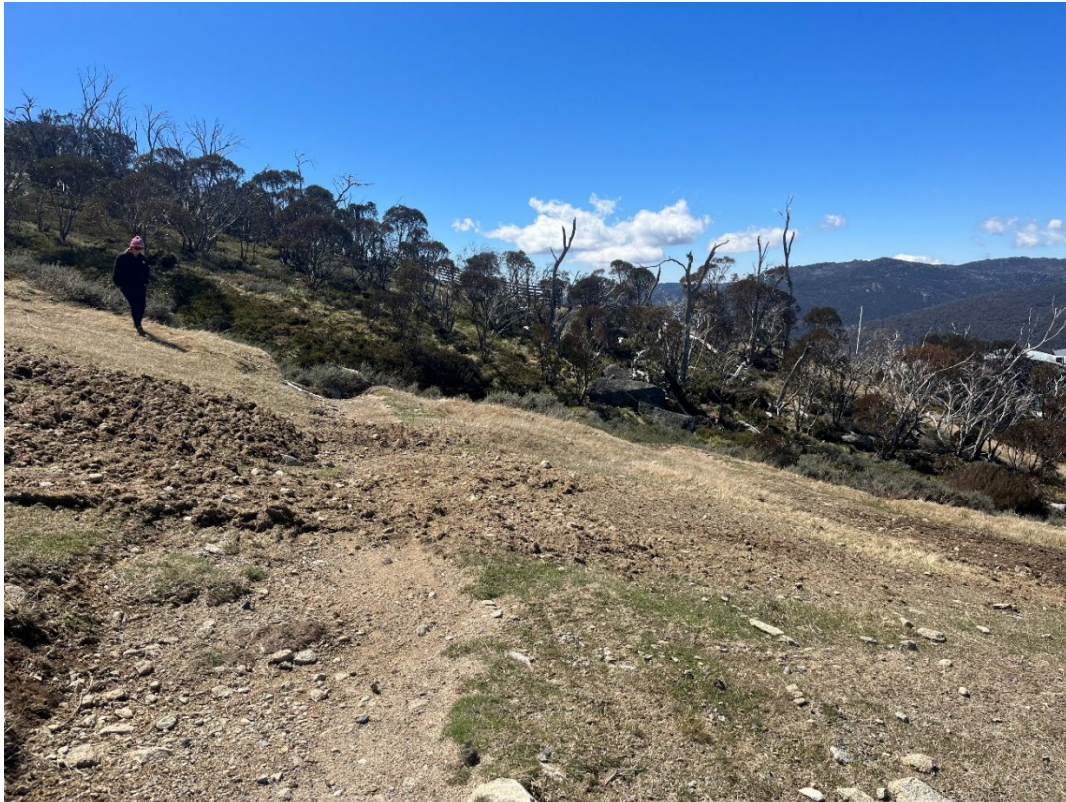
**Plate 1: Trail erosion and rock displacement from existing trail on Lenny's Leap ski run**

During low snowfall winter seasons, exposed rocks from trail and berm construction on Lenny's Leap has created hazards for skiers and snowboarders. This was particularly evident during winter 2023 as documented by Thredbo's Ski Patrollers. The trail remains impacted by multiple road crossings which also creates rider safety concerns when riding at speed. There are several reported incidents in KT's DoneSafe incident reporting database along this section of trail to be closed.

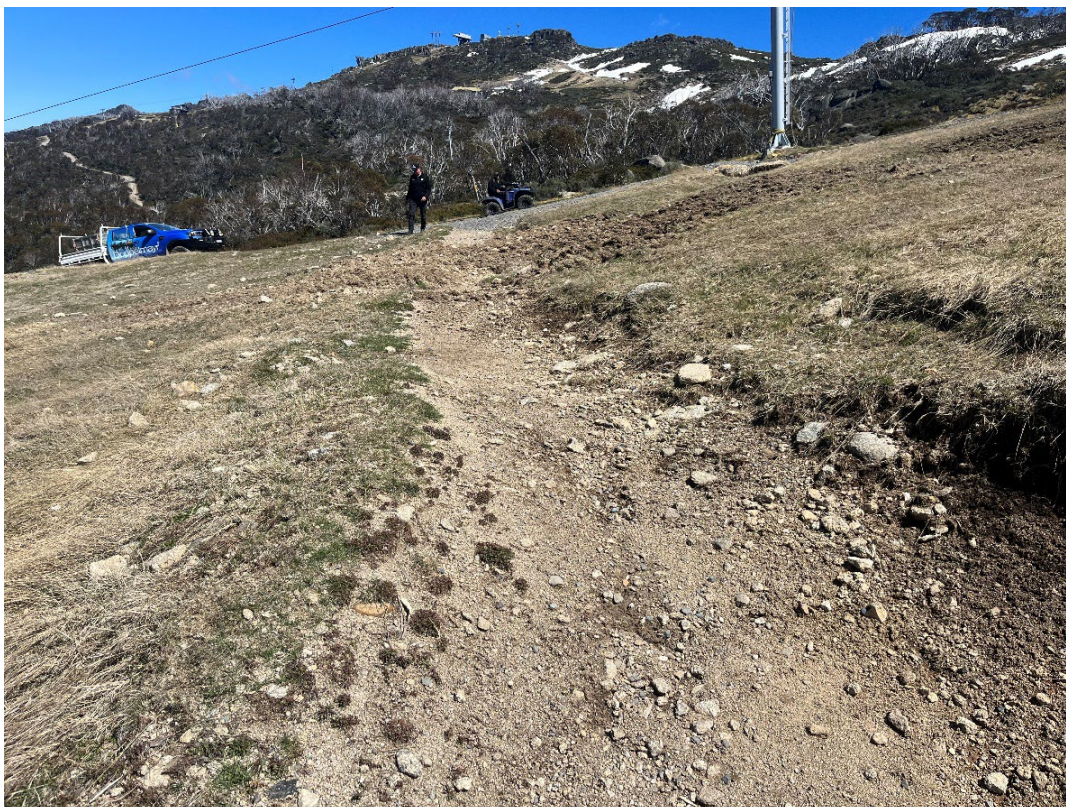
**Plate 2: Trail erosion on Lenny's Leap ski run facing towards Anton's tbar corridor**

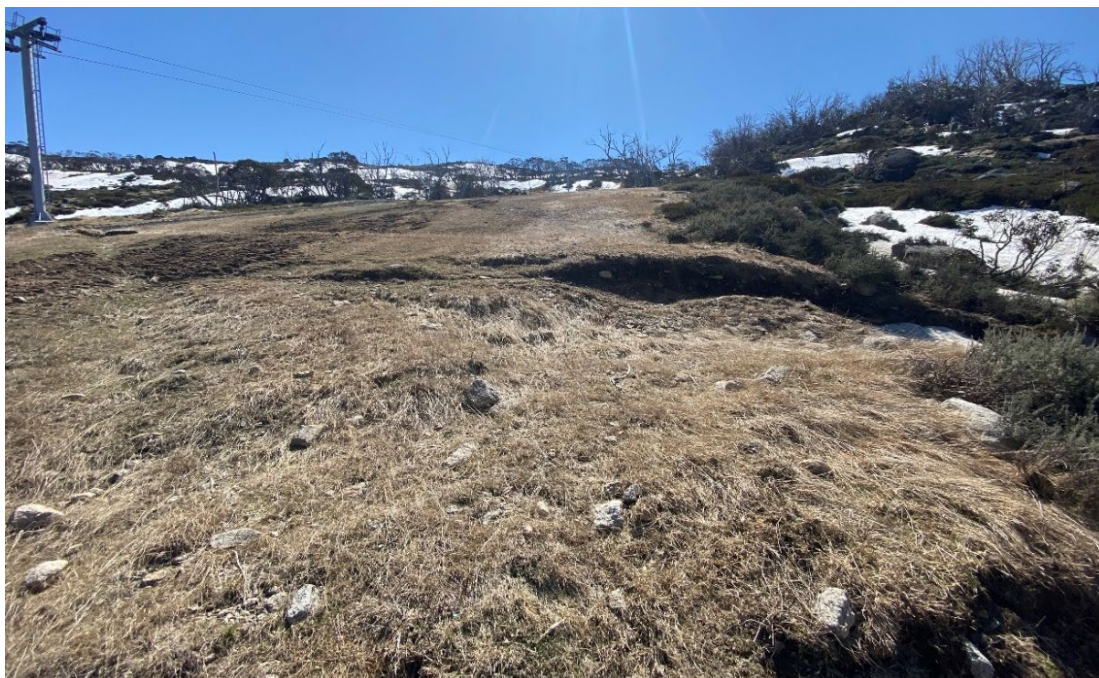
**Plate 3: Evidence of rock displacement associated with existing trail (post-winter 2023)**

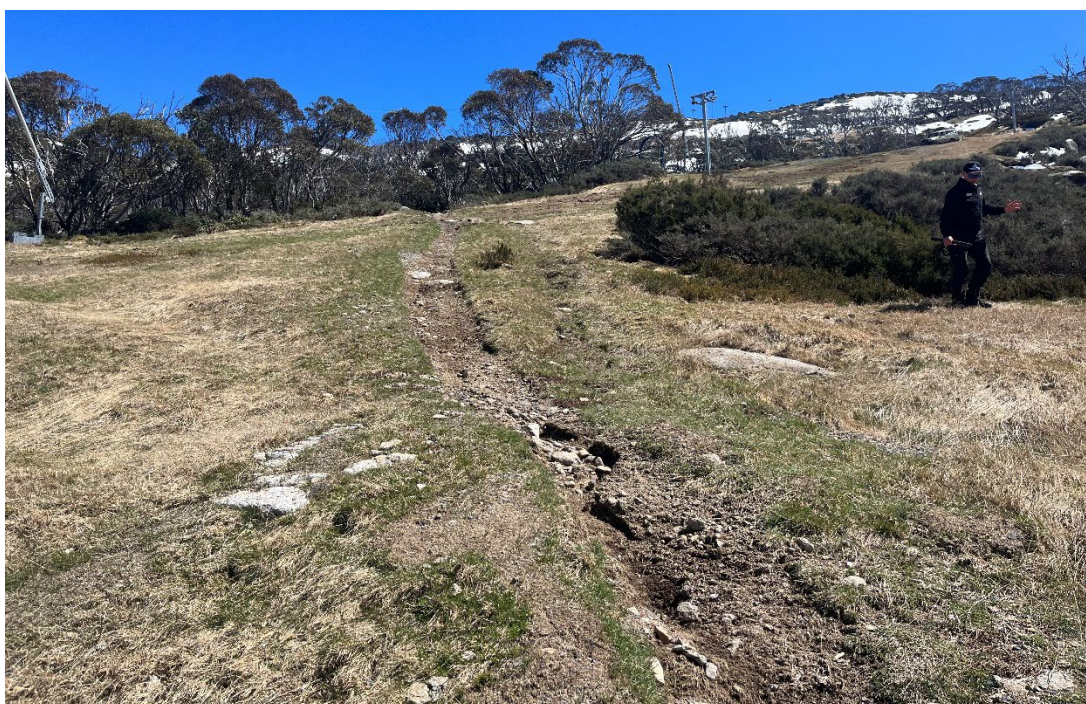
**Plate 4: Ricochet trail erosion and braiding (post-winter 2023)**

The section of trail below Frost Bite to be closed is steep and prone to erosion and trail braiding as shown in **Plate 4** and **Plate 5**.

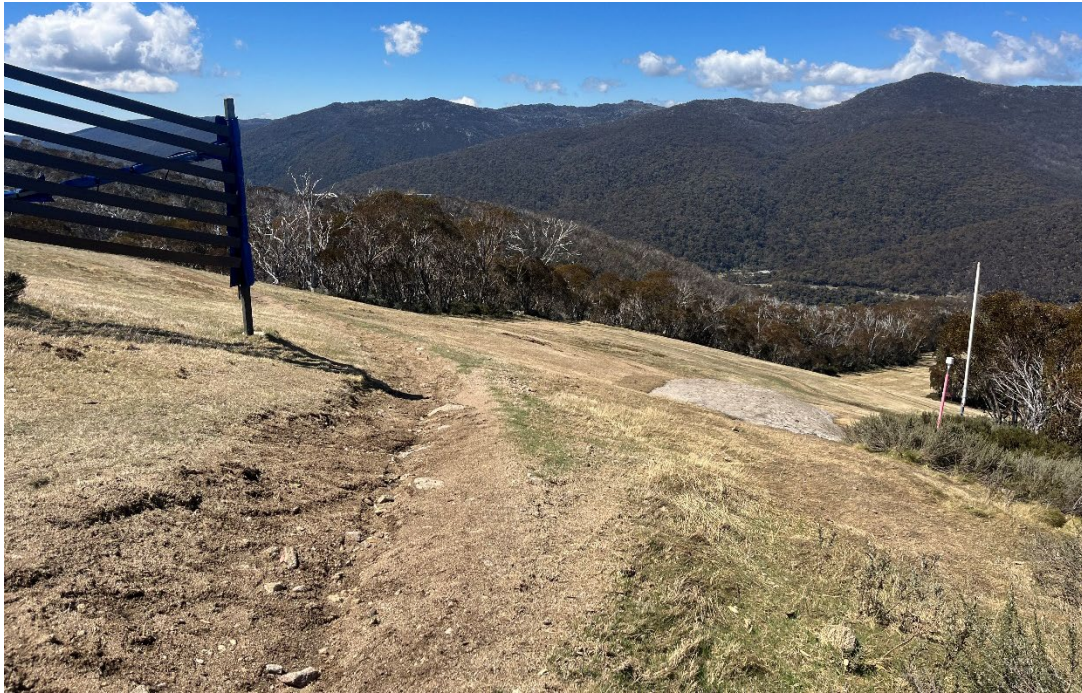
**Plate 5: Ricochet trail channel erosion on the Frostbite crossing (post-winter 2023)**

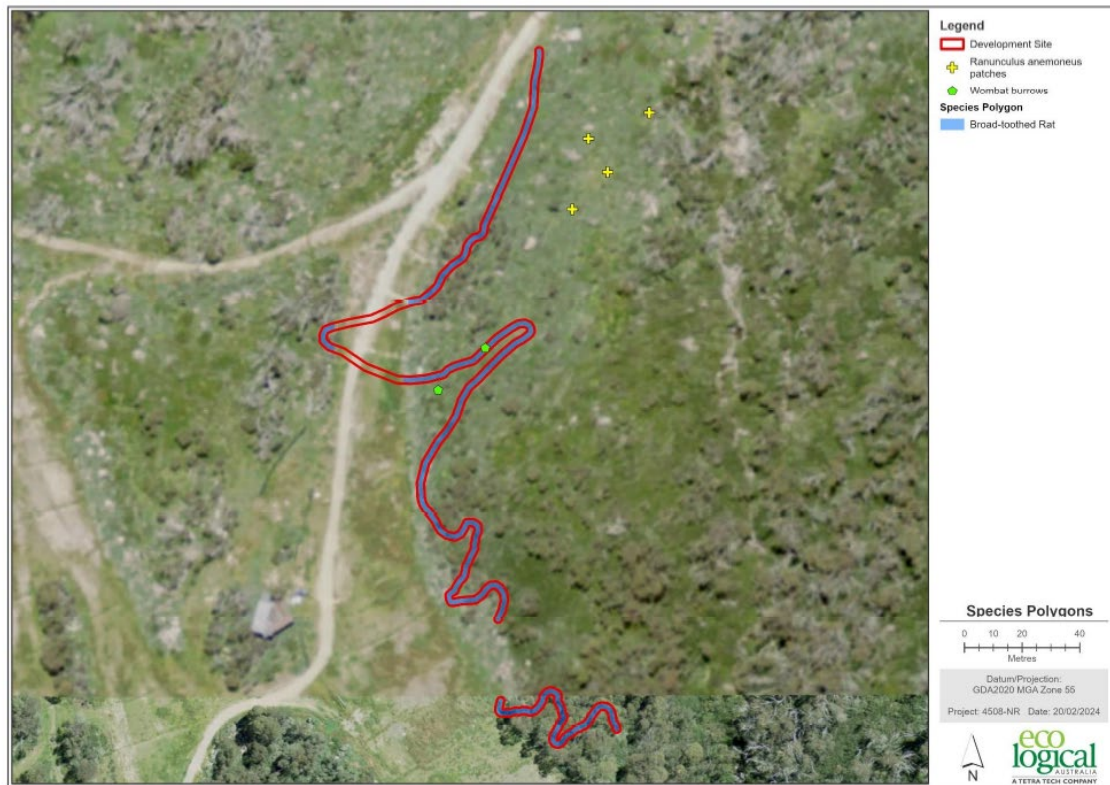
**Figure 2: Wombat burrows identified in the field survey (ELA 2024)**

During the field surveys, two wombat burrows were identified within proximity of the trail alignment (refer **Figure 2**).
