Additional Geotechnical Comment

Proposed Additions

Lot 108 DP1242013, Charlotte Pass NSW

Architectural Drawing Set #220

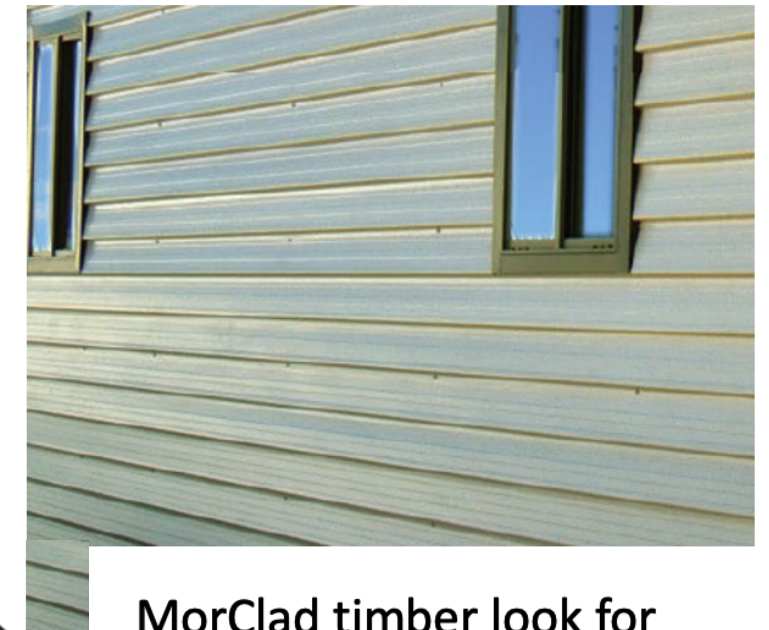
MorClad timber look for
main lodge.
Colour: Monument matt

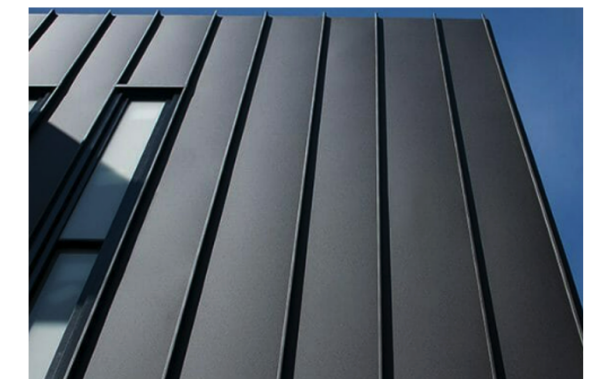
Colorbond vertical for porticos
Colour: Monument Matt

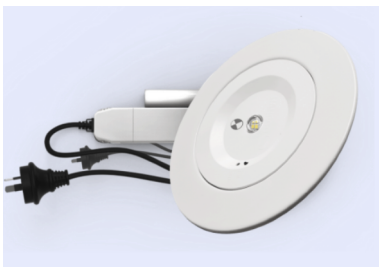
Spitfire Emergency Light

- existing walls
- existing elements for removal/demolition
- emergency lighting 'spitfire' to be installed where required : certification to be provided
- exit lighting in portico to AS/NZ 2293.1

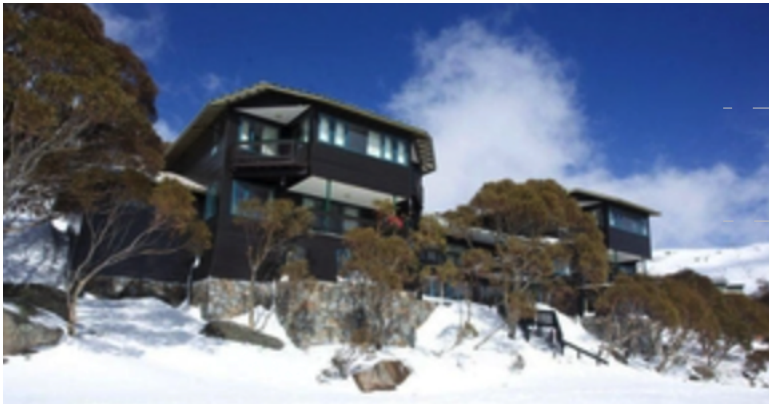
existing photo (east wing)

1. First Floor external columns, which support quiet lounges, are to be core filled with non-shrink structural grout. The grout mix must be equal to concrete block core fill mix with a minimum strength of 20MPa. The grout must extend to the top cap of the column to ensure the grout takes the load of the column. All four columns, two on the east side and two in the west side are to be core filled.

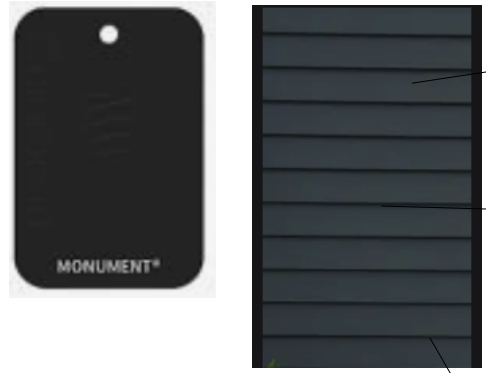
existing single glazed doors at to be infilled with gyprock, timber frame, F2.7 insulation and steel cladding

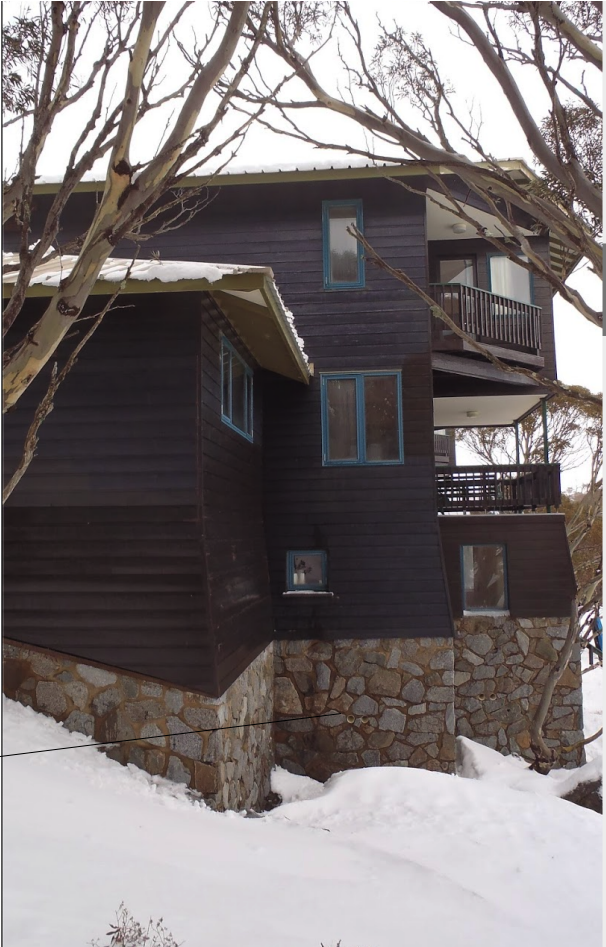
existing photo
(east wing front)

- All fame damage to be inspected and photographed and emailed to the structural engineer for review
 - Subject to structural engineering approval : repairs to be undertaken by builder

- Replace all existing R2.5 insulation with new R2.7 insulation
 - Wall to be sealed with Bradford Enviroseal Protector Wrap
 - Vertical strip batten installed over the sarking (30x11 H3 treated), aligned to studs. This will provide ventilation between the sarking and cladding

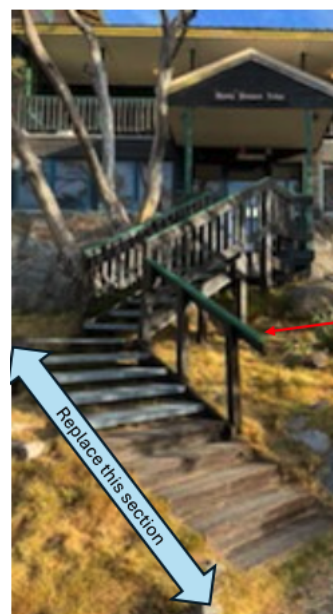
lower balustrade
to be simple
handrail

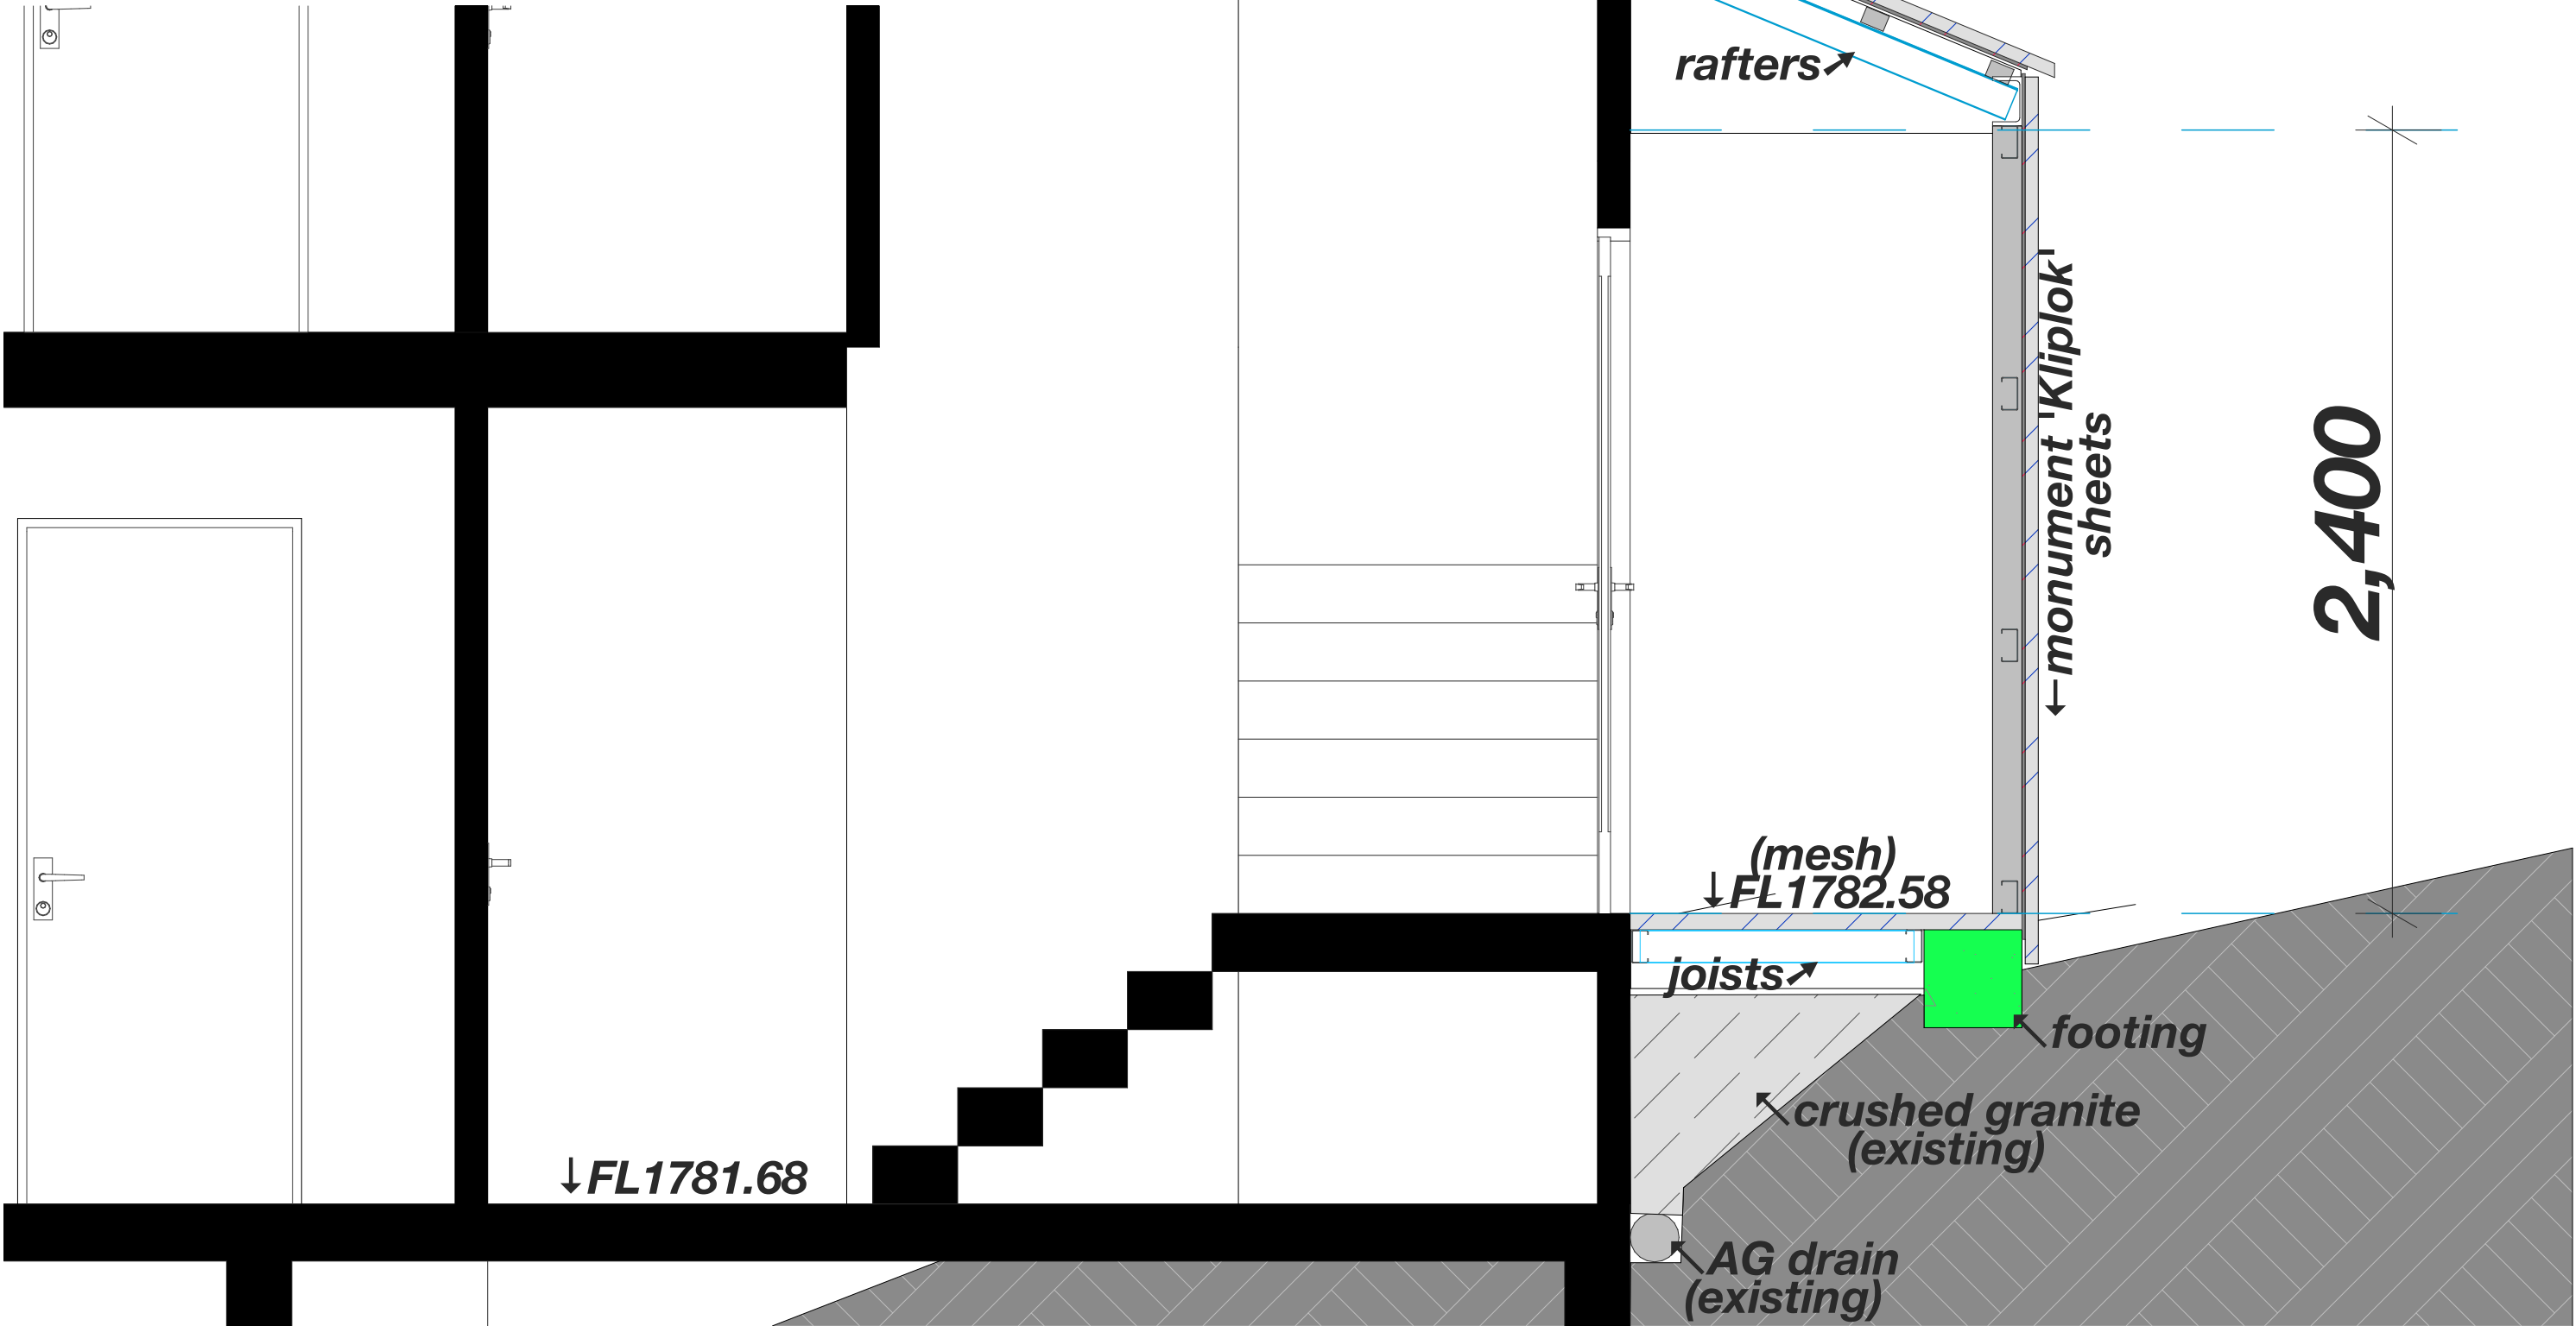
west wing fire escape
[section view] scale 1:20 detail

*Wall, Roof and Floor framing steel RHS as detailed in Camstruct 'Fire Escape details'

For Items 1 and 2 above, given the location of these two areas are in steeper parts of the site, Douglas Partners Pty Ltd would recommend all footings found within weathered rock. This would be in accordance with our 22 July 2022 report (Project No 215571.00) for likely footing depth and allowable bearing pressure recommendations.
