Land & Housing  
Corporation

## DETAIL & CONTOUR SURVEY

189 RIVERSIDE DRIVE, AIRDS

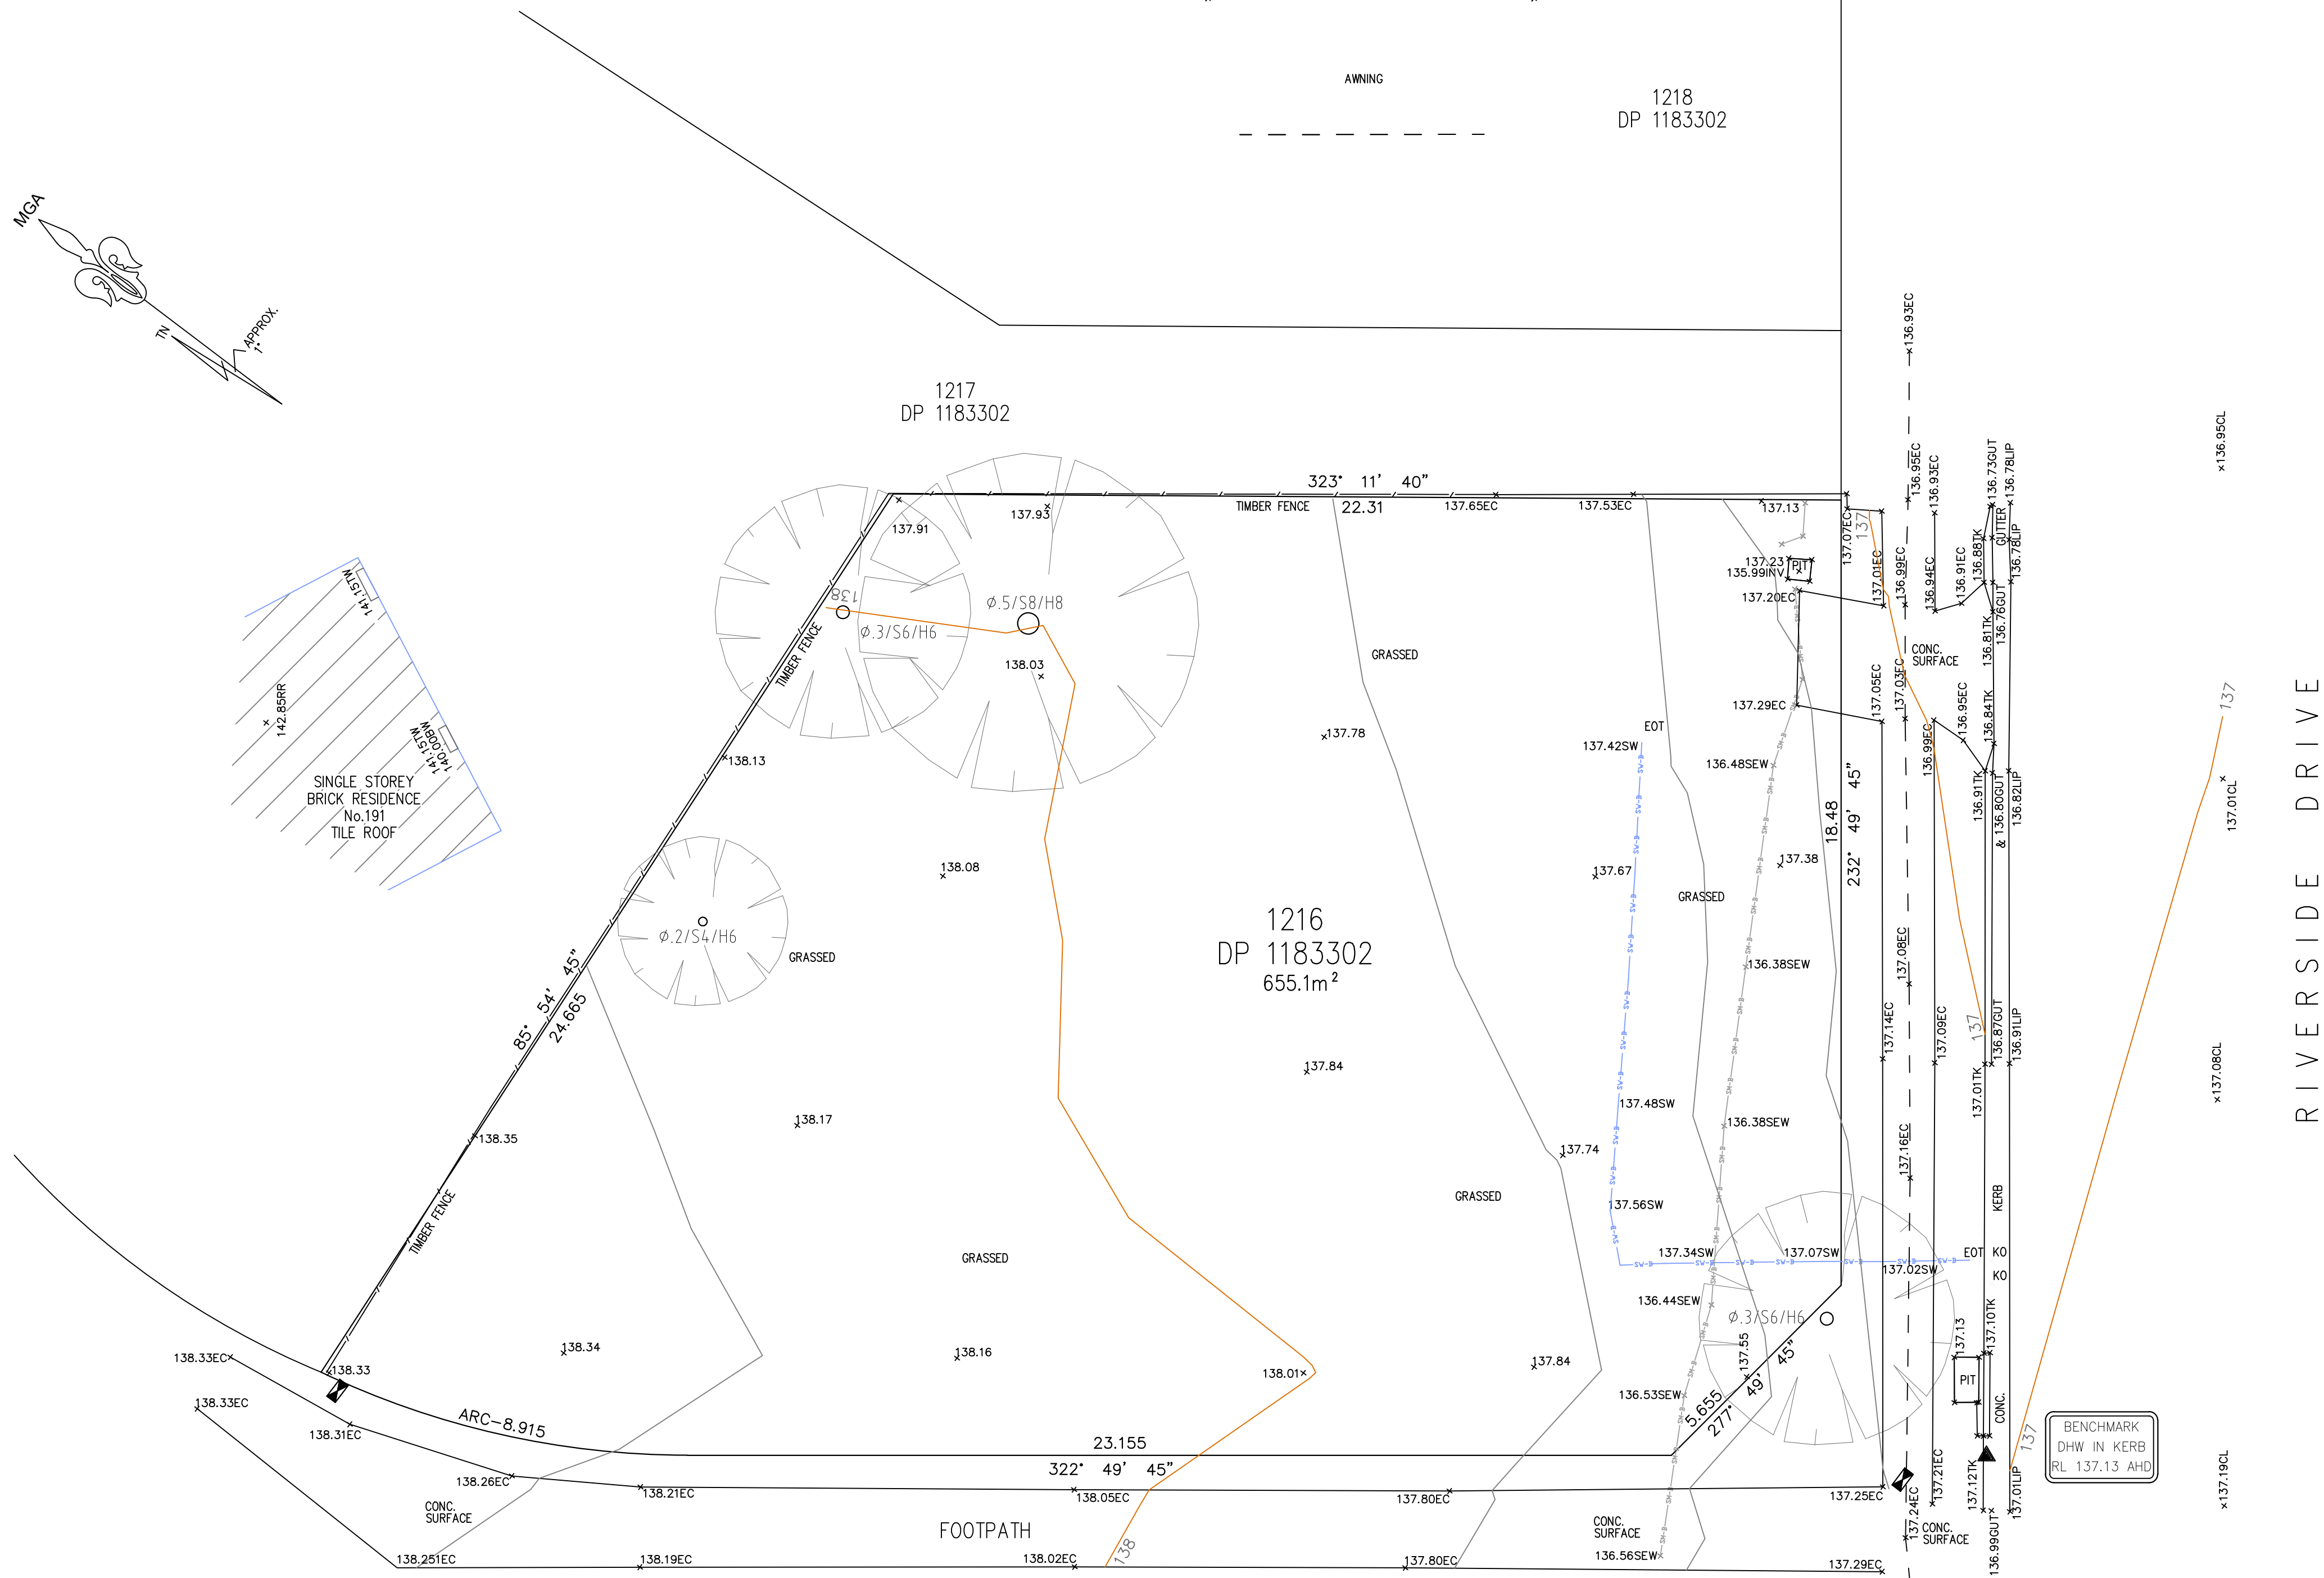
BOUNDARIES HAVE BEEN DETERMINED BY SURVEY ON 16/06/2020.

SERVICES SHOWN ARE INDICATIVE ONLY. POSITIONS ARE BASED ON SURFACE INDICATOR(S) LOCATED DURING FIELD SURVEY. CONFIRMATION OF THE EXACT POSITION SHOULD BE MADE PRIOR TO ANY EXCAVATION WORK. OTHER SERVICES MAY EXIST WHICH ARE NOT SHOWN.

RIDGE & GUTTER HEIGHTS HAVE BEEN OBTAINED BY INDIRECT METHOD AND ARE ACCURATE TO  $\pm 0.05\text{m}$

CONTOURS SHOWN DEPICT THE TOPOGRAPHY. EXCEPT AT SPOT LEVELS SHOWN THEY DO NOT REPRESENT THE EXACT LEVEL AT ANY PARTICULAR POINT. THE SPOT LEVELS ARE TRUE FOR THEIR POSITION, AND ARE INTENDED TO BE USEFUL TO REPRESENT THE GENERAL TERRAIN. CARE SHOULD BE TAKEN IF EXTRAPOLATING.
